PRESENTATION ON PEER REVIEW, SUPPLEMENTAL INVESTIGATION AND SEEPAGE ANALYSIS FOR KINGSTON FOSSIL PLANT, DREDGE CELL KINGSTON, TENNESSEE

Prepared for
Tennessee Valley Authority

Prepared by
GeoSyntec Consultants

April 2005

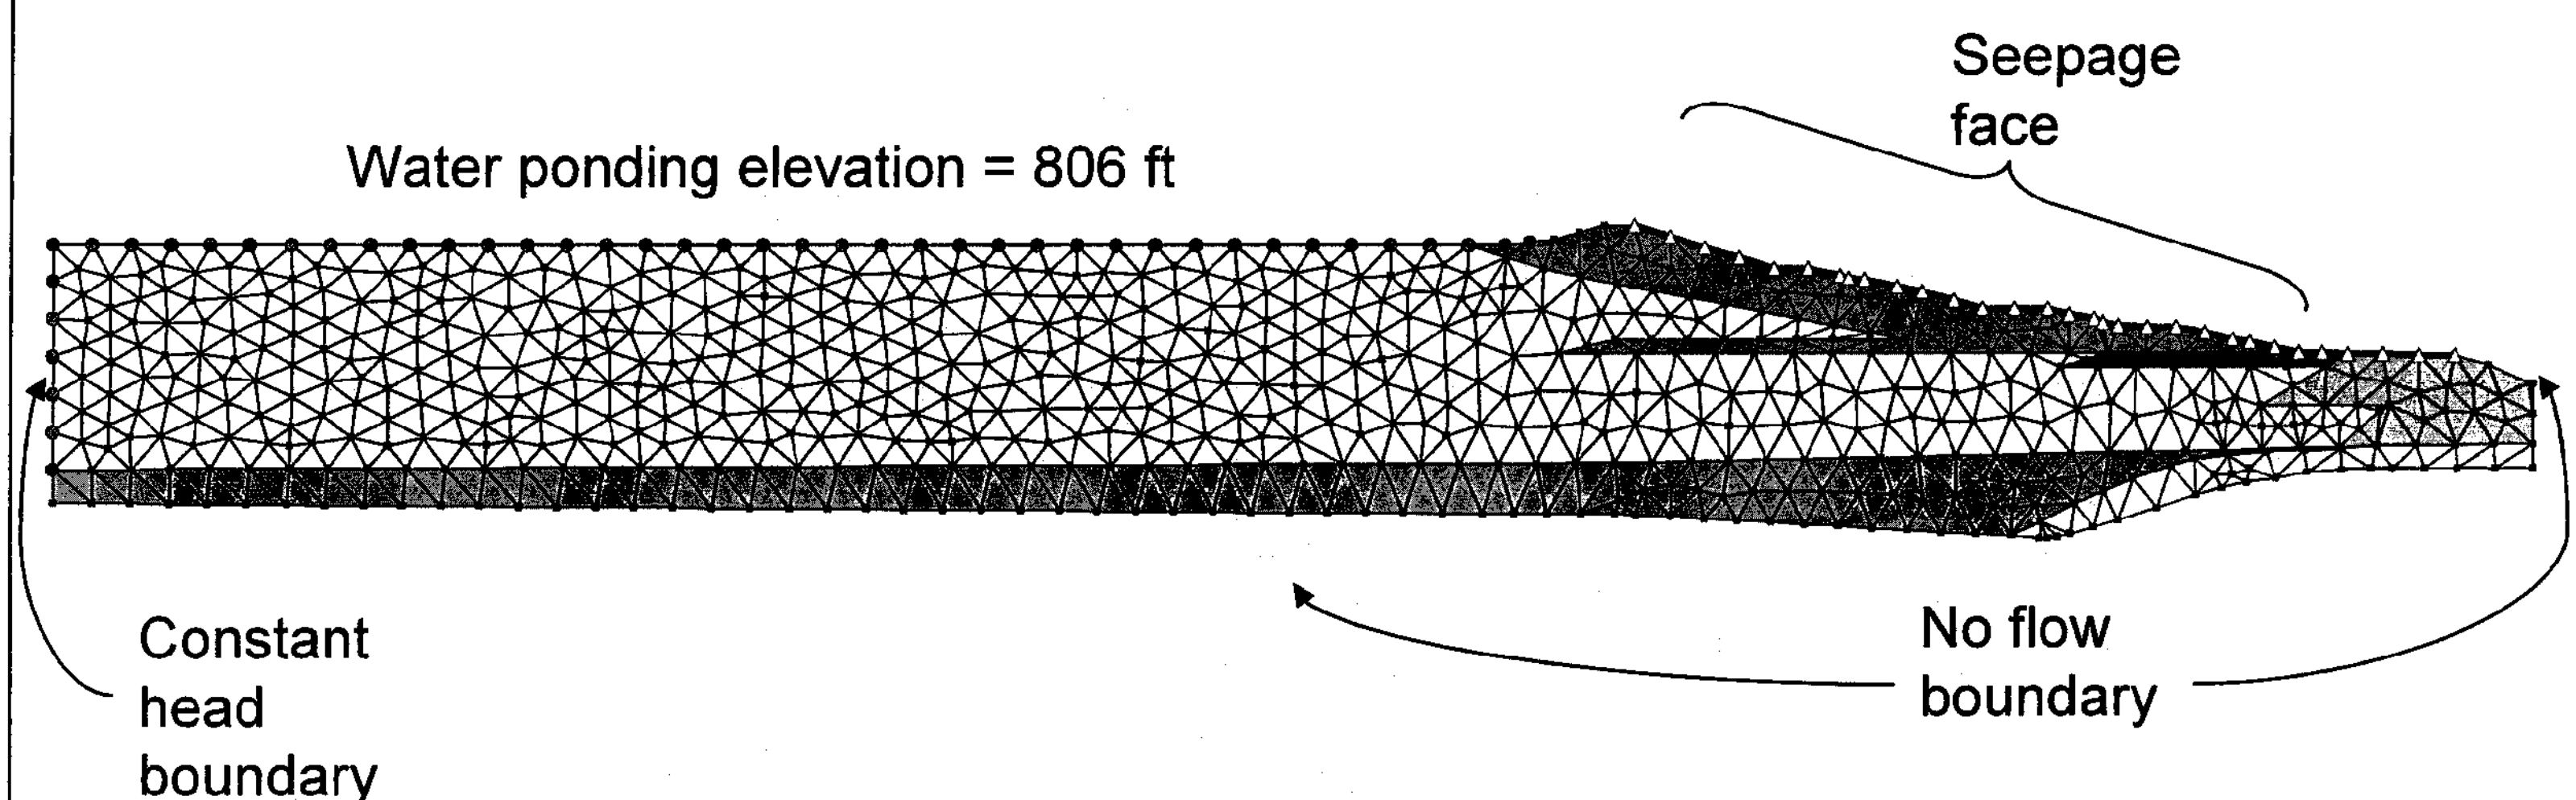
Case 2 (Blow-out condition)

Information regarding the depth of water in the dredge cells at the time of blow-out was estimated based on field observations and was provided by TVA personnel during the January 2005 meeting. Water depth in the dredge cell was observed to be 4 feet below the elevation of the top dike (i.e., elevation 810 ft MSL).

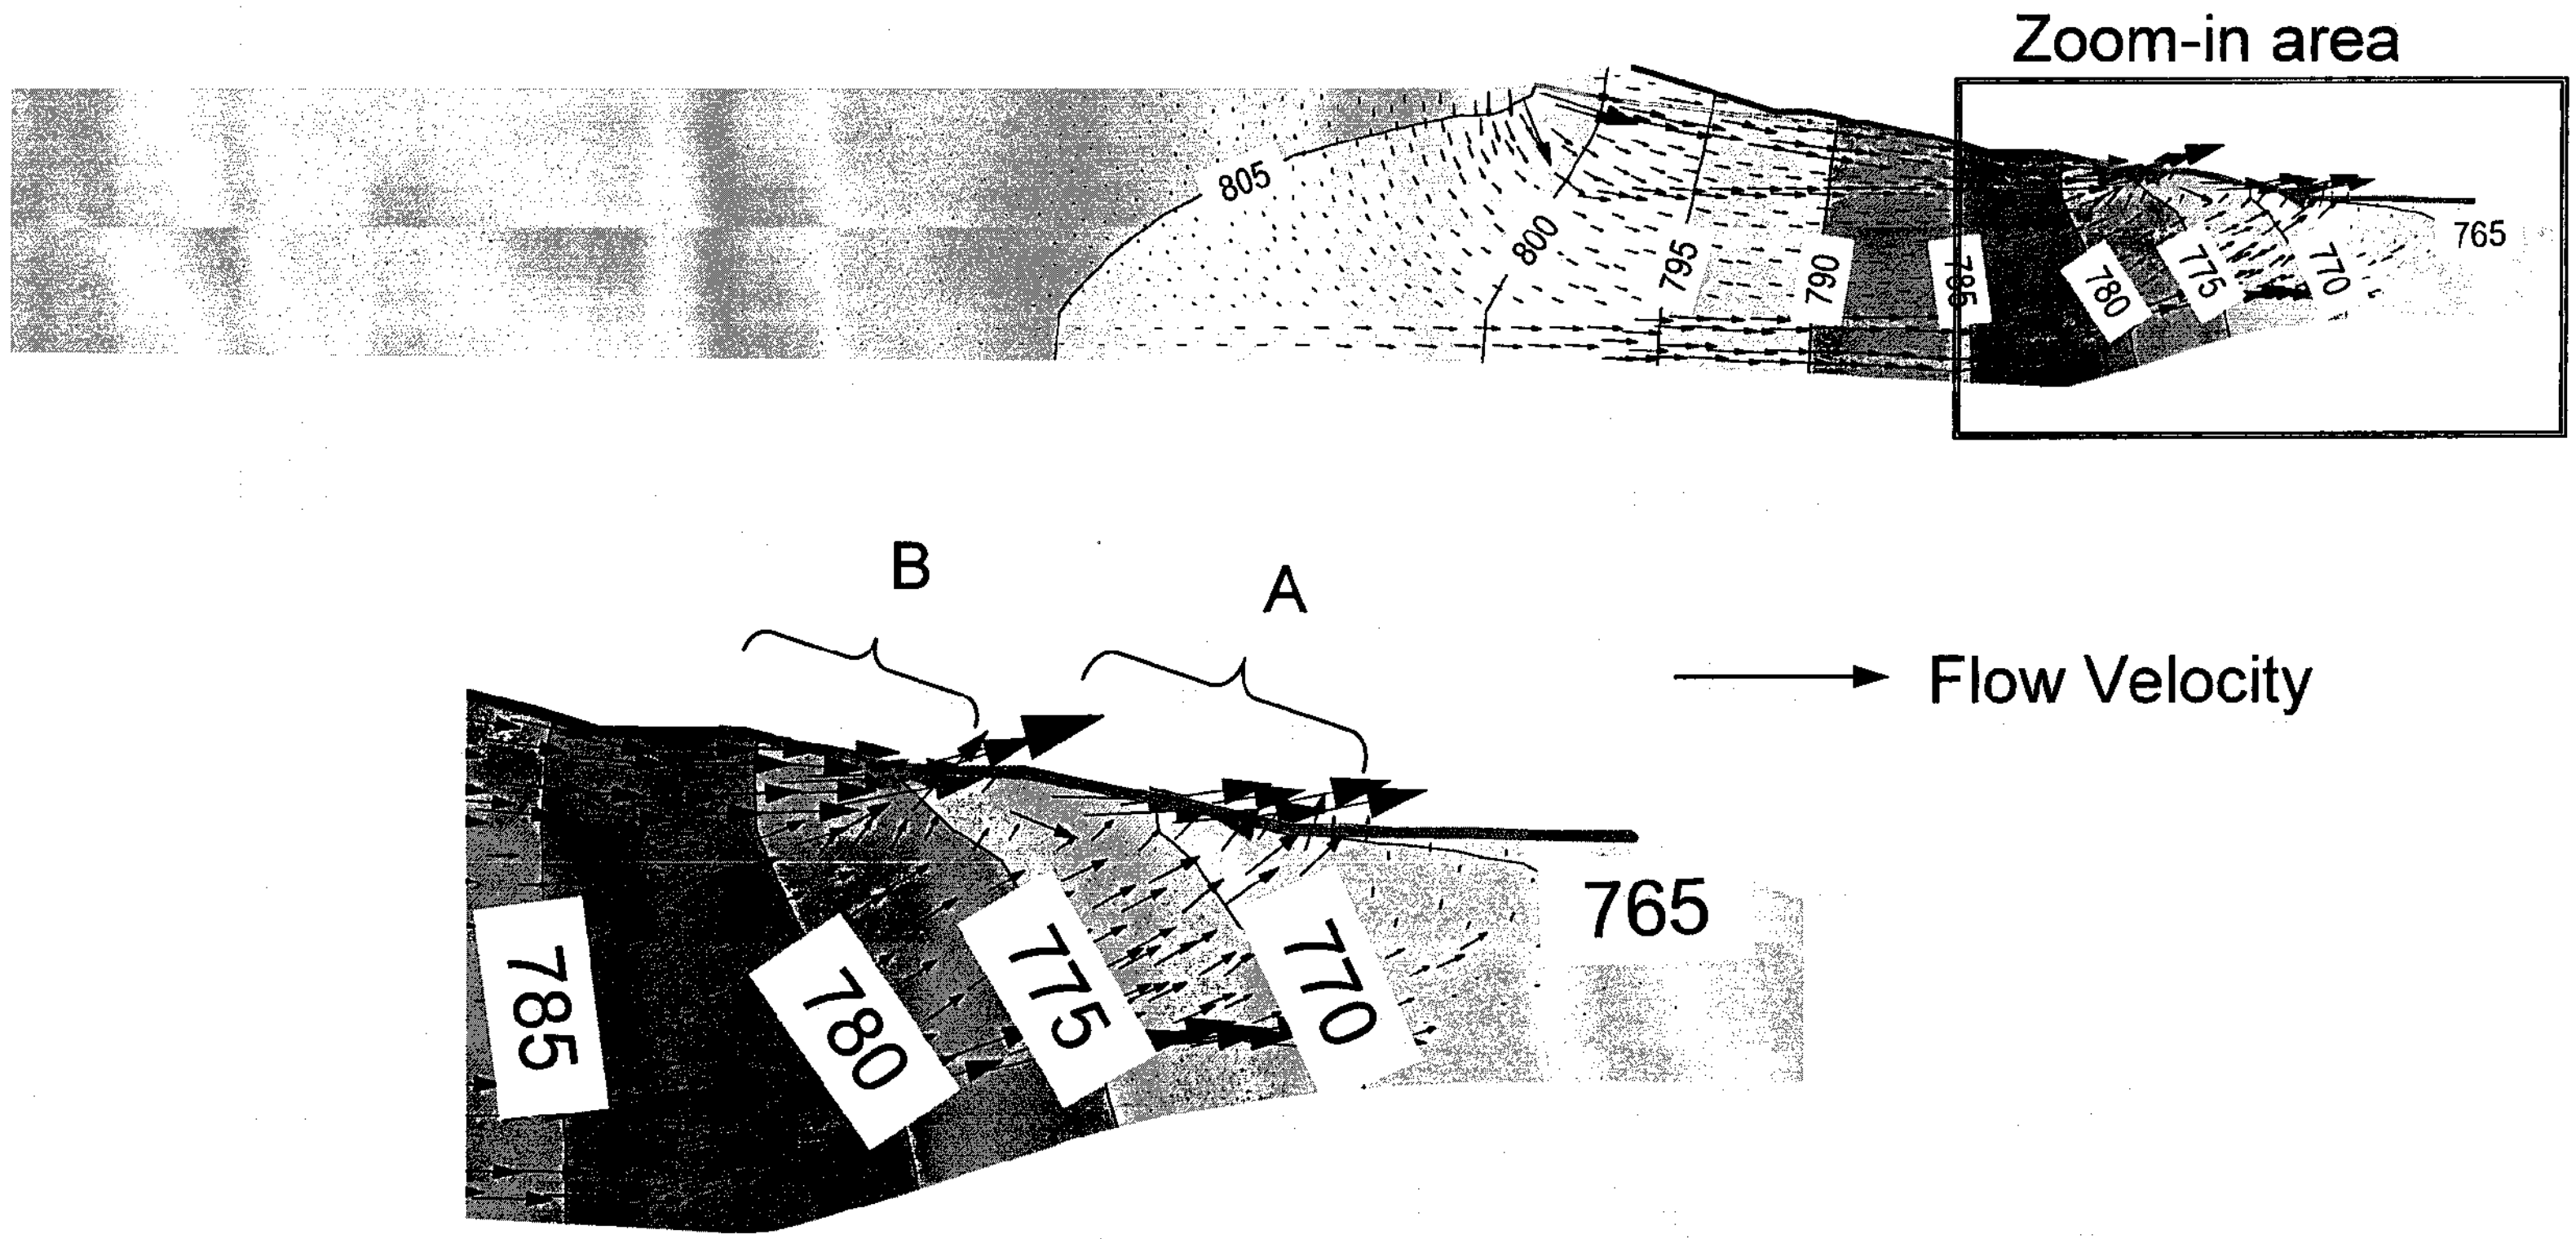
Model-predicted Total Head Distribution (equipotential lines)

Model-predicted Hydraulic Gradient, i	Critical Hydraulic Gradient, i_c	Piping will occur? (Y/N)	Factor of safety against piping F.S. = i_c / i
Slope face A	**0.25 – 0.31**	**0.28**	**Y**	**0.90 – 1.12**
Slope face B	**0.14 - 0.25**	**0.28**	**N**	**1.12 – 2.00**
Base of slope	**0.21-0.24**	**0.28**	**N**	**1.17 -- 1.33**

Considering the unit weight of fly ash to be 80 pcf, the critical hydraulic gradient = (80-62.4)/62.4 = 0.28.

Acceptable factor of safety against piping is 1.50.

- The computed hydraulic gradient at the lower portions along exit face 'A' is greater than the critical hydraulic gradient, confirming the likelihood that piping and blow-out will occur consistent with that observed in field.

- Model-predicted location of blow-out (i.e., exit face 'A') coincides with blow-out location observed in the field (i.e., at elevation 766 ft MSL).

- As indicated from the analytical results of Case 2 (blow-out condition), blow-out resulted from the development of internal pore water pressure on the face of the slope that caused piping to occur that led eventually to excessive seepage.

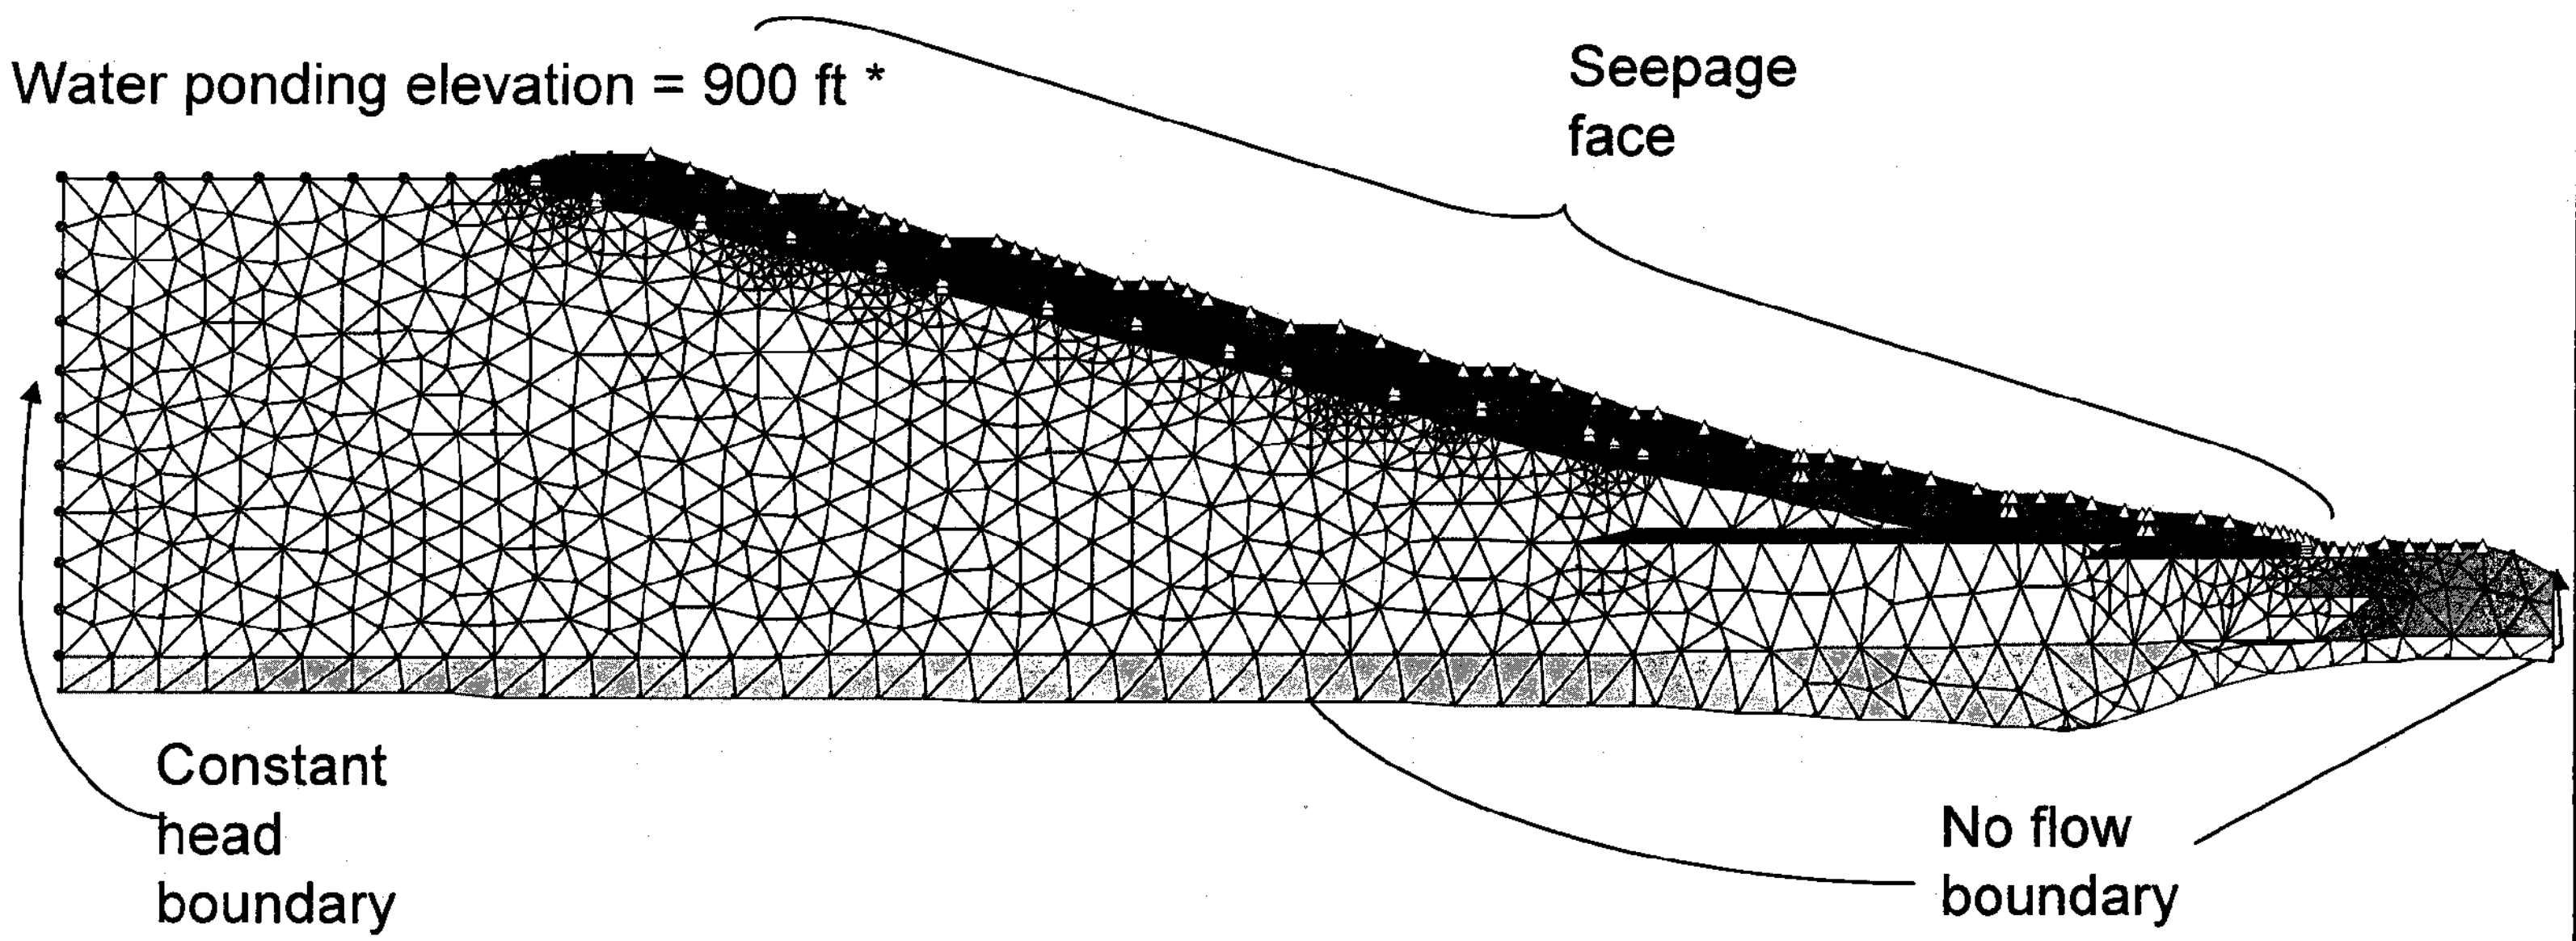
Case 3 (Future condition)

*Speculative Elevation
Only Proposing to Return to the Permitted Dredge Cell Elevation of 841/842.
(Conservative)

- Based on analytical results for Case 3, the proposed improvements are expected to lower the phreatic surface away from the face of the lower portion of the side slope significantly reducing the future potential for piping and providing an acceptable factor of safety.

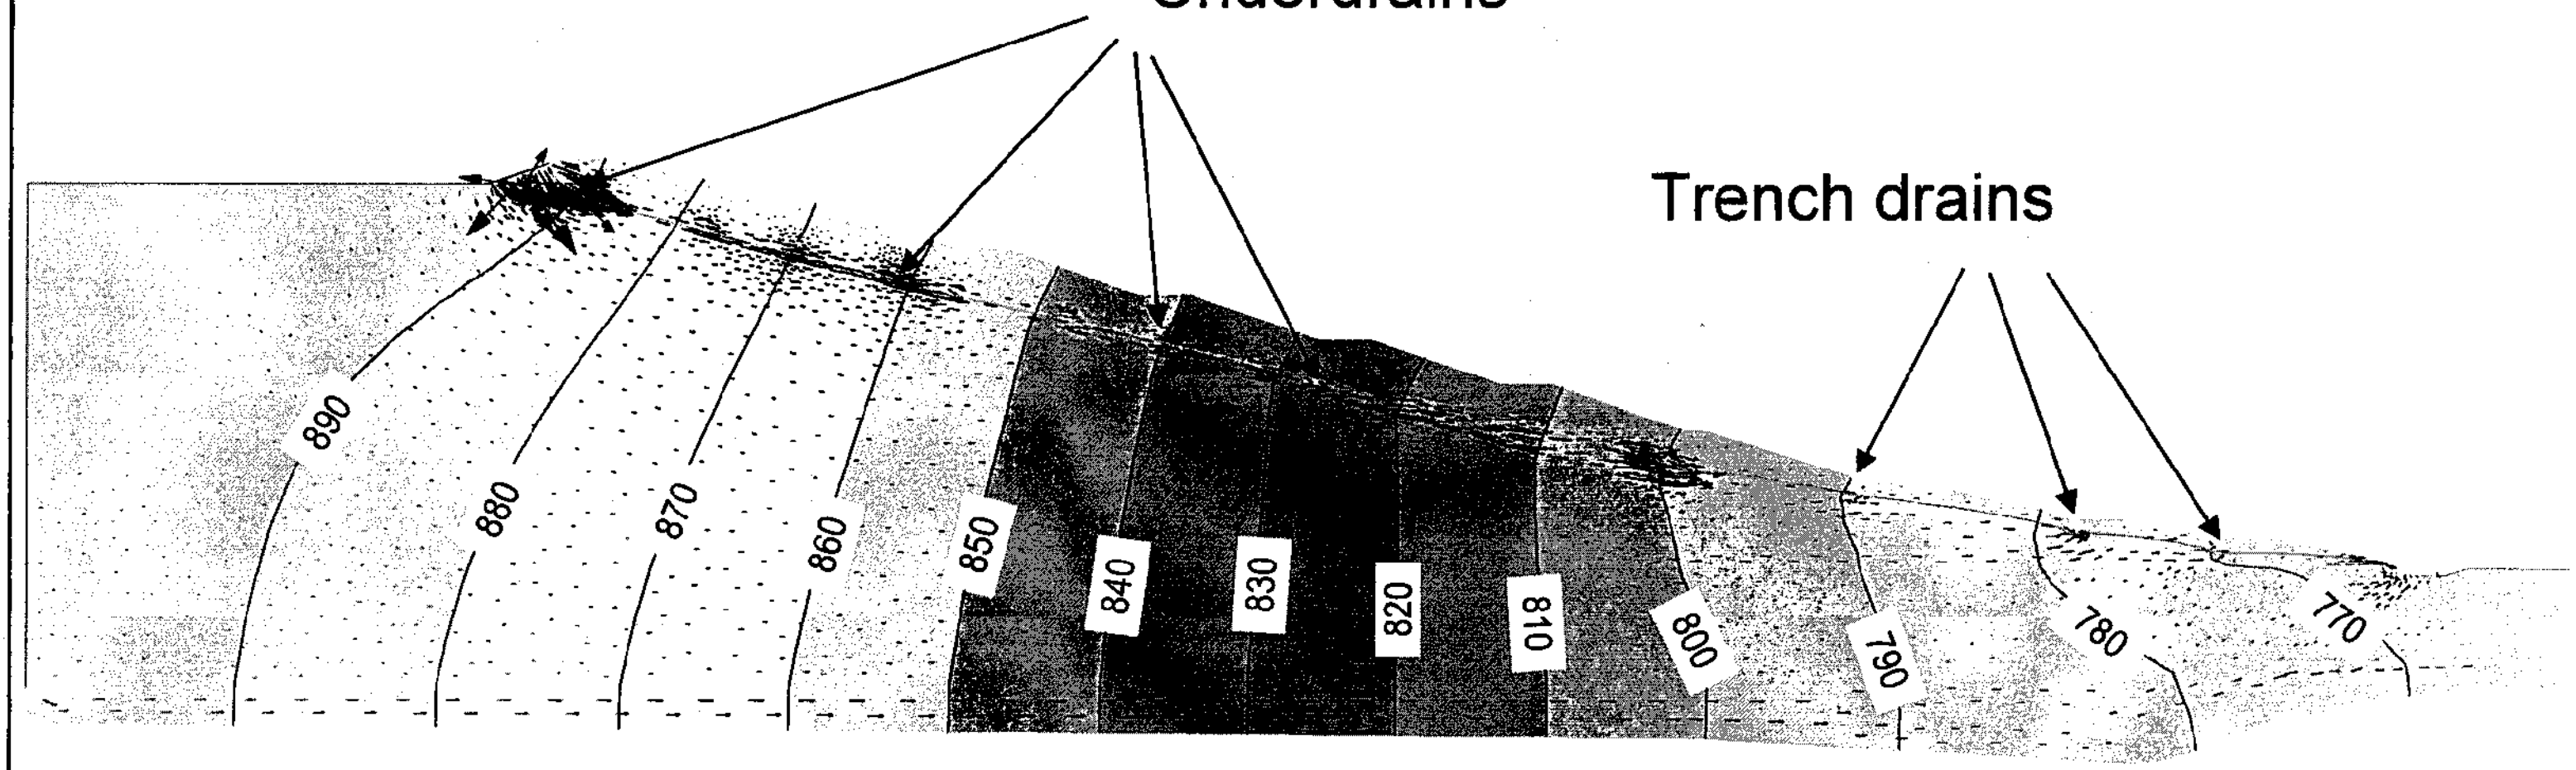
Model-predicted Total Head Distribution (equipotential lines)

Elevation	Flow rate into drains	
		ft^3/day/ft	gpd/ft
Trench drain	795	0.33	2.43
Trench drain	781	0.98	7.33
Trench drain	775	0.90	6.74
Toe Drain		0.68	5.08

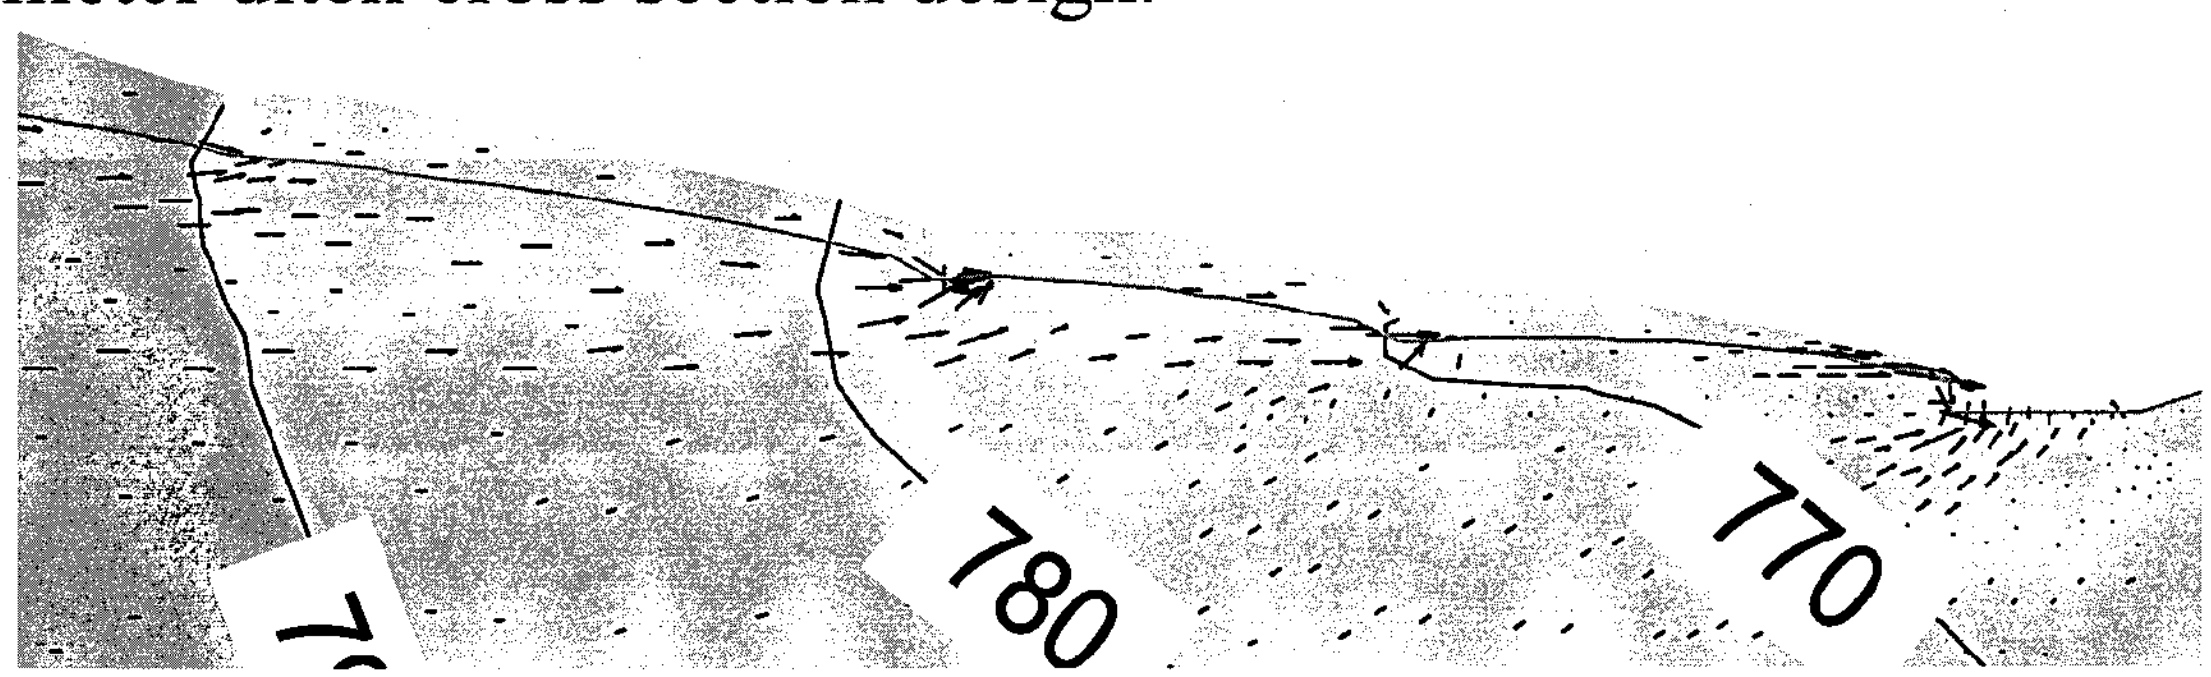
Flow rates estimated from the analytical model are used for trench drain design and perimeter ditch cross section design.
