#7 North Belt
MSHA MOUNT HOPE W
SEP 1 0 2009
Headgate 1 North
MMU-050-0 LOB = 42,912 CFM
Headgate 1 North
MMU-040-0 LOB = 23,664 CFM
This is necessary due to violations issued 9/15/09 where the primary escapeway has been compromised at numerous locations. The necessity for an isolated escapeway, free of potential fire sources, cannot be ignored. -JS
provide a list of safety precautions to ensure primary escapeway isn't compromised for two way travel of equipment. Further, an escapeway must be provided per 75.380(f)(3)
STOP
20" Dia. Borehole JARRELLS BRANCH
20CR Diesel
20CR Diesel
Est. 5,000 CFM
This regulator will be installed prior to hole-through of the dewatering hole and will be removed once the hole is regulated on the surface.
Proposed dewater hole location
PERFORMANCE COAL COMPA
P.O. BOX 69, MACKO, WV 25645
UPPER BIG BRANCH MINE
R.B.H.C. ID No. 46-08436
MSHA ID No. 46-08436
Date: 03-09-09
DRAWN BY: RL 3 Staff

SCALE: 1"=200'
DRG No. 1 of 1
CHECKED BY:
VENTILATION REVISION
DEWATERING HOLE
marked up original

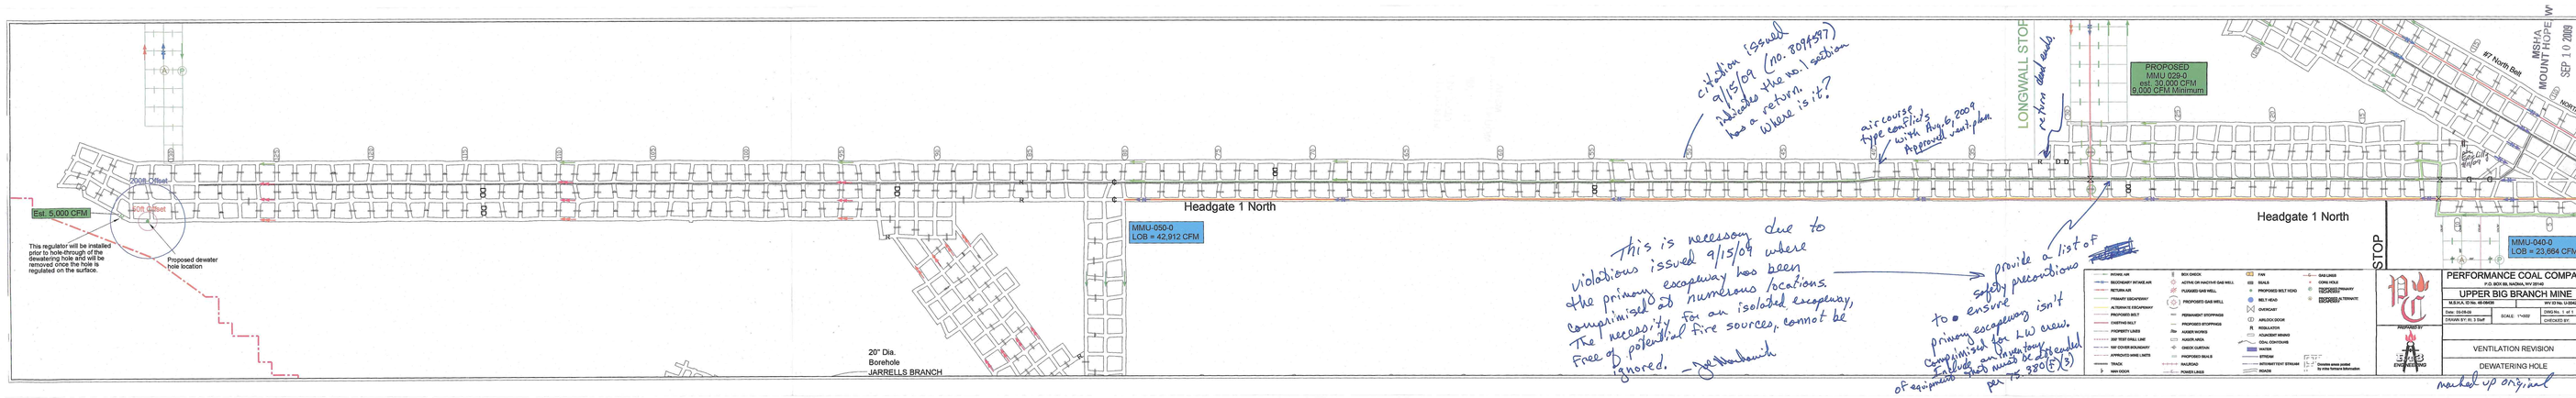
citation issued 9/15/09 (no. 8094597) indicates the no.1 section has a return. Where is it?
air course type conflicts with August 6, 2009 Approved ventilation
LONGWALL STOP
return dead ends.
PROPOSED MMU 029-0 est. 30,000 CFM 2,000 CFM Minimum
