Memorandum

U.S. Department of Transportation
Federal Highway Administration

Subject: INFORMATION: Performance of Guardrail/Curb Combinations

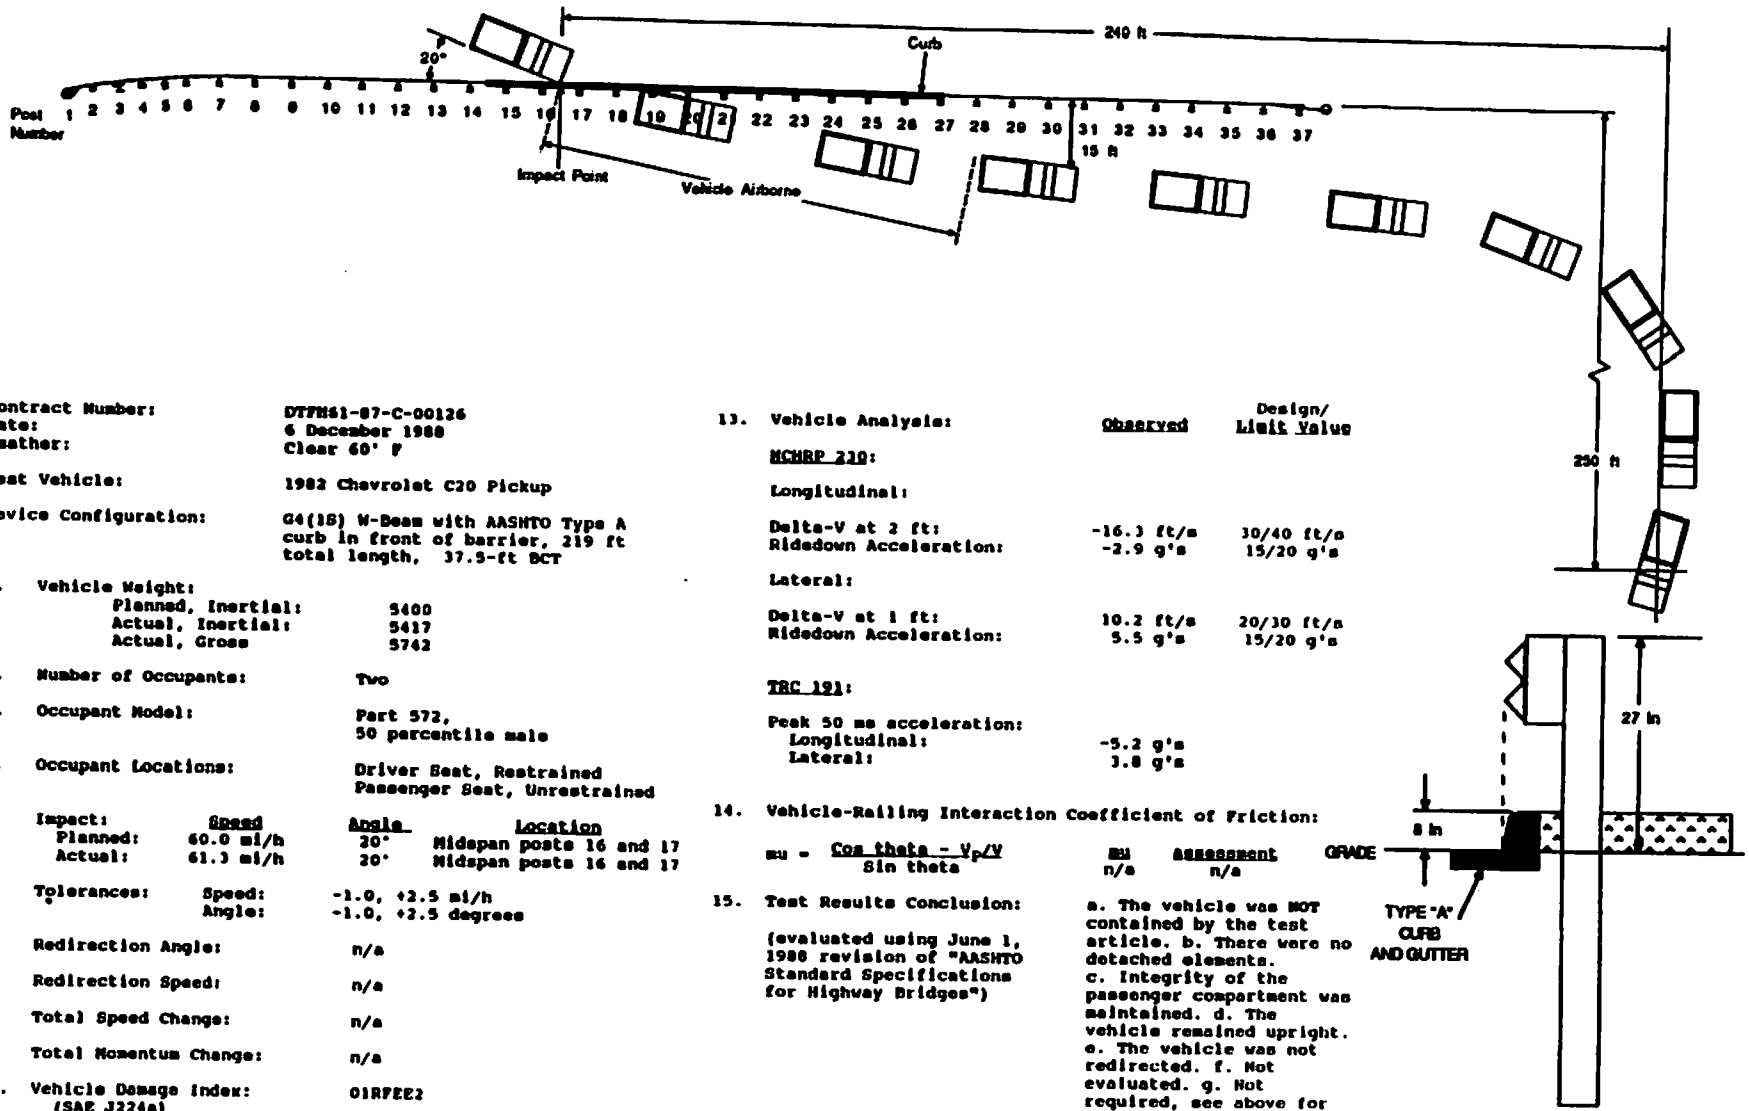
Figure 4. Test summary, test 1862-1-88.

In Test Number 1862-1-88, a 2,450 kg (5,400-pound) pickup truck vaulted over a G4(1S) w-beam on strong post guardrail after an impact at 100 km/h (60 mi/h), and 20 degrees. The guardrail had a 20 cm (8-inch) high concrete curb (AASHTO Type A) installed behind the face of the w-beam rail. In Test Number 1862-5-89, a 2040 kg (4,500-pound) sedan impacted at 100 km/h (60 mi/h), and 25 degrees, and vaulted over a G4(1S) guardrail with a 15 cm (6-inch) high asphalt dike. In both tests, the guardrail deflected enough for the wheels to impact the curb. The resulting compression of the suspension systems produced upward forces on the vehicles that caused them to vault over the guardrail.

Device Configuration: G4(1S) W-Beam with AASHTO Type A curb in front of barrier, 219 ft total length, 37.5-ft BCT

a. The vehicle was NOT contained by the test article. b. There were no detached elements. c. Integrity of the passenger compartment was maintained. d. The vehicle remained upright. e. The vehicle was not redirected. f. Not evaluated. g. Not required, see above for data. h. No exit angle, vehicle exited on the field side of rail. THE TEST ARTICLE FAILED DUE TO VEHICLE PENETRATION AND VEHICLE VAULTING RAIL.

Except for specific guardrail-to-bridgerail transition designs that include a curb and have been successfully crash-tested, the continued use of <u>any</u> guardrail/curb combinations should be discouraged at locations where high-speed, high-angle impacts are likely. Where there are no feasible alternatives to guardrail/curb combinations, the use of a low curb no higher than 10 cm (4-inches) and/or one of the modifications to the w-beam guardrail described above will usually prove satisfactory. On lower speed facilities, a vaulting potential still exists, but since the risk of such an occurrence is lessened, a design change may not be cost-effective. Such locations are best analyzed on a case-by-case basis, taking actual or anticipated operating speeds into account and considering the consequences of vehicular penetration.

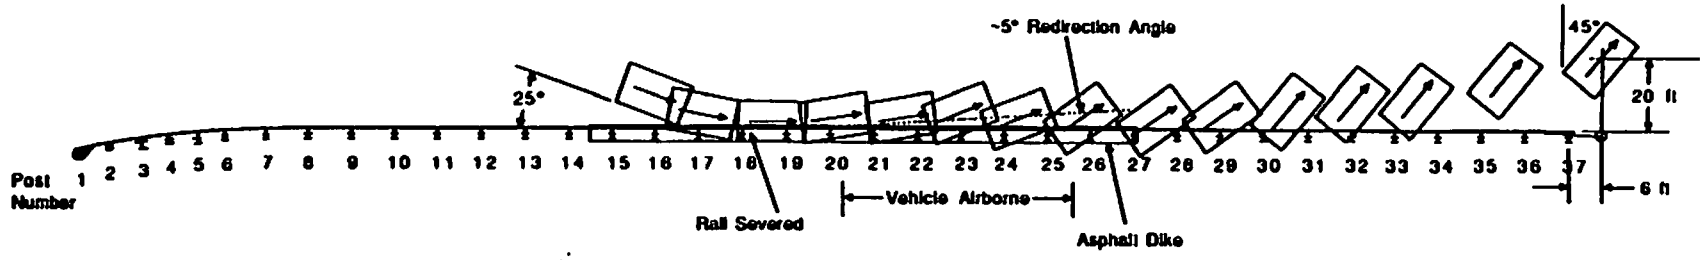
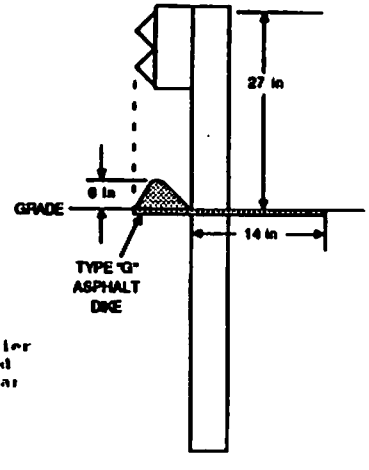
Figure 4. Test summary, test 1862-5-89.

Device Configuration: G4(1S) W-Beam with AASHTO 6-in, Type G asphalt dike in front of barrier, 219 ft total length, 37.5-ft BCT

NCHRP 230: MEETS ALL CRITERIA. Although the test barrier successfully redirected the vehicle, it is clear the barrier is at its performance limit.

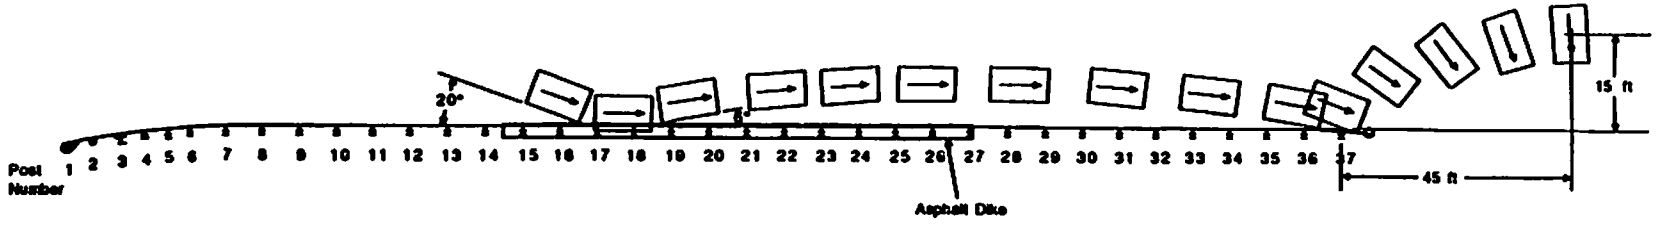
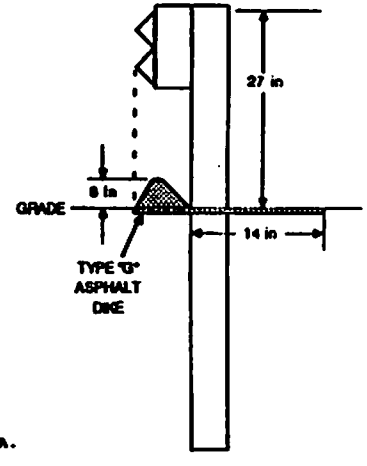
Figure 4. Test summary, test 1862-4-89.

In Test Number 1862-4-89, the same guardrail/asphalt dike combination smoothly redirected an 820 kg (1,800-pound) car that impacted at 100 km/h (60 mi/h), and 20 degrees. In this test, the guardrail did not deflect enough for the wheels to contact the curb.

Device Configuration: G4(1S) W-Beam with AASHTO 6-in, Type G asphalt dike in front of barrier, 219 ft total length, 37.5-ft BCT

$\mu = \frac{\cos\theta - V_p/V}{\sin\theta}$ μ = 0.43, Assessment: Marginal

AASHTO Bridge Rail Specification: MEETS ALL REQUIRED CRITERIA.

NCHRP 230: MEETS ALL CRITERIA.

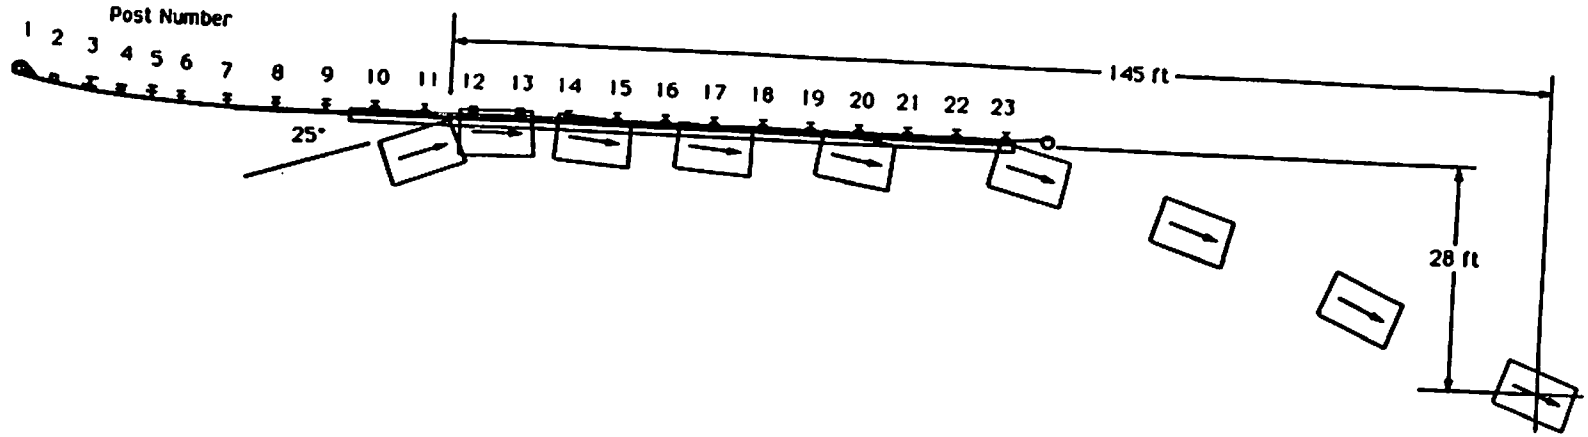
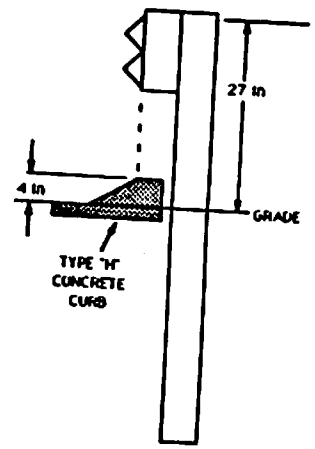
Figure 4. Test summary, test 1862-12-90.

In Test Number 1862-12-90, the G4(1S) guardrail had a 10 cm (4-inch) high concrete curb (AASHTO Type H). When a 2040 kg (4,500-pound) sedan impacted this combination at 100 km/h (60 mi/h), and 25 degrees, the car became airborne but did not vault the rail. This test showed that reducing the curb height to 10 cm (4-inches) or less is one solution to the vaulting problem. However, stiffening the guardrail to reduce its deflection, as noted below, may be a better approach because the vehicles in these tests were redirected in a more stable manner.

Device Configuration: G4(1S) W-Beam with AASHTO 4-in, Type H concrete curb in front of barrier, 131.25 ft total length, 37.5-ft BCT Terminal, 93.75-ft LON.

14. Test Results Conclusion:
    NCHRP 230: MEETS ALL CRITERIA.

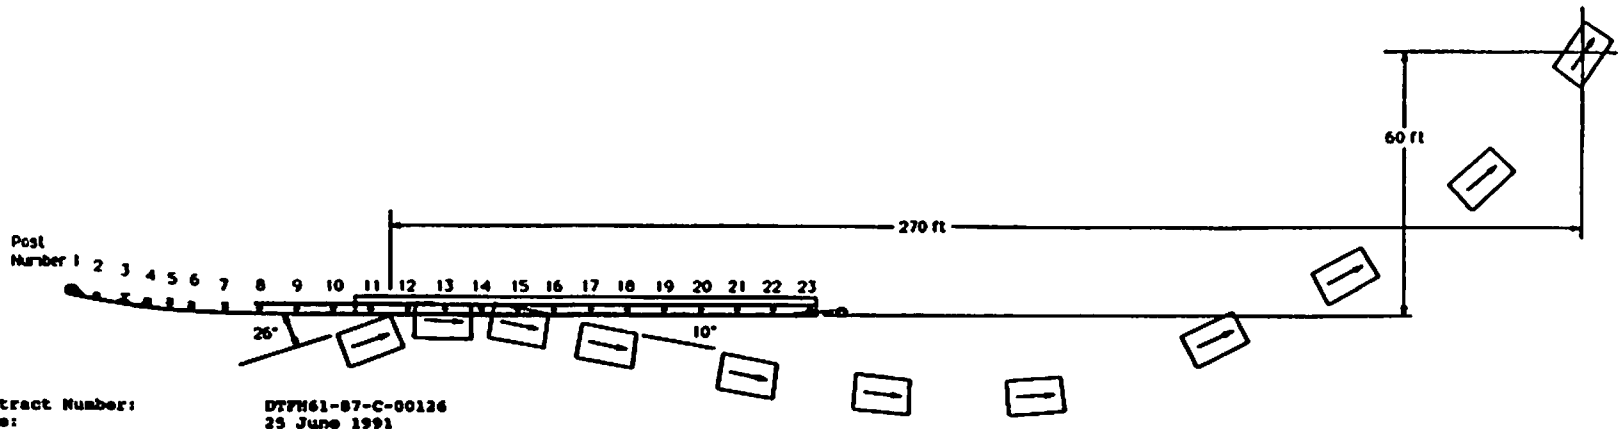
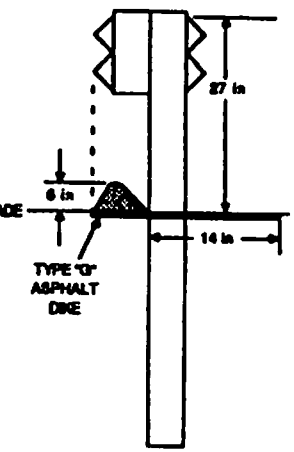
Figure 4. Test summary, test 1862-13-91.

In Test Number 1862-13-91, a G4(1S) guardrail with a 15 cm (6-inch) asphalt dike was stiffened by bolting an extra w-beam to the back of the steel posts. This retrofitted guardrail successfully redirected a 2040 kg (4,500-pound) sedan impacting at 100 km/h (60 mi/h), and 25 degrees. In Test Number 1862-14-91, a G4(1S) guardrail with a 15 cm (6-inch) asphalt dike was modified by adding a C6x8.2 hot-rolled channel rub rail. This design also worked well, smoothly redirecting a 2040 kg (4,500-pound) sedan impacting at 100 km/h (60 mi/h), and 25 degrees.

Device Configuration: Modified G4(1S) W-Beam with AASHTO 6-in, Type G asphalt dike in front of barrier, 131.25 ft total length, 37.5-ft BCT Terminal, 93.75-ft LON. Second span of W-beam bolted to back of posts with no blockout, at 27 in height.

14. Test Results Conclusion:
    - NCHRP 230: MEETS ALL CRITERIA.

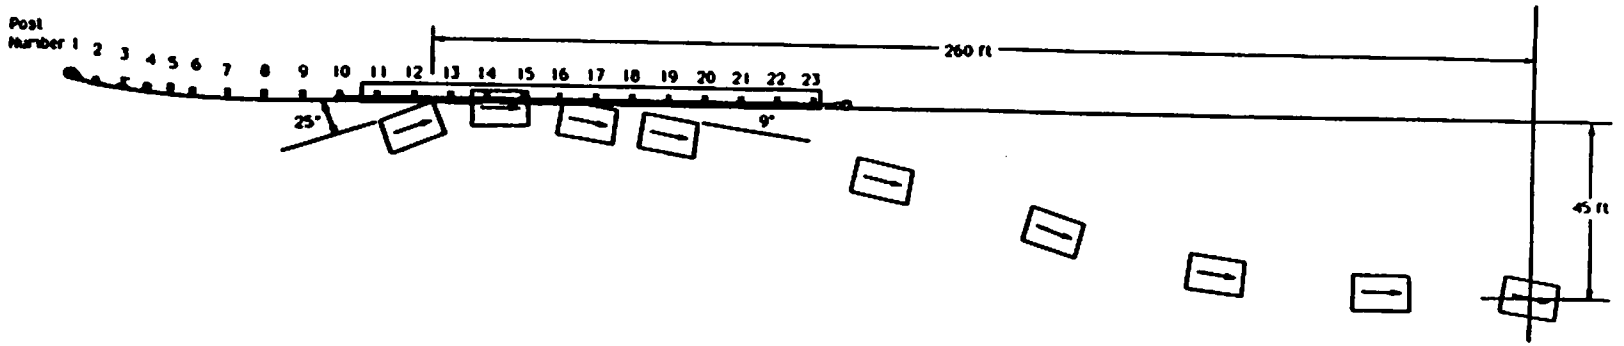
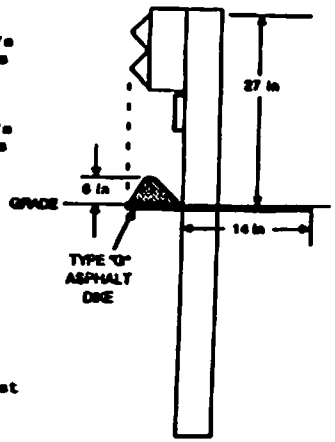
Figure 4. Test summary, test 1862-14-91.

Device Configuration: Modified G4(1S) W-Beam with AASHTO 6-in, Type G asphalt dike in front of barrier, 131.25 ft total length, 37.5-ft BCT Terminal, 93.75-ft LON. C6x8.2 channel rubrail mounted 0.5 in below bottom of blockout.

NCHRP 230: DOES NOT MEET ALL CRITERIA. The vehicle speed change at redirection is greater than the 15 mi/h maximum. The test meets all other evaluation criteria.
