Highway–Railroad Grade Crossing Collision  
Rosedale, Maryland  
May 28, 2013

NTSB/HAR-14/02  
PB2014-109131

# Highway Accident Report

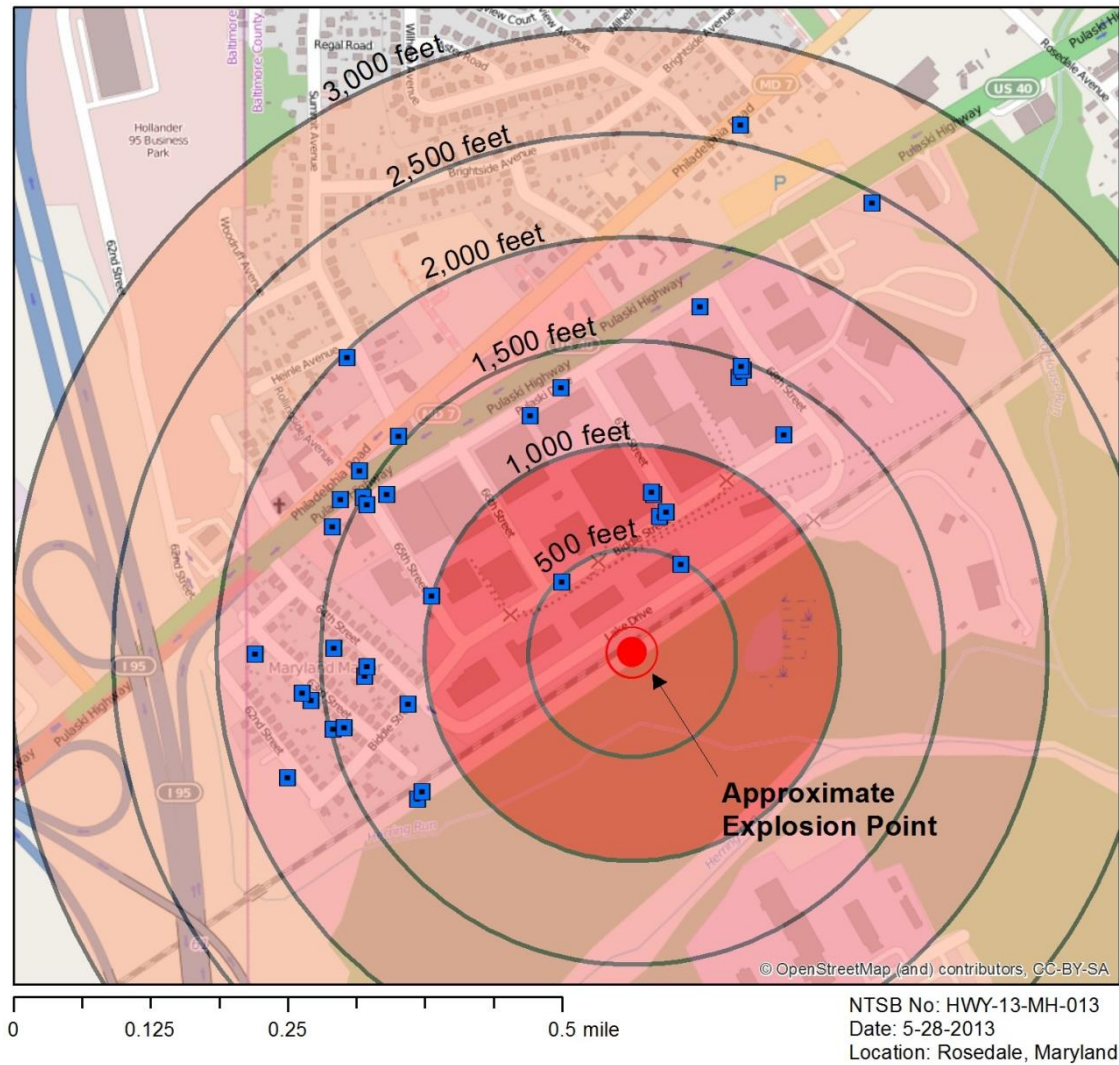
The BCFD chief fire protection engineer conducted damage and safety assessments on four of the five steel frame storage/industrial buildings along Lake Drive parallel to the area of the explosion.<sup>13</sup> All four buildings were placarded as unsafe due to overhead risks from loose exterior wall panel material, and damage to interior lighting and heat fixtures. The most severe damage was observed on the south façades of the three buildings closest to the explosion site. Several industrial buildings on the streets that run perpendicular between Lake Drive and Pulaski Highway and several residential dwellings in the Maryland Manor subdivision were also damaged. As of July 12, 2013, CSXT had received 64 damage reports from property owners within an approximate 0.5-mile radius of the crash site. Figure 6 depicts the locations of the properties named in the damage reports, which cited siding damage, broken windows, cracked walls, cracked pipes, and damaged furniture.

**Figure 6.** Plotted damage reports near crash location in Rosedale, Maryland. [Note: Map reflects only those property and business reports that were successfully geocoded based on submitted claims.]

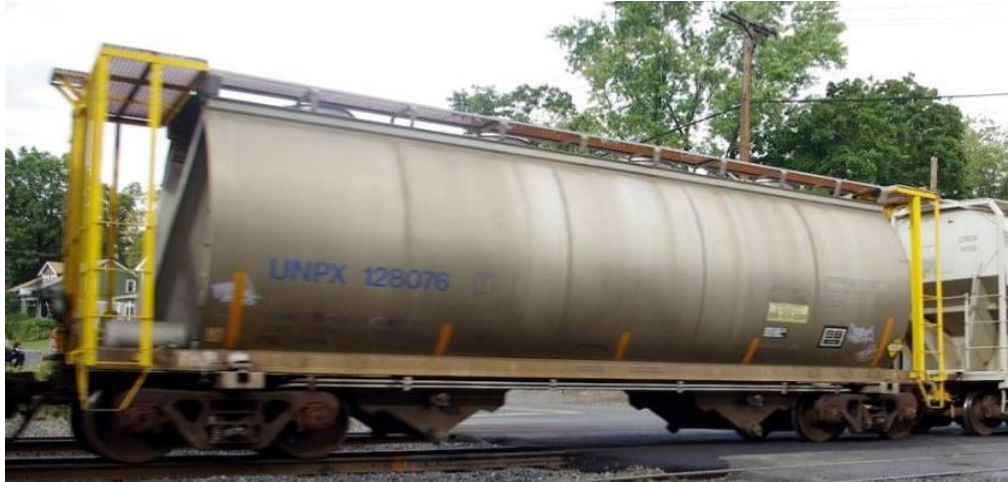
Car 7 (UNPX 128076, shown in figure 12) was an Association of American Railroads type C712 two-bay cylindrical aluminum covered hopper car loaded with 218,279 pounds of sodium chlorate crystal (hazard class 5.1, oxidizer).<sup>61</sup> This car was destroyed in a postcrash explosion and released its entire contents.

**Figure 12.** Precrash photo of cylindrical aluminum covered sodium chlorate hopper car UNPX 128076, September 29, 2012. (Source: Railroad Picture Archives)

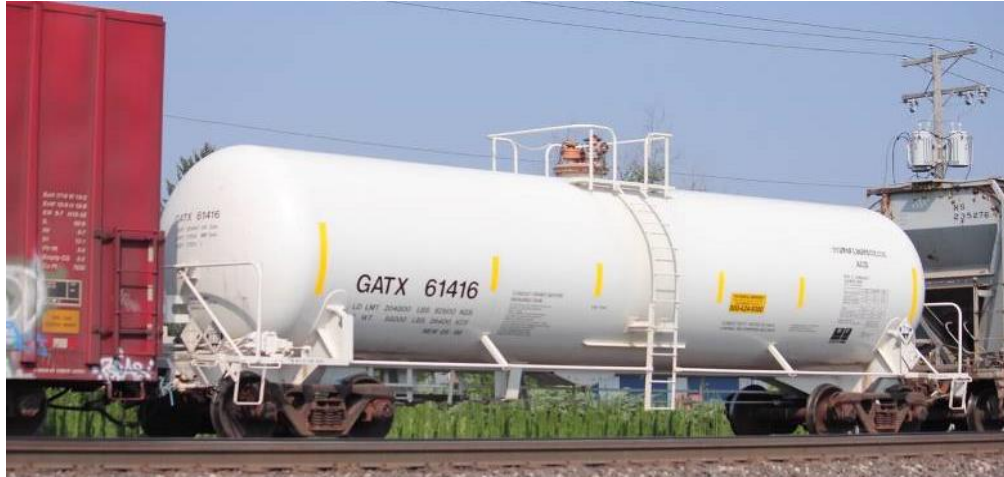
Car 8 (GATX 61416, shown in figure 13) was a class DOT-111A100W5 tank car that contained fluorosilicic acid (hazard class 8, corrosive liquids) residue.<sup>62</sup> The empty car weight was about 29 tons. No evidence of liquid release was observed from this tank car.

**Figure 13.** Precrash photo of fluorosilicic acid tank car GATX 61416, July 10, 2011.  
(Source: Railroad Picture Archives)

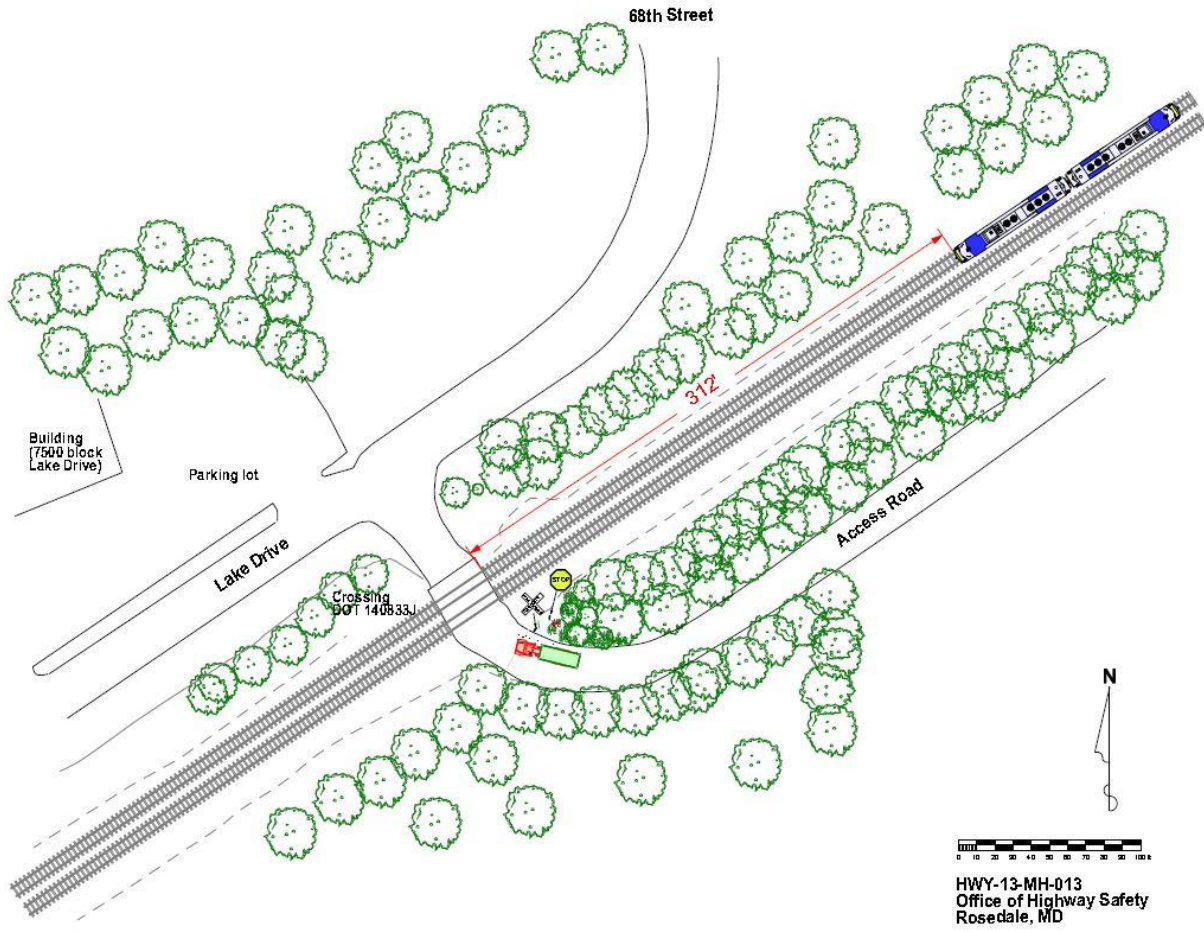
Figure 14. Crash scene diagram.

Security video from a building in the area and data from the truck’s VECU and the train’s locomotive event recorder and forward-facing locomotive video were analyzed to evaluate the relative positions of the truck and the train. When the front of the truck reached the crossbuck sign, the train was about 312 feet from the crossing and traveling 49 mph. At this point, the truck was 25 feet from the nearest rail, traveling 13 mph, and vegetation completely obscured the train from the truck driver’s view. Figures 14 and 15 depict the relative positions of the truck and the train at this location and time. After passing the vegetation, the truck driver did not reduce his speed or stop to ensure that the railroad tracks were clear. About 1.6 seconds later, the front of the truck began to cross the nearest rail. The train struck the truck on the right side near the rear drive axles about 2.8 seconds later. The NTSB concludes that had the truck driver slowed and stopped his truck before traversing the crossing, he could have seen the train and the crash could have been prevented.
