*METALLURGICAL INVESTIGATION OF A
FRACTURED SECTION OF THE 20" O.D.
PIPELINE AT MILEPOST 314.77 IN THE
CONWAY TO CORSICANA SEGMENT OF
THE PEGASUS CRUDE OIL PIPELINE*

REPORT NO. 64961, REV. 1

Prepared for
ExxonMobil Pipeline Company and the
Pipeline and Hazardous Materials Safety Administration
pursuant to Corrective Action Order CPF 4-2013-5006H

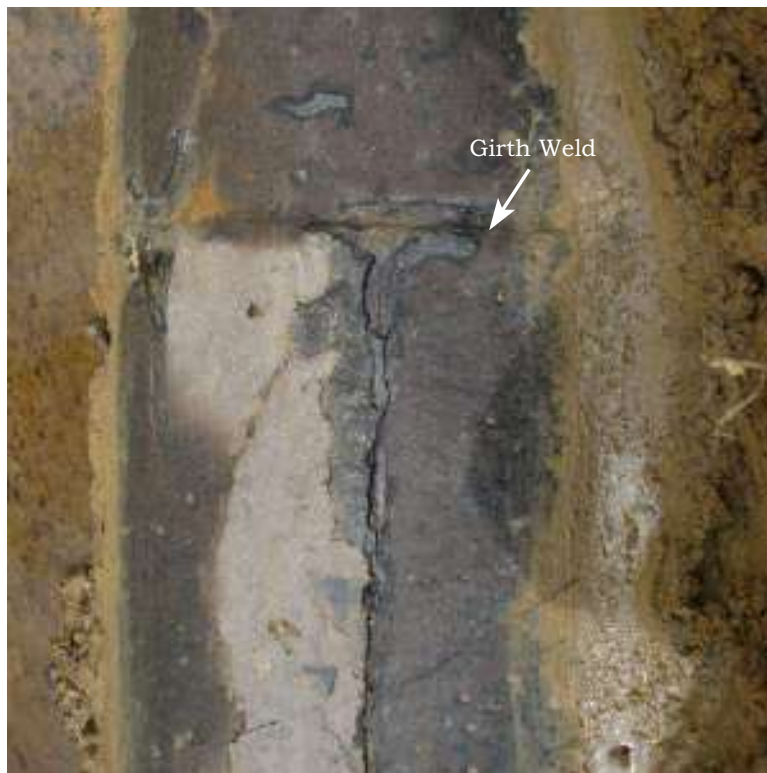
Photograph No. 2

The photographs provided by EMPCo of the 20" O.D. x 0.312" wall pipe at Milepost 314.77 of the Conway to Corsicana Pegasus crude oil pipeline, which failed on Friday, March 29, 2013 at 2:47 pm CST in Mayflower, Arkansas, display a straight, linear crack at approximately the 12:00 o'clock position.

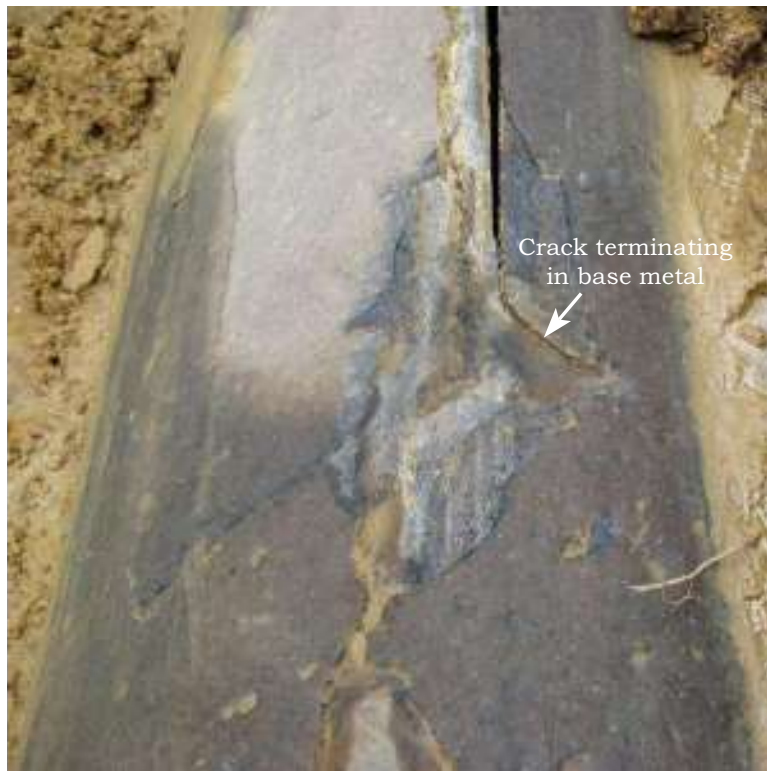
Photograph No. 3

The photographs display close-up views of the crack tips near the north girth weld in the ERW seam of the pipe and the south end in the base metal, respectively.

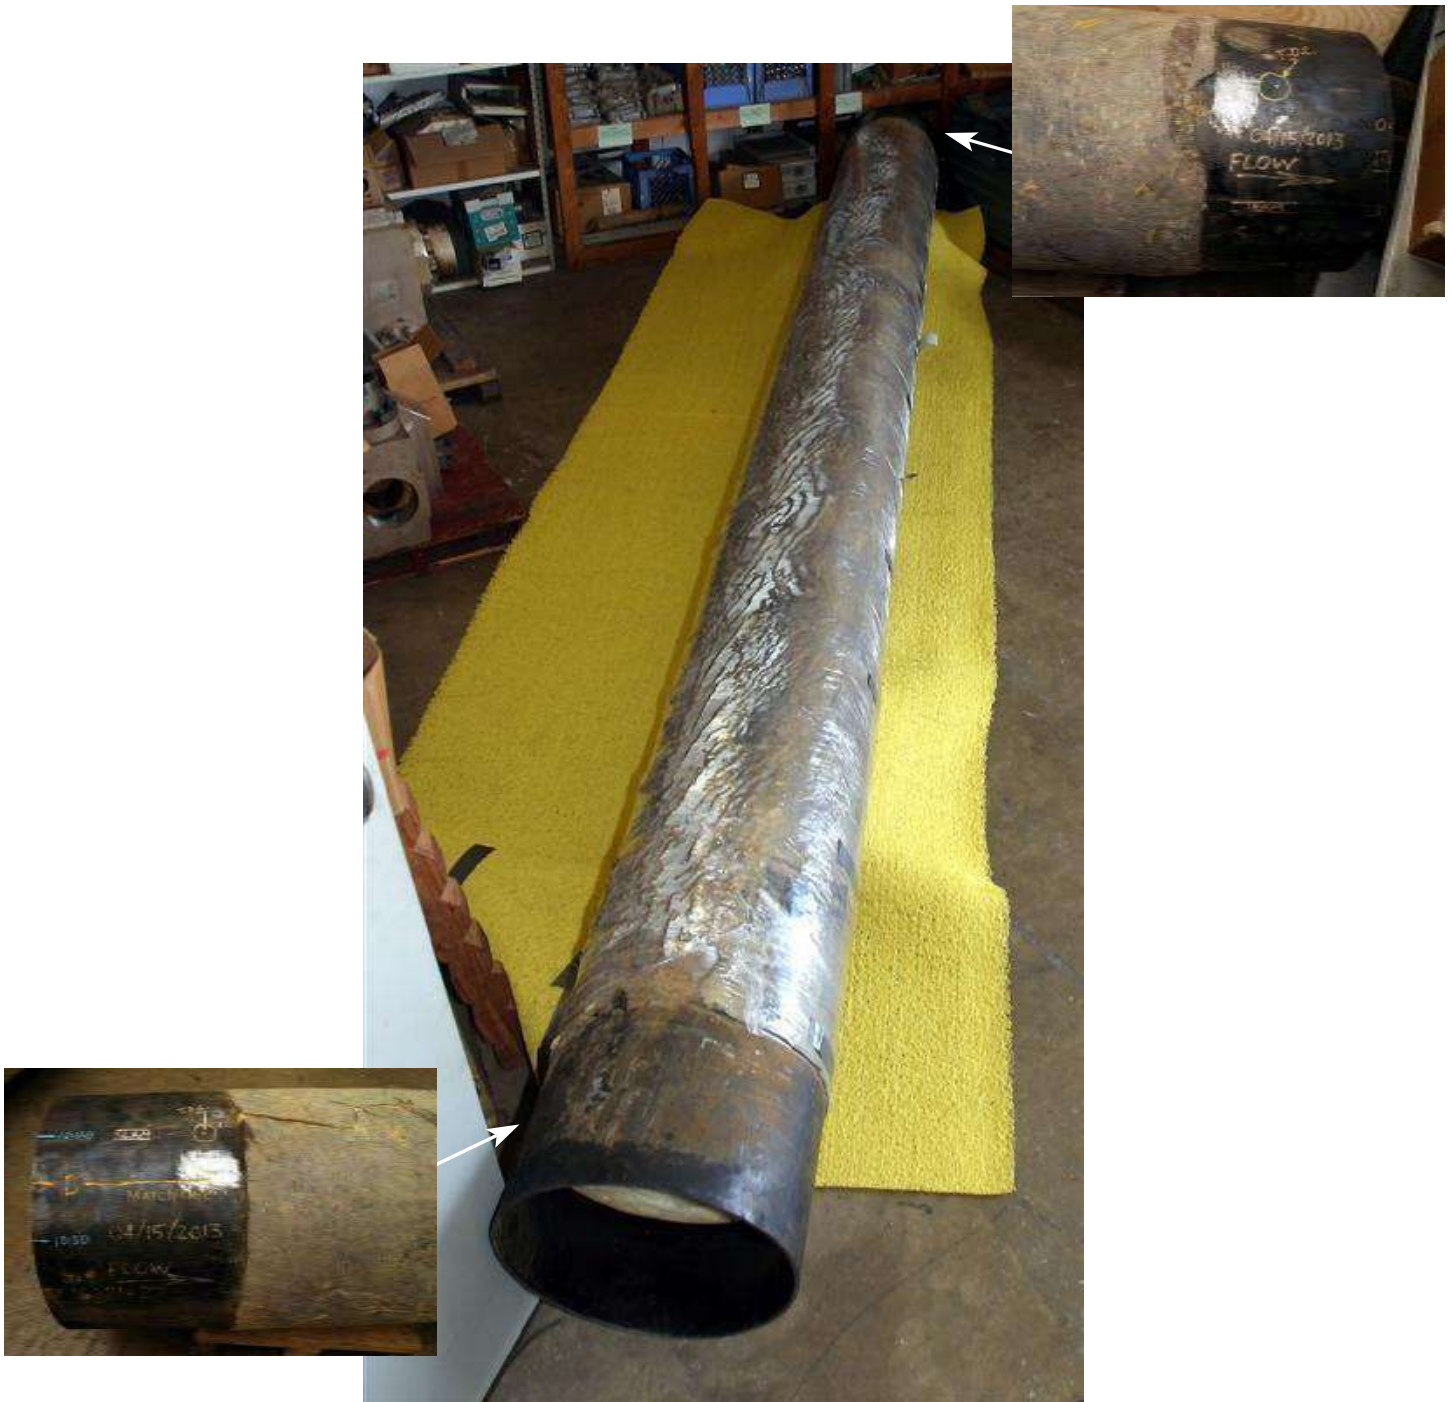
Photograph No. 9

The photograph displays the fractured pipe section following removal of the 2nd wrapping material, revealing the fracture faces coated with grease to protect from post-incident corrosion.

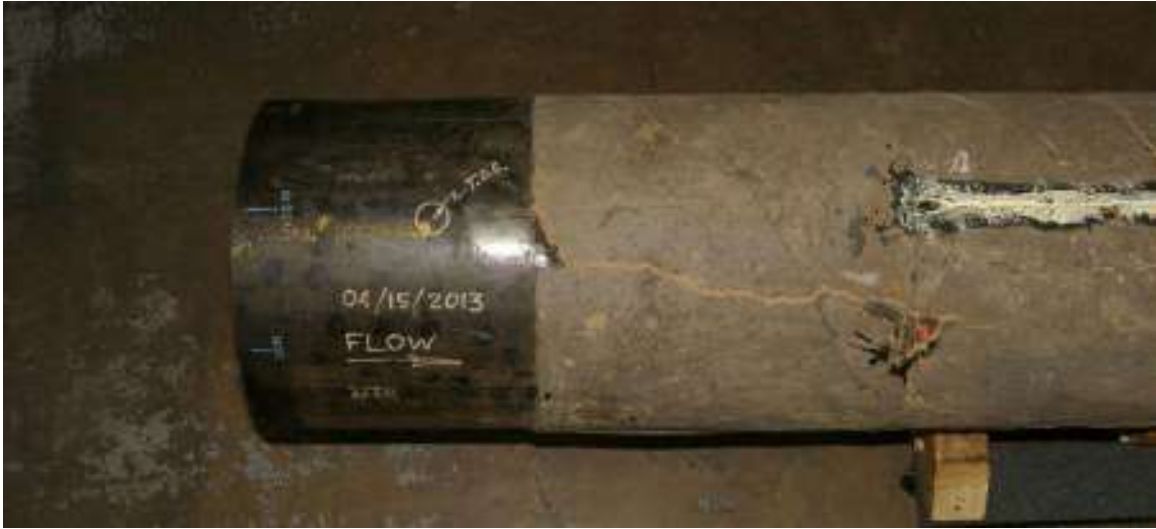
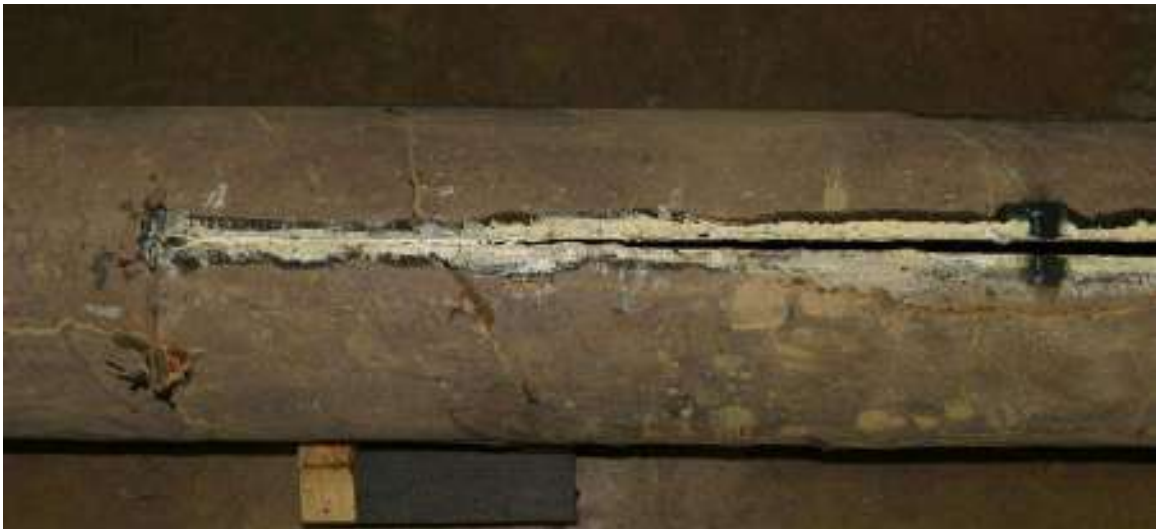
As-received Condition of the Coating			
Circumferential Location	Distance from North Girth Weld	Split Width Maximum	Split Depth Maximum
10:30 o'clock to 1:30 o'clock	-3' to 0'	1"	-
	0' to 4'	2"	0.10"

The photographs display overall top views of the pipe adjacent to the fractured pipe from approximately 3' north of the north girth weld (-3') to the center of the north girth weld (0'), and the fractured pipe from the center of the girth weld to 4' south of the north girth weld, respectively, in the as-received condition prior to removing the coating. The fracture in the pipe along the ERW seam terminated at the north girth weld. The fracture was extremely tight at the girth weld but was measured to be approximately 13/16" in width approximately 4' south of the north girth weld. Relatively narrow longitudinal and transverse splits were present in the coating. The coating had been removed from the adjacent intact pipe prior to sectioning approximately 3' north of the north girth weld.

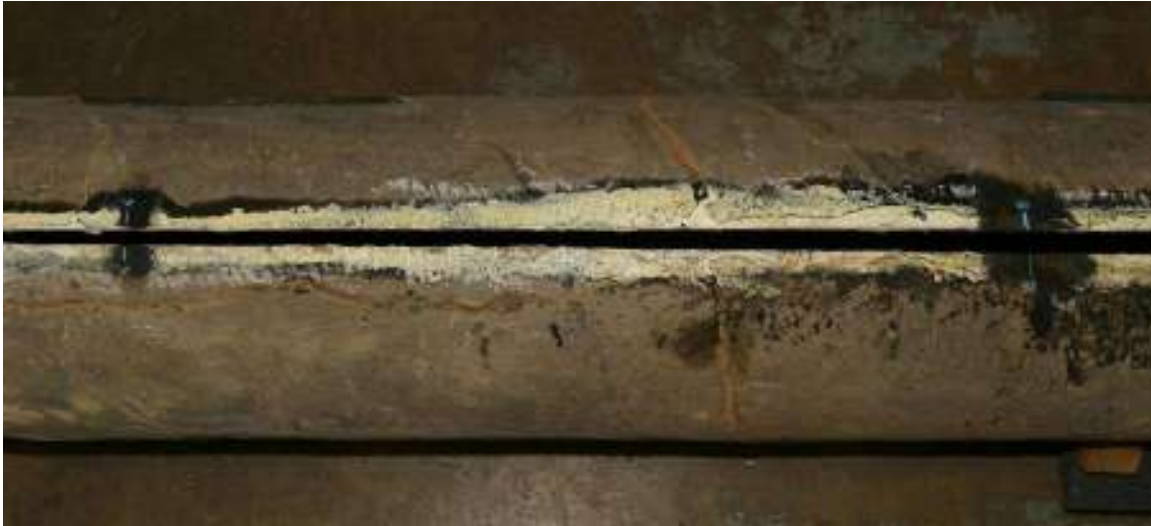
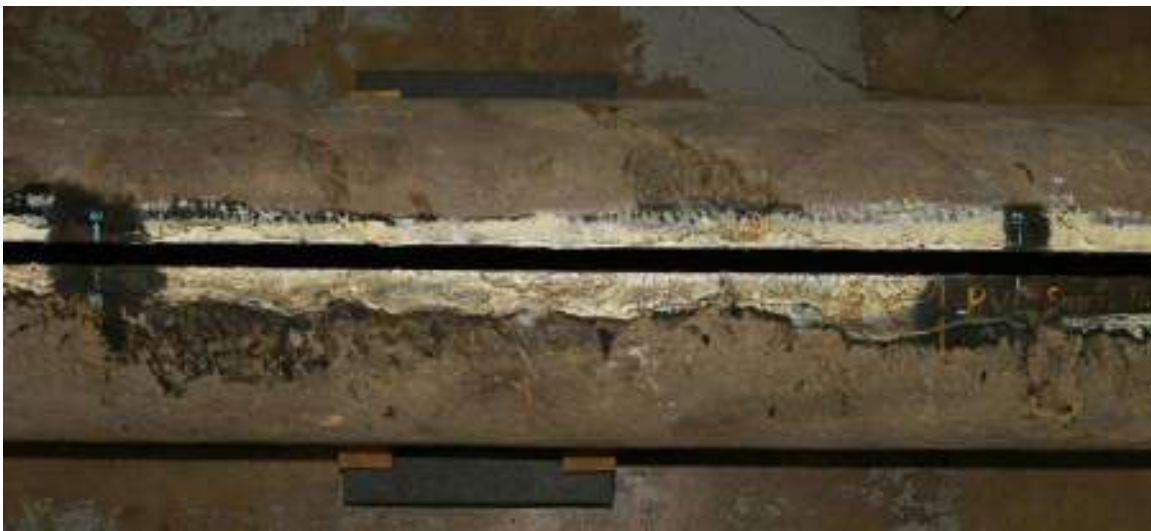
As-received Condition of the Coating			
Circumferential Location	Distance from North Girth Weld	Split Width Maximum	Split Depth Maximum
10:30 o'clock to 1:30 o'clock	4' to 8'	0.5"	0.14"
	8' to 12'	0.5"	-

The photographs display overall top views of the fractured pipe from 4' south to 8' south of the north girth weld, and from 8' south to 12' south of the north girth weld, respectively, in the as-received condition prior to removing the coating. Longitudinal and transverse splitting is present in the coating, and some of the coating is missing on either side of the fracture.

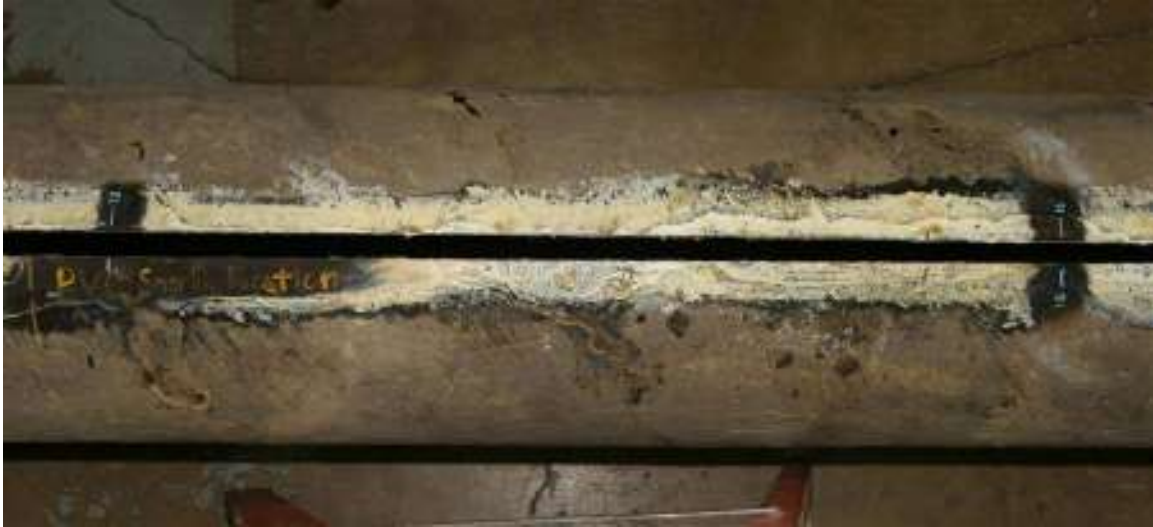
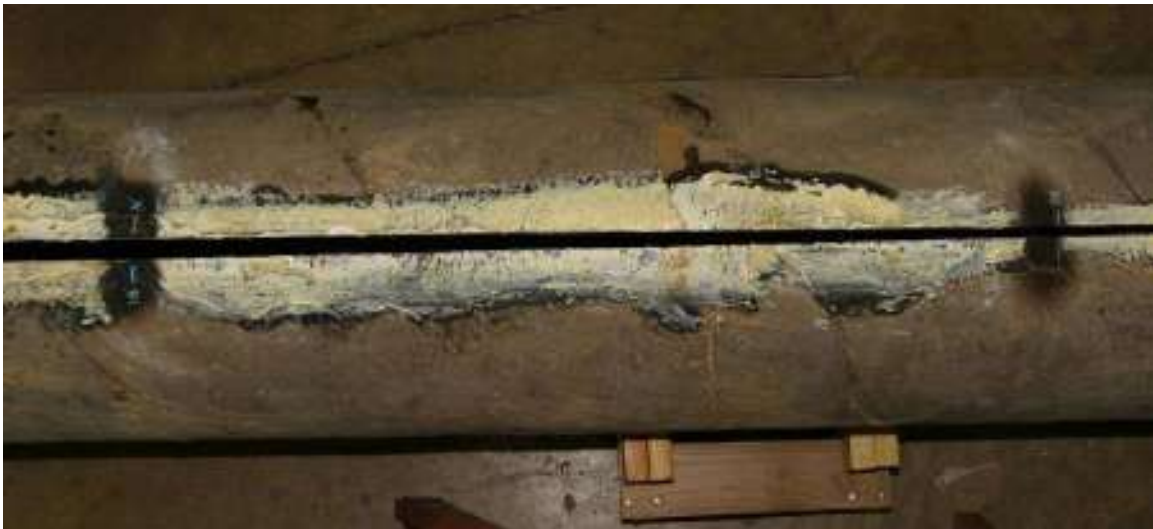
As-received Condition of the Coating			
Circumferential Location	Distance from North Girth Weld	Split Width Maximum	Split Depth Maximum
10:30 o'clock to 1:30 o'clock	12' to 16'	-	0.07"
	16' to 20'	0.25"	0.09"

The photographs display overall top views of the fractured pipe from 12' south to 16' south of the north girth weld, and from 16' south to 20' south of the north girth weld, respectively, in the as-received condition prior to removing the coating. Longitudinal and transverse splitting is present in the coating, and some of the coating is missing on either side of the fracture.

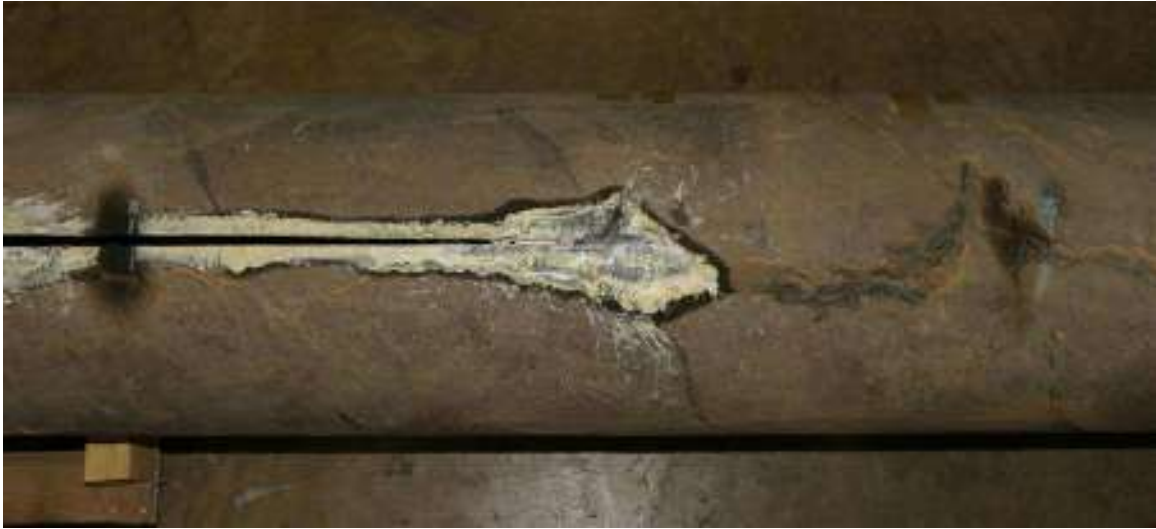
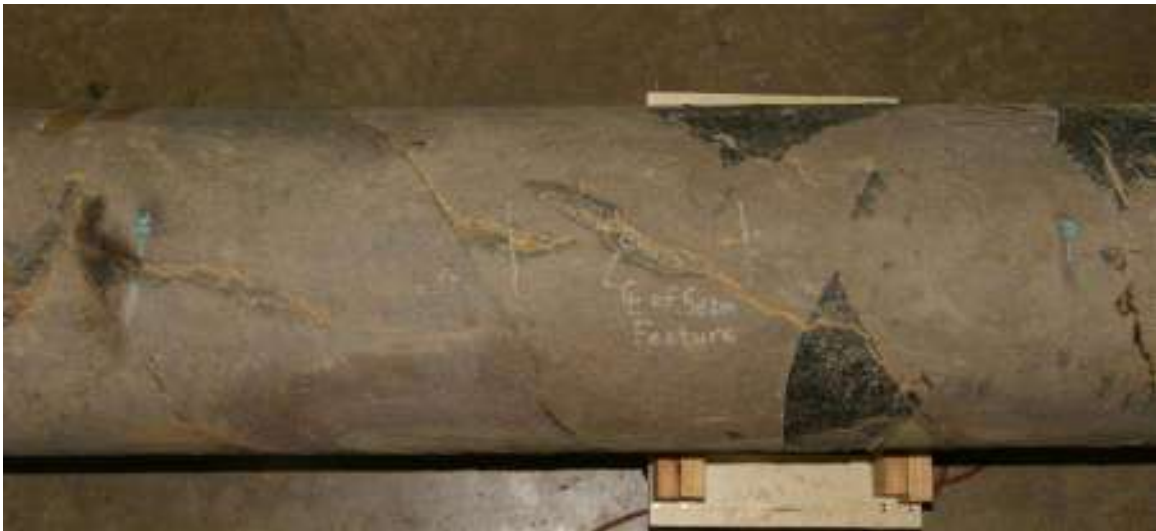
As-received Condition of the Coating			
Circumferential Location	Distance from North Girth Weld	Split Width Maximum	Split Depth Maximum
10:30 o'clock to 1:30 o'clock	20' to 24'	0.5"	0.10"
	24' to 28'	1.5"	0.10"

The photographs display overall top views of the fractured pipe from 20' south to 24' south of the north girth weld, and from 24' south to 28' south of the north girth weld, respectively, in the as-received condition prior to removing the coating. At approximately 22' south of the girth weld, the fracture in the ERW seam turned into the pipe material, progressing several inches prior to terminating. The damaged area of coating near the pipe fracture extended longitudinally past the fracture tip several feet.

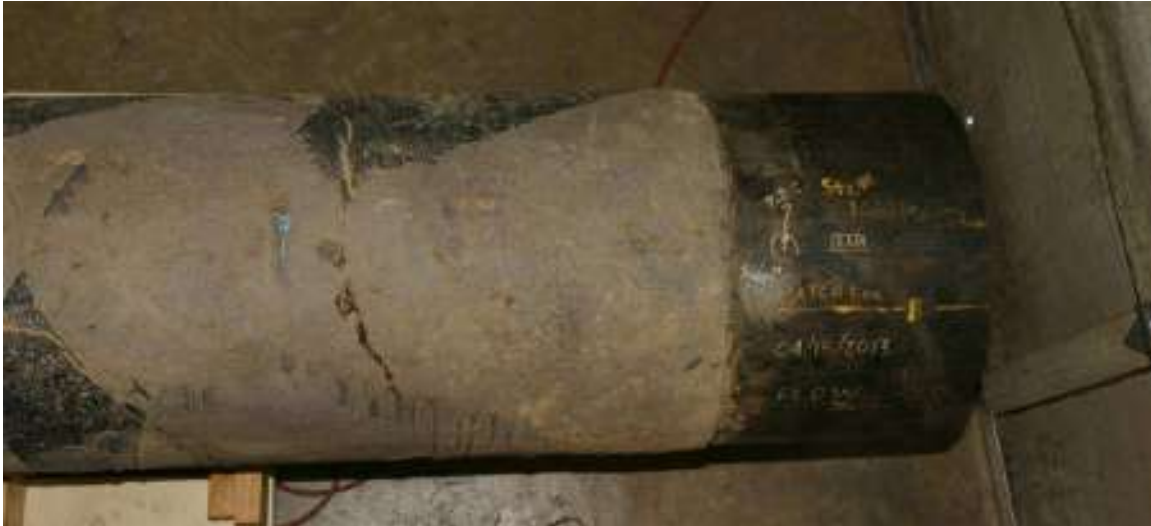
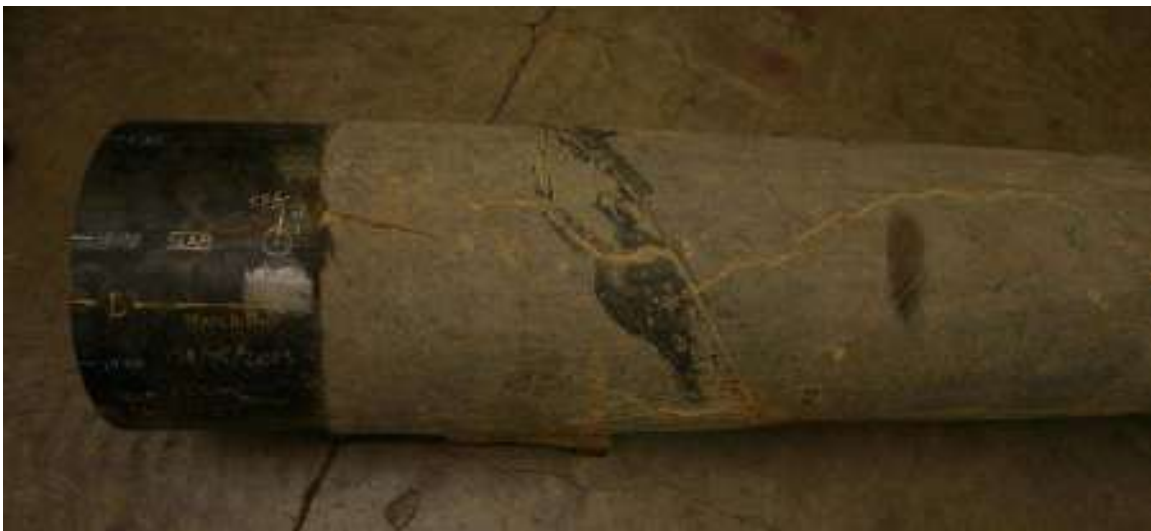
As-received Condition of the Coating			
Circumferential Location	Distance from North Girth Weld	Split Width Maximum	Split Depth Maximum
10:30 o'clock to 1:30 o'clock	28' to 31'	1"	0.05"
	31' to 35'	1"	0.15"

The photographs display overall top views of the fractured pipe from 28' south to 31' south of the north girth weld, and from 31' south to 35' south of the north girth weld, respectively, in the as-received condition prior to removing the coating. The approximately 49' 9-1/2" long pipe was sectioned in the field transversely approximately 31' south of the north girth weld. The coating was removed in the field approximately 13" in either direction from the transverse cut prior to sectioning.

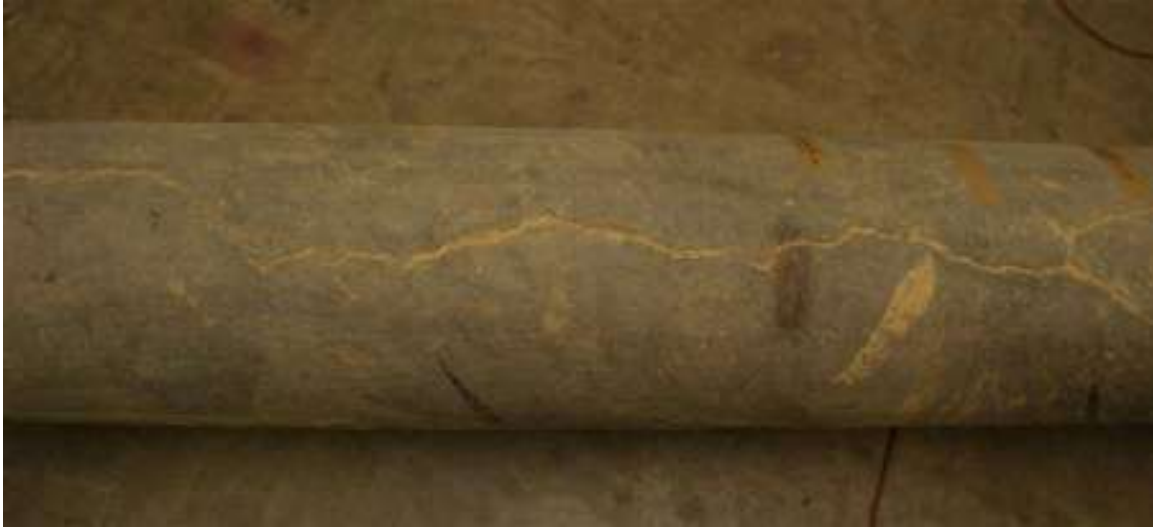
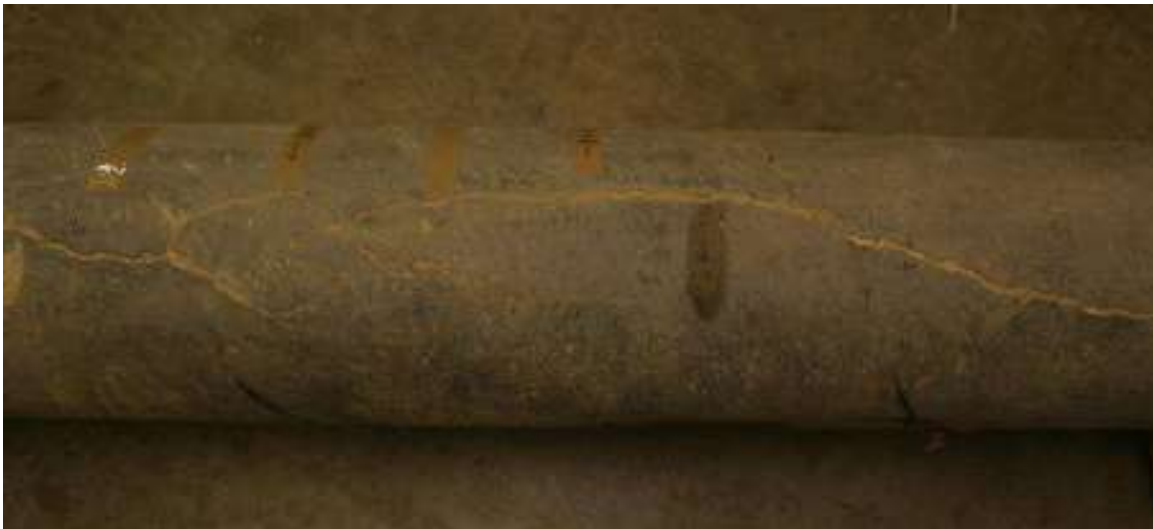
As-received Condition of the Coating			
Circumferential Location	Distance from North Girth Weld	Split Width Maximum	Split Depth Maximum
10:30 o'clock to 1:30 o'clock	35' to 39'	1"	0.10"
	39' to 43'	0.75"	0.11"

The photographs display overall top views of the fractured pipe from 35' south to 39' south of the north girth weld, and from 39' south to 43' south of the north girth weld, respectively, in the as-received condition prior to removing the coating. Longitudinal splitting is visible on the surface of the coating.

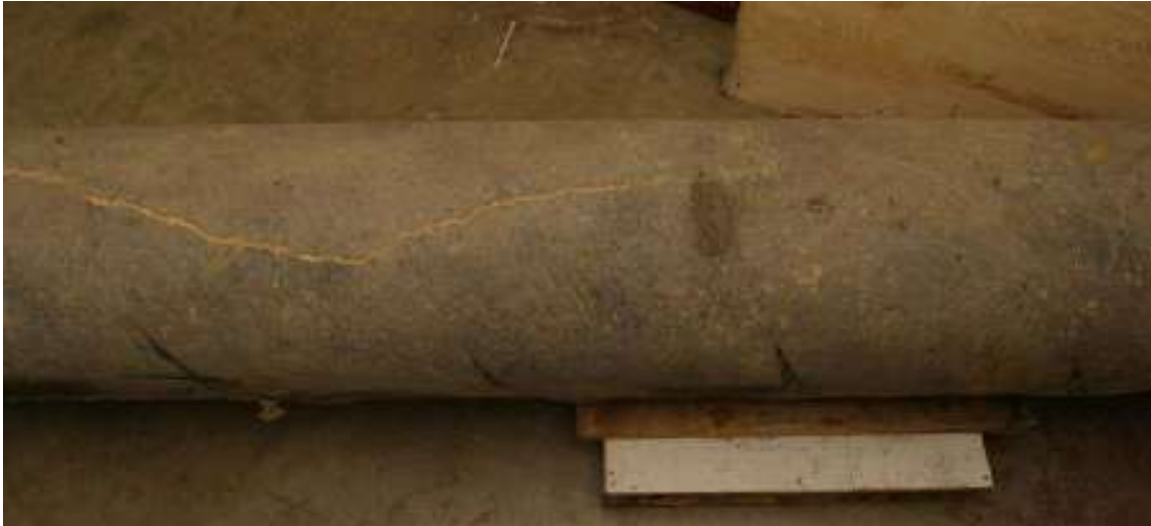
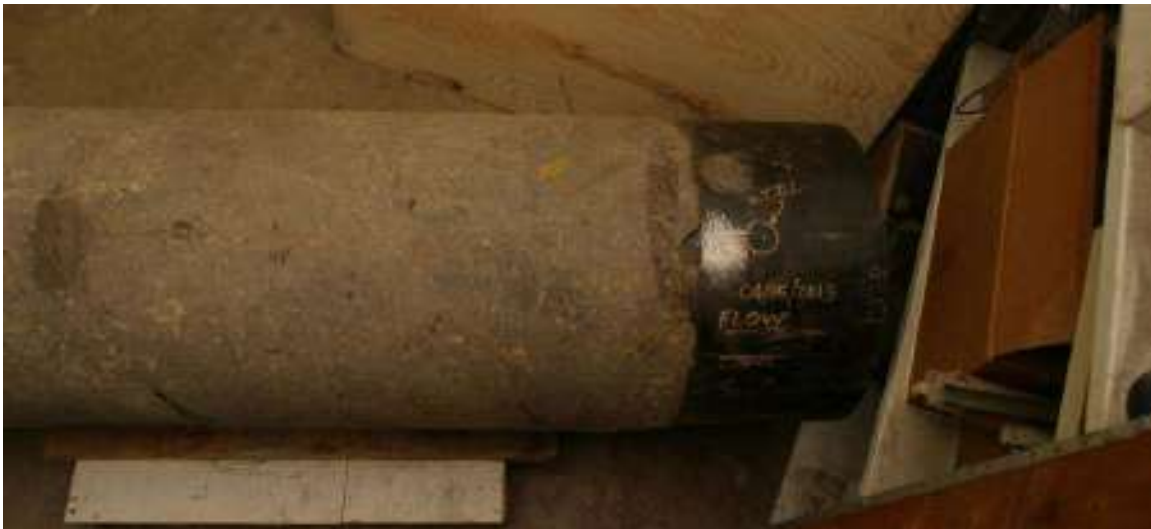
As-received Condition of the Coating			
Circumferential Location	Distance from North Girth Weld	Split Width Maximum	Split Depth Maximum
10:30 o'clock to 1:30 o'clock	43' to 47'	0.5"	0.11"
	47' to 51'	1"	-

The photographs display overall top views of the fractured pipe from 43' south to 47' south of the north girth weld, and from 47' south to 51' south of the north girth weld, respectively, in the as-received condition prior to removing the coating. Longitudinal splitting is visible on the surface of the coating. Some of the coating had been removed from the adjacent area pipe prior to sectioning.

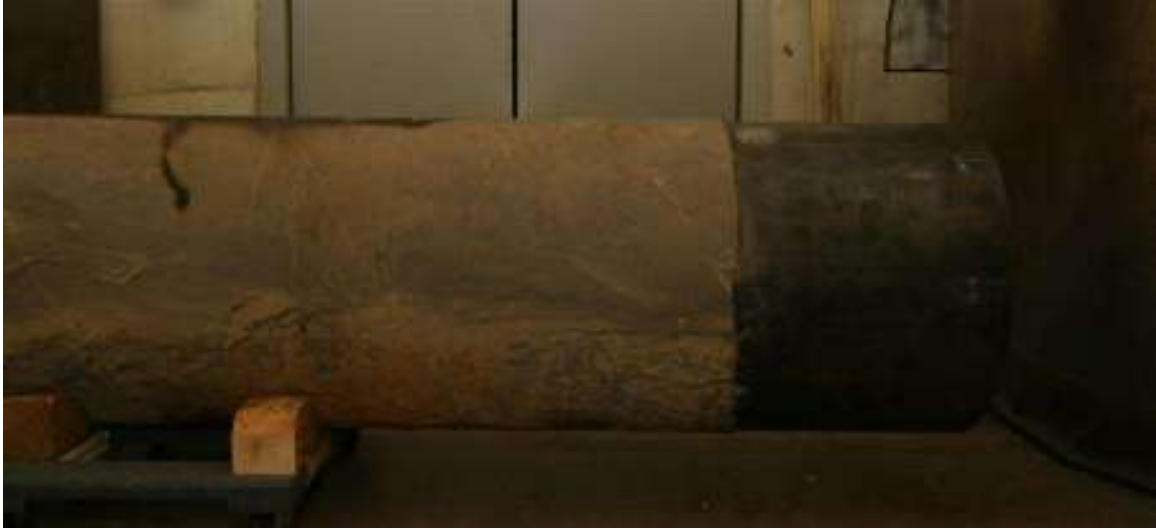
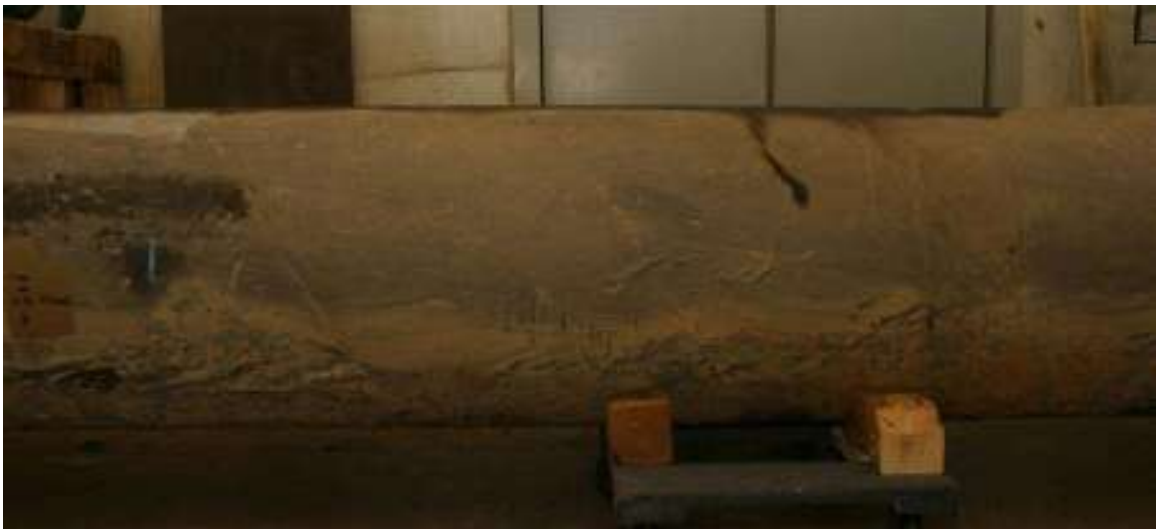
The photographs display overall views of the west side of the pipe from 7:30 to 10:30 o'clock, adjacent to the fractured pipe from approximately 3' north of the girth weld (-3') to the center of the north girth weld (0'), and the fractured pipe from the center of the girth weld to 4' south of the north girth weld (+4'), respectively, in the as-received condition prior to removing the coating. The lower half of the pipe contains disbonded and wrinkled coating.

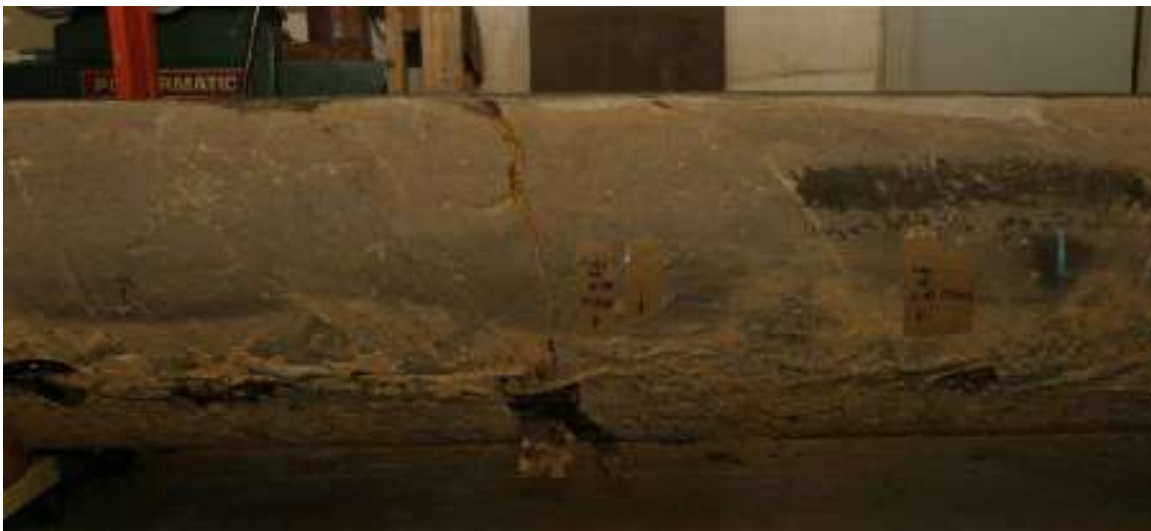
Photograph No. 26

The photograph displays an overall view of the west side from 7:30 to 10:30 of the fractured pipe from 4' south to 8' south of the north girth weld in the as-received condition prior to removing the coating. The lower half of the pipe contains disbonded and wrinkled coating, and some openings in the coating are present where the coating had begun to sag.

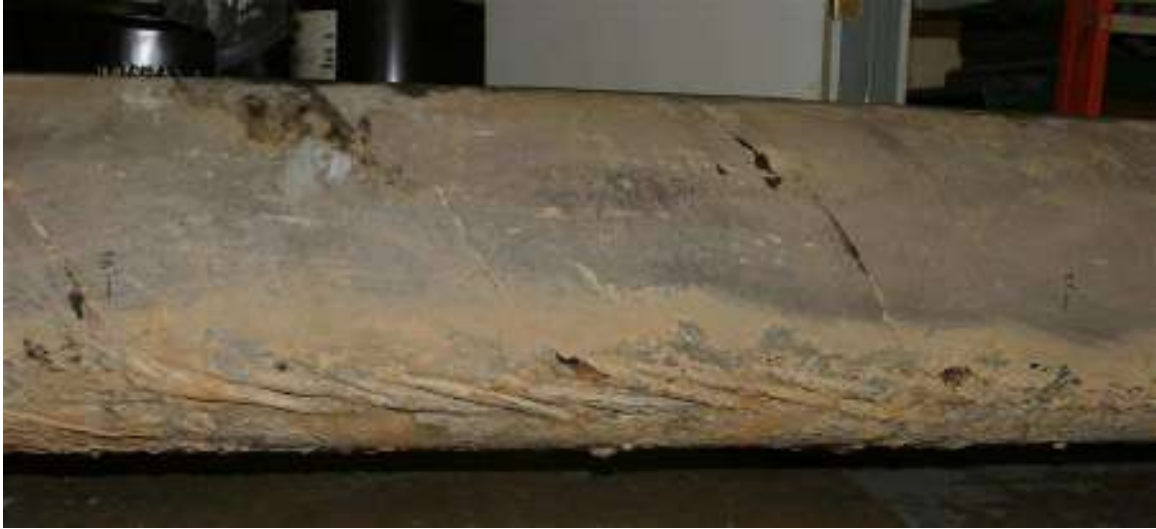
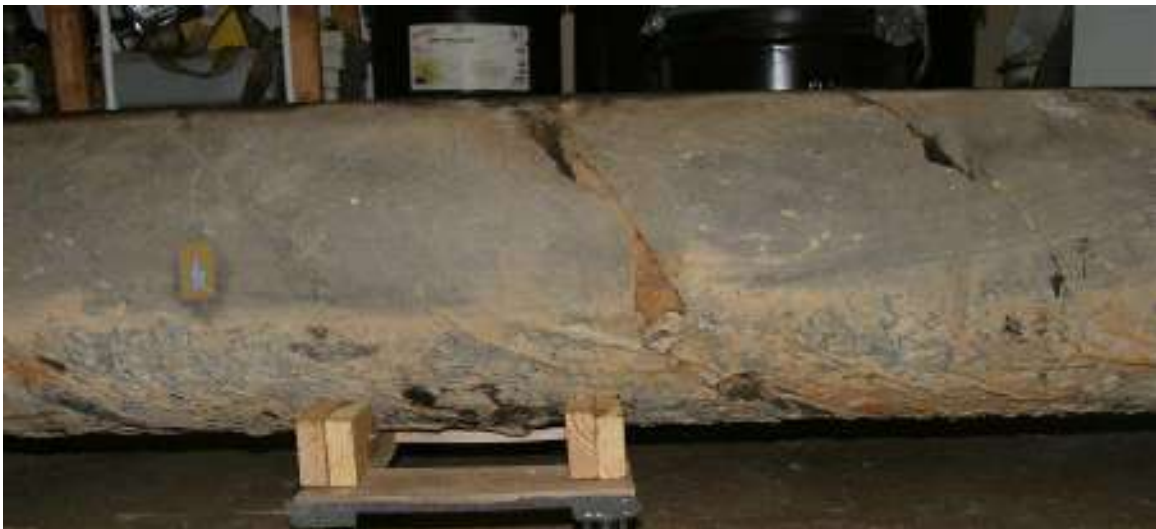
The photographs display overall views of the west side between 7:30 and 10:30 of the fractured pipe from 12' south to 16' south of the north girth weld, and from 16' south to 20' south of the north girth weld, respectively, in the as-received condition prior to removing the coating. The lower half of the pipe contains disbonded and wrinkled coating, along with some openings in the coating.

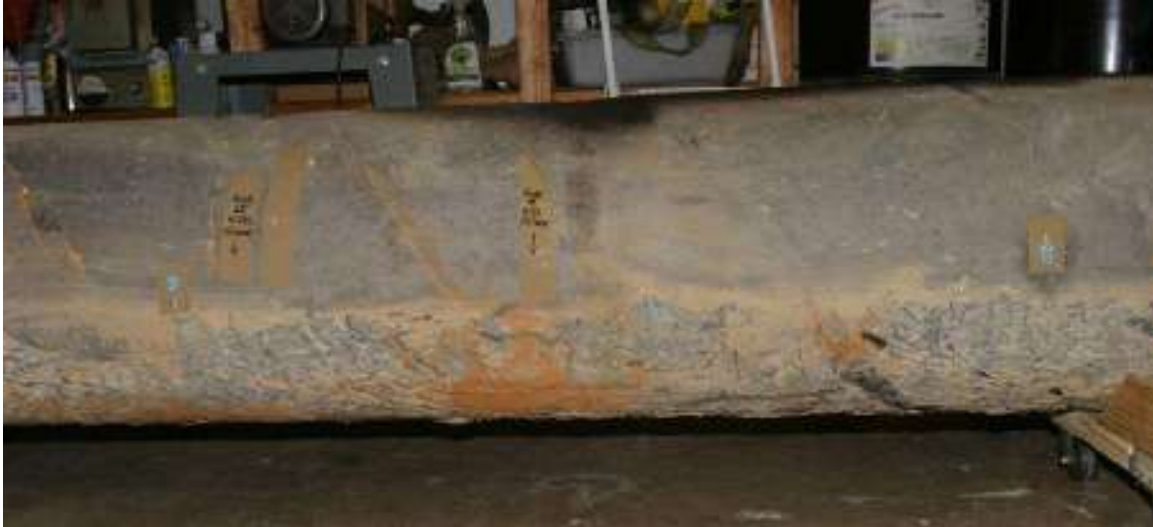
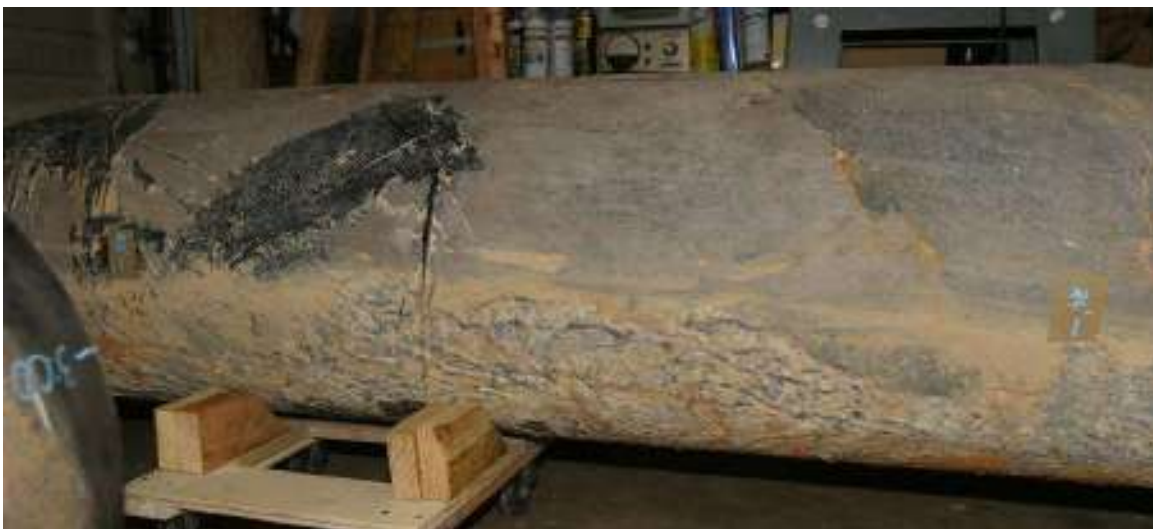
The photographs display overall views of the west side from 7:30 to 10:30 of the fractured pipe from 20' south to 24' south of the north girth weld, and from 24' south to 28' south of the north girth weld, respectively, in the as-received condition prior to removing the coating. The lower half of the pipe contains disbonded and wrinkled coating.

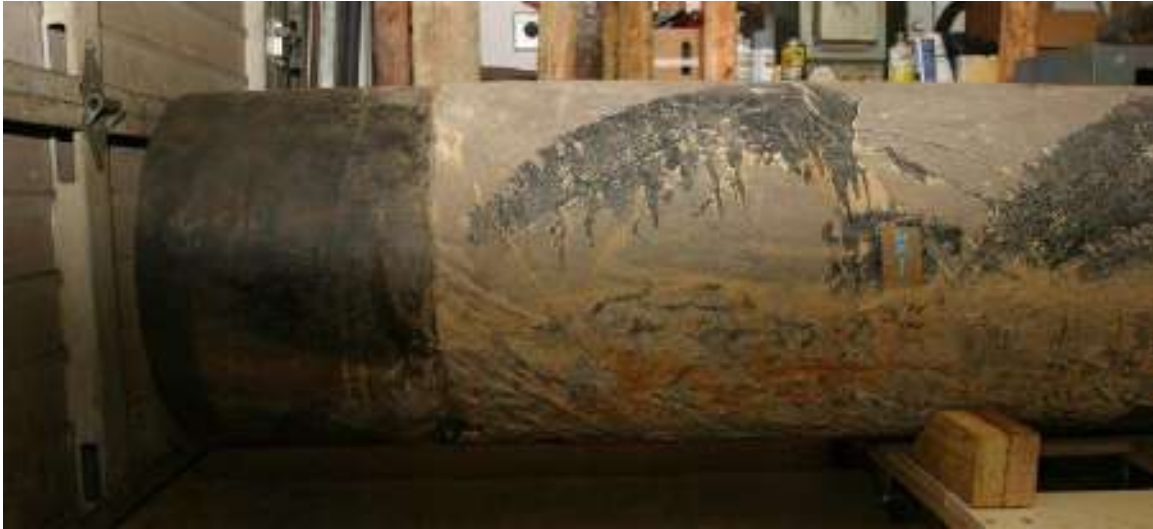
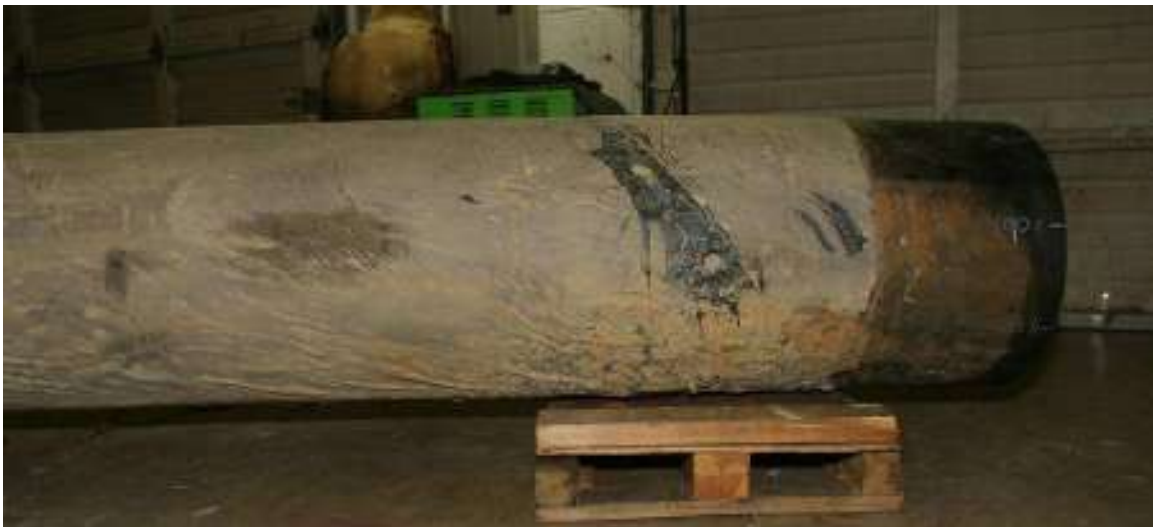
The photographs display overall views of the west side from 7:30 to 10:30 of the fractured pipe from 28' south to 31' south of the north girth weld, and from 31' south to 35' south of the north girth weld, respectively, in the as-received condition prior to removing the coating. The pipe had been sectioned transversely approximately 31' south of the north girth weld. The lower half of the pipe contains disbonded and wrinkled coating.

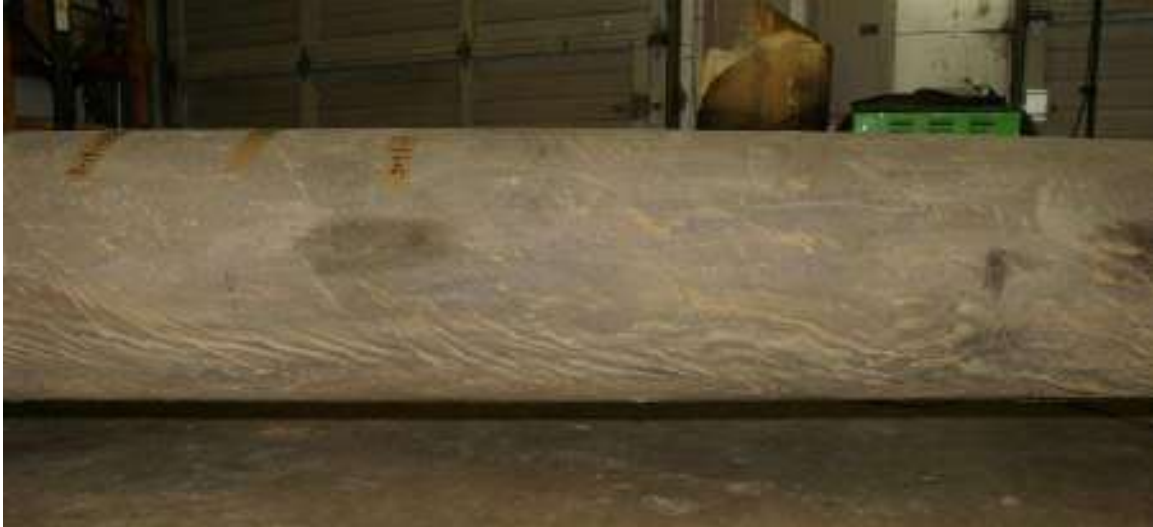
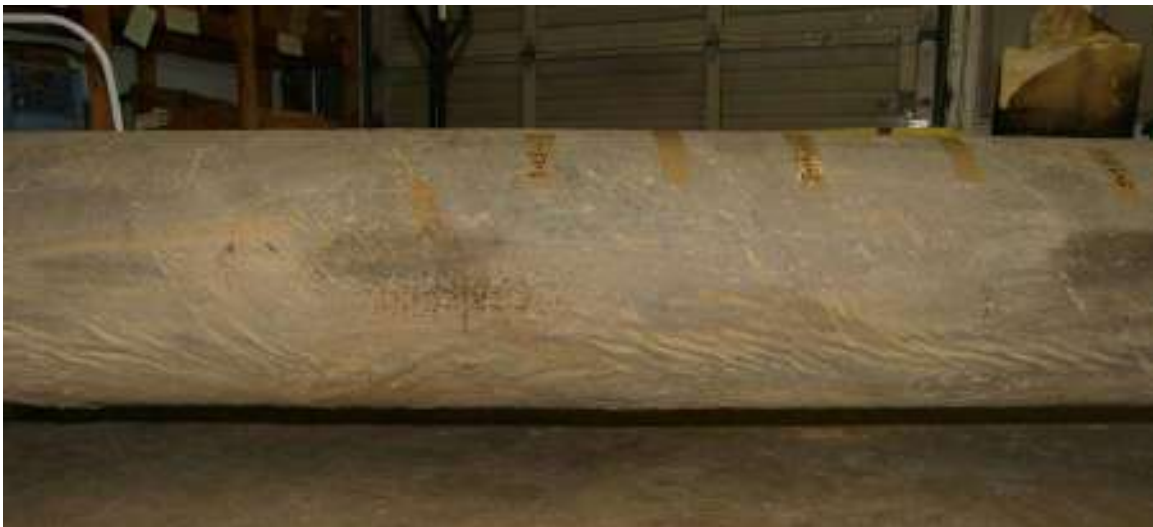
The photographs display overall views of the west side between 7:30 and 10:30 of the fractured pipe from 35' south to 39' south of the north girth weld, and from 39' south to 43' south of the north girth weld, respectively, in the as-received condition prior to removing the coating. The lower half of the pipe contains disbonded and wrinkled coating.

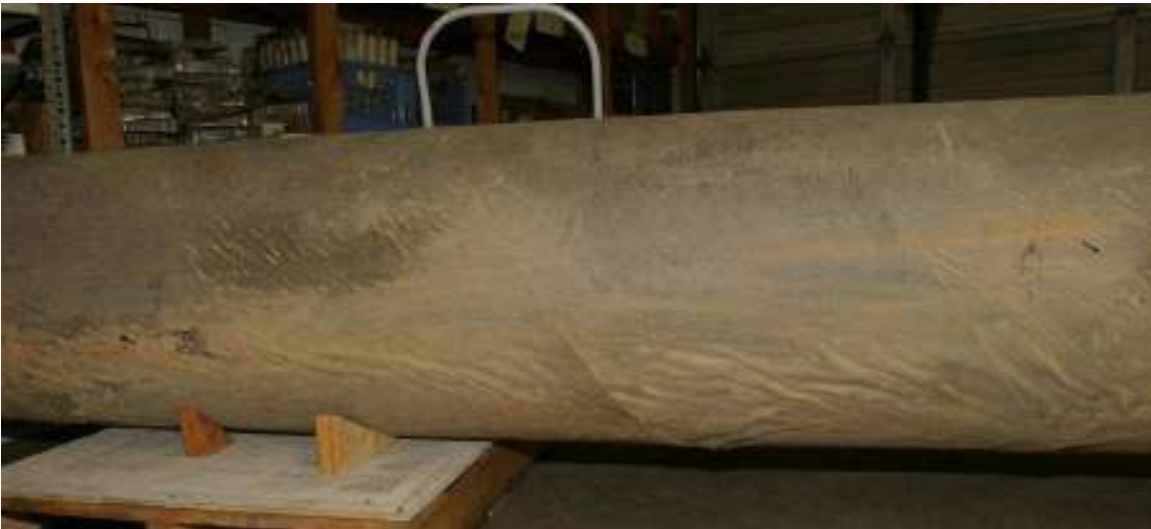
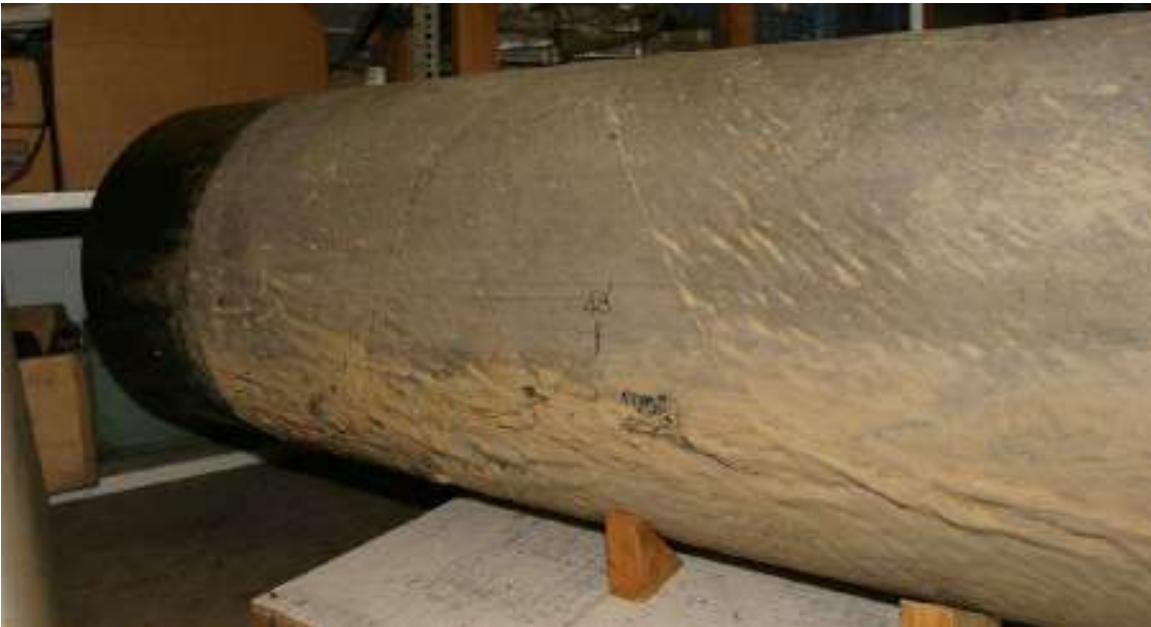
The photographs display overall views of the west side from 7:30 to 10:30 of the fractured pipe and adjacent intact pipe from 43' south to 47' south of the north girth weld, and from 47' south to 51' south of the north girth weld, respectively, in the as-received condition prior to removing the coating. The coating had been removed from the adjacent intact pipe prior to allow for sectioning. The lower half of the pipe contains disbonded and wrinkled coating.
