*METALLURGICAL INVESTIGATION OF A
FRACTURED SECTION OF THE 20" O.D.
PIPELINE AT MILEPOST 314.77 IN THE
CONWAY TO CORSICANA SEGMENT OF
THE PEGASUS CRUDE OIL PIPELINE*

REPORT NO. 64961, REV. 1

Prepared for
ExxonMobil Pipeline Company and the
Pipeline and Hazardous Materials Safety Administration
pursuant to Corrective Action Order CPF 4-2013-5006H

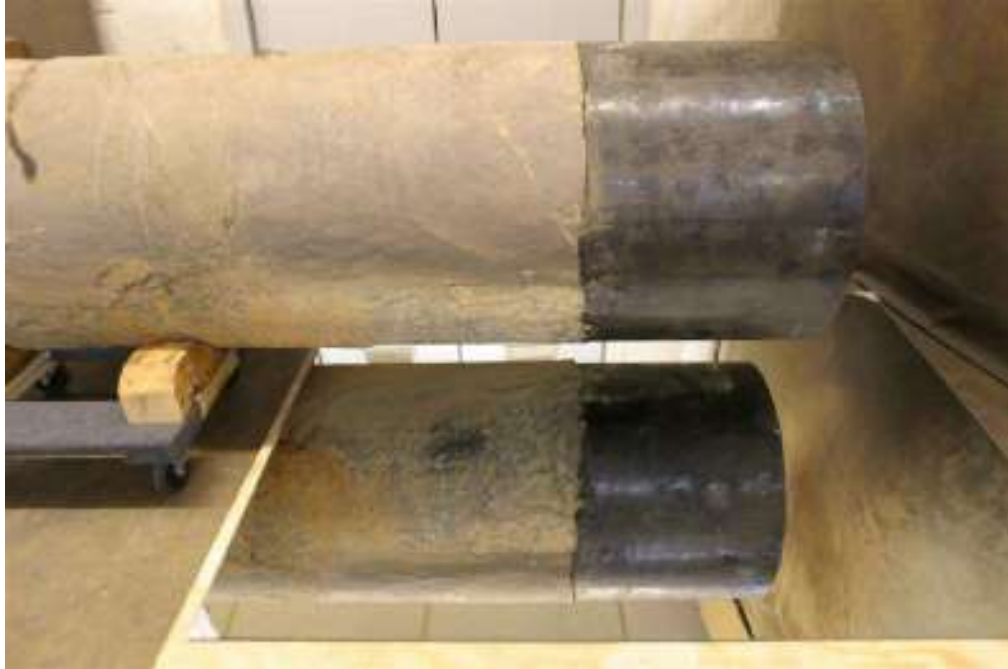
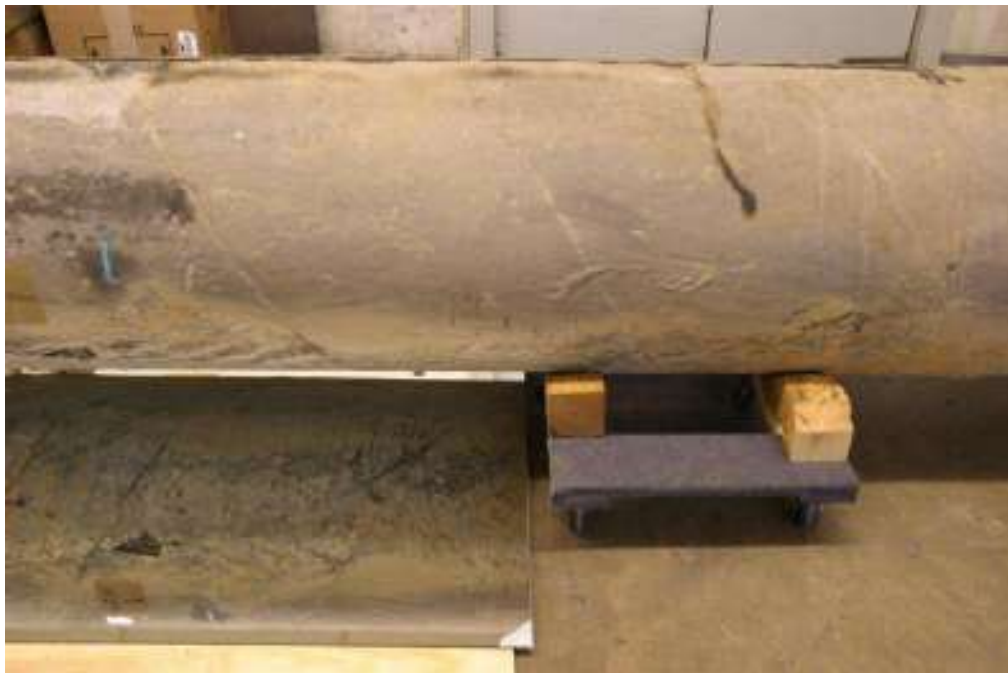
The photographs display overall bottom views of the pipe from 4:30 to 7:30 o'clock adjacent to the fractured pipe from approximately 3' north of the north girth weld (-3') to the center of the north girth weld (0'), and the fractured pipe from the center of the north girth weld to 4' south of the north girth weld (+4'), respectively, in the as-received condition prior to removing the coating. The coating had been removed from the adjacent intact pipe prior to sectioning in the field. The coating on the lower half of the pipe is sagging and contains wrinkles.

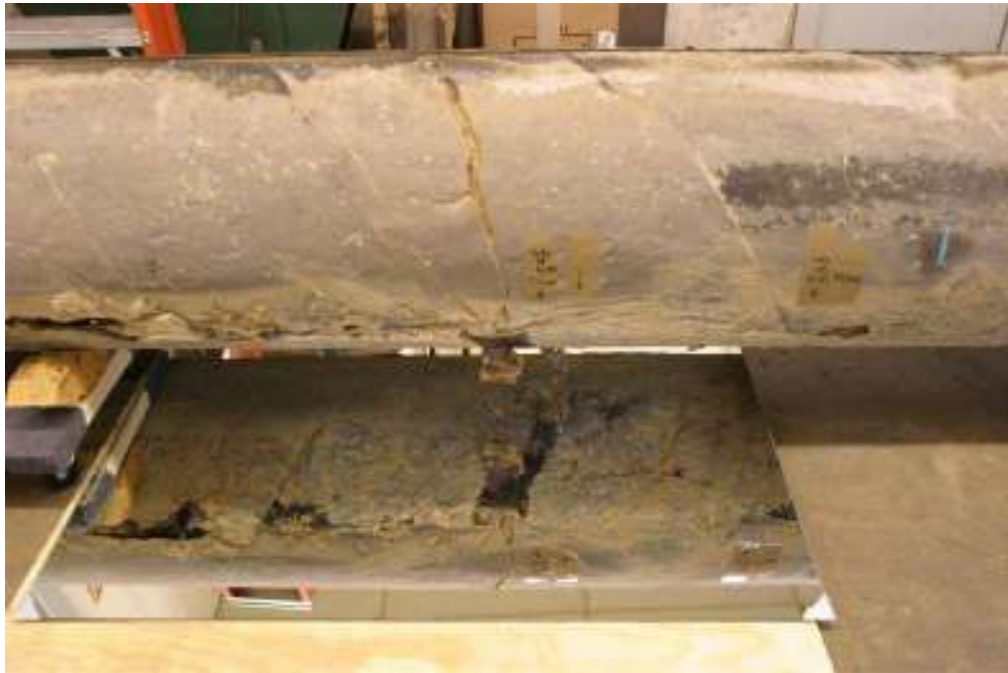
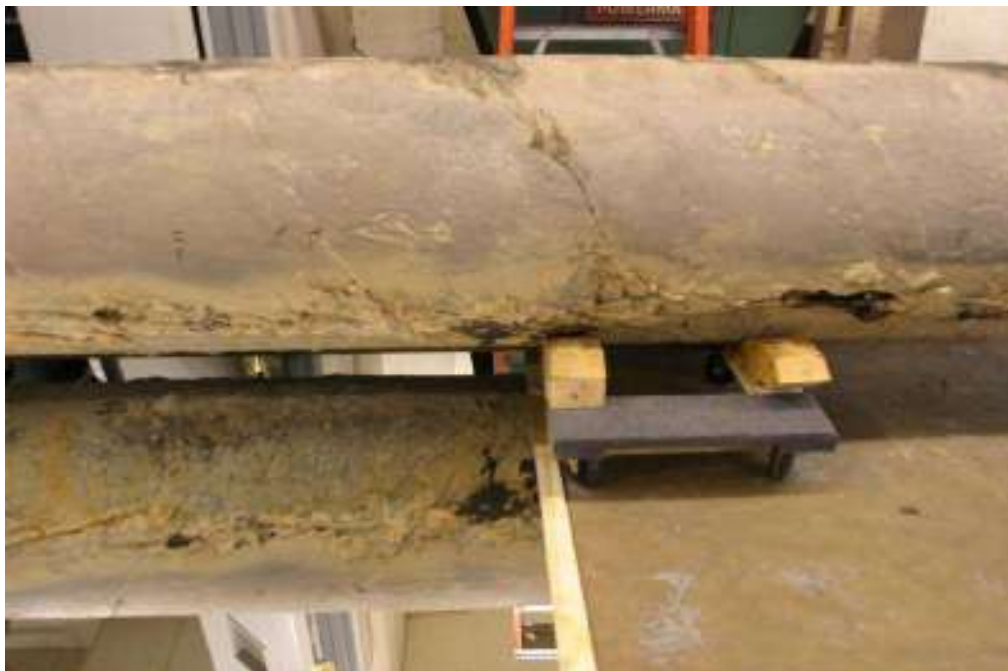
The photographs display overall bottom views of the fractured pipe from 4:30 to 7:30 from 4' south to 8' south of the north girth weld, and from 8' south to 12' south of the north girth weld, respectively, in the as-received condition prior to removing the coating. The coating on the lower half of the pipe is sagging and contains wrinkles.

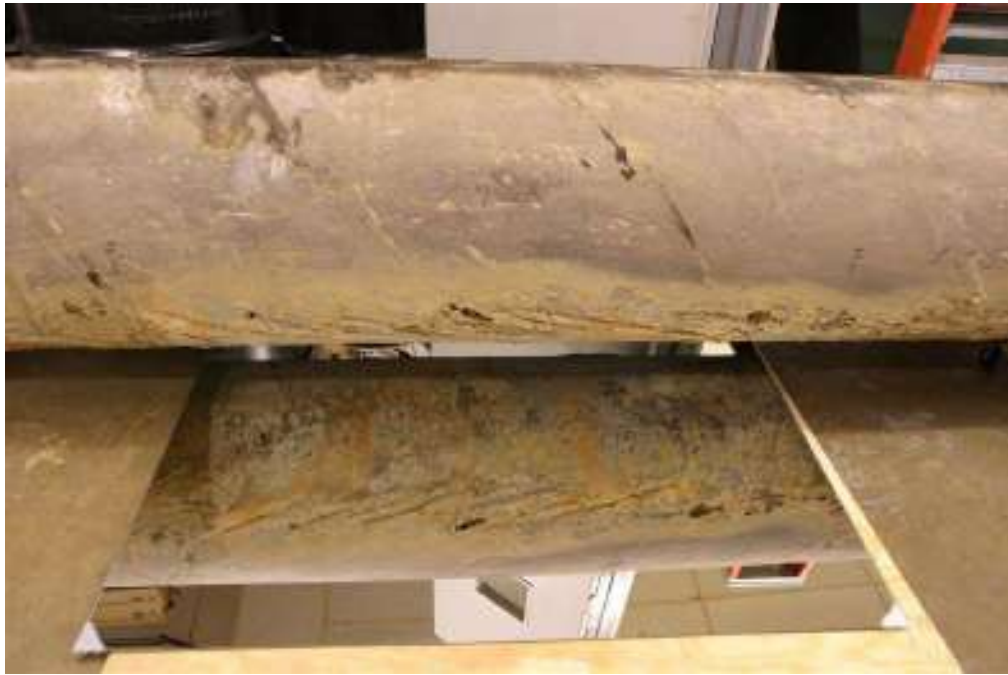
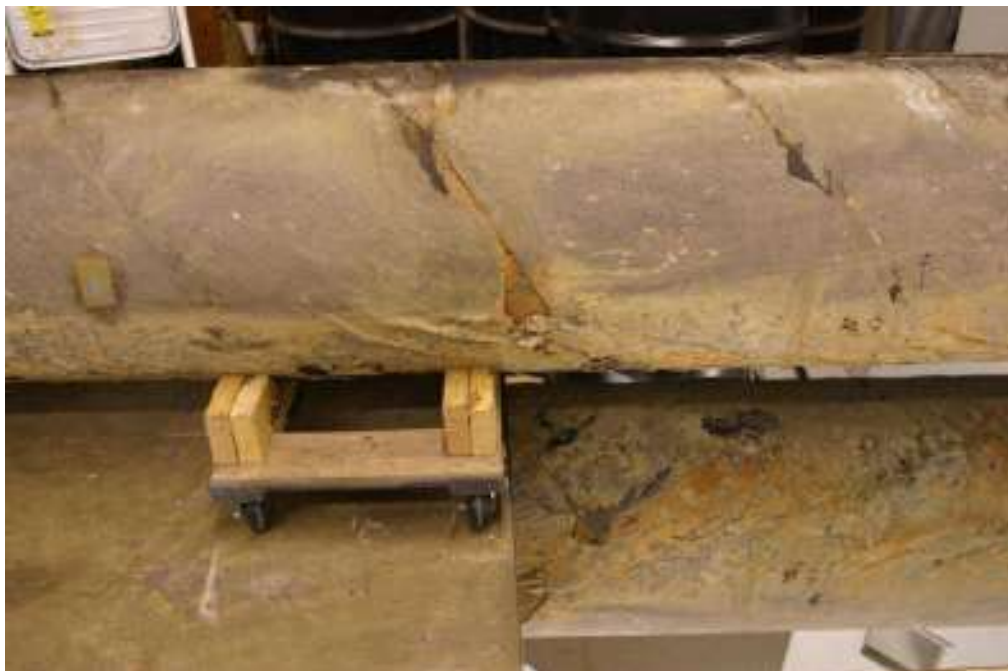
The photographs display overall bottom views of the fractured pipe from 4:30 to 7:30 from 12' south to 16' south of the north girth weld, and from 16' south to 20' south of the north girth weld, respectively, in the as-received condition prior to removing the coating. The coating on the lower half of the pipe contains wrinkles and has sagged.

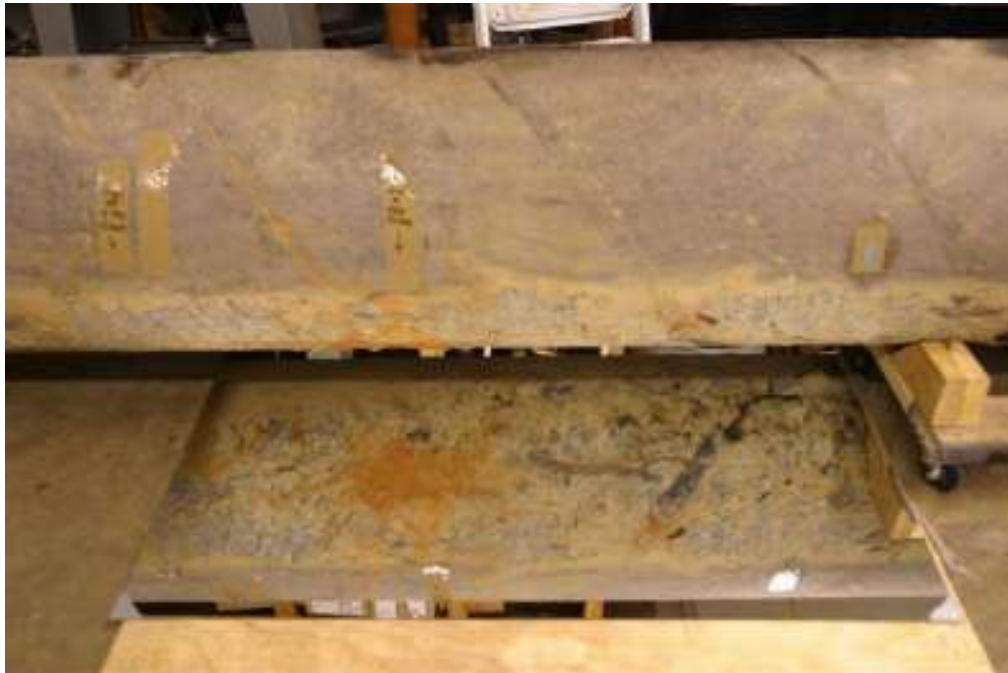
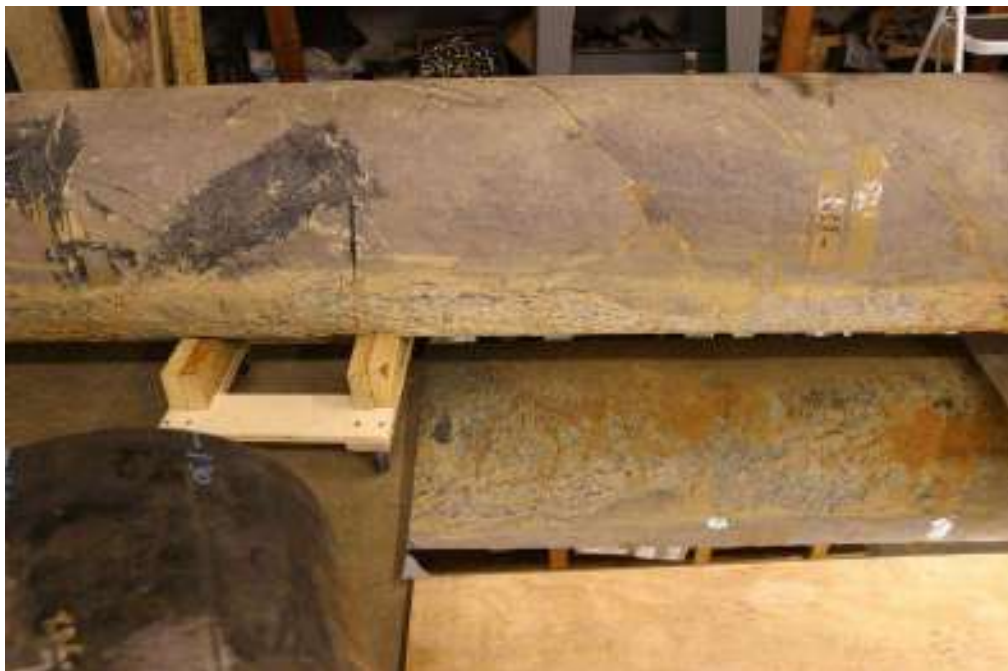
The photographs display overall bottom views of the fractured pipe from 4:30 to 7:30 from 20' south to 24' south of the north girth weld, and from 24' to 28' south of the north girth weld, respectively, in the as-received condition prior to removing the coating. The coating on the lower half of the pipe contains a significant amount of wrinkles and has sagged quite a bit.

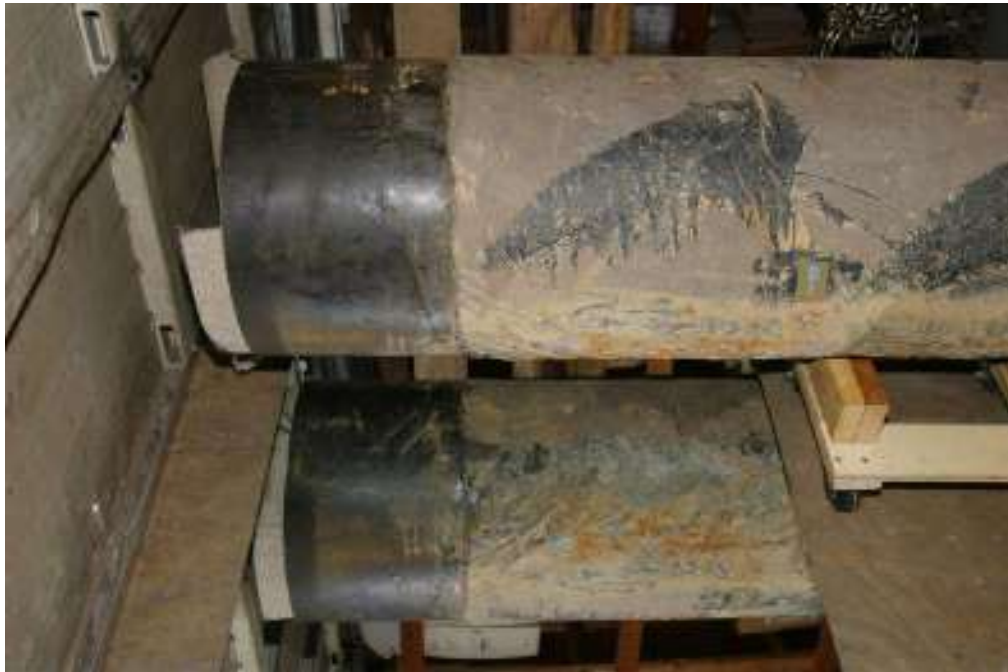
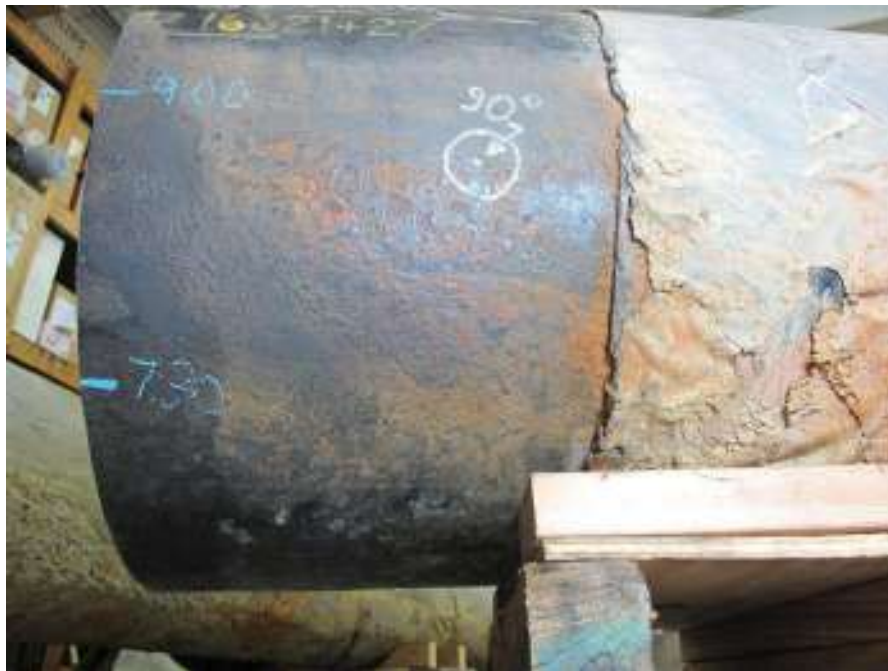
The photographs display overall bottom views of the fractured pipe from 4:30 to 7:30 from 28' south to 31' south of the north girth weld, and from 31' south to 35' south of the north girth weld, respectively, in the as-received condition prior to removing the coating. The fractured pipe was sectioned transversely approximately 31' south of the north girth weld into two sections.

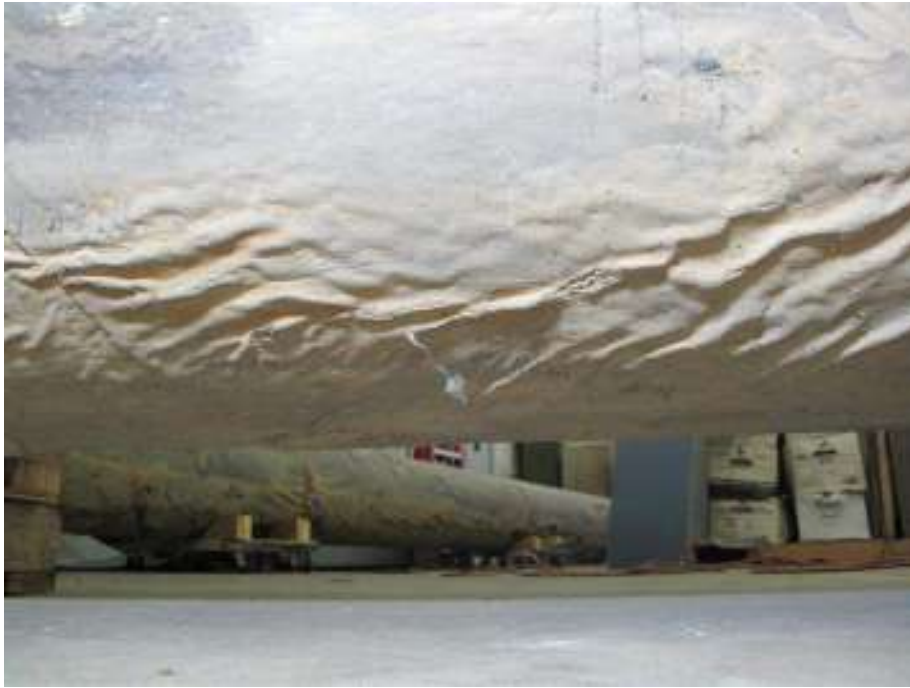
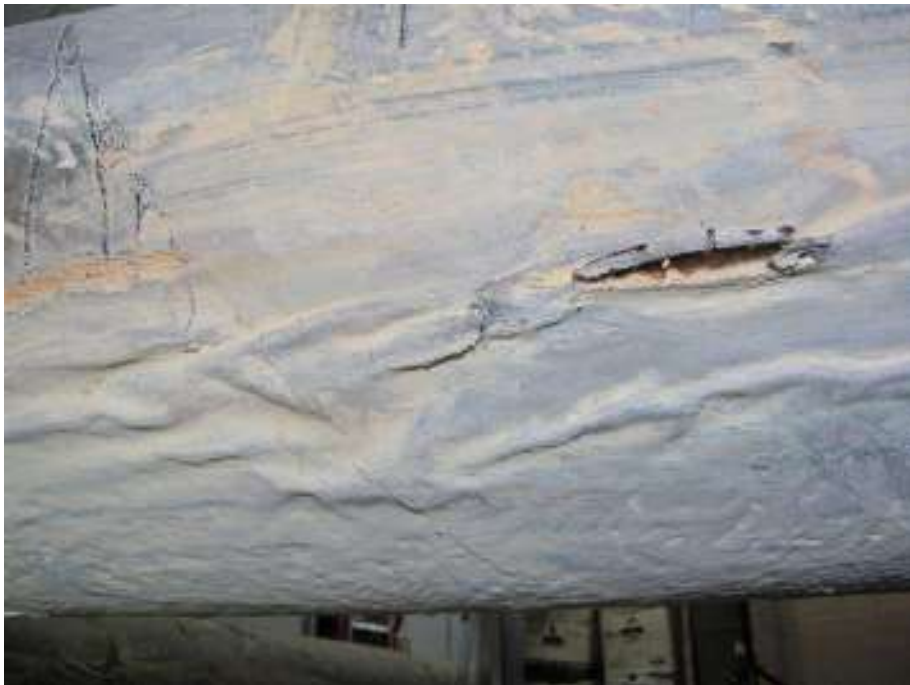
The photographs display overall bottom views of the fractured pipe from 4:30 to 7:30 from 35' south to 39' south of the north girth weld, and from 39' south to 43' south of the north girth weld, respectively, in the as-received condition prior to removing the coating. The coating on the lower half of the pipe had sagged quite a bit and contains a significant amount of wrinkles.

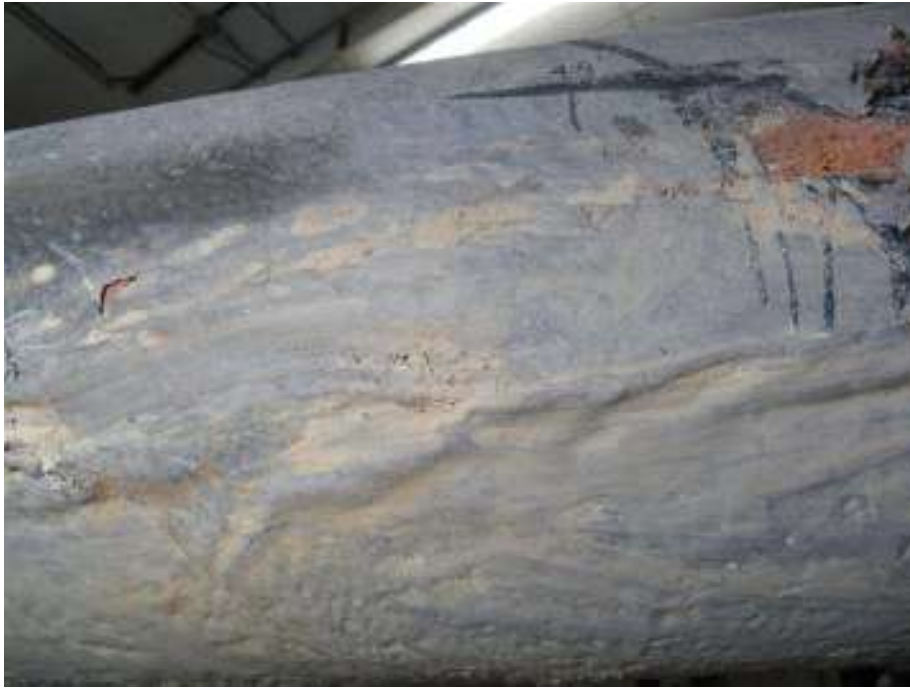
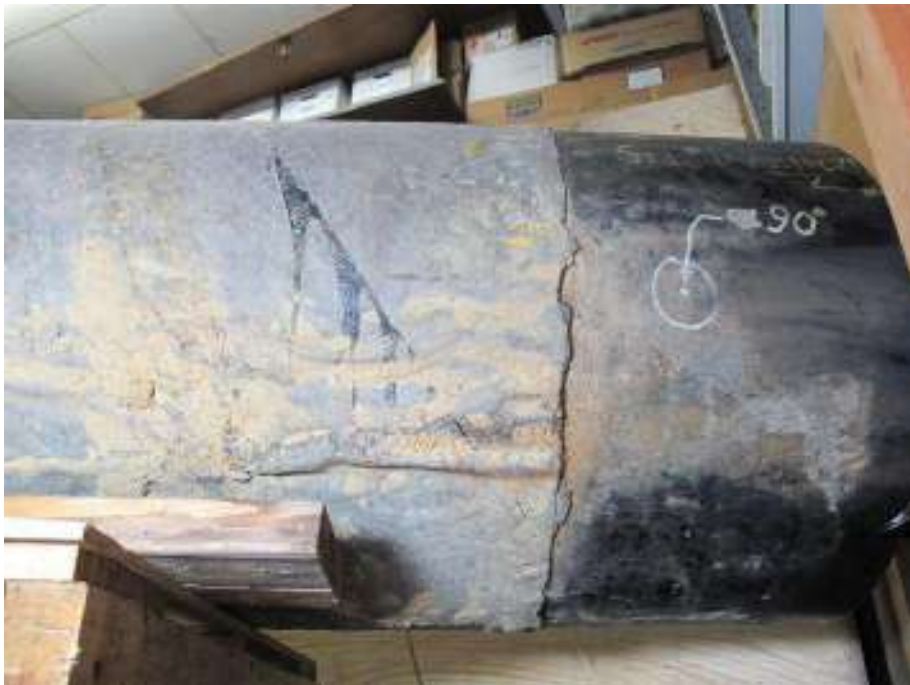
The photographs display overall bottom views of the fractured pipe from 4:30 to 7:30 and the adjacent intact pipe from 43' south to 47' south of the north girth weld, and from 47' south to 51' south of the north girth weld, respectively, in the as-received condition prior to removing the coating. The coating on the lower half of the pipe contains a significant amount of wrinkles. The coating on the lower half of the pipe contains wrinkles.

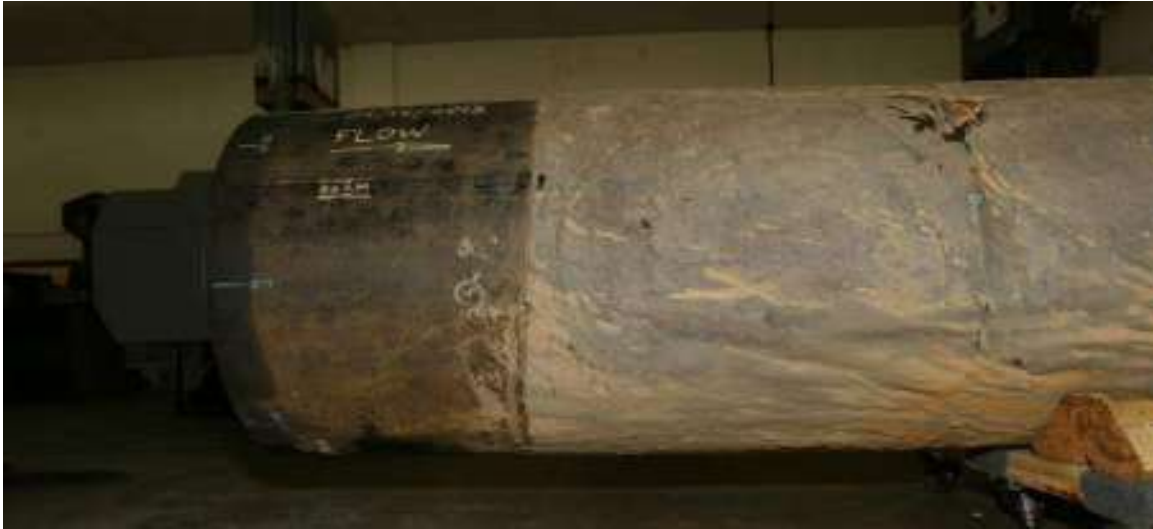
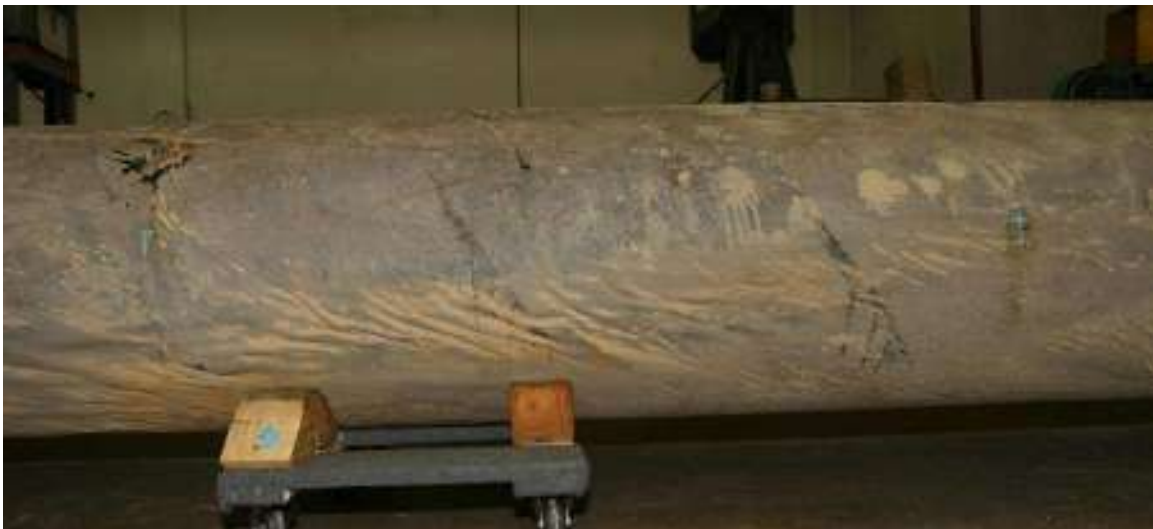
The photographs display overall views of the east side of a pipe from 1:30 to 4:30 adjacent to the fractured pipe from approximately 3' north of the north girth weld (-3') to the center of the north girth weld (0'), and the fractured pipe from the center of the north girth weld to 4' south of the north girth weld (+4'), respectively, in the as-received condition prior to removing the coating. The lower half of the pipe contains wrinkled coating.

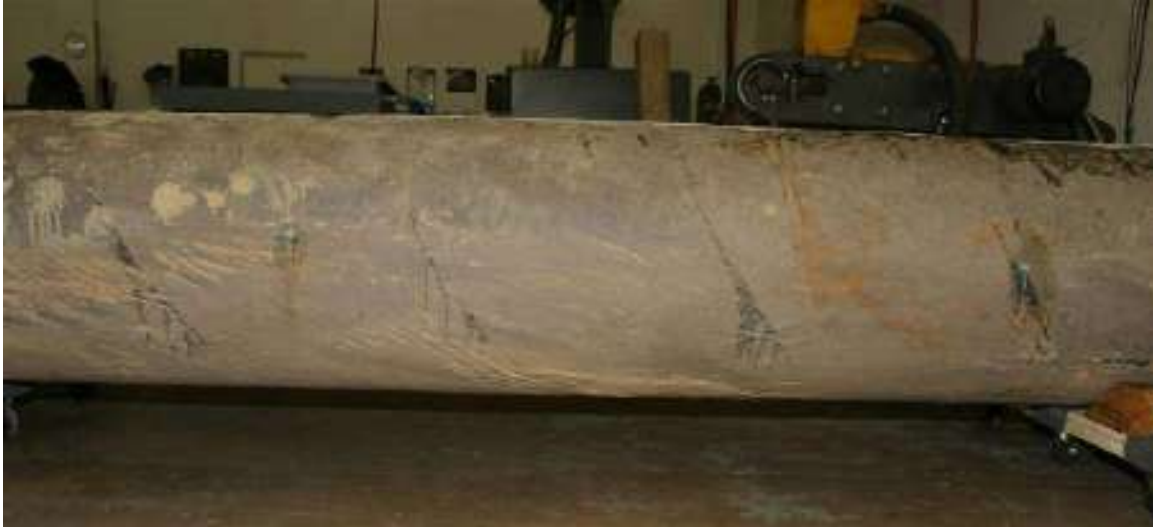
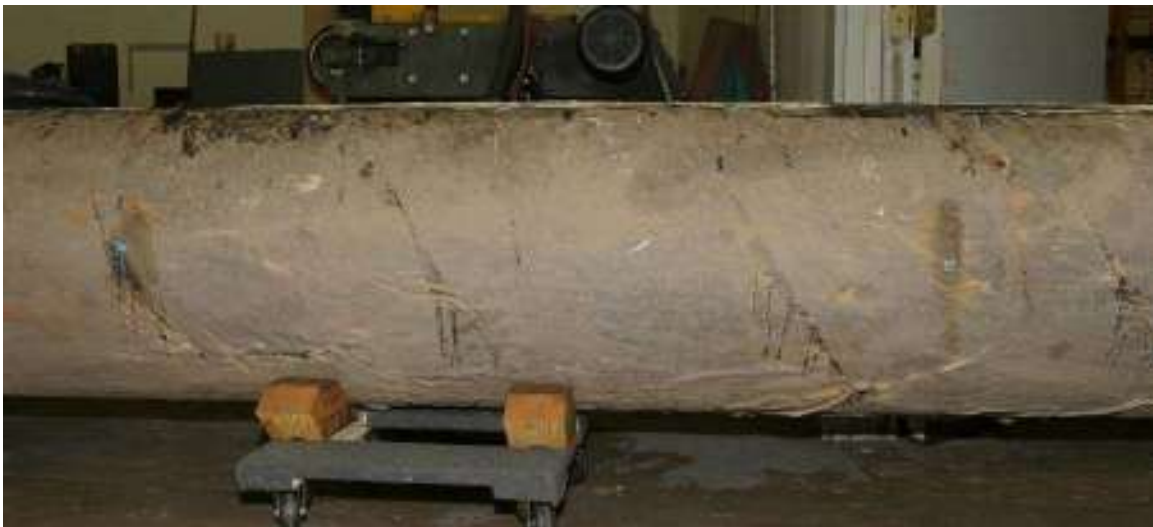
The photographs display overall views of the east side of the fractured pipe from 1:30 to 4:30 from 4' south to 8' south of the north girth weld, and from 8' south to 12' south of the north girth weld, respectively, in the as-received condition prior to removing the coating. The lower half of the pipe contains sagging and wrinkled coating.

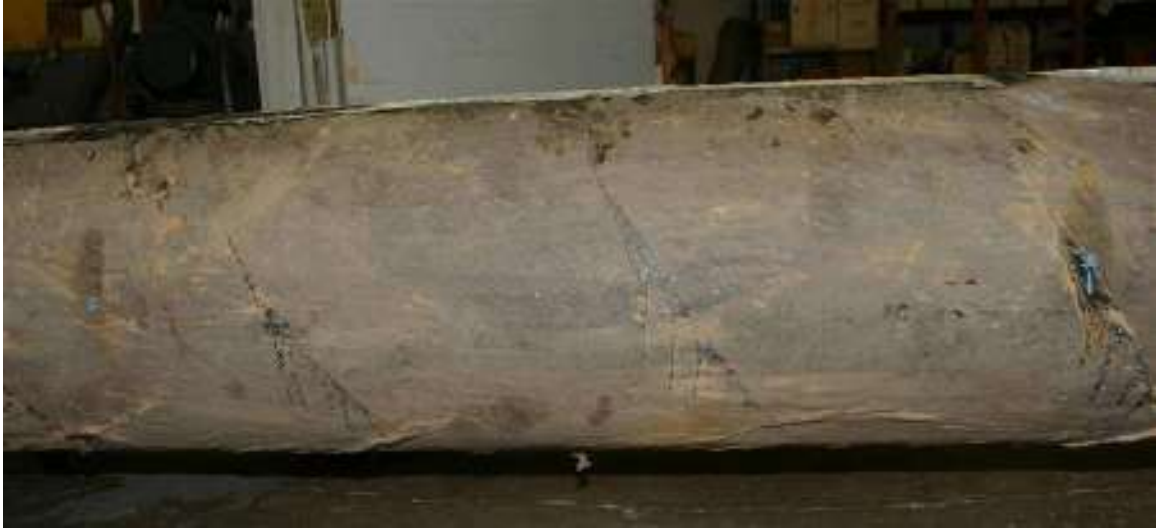
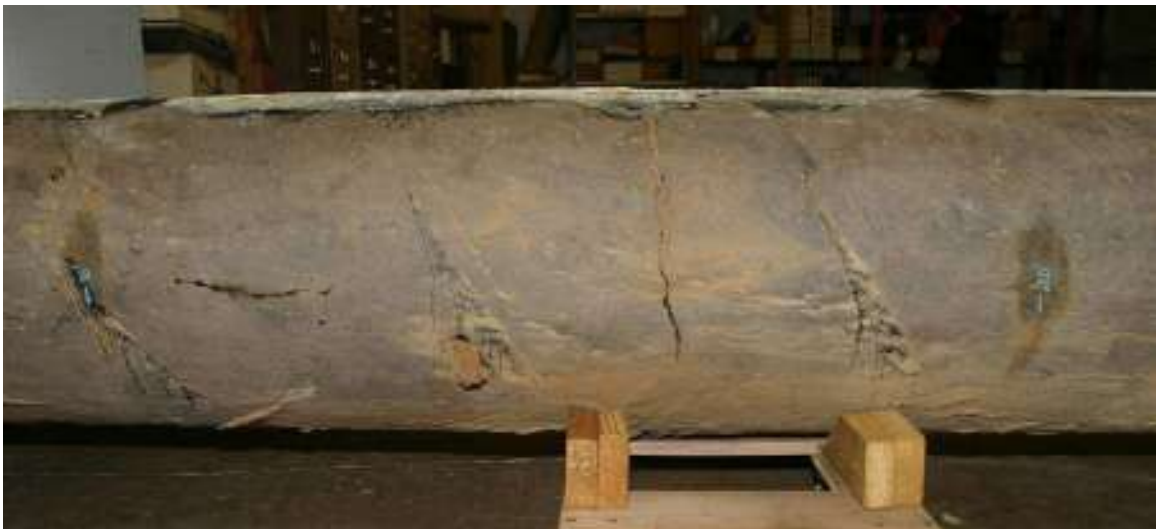
The photographs display overall views of the east side of the fractured pipe from 1:30 to 4:30 from 12' south to 16' south of the north girth weld, and from 16' south to 20' south of the north girth weld, respectively, in the as-received condition prior to removing the coating. The lower half of the pipe contains sagging and wrinkled coating.

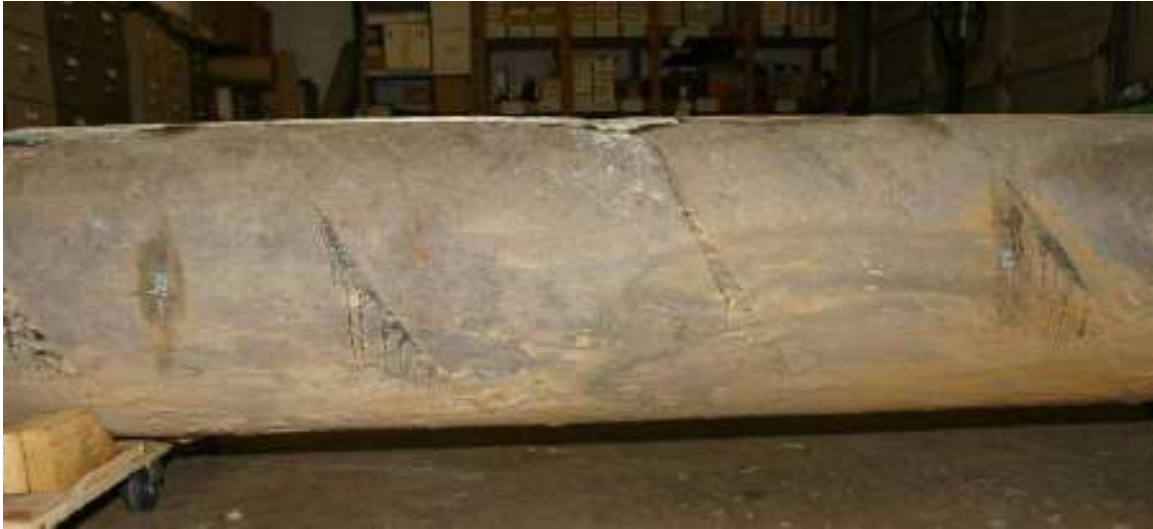
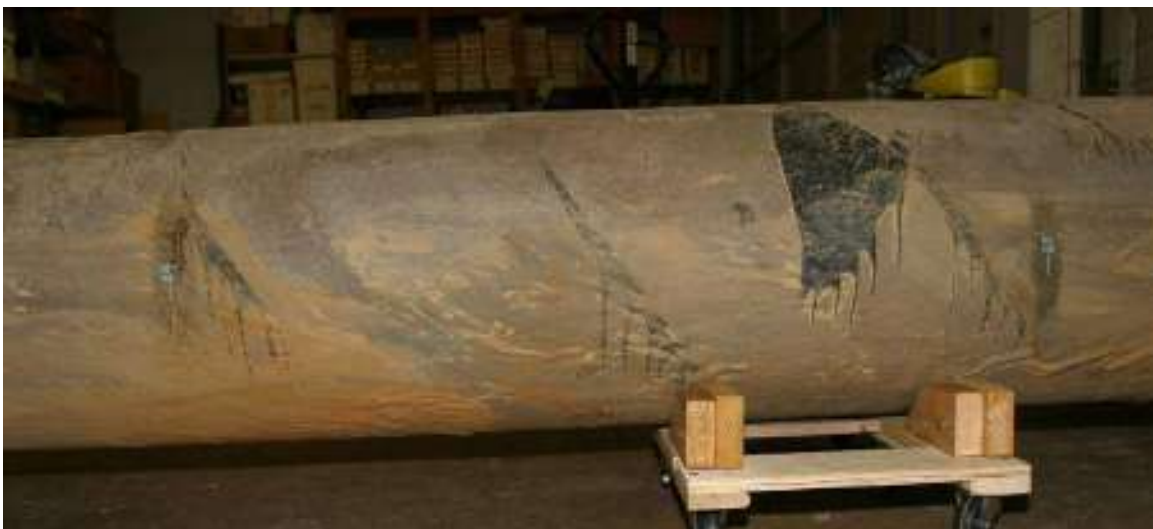
The photographs display overall views of the east side of the fractured pipe from 1:30 to 4:30 from 20' south to 24' south of the north girth weld, and from 24' south to 28' south of the north girth weld, respectively, in the as-received condition prior to removing the coating. The coating on the lower half of the pipe contains sagging and wrinkles.

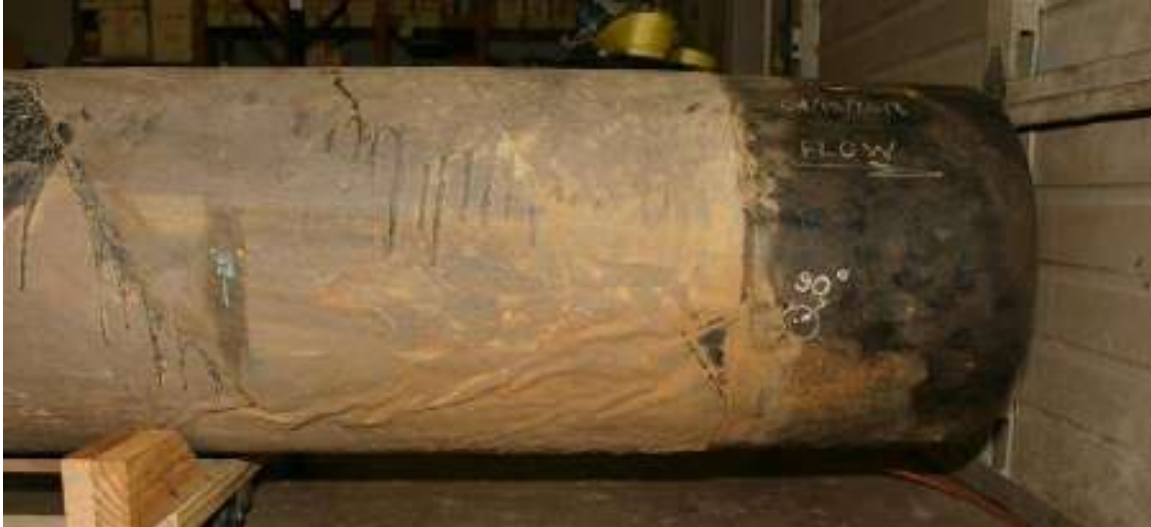
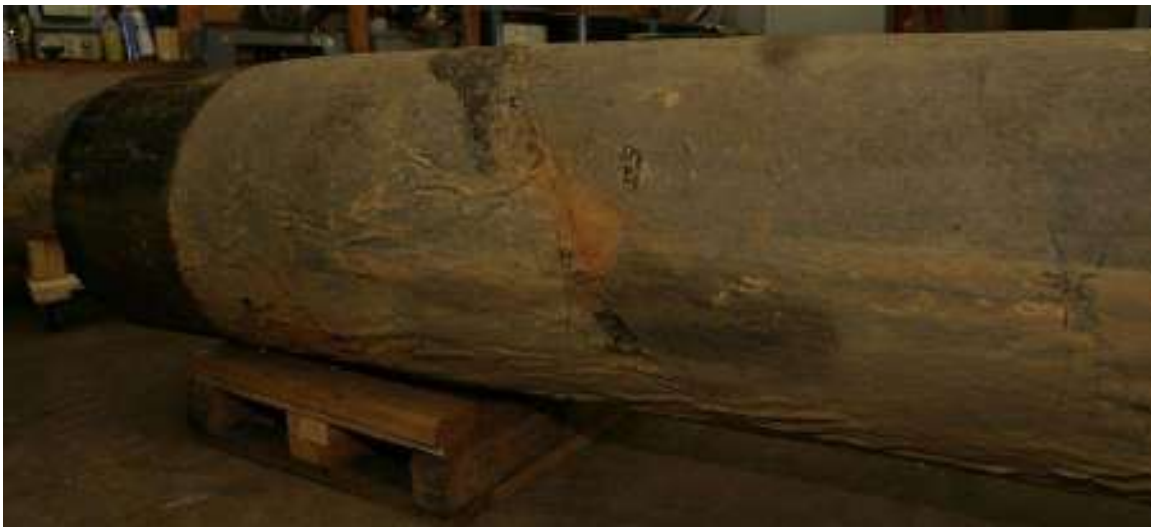
The photographs display overall views of the east side of the fractured pipe from 1:30 to 4:30 from 28' south to 31' south of the north girth weld, and from 31' south to 35' south of the north girth weld, respectively, in the as-received condition prior to removing the coating. The lower half of the pipe contains sagging and wrinkled coating.

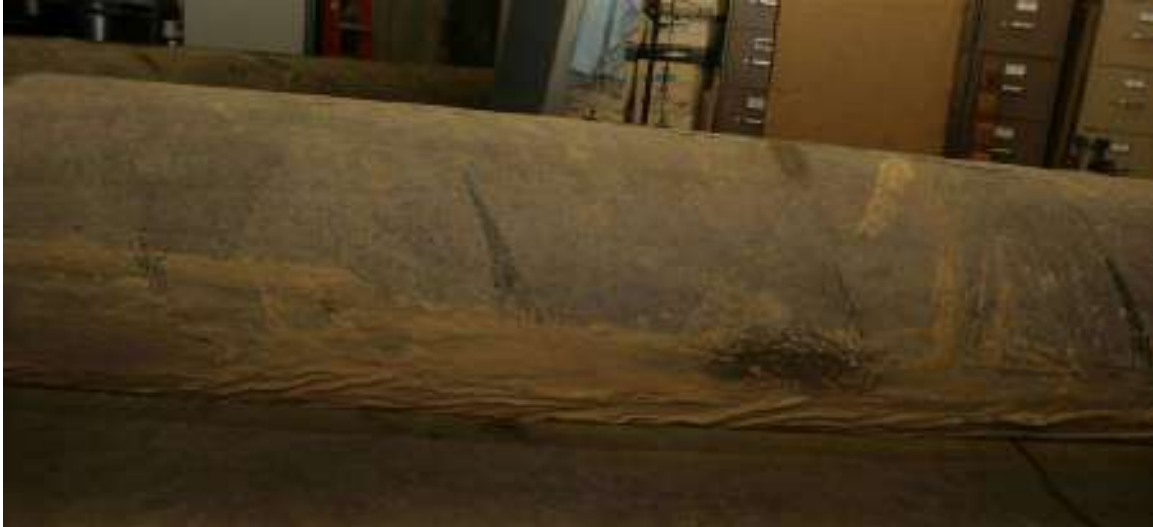
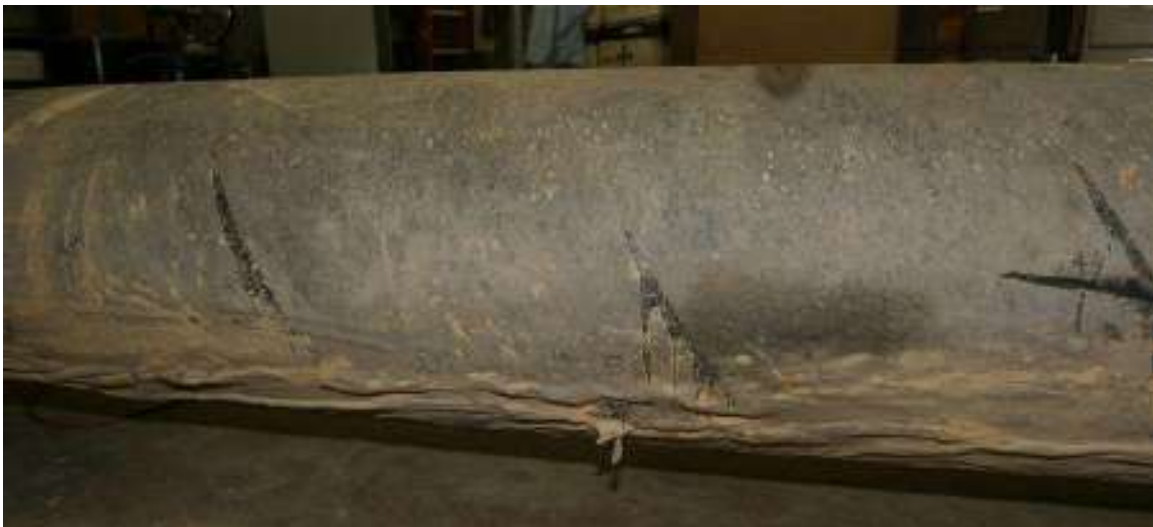
The photographs display overall views of the east side of the fractured pipe from 1:30 to 4:30 from 35' south to 39' south of the north girth weld, and from 39' south to 43' south of the north girth weld, respectively, in the as-received condition prior to removing the coating. The coating on the lower half is wrinkled and sagging.

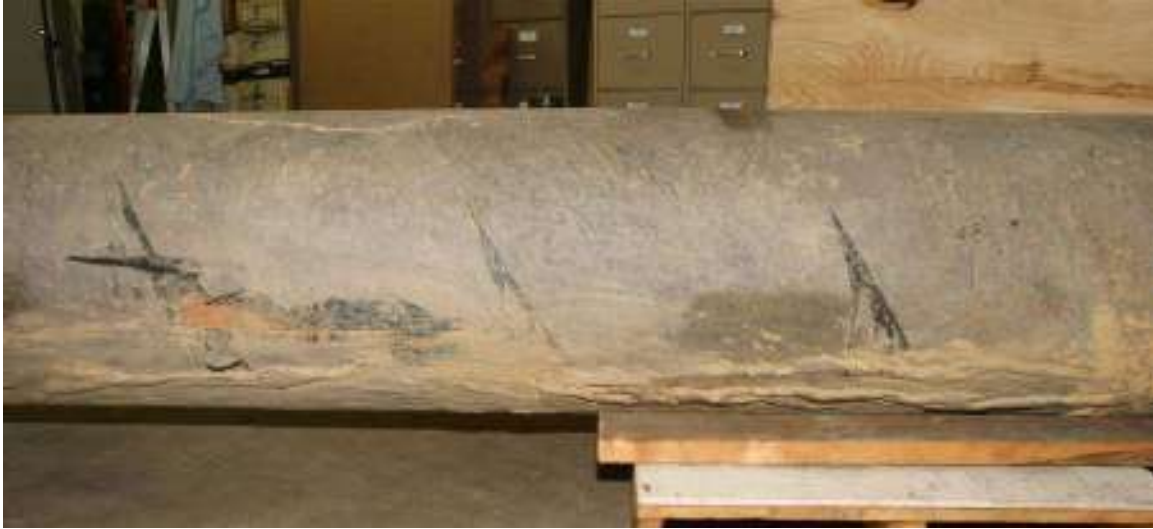
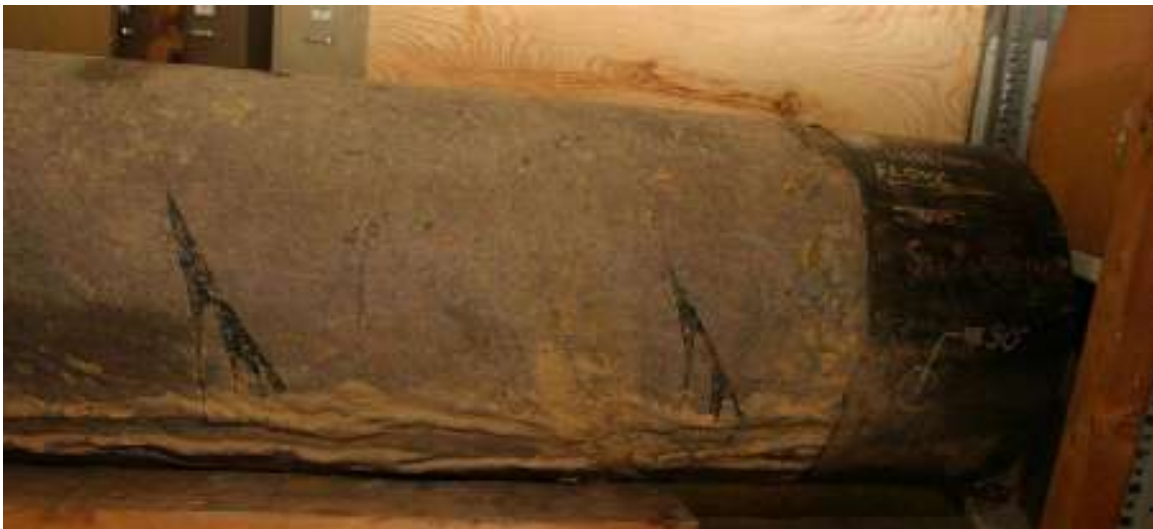
The photographs display overall views of the east side of the fractured pipe from 1:30 to 4:30 and adjacent intact pipe from 43' south to 47' south of the north girth weld, and from 47' south to 51' south of the north girth weld, respectively, in the as-received condition prior to removing the coating. The coating had been removed from the adjacent intact pipe prior to sectioning. The coating on the lower half of the pipe is wrinkled and sagging.

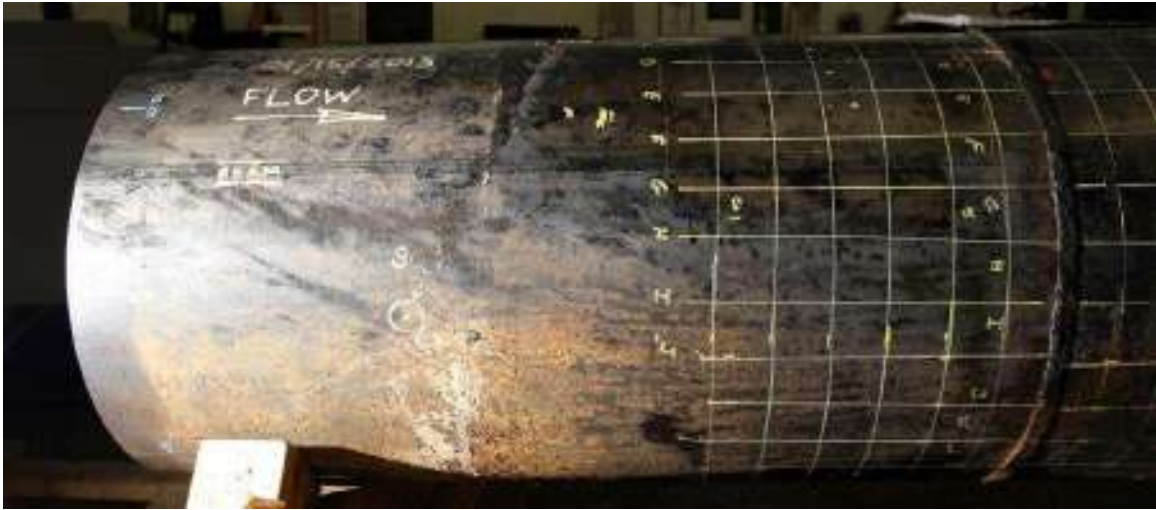
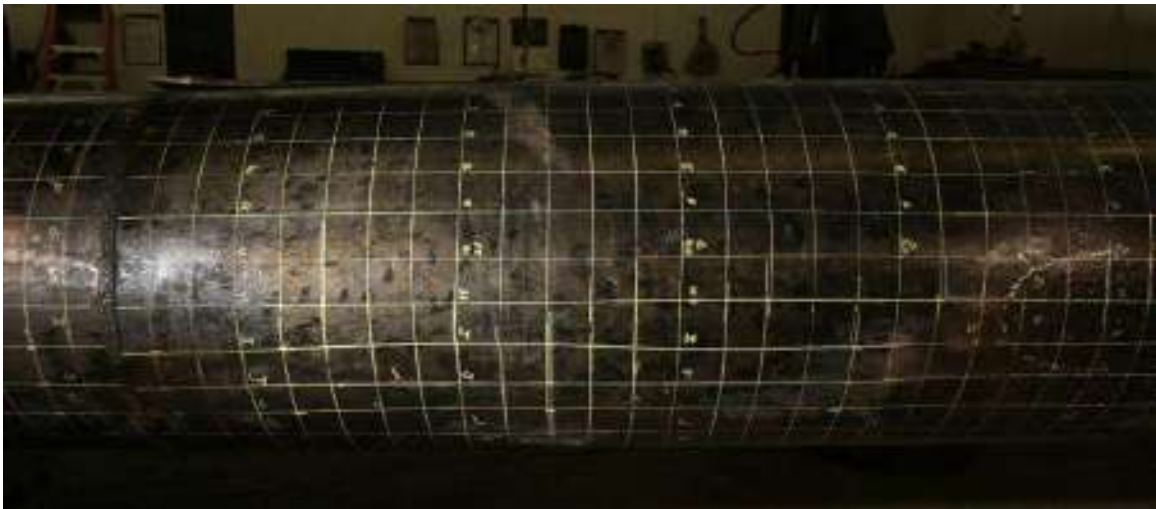
Circumferential Location	Distance from North Girth Weld	Depth of Corrosion Pitting		
		Minimum	Average	Maximum
All	-3' to 0'	No Corrosion Pitting Visible		
7:26 o'clock to 10:07 o'clock	0' to 4'	0.006"	0.017"	0.029"

The photographs display overall views of the west side of the pipe adjacent to the fractured area of the pipe, from approximately 3' north of the north girth weld (-3') to the center of the girth weld (0'), and the fractured pipe from the center of the girth weld to 4' south of the girth weld (+4'), respectively, after the removal of the coating. The lower half of the pipe shows corrosion pitting on the O.D. surface where the coating had wrinkled and sagged.

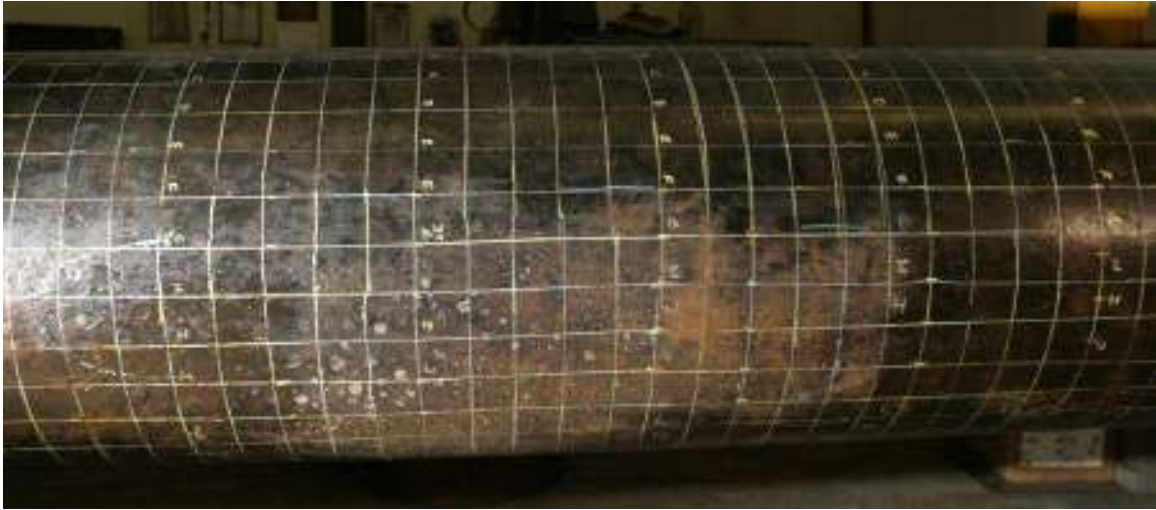
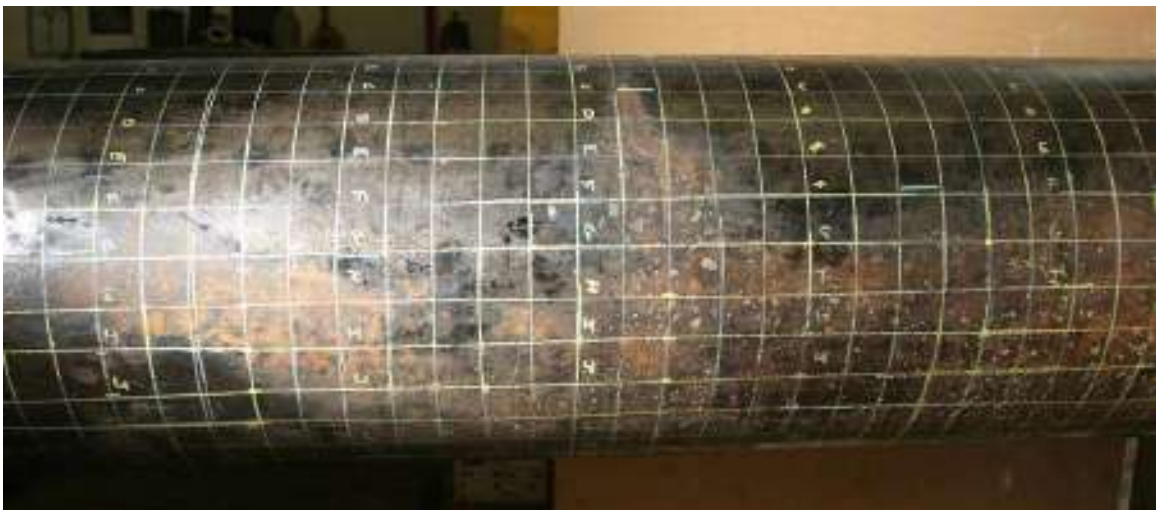
Circumferential Location	Distance from North Girth Weld	Depth of Corrosion Pitting		
		Minimum	Average	Maximum
6:41 o'clock to 10:07 o'clock	4' to 8'	0.002"	0.013"	0.037"
7:03 o'clock to 11:16 o'clock	8' to 12'	0.002"	0.011"	0.026"

The photographs display overall views of the west side of the fractured pipe from 4' south to 8' south of the north girth weld, and 8' south to 12' south of the north girth weld, respectively, after the removal of the coating. The lower half of the pipe shows corrosion pitting on the O.D. surface where the coating had wrinkled and sagged.
