*METALLURGICAL INVESTIGATION OF A
FRACTURED SECTION OF THE 20" O.D.
PIPELINE AT MILEPOST 314.77 IN THE
CONWAY TO CORSICANA SEGMENT OF
THE PEGASUS CRUDE OIL PIPELINE*

REPORT NO. 64961, REV. 1

Prepared for
ExxonMobil Pipeline Company and the
Pipeline and Hazardous Materials Safety Administration
pursuant to Corrective Action Order CPF 4-2013-5006H

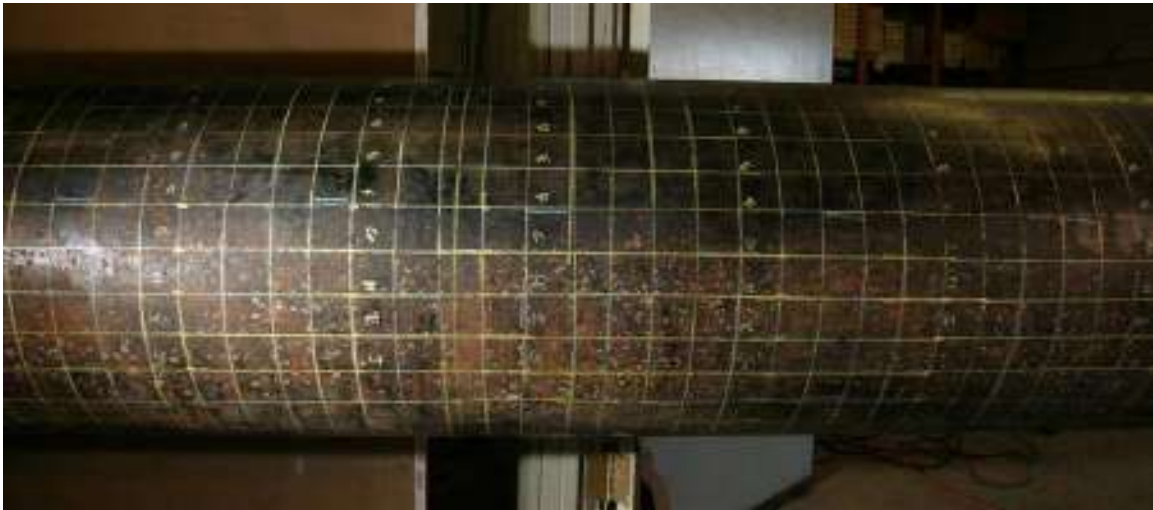
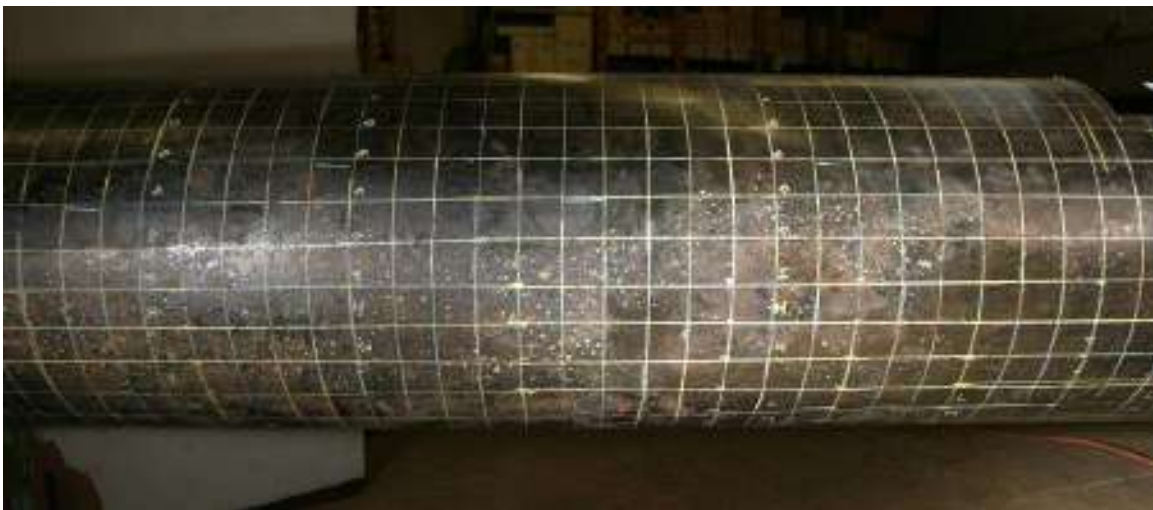
Circumferential Location	Distance from North Girth Weld	Depth of Corrosion Pitting		
		Minimum	Average	Maximum
6:29 o'clock to 9:55 o'clock	12' to 16'	0.003"	0.017"	0.031"
6:52 o'clock to 10:07 o'clock	16' to 20'	0.006"	0.012"	0.021"

The photographs display overall views of the west side of the fractured pipe from 12' south to 16' south of the north girth weld, and 16' south to 20' south of the north girth weld, respectively, after the removal of the coating. The lower half of the pipe shows corrosion pitting on the O.D. surface where the coating had wrinkled and sagged.

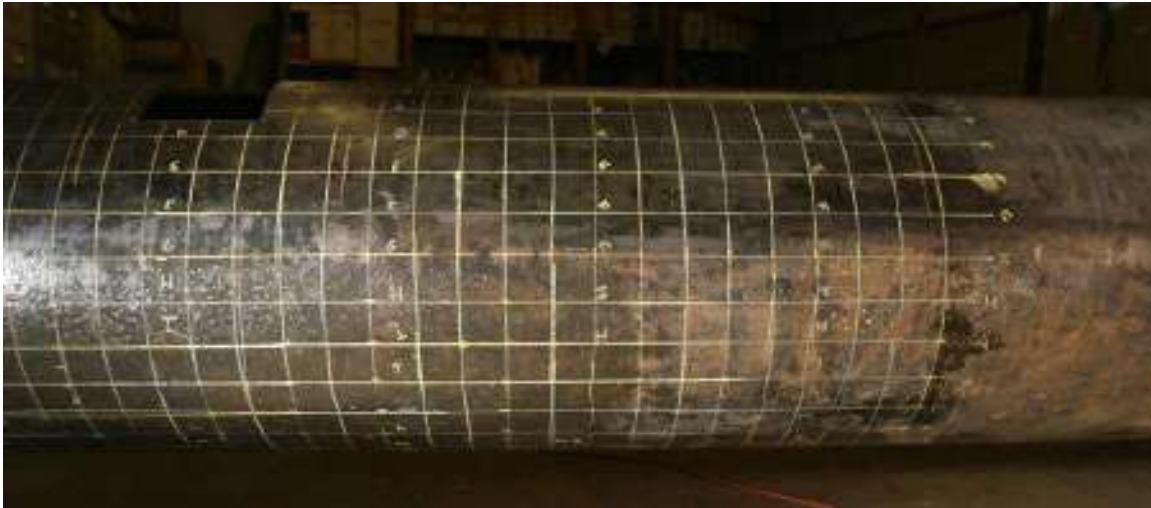
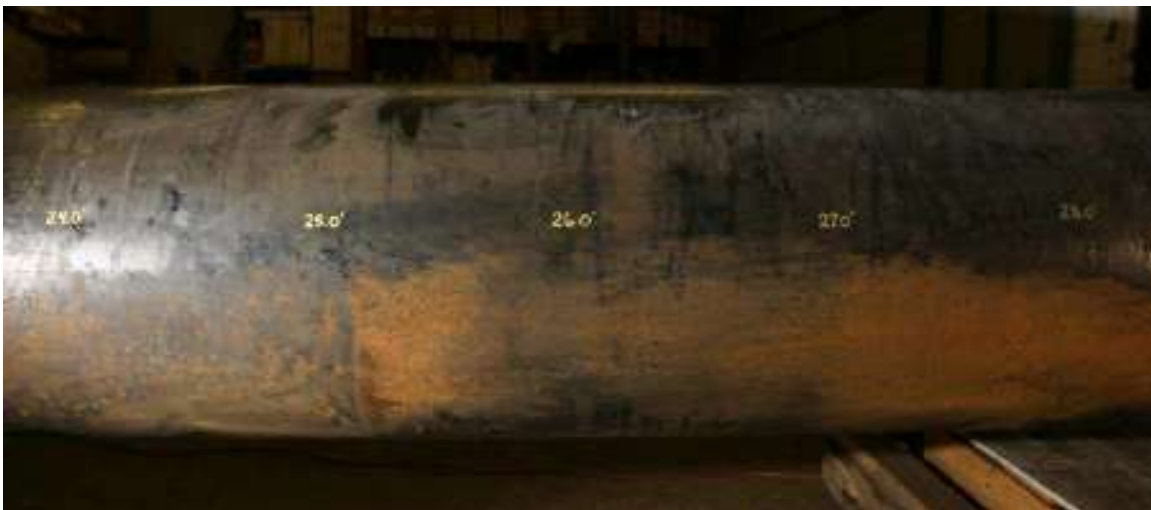
Circumferential Location	Distance from North Girth Weld	Depth of Corrosion Pitting		
		Minimum	Average	Maximum
7:15 o'clock to 9:55 o'clock	20' to 24'	0.005"	0.010"	0.021"
All	24' to 28'	No Corrosion Pitting Visible

The photographs display overall views of the west side of the fractured pipe from 20' south to 24' south of the north girth weld, and 24' south to 28' south of the north girth weld, respectively, after the removal of the coating. The lower half of the pipe shows corrosion pitting on the O.D. surface where the coating had wrinkled and sagged.

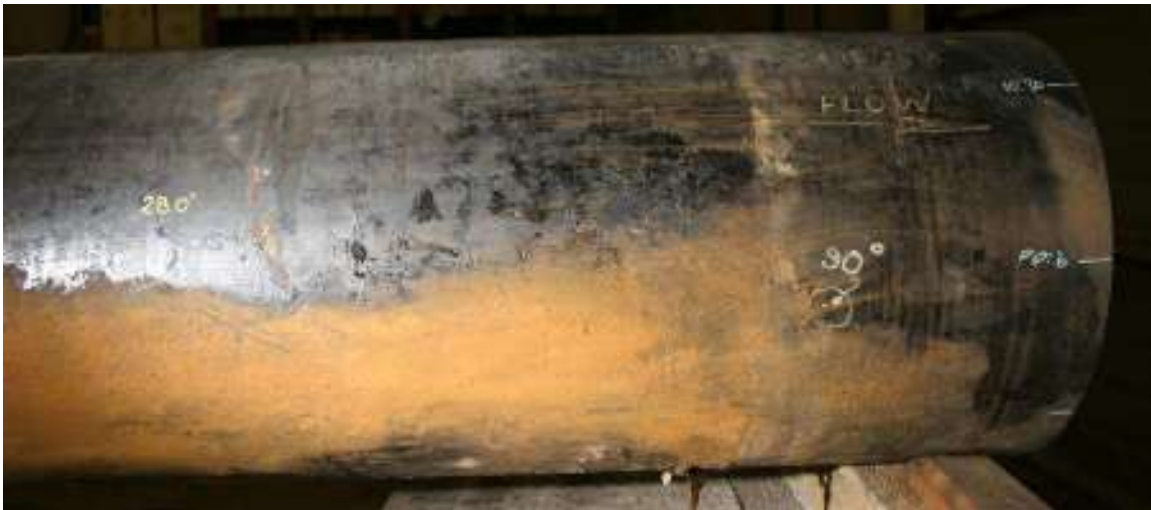
Photograph No. 73

Circumferential Location	Distance from North Girth Weld	Depth of Corrosion Pitting		
		Minimum	Average	Maximum
All	28' to 31'	No Corrosion Pitting Visible

The photograph displays an overall view of the west side of the fractured pipe from 28' south to 31' south of the north girth weld, respectively, after the removal of the coating. The fractured pipe was sectioned in the field transversely approximately 31' south of the north girth weld to allow for removal of the fractured section of pipe. No corrosion pitting is visible on the O.D. surface near the transverse cut at the south end of the fractured section of the pipe.

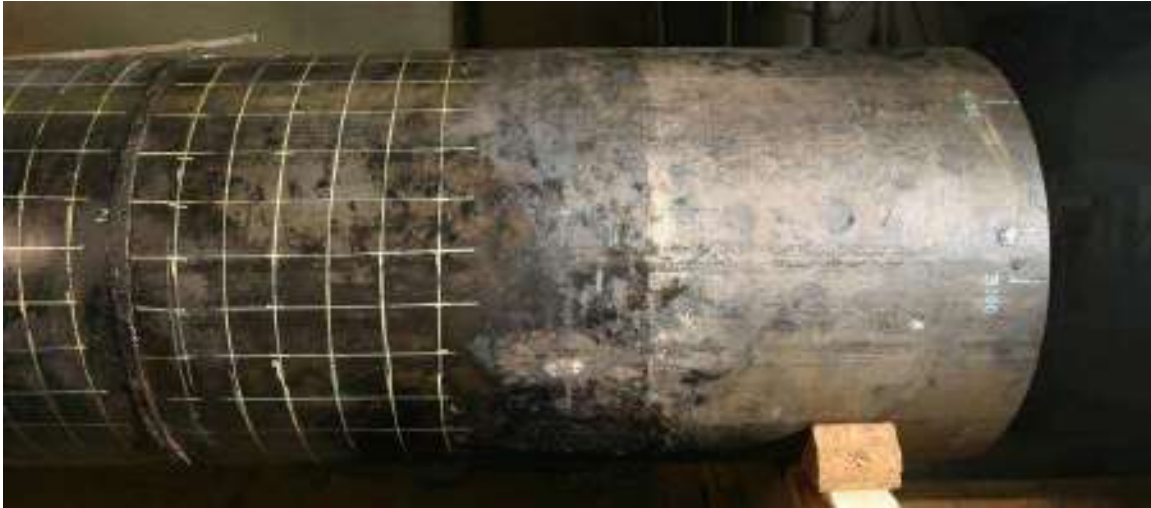
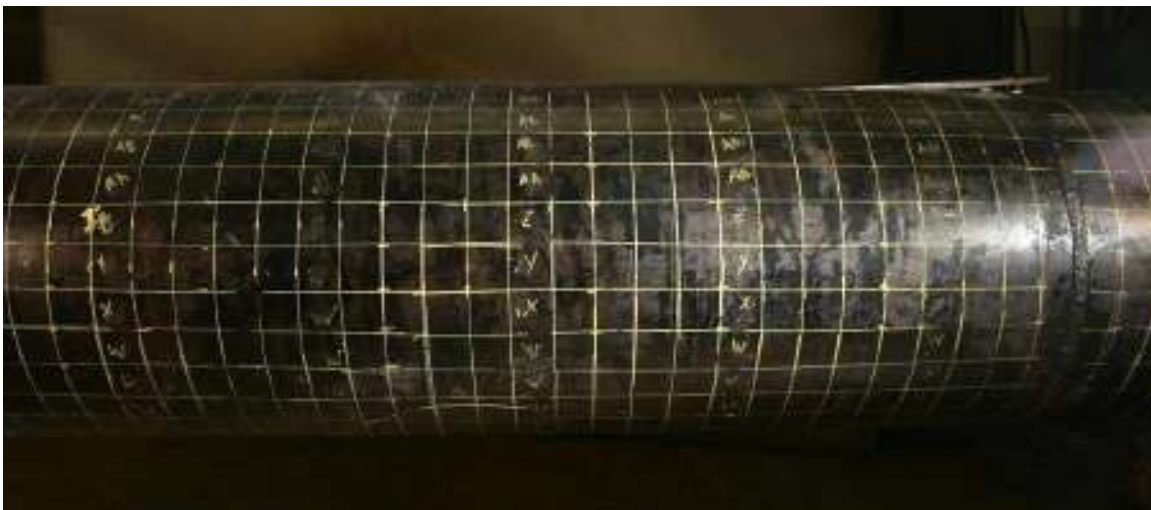
Circumferential Location	Distance from North Girth Weld	Depth of Corrosion Pitting		
		Minimum	Average	Maximum
All	-3' to 0'	No Corrosion Pitting Visible		
All	0' to 4'	No Corrosion Pitting Visible

The photographs display overall views of the east side of the pipe adjacent to the fractured pipe from approximately 3' north of the girth weld (-3') to the center of the north girth weld (0'), and the fractured pipe from the center of the girth weld to 4' south of the north girth weld (+4'), respectively, after the removal of the coating. No corrosion pitting is visible on the O.D. surfaces on the fractured or intact pipe around the north girth weld.

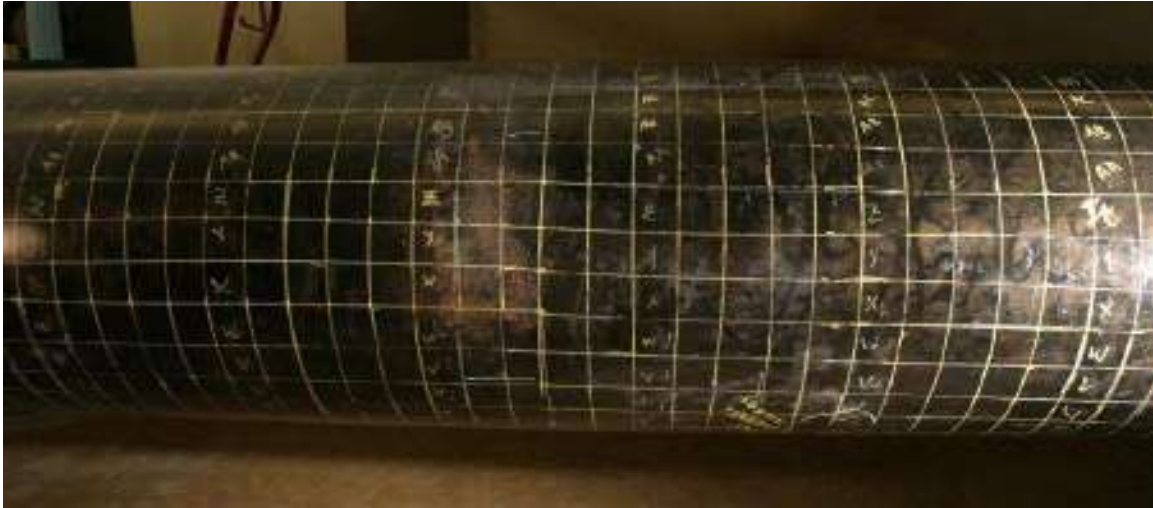
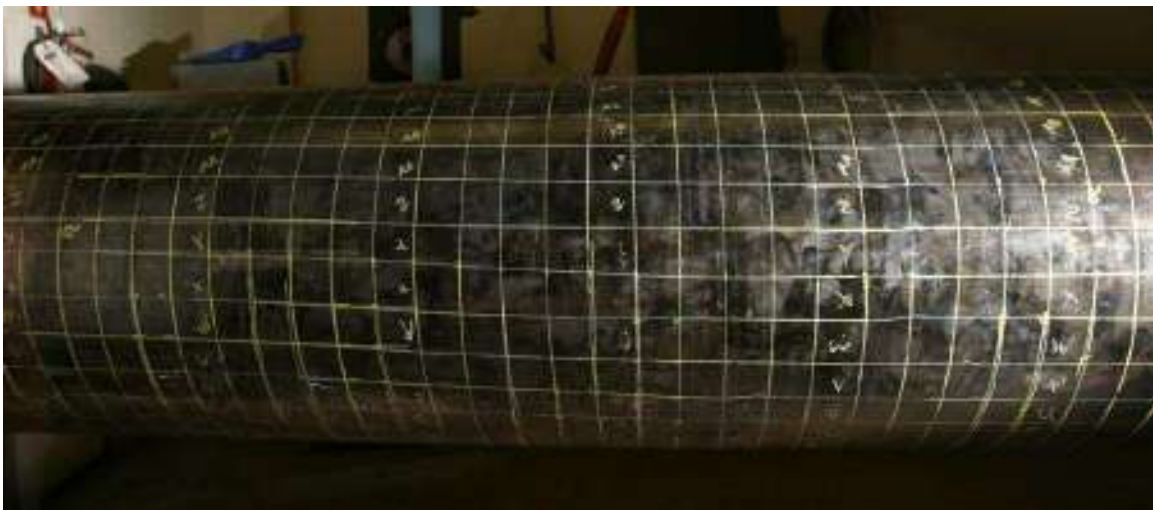
Circumferential Location	Distance from North Girth Weld	Depth of Corrosion Pitting		
		Minimum	Average	Maximum
1:31 o'clock to 3:03 o'clock	4' to 8'	0.008"	0.013"	0.026"
3:49 o'clock to 4:57 o'clock	8' to 12'	0.004"	0.011"	0.022"

The photographs display overall views of the east side of the fractured pipe from 4' south to 8' south of the north girth weld, and 8' south to 12' south of the north girth weld, respectively, after the removal of the coating. The lower half of the pipe shows corrosion pitting on the O.D. surface where the coating had wrinkled and sagged.

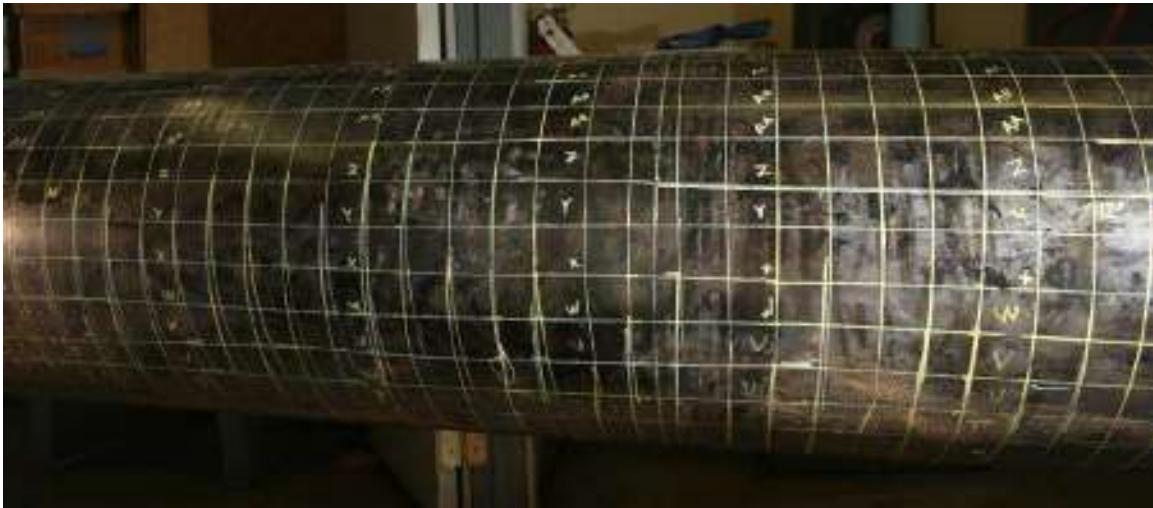
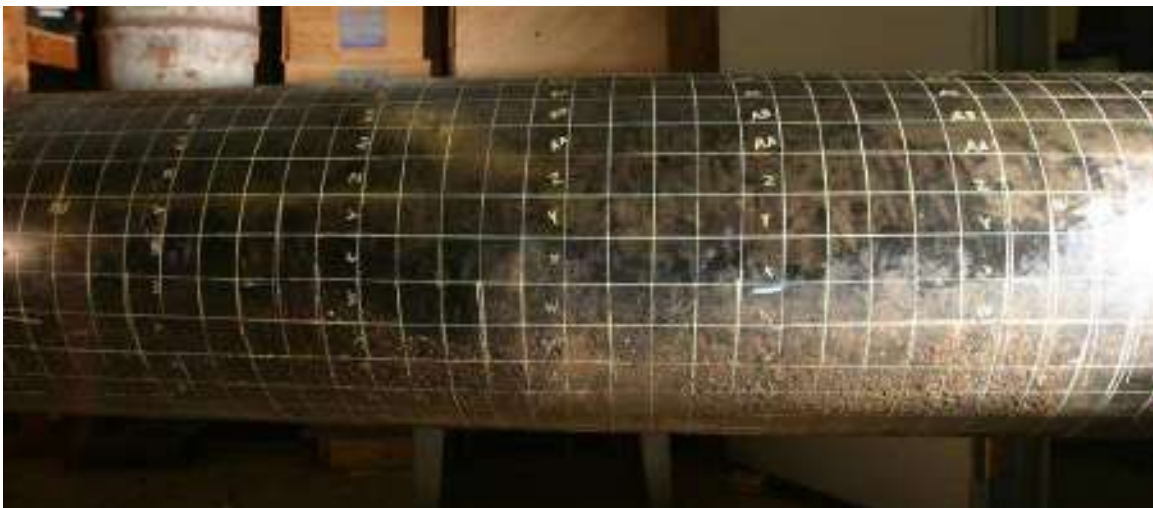
Circumferential Location	Distance from North Girth Weld	Depth of Corrosion Pitting		
		Minimum	Average	Maximum
3:03 o'clock to 4:57 o'clock	12' to 16'	0.003"	0.013"	0.033"
2:40 o'clock to 5:20 o'clock	16' to 20'	0.005"	0.015"	0.031"

The photographs display overall views of the east side of the fractured pipe from 12' south to 16' south of the north girth weld, and 16' south to 20' south of the north girth weld, respectively, after the removal of the coating. The lower half of the pipe shows corrosion pitting on the O.D. surface where the coating had wrinkled and sagged.

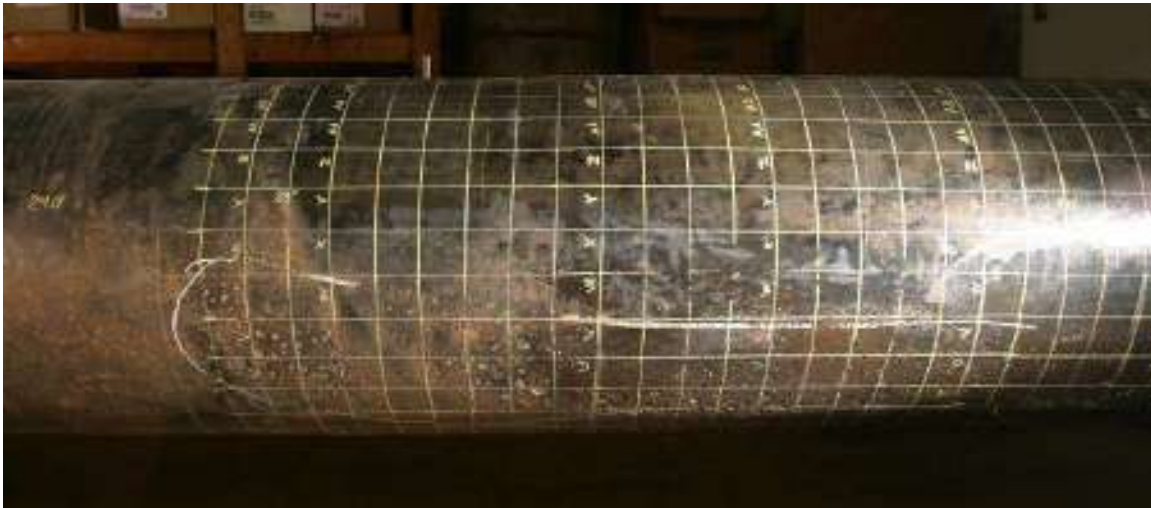
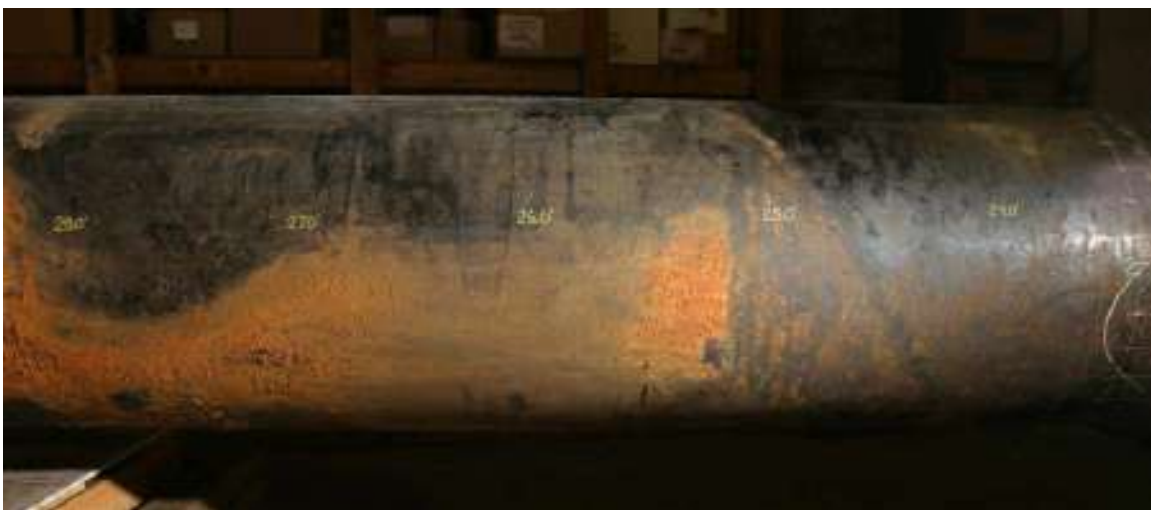
Circumferential Location	Distance from North Girth Weld	Depth of Corrosion Pitting		
		Minimum	Average	Maximum
2:40 o'clock to 4:57 o'clock	20' to 24'	0.004"	0.020"	0.033"
All	24' to 28'	No Corrosion Pitting Visible

The photographs display overall views of the east side of the fractured pipe from 20' south to 24' south of the north girth weld, and 24' south to 28' south of the north girth weld, respectively, after the removal of the coating. The lower half of the pipe shows corrosion pitting on the O.D. surface where the coating had wrinkled and sagged.

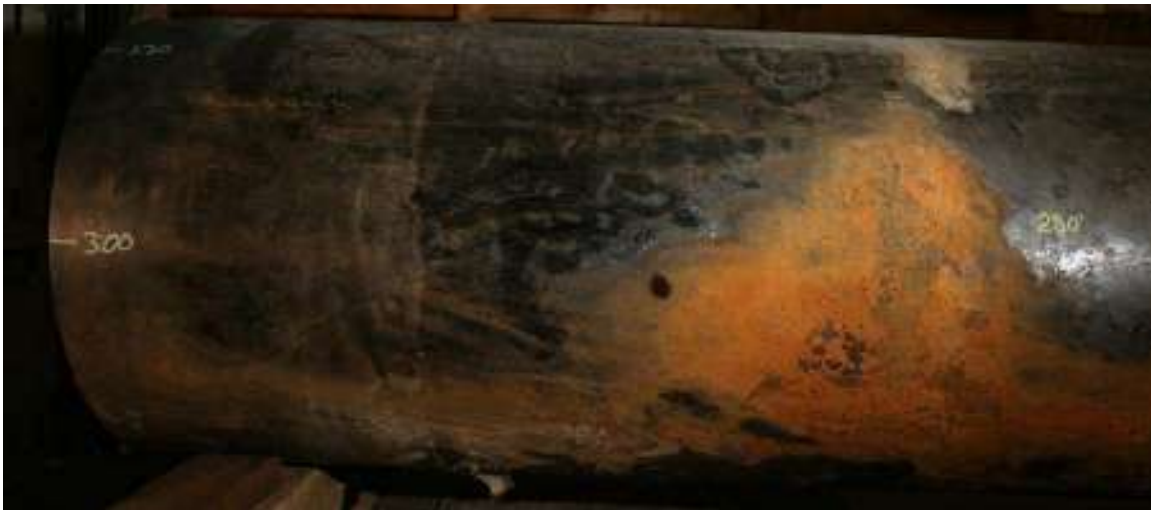
Photograph No. 82

Circumferential Location	Distance from North Girth Weld	Depth of Corrosion Pitting		
		Minimum	Average	Maximum
All	28' to 31'	No Corrosion Pitting Visible

The photograph displays an overall view of the east side of the fractured pipe from 28' south of the north girth weld to 31' south of the north girth weld, respectively, after the removal of the coating. No corrosion pitting was visible on the O.D. surface near the transverse cut at the south end of the fractured section of the pipe.

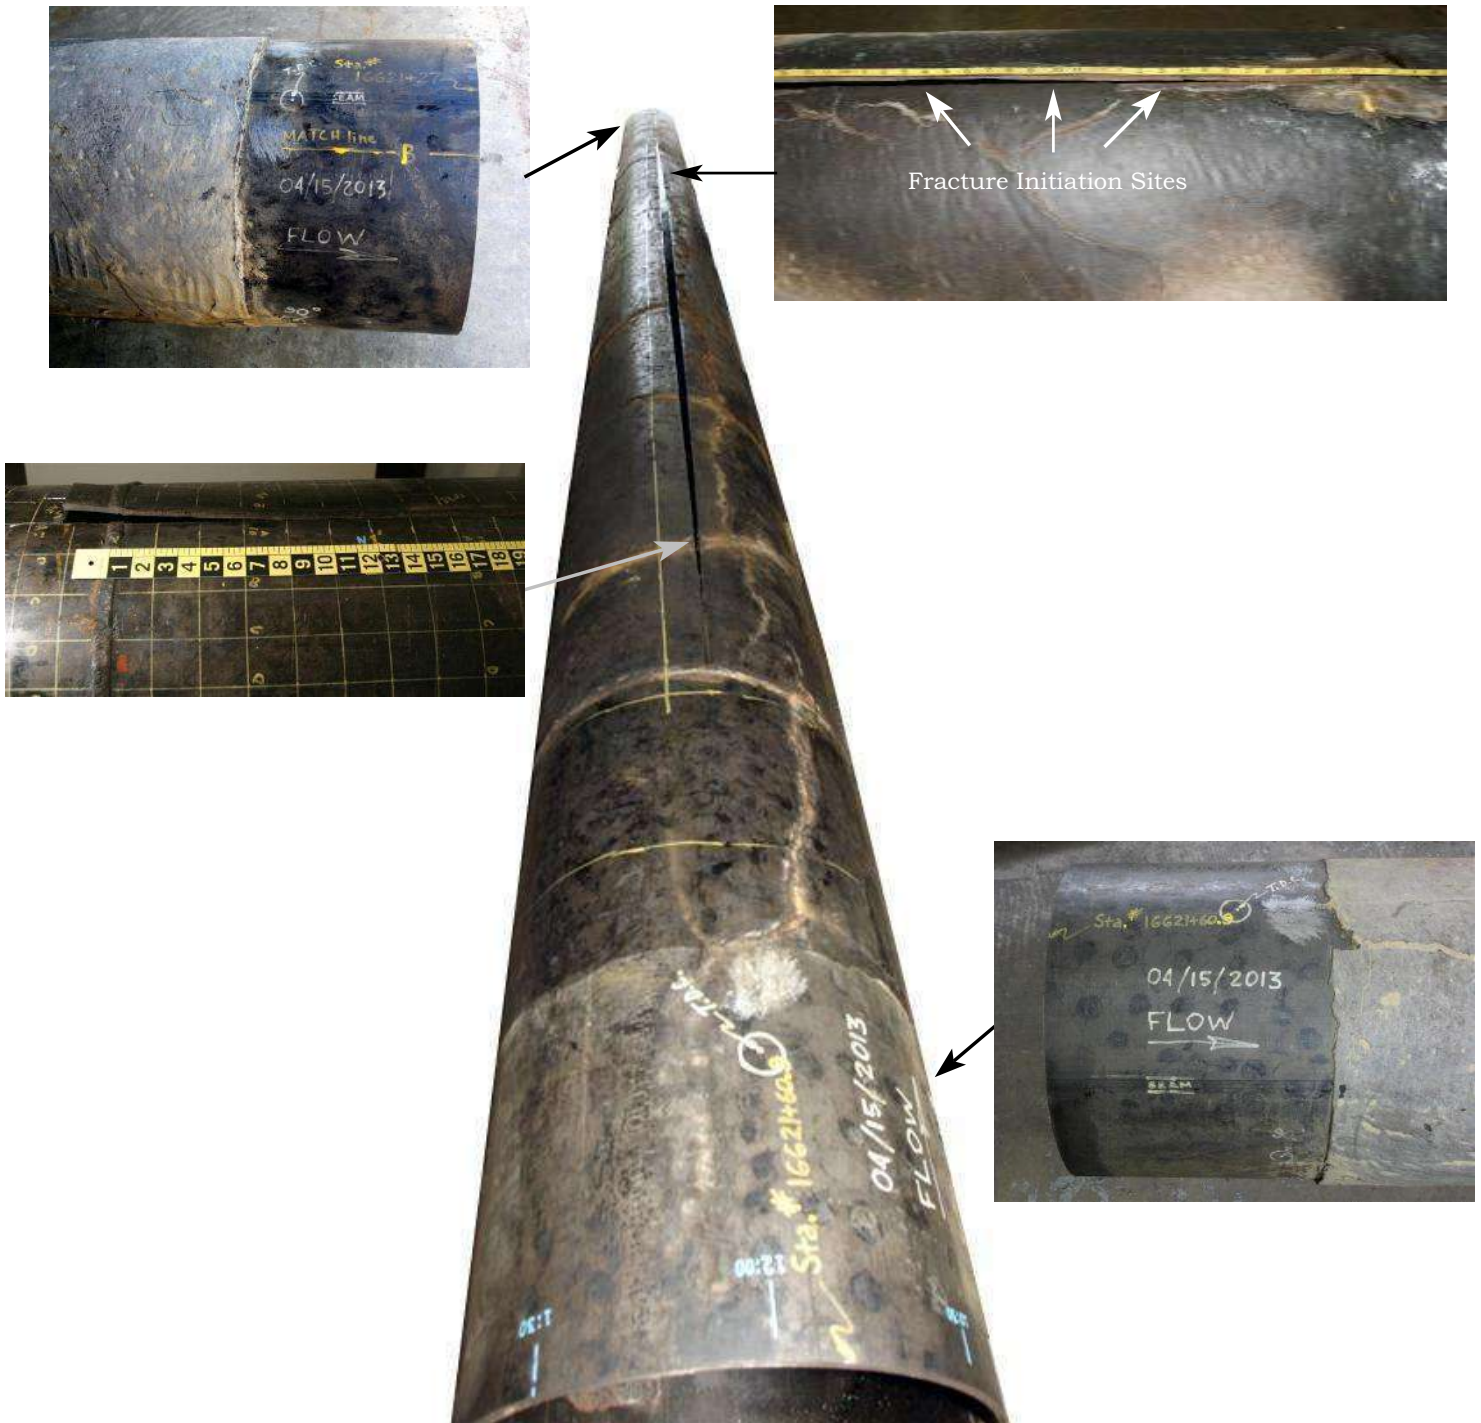
Photograph No. 86

The photographs display overall and close-up views of the 33' 11-1/2" long section of a fractured 20" O.D. x 0.312" wall pipe, which was removed from the Conway to Corsicana section of the Pegasus Crude Oil Pipeline at Milepost 314.77 in Mayflower, Arkansas.

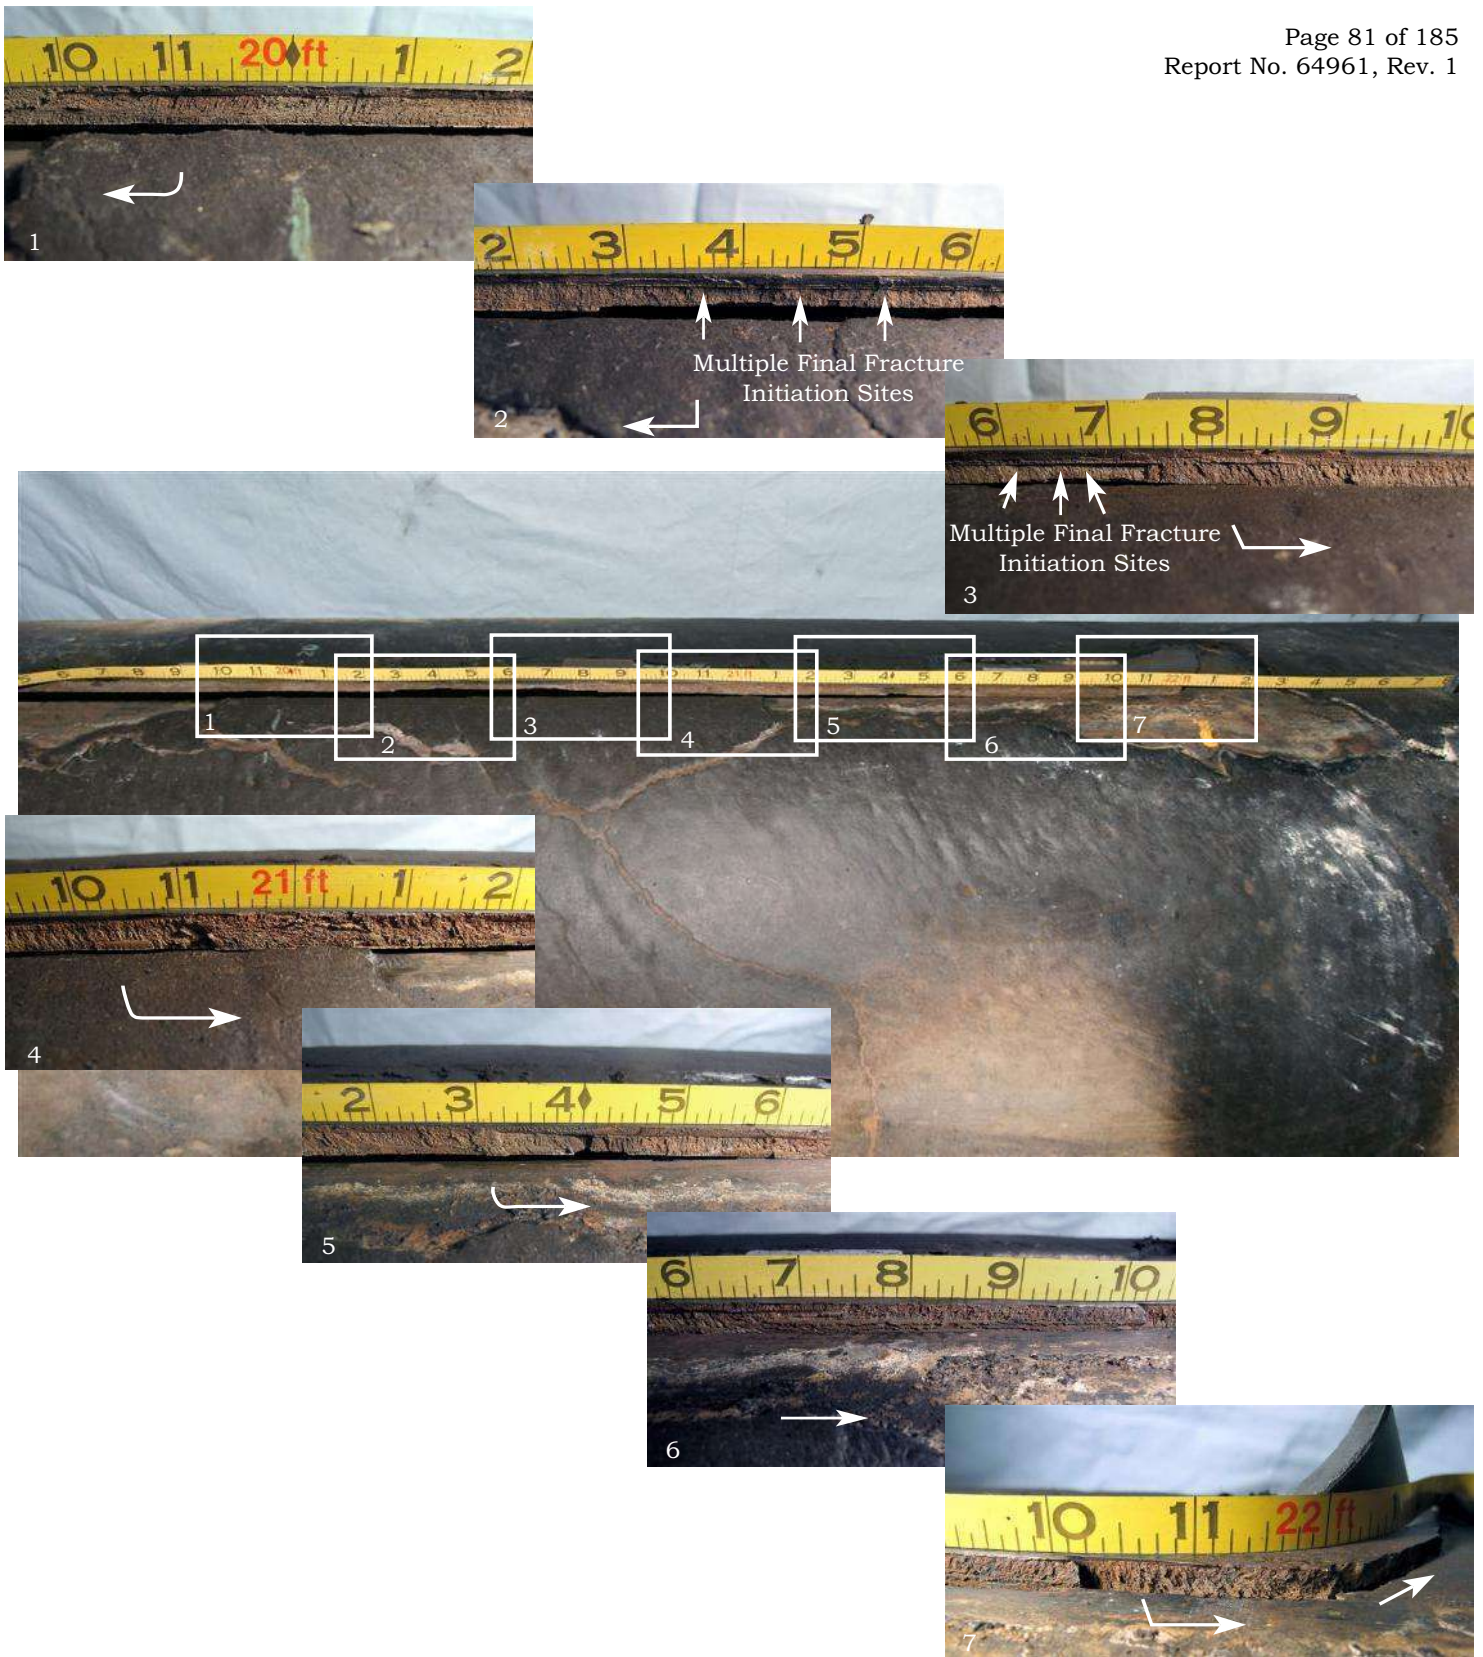
Photograph No. 87

The photographs display overall and close-up views of one of the mating fracture faces from where the final rupture had occurred, resulting in the leakage of crude oil on March 29, 2013. The fractographs show the presence of hook cracks adjacent to the fusion line near the O.D. surface along the ERW seam, between a distance of 19' 10" and 21' 6-1/4" from the north girth weld, and radial lines emanating from the ends of the hook cracks as well as chevron marks revealing the crack propagation direction, which is denoted by the arrows.

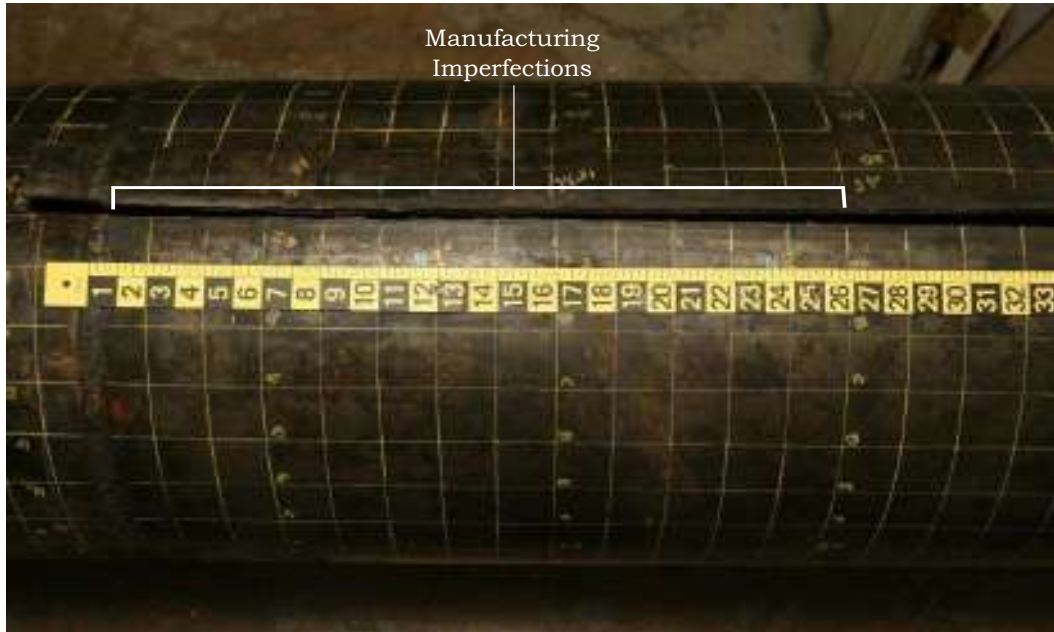
Photograph No. 88

The photograph displays the presence of manufacturing imperfections that were found between a distance of 1/4" and 2' 2" from the north girth weld in the path of the final fracture.

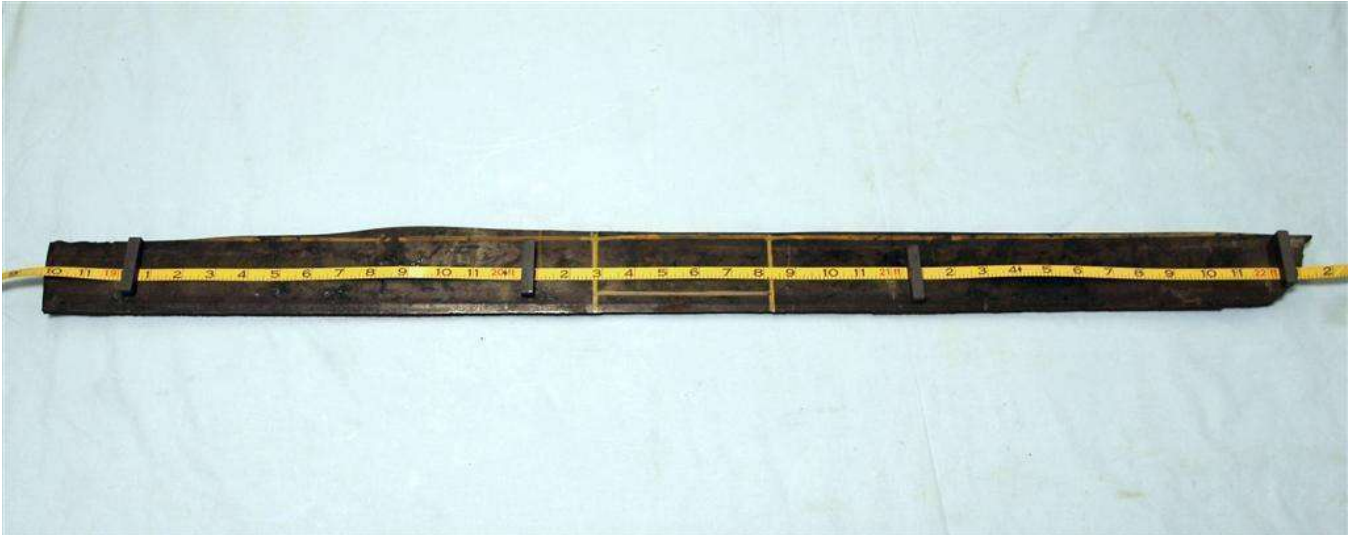
Photograph No. 95

The photographs display the O.D. and I.D. surfaces of a section of the pipe that was removed between a distance of 18' 10" and 22' as measured from the north girth weld and which contained hook cracks along the ERW seam, from where the final failure initiated on March 29, 2013.

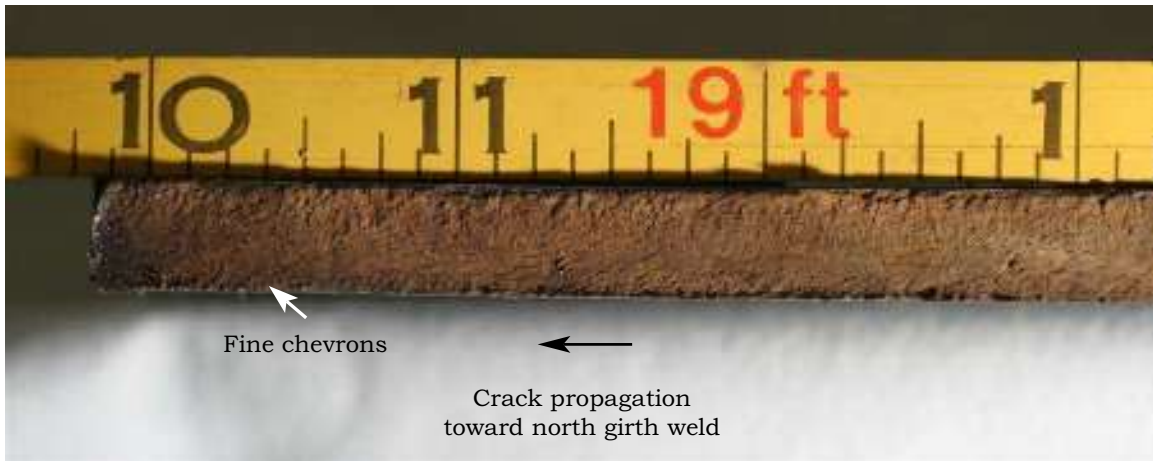
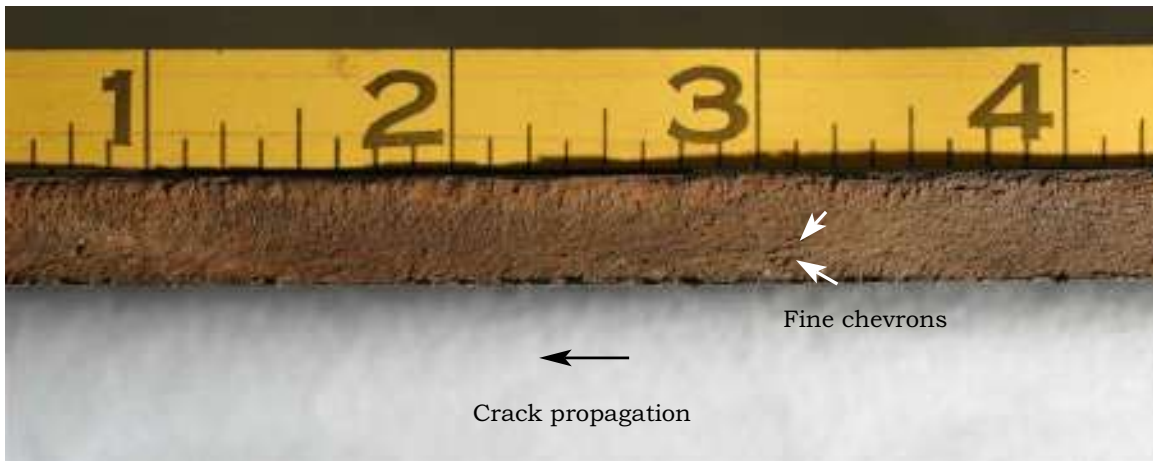
Photograph No. 97

The photographs display close-up views of the fracture face between a distance of 18' 10" and 19' 4" from the north girth weld of the pipe section, showing faint evidence of chevrons pointing toward the right (south end) near the fracture origins.

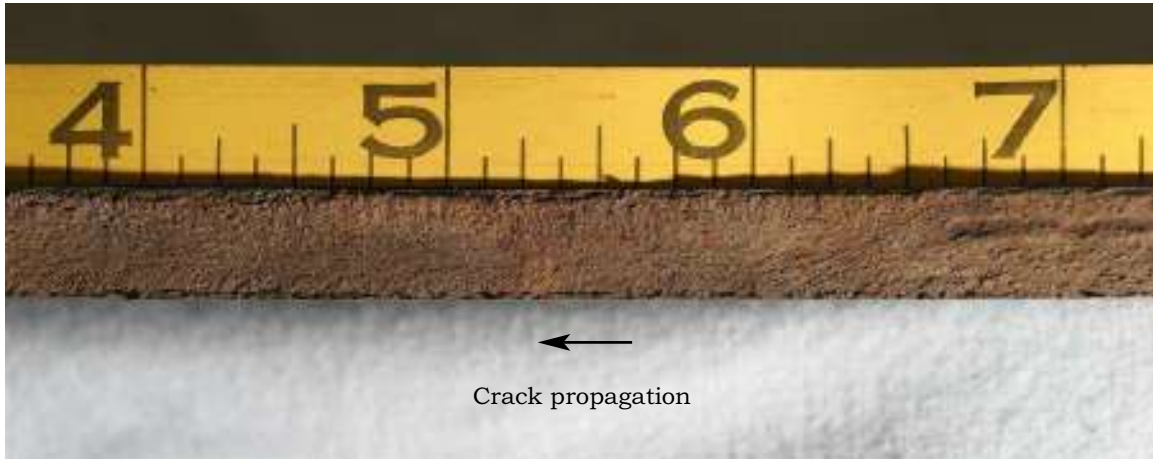
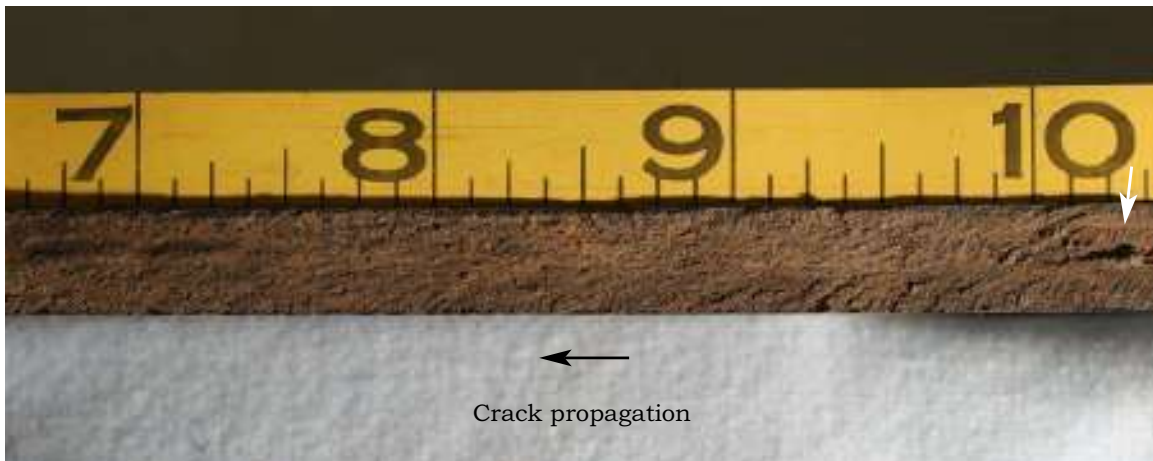
Photograph No. 99

The photographs display close-up views of the fracture face between a distance of 19' 4" and 19' 10" from the north girth weld of the pipe section, showing chevrons pointing toward the right (south end) near the fracture origins. The arrow in Photograph No. 100 points to the beginning of the hook cracks.

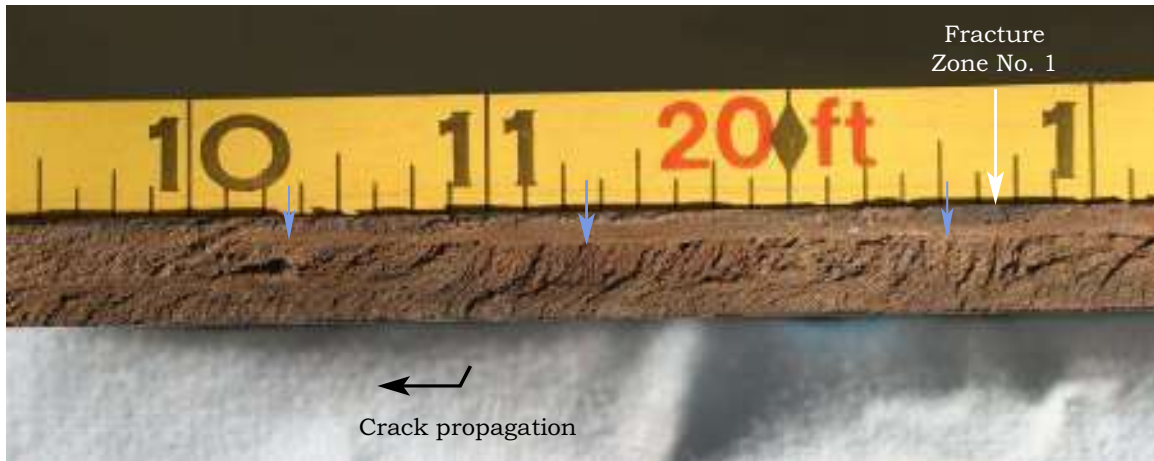
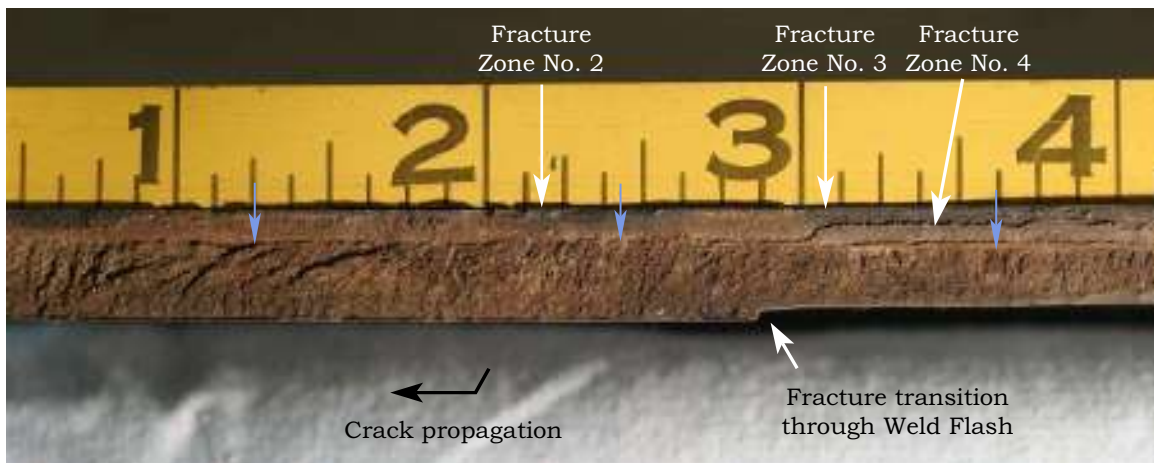
Photograph No. 101

The photographs display close-up views of the fracture face between a distance of 19' 10" and 20' 4" from the north girth weld, showing radial lines, marked by the blue arrows, which originated from hook cracks through the grain flow or banding formed during manufacturing the ERW seam.

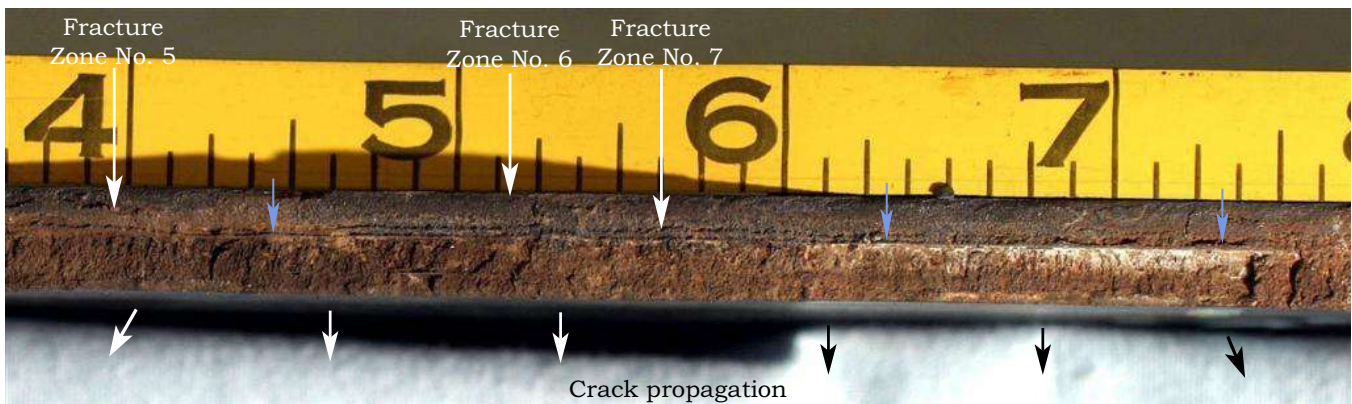
Photograph No. 103

The photograph displays a close-up view of the fracture face between a distance of 20' 4" and 20' 8" from the north girth weld, showing vertical radial lines emanating from the hook cracks, which are marked by the blue arrows, indicating the primary fracture initiation sites which resulted in the 22' 3" long fracture along the ERW seam of the 49' 9-1/2" long pipe.

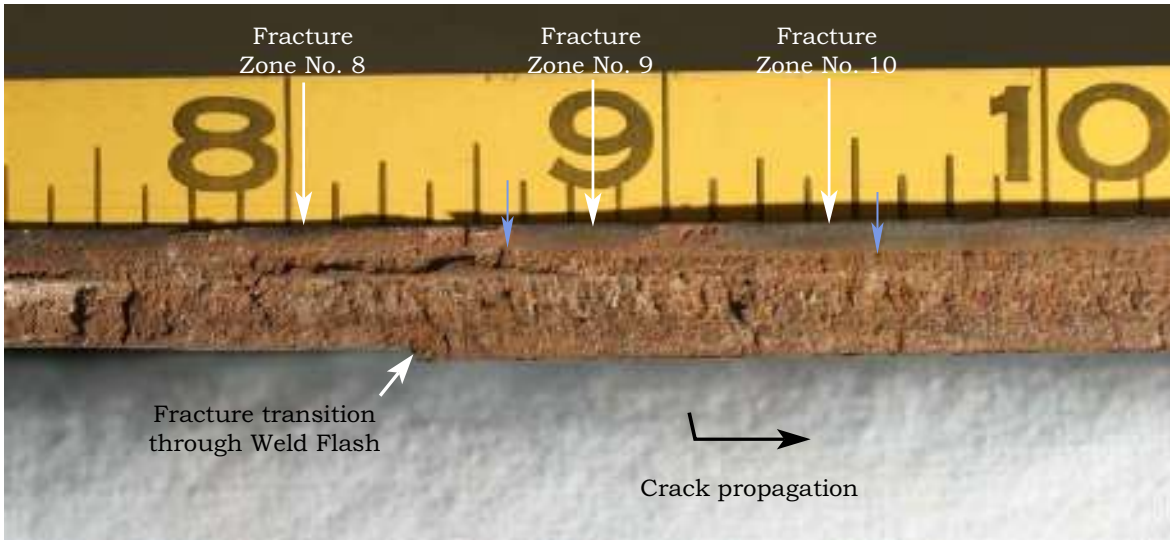
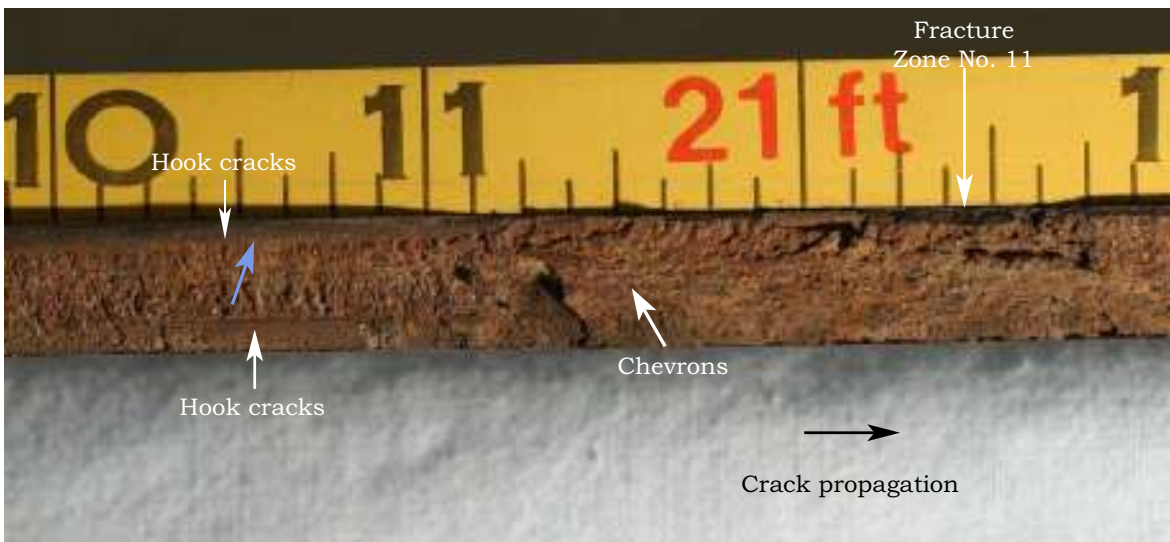
Photograph No. 104

The photographs display close-up views of the fracture face between a distance of 20' 8" and 21' 1" from the north girth weld, showing radial lines emanating from the hook cracks, marked by the blue arrow, and chevrons pointing to the cracks, revealing some of the final fracture origins.

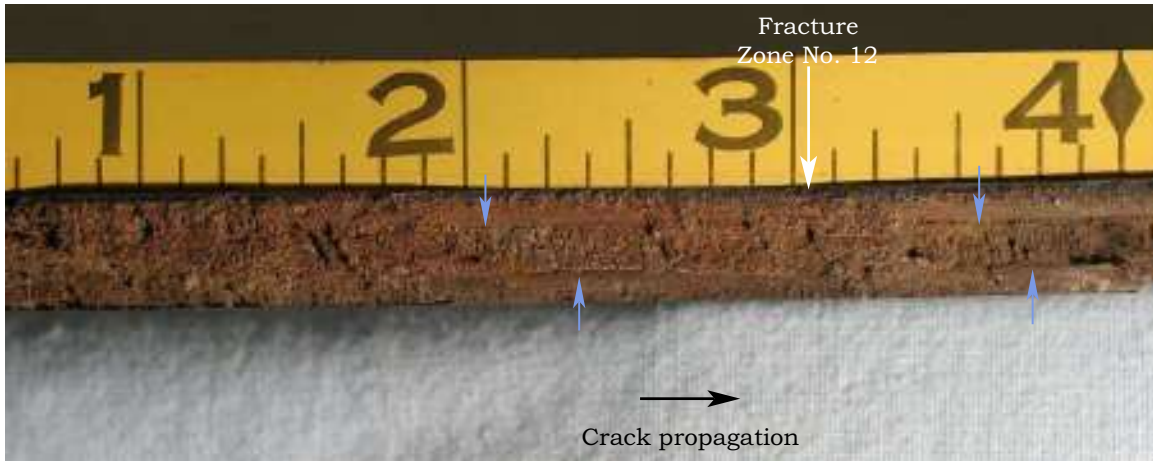
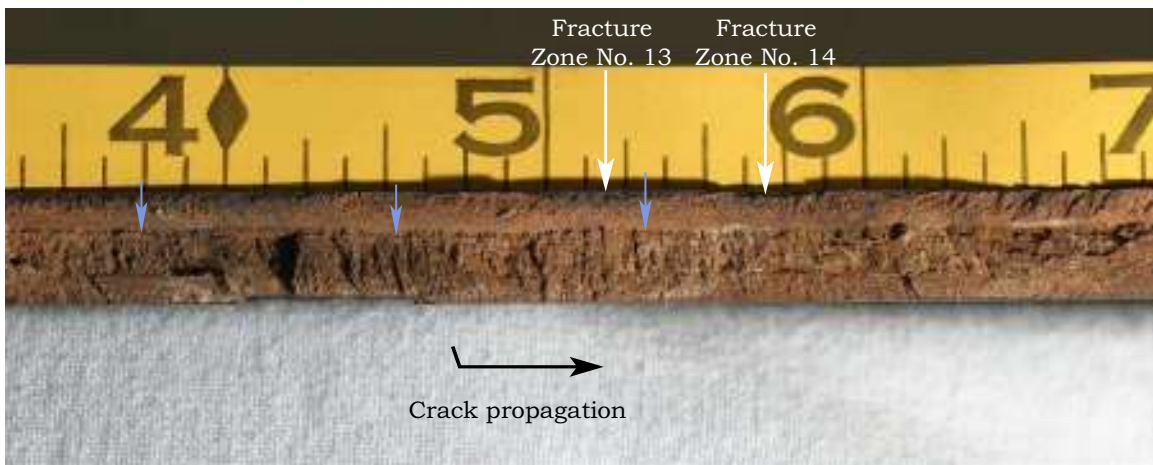
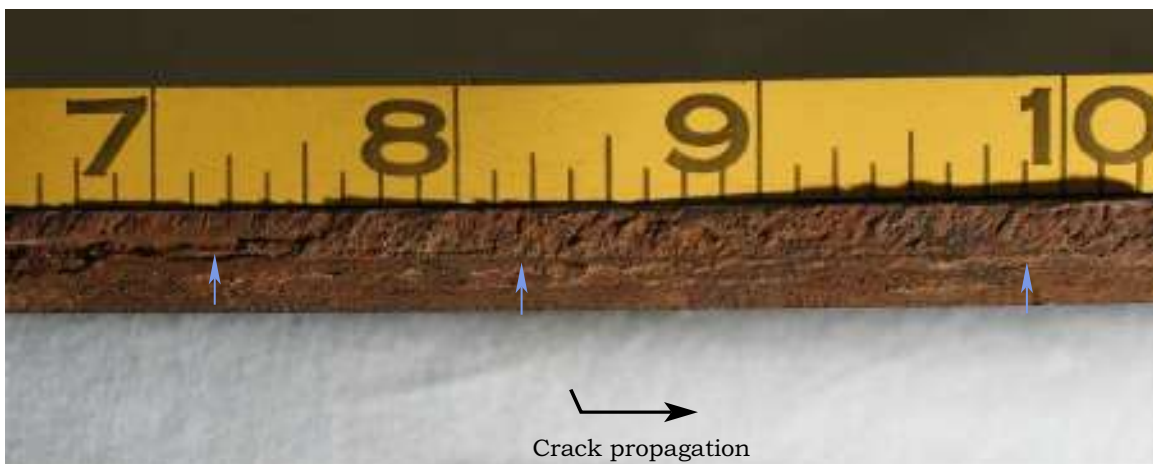
Photograph No. 106

The photographs display close-up views of the fracture face between a distance of 21' 1" and 21' 10" from the north girth weld showing radial lines emanating from the hook cracks. The blue arrows point to the radial lines, indicative of some of the final fracture initiation sites.
