*METALLURGICAL INVESTIGATION OF A
FRACTURED SECTION OF THE 20" O.D.
PIPELINE AT MILEPOST 314.77 IN THE
CONWAY TO CORSICANA SEGMENT OF
THE PEGASUS CRUDE OIL PIPELINE*

REPORT NO. 64961, REV. 1

Prepared for
ExxonMobil Pipeline Company and the
Pipeline and Hazardous Materials Safety Administration
pursuant to Corrective Action Order CPF 4-2013-5006H

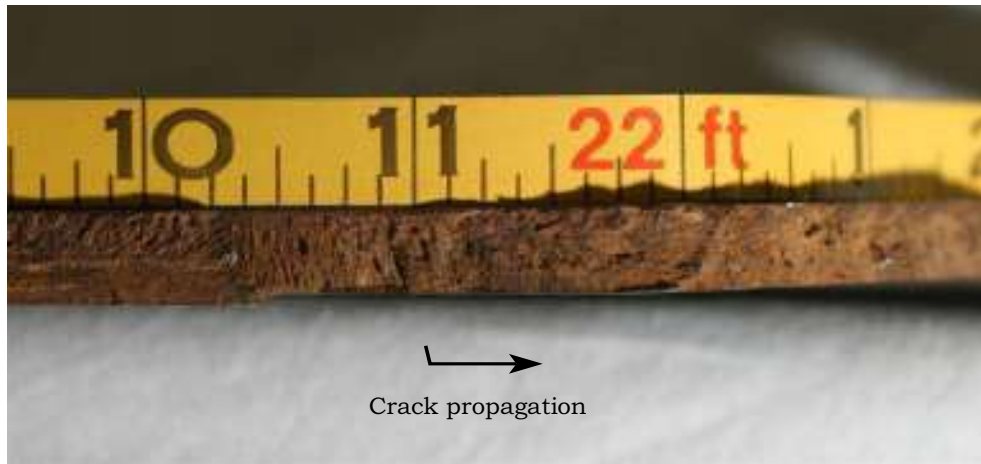
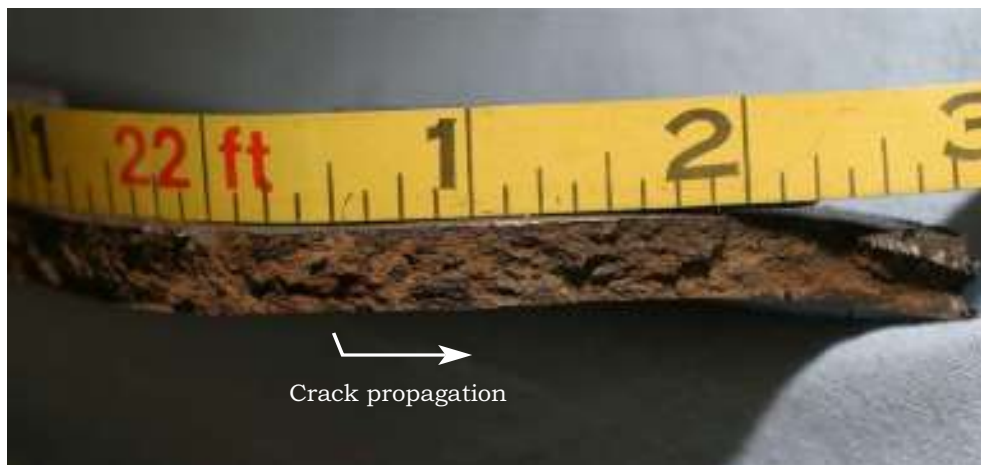
Photograph No. 109

The photographs display close-up views of the fracture face between a distance of 21' 10" and 22' from the north girth weld, showing the final fracture which terminated in the base metal of the pipe, diagonally to a distance of approximately 3".

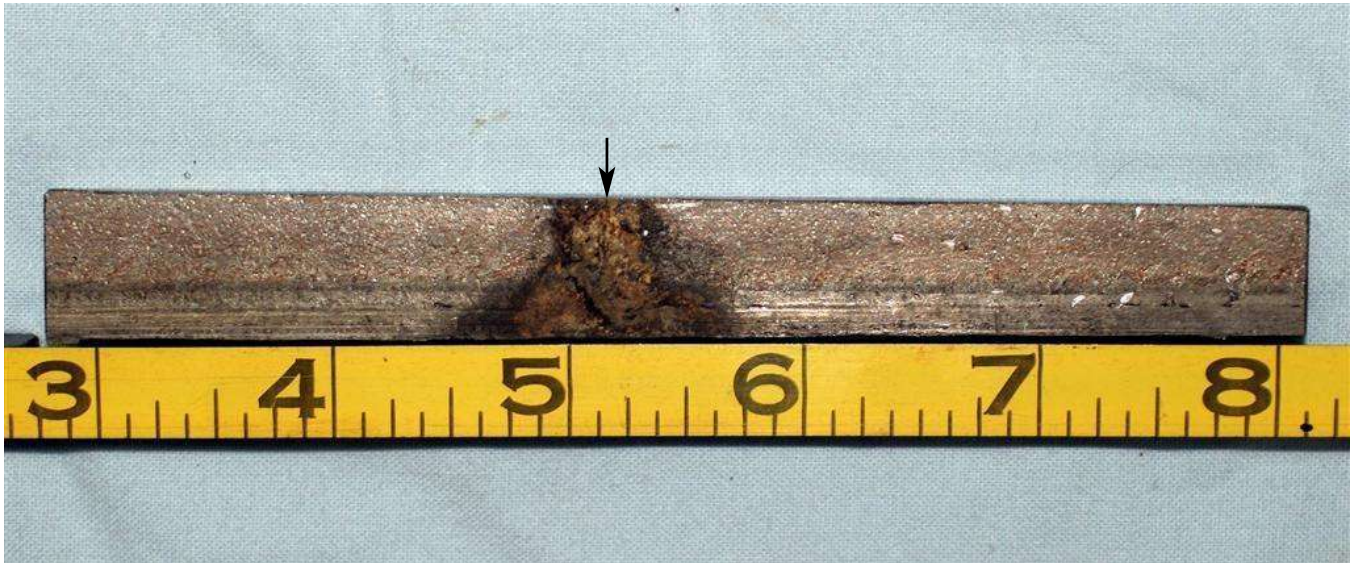
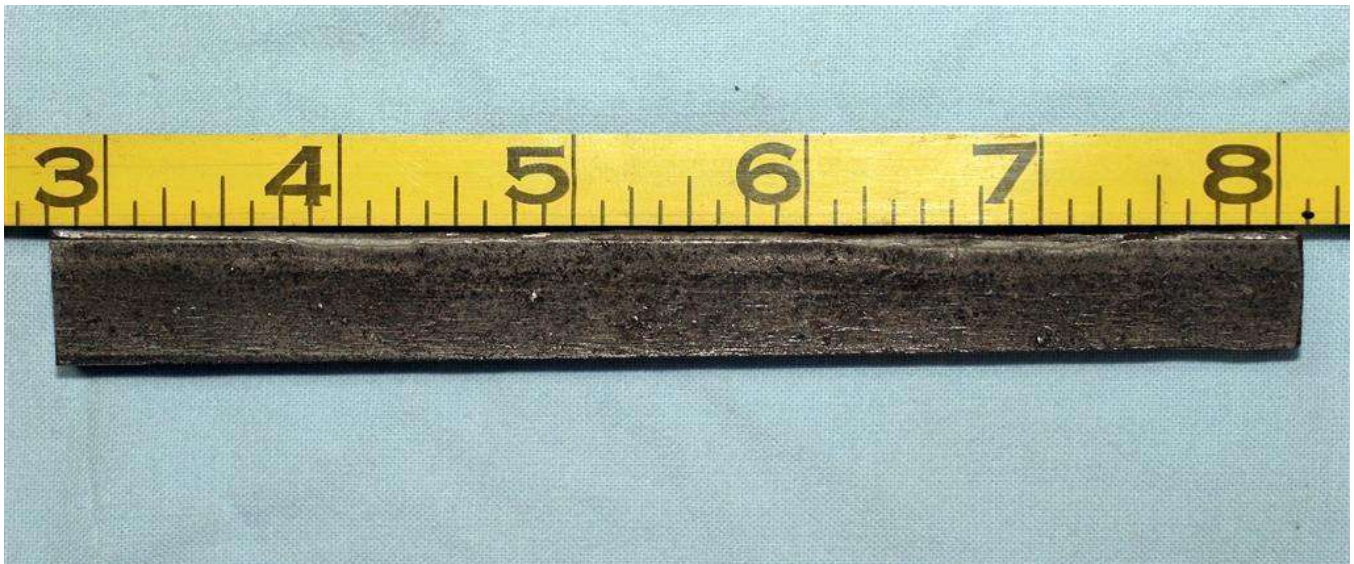
Photograph No. 111

The photographs display the O.D. and I.D. surfaces adjacent to one of the mating fracture faces which contained multiple hook cracks. The arrow points to an area where the coating was apparently damaged prior to the incident.

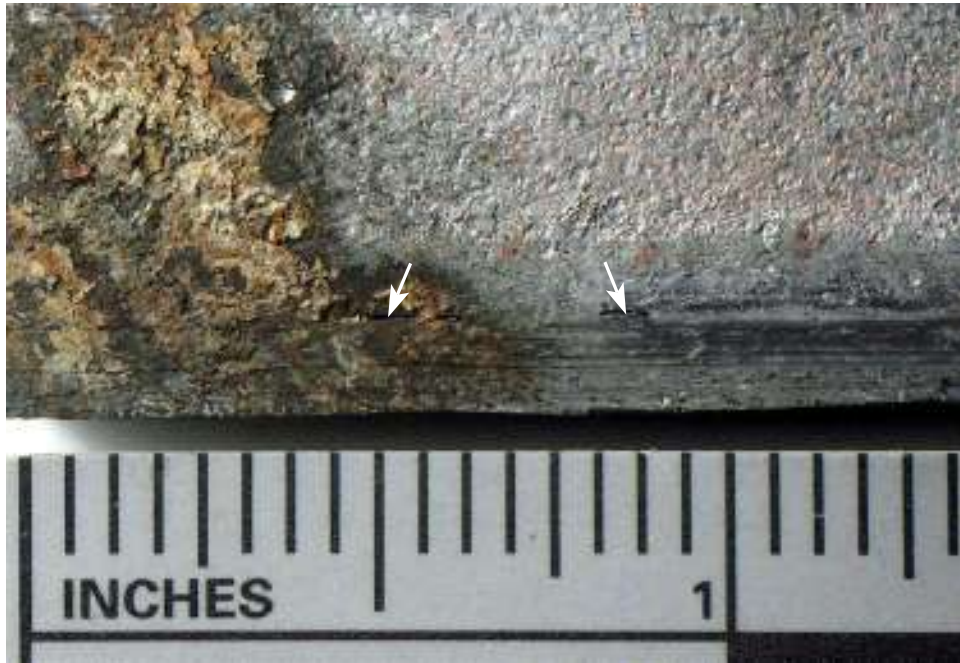
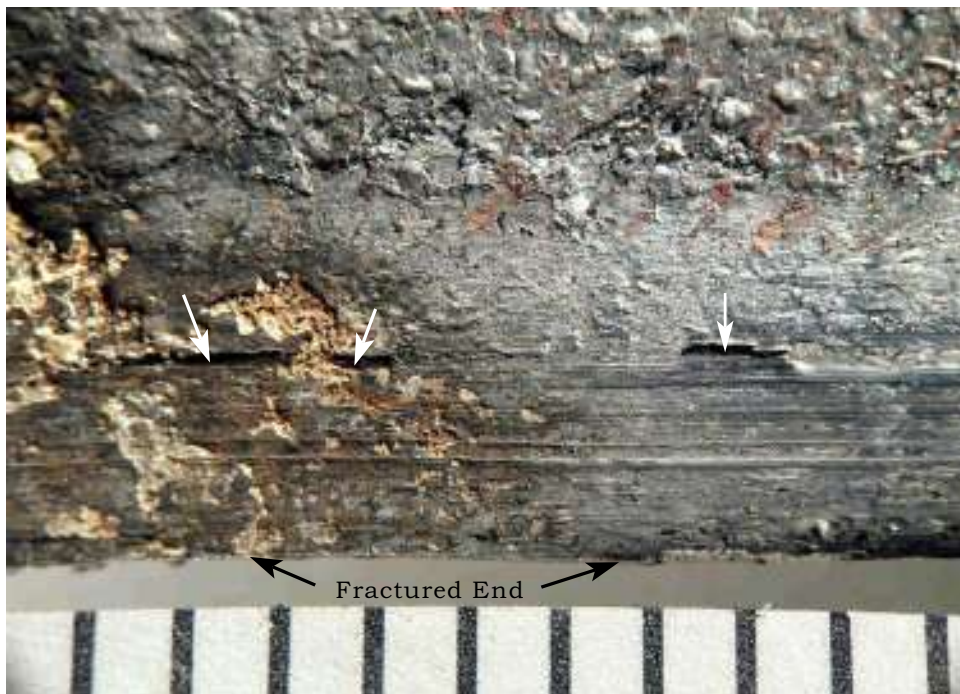
Photograph No. 113

The photographs of the outside surface of the fractured ERW seam at a distance between 20' 4-1/2" and 20' 6" from the north girth weld show evidence of what appears to be crack or melting caused by copper electrode contacts during the ERW seam fabrication. The arrows point to these imperfections.

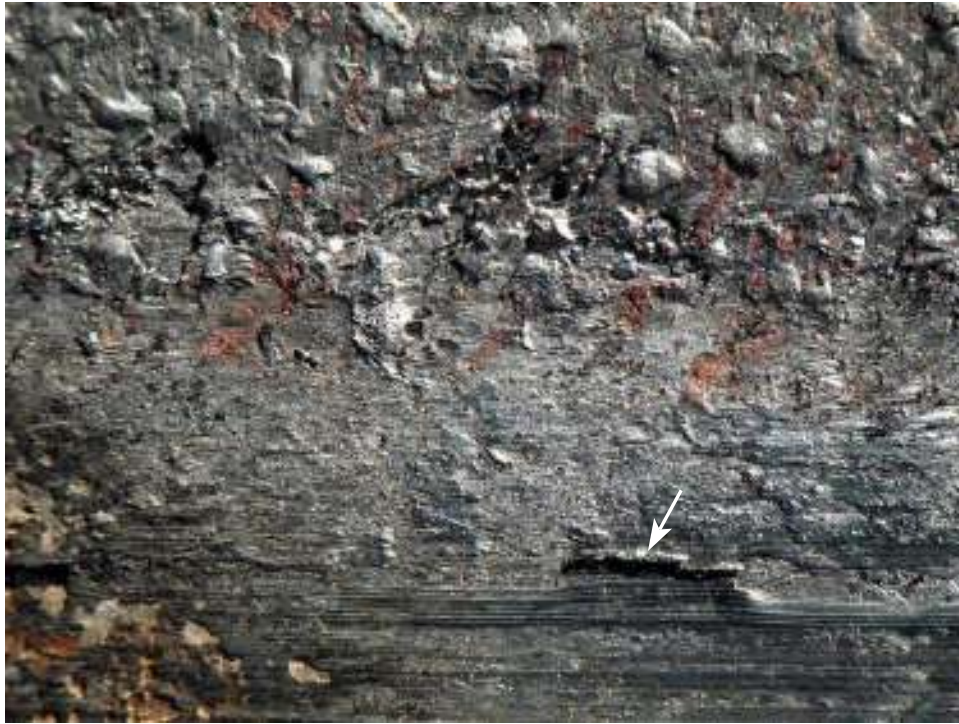
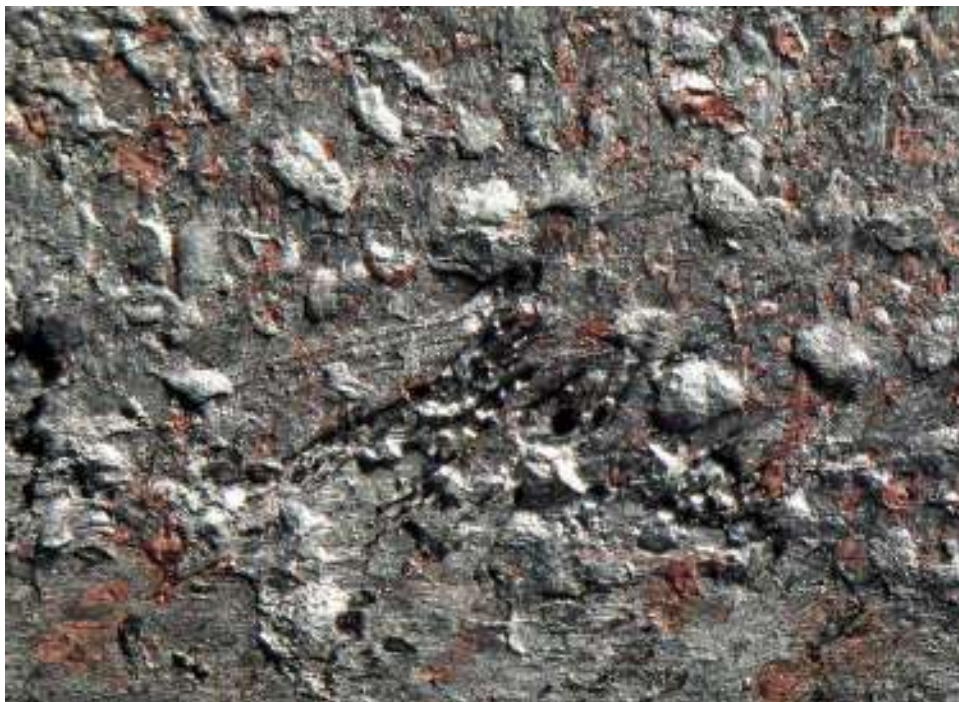
Photograph No. 115

The photographs display close-up views of the copper electrode contact marks in the heat-affected zone of the ERW seam, at the arrow, on the O.D. surface and the presence of copper.

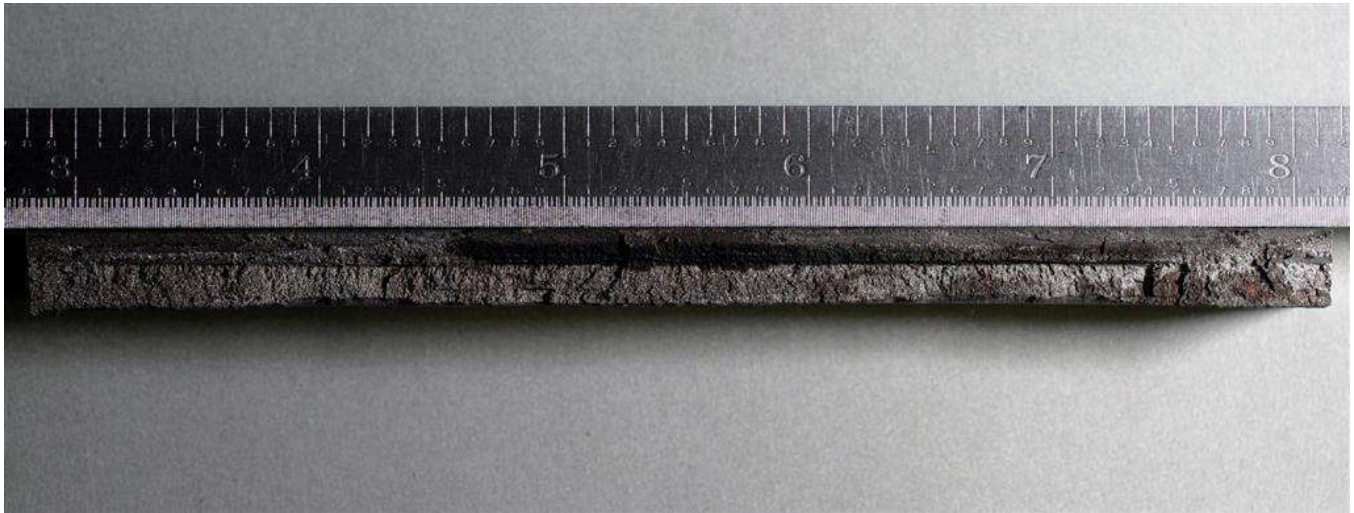
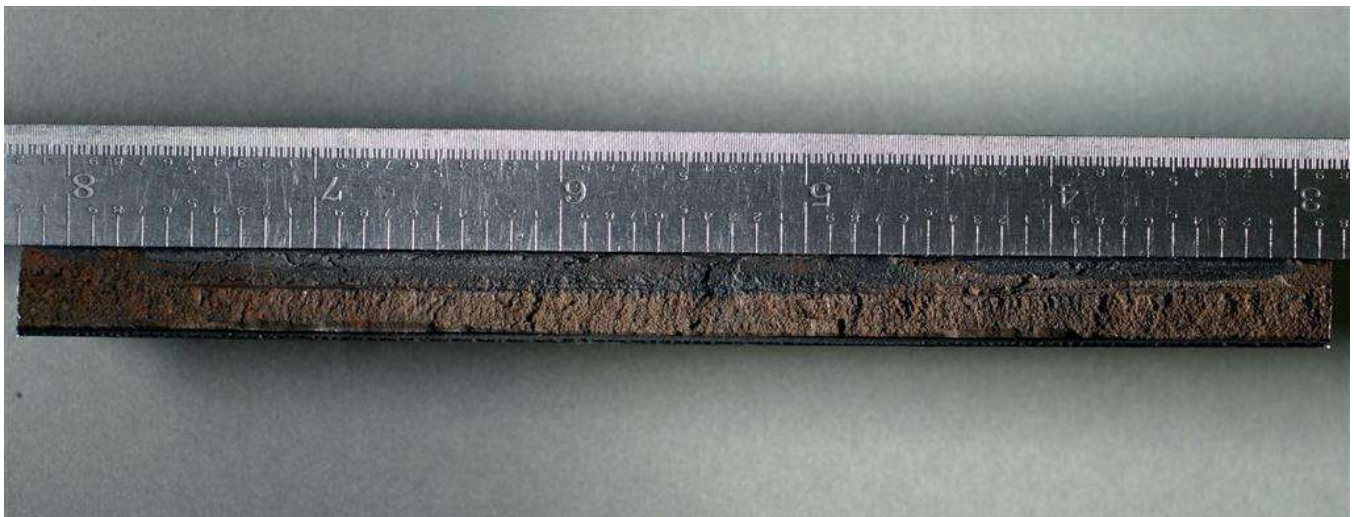
Photograph No. 117

The photographs display the mating fracture faces between a distance of approximately 20' 2-1/2" and 20' 8" from the north girth weld, revealing hook cracks in the heat-affected zone of the ERW seam to a maximum depth of 0.150" as measured from the O.D. surface, and vertical lines emanating from the tips of the hook cracks, indicative of the final fracture origin sites.

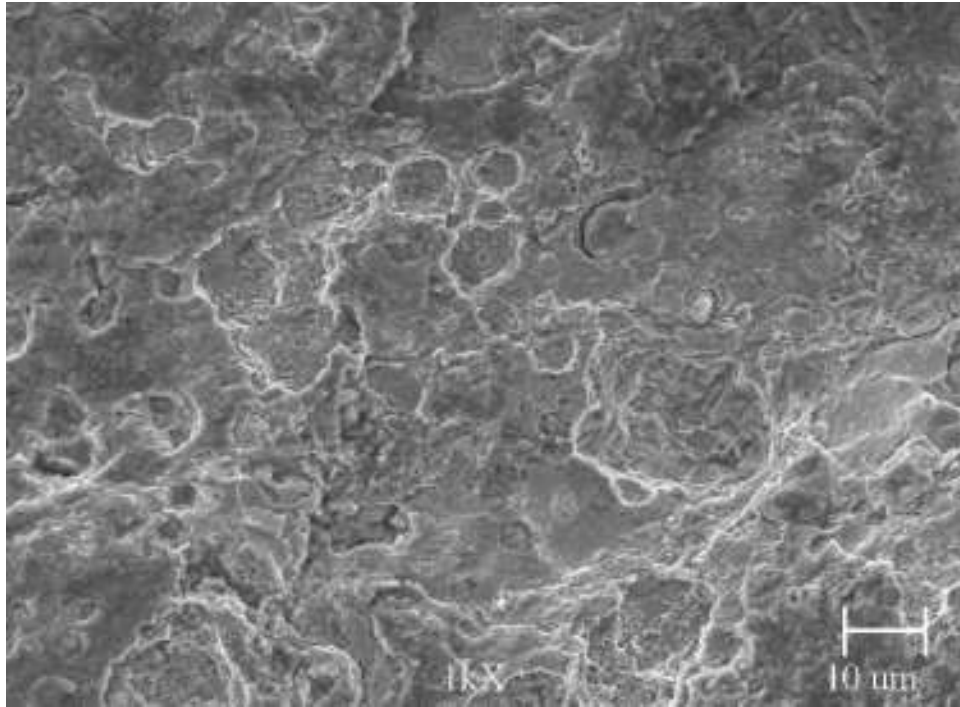
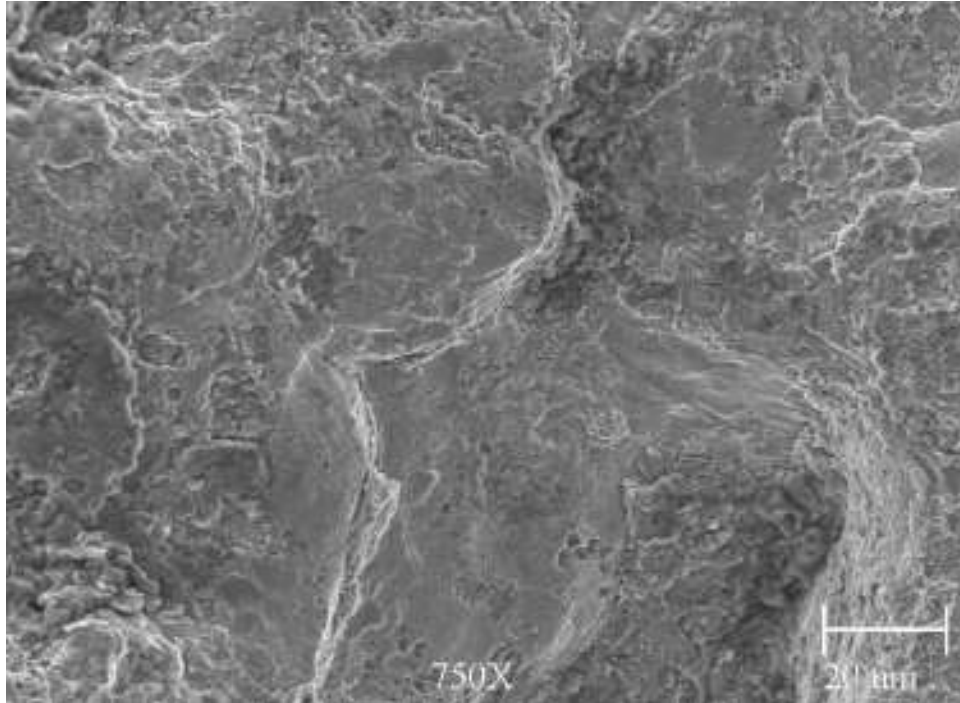
Area-A, Location-1A
Photograph No. 125

The SEM fractographs of the two (2) fracture locations labeled as Location-1A and Location-1B in Area-A of the hook crack zone near the O.D. display tightly adhered oxidation product, suggesting that the crack had occurred some time prior to the final fracture.

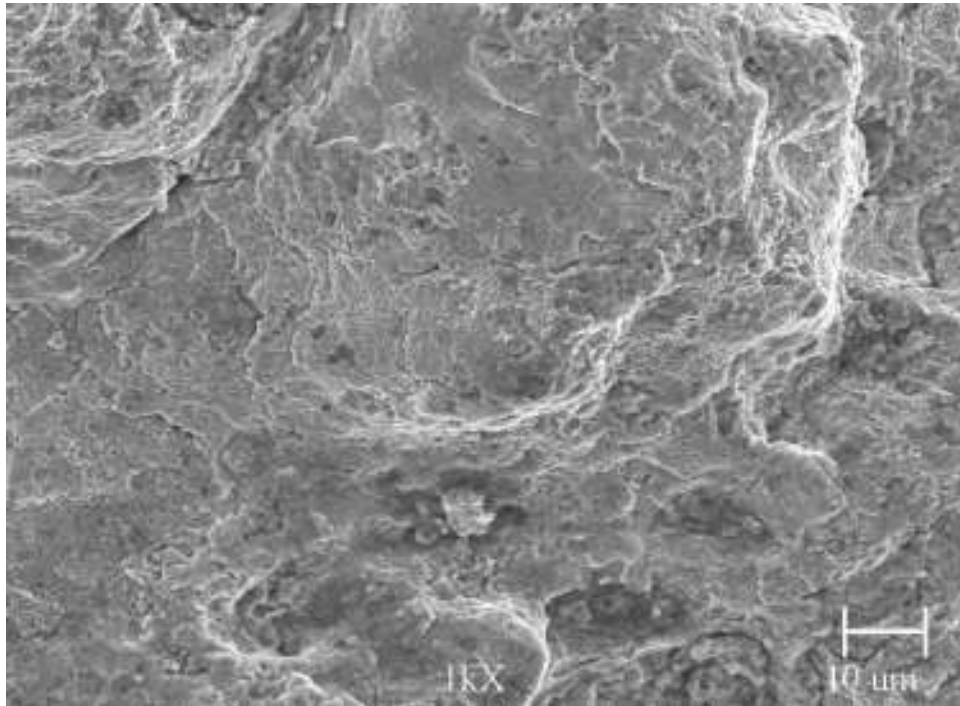
Area-B, Location-2A
Photograph No. 128

The SEM fractograph taken of the Area-B at Location-2A of the hook crack zone, as displayed in Photograph No. 127, reveals tightly adhered oxidation product on the fracture surface.

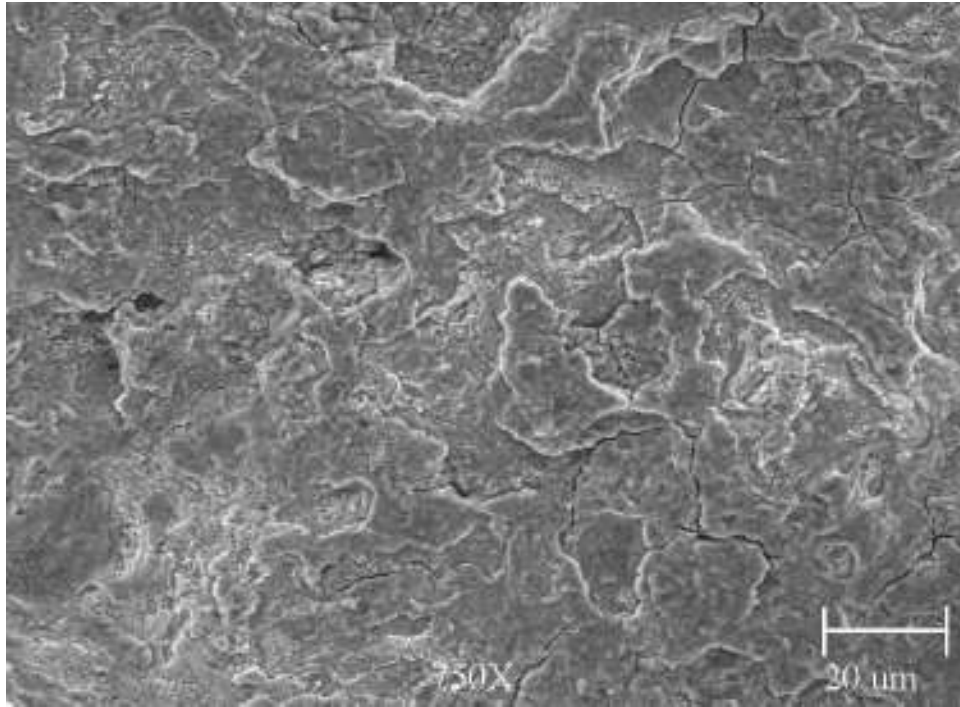
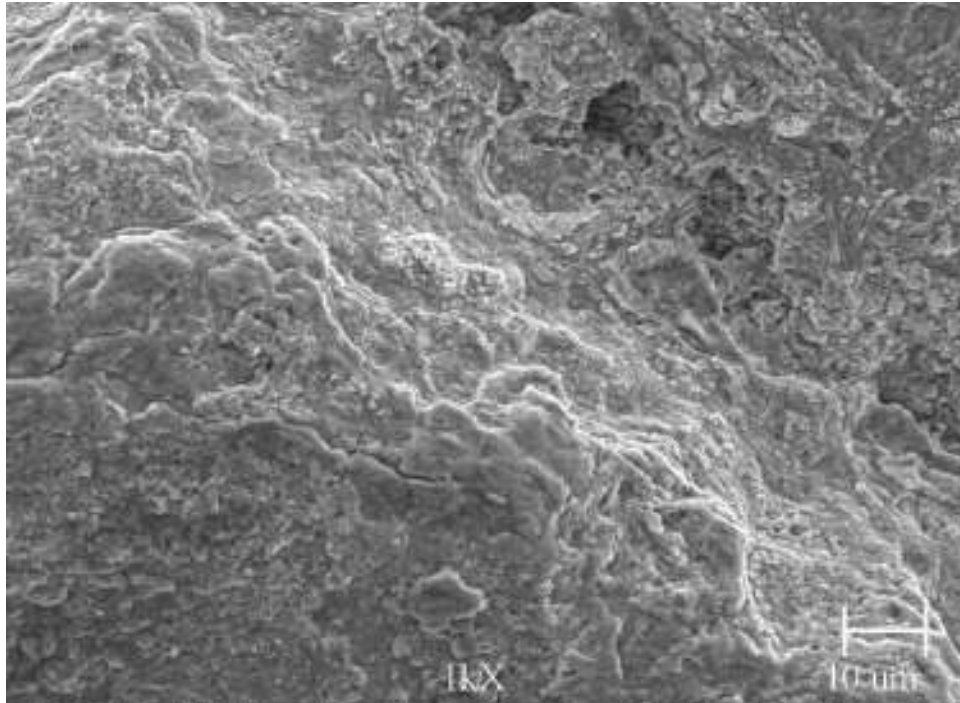
Area-C, Location-3A
Photograph No. 130

The SEM fractographs taken of the Area-C at Location-3A and Location-3B of the hook crack zone, as displayed in Photograph No. 129, reveal tightly adhered oxidation product.

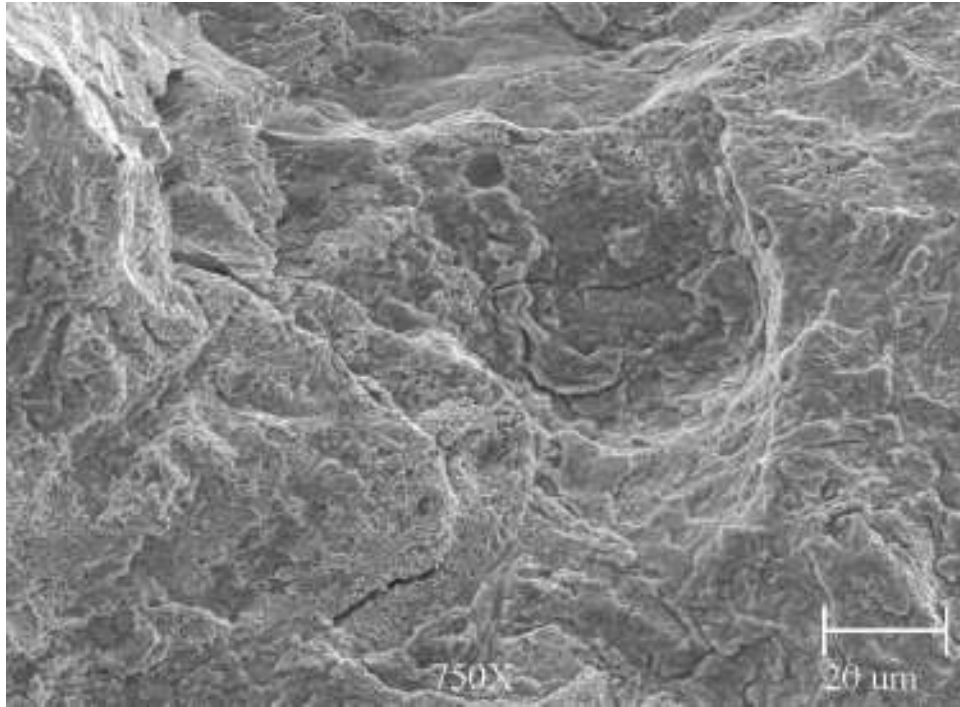
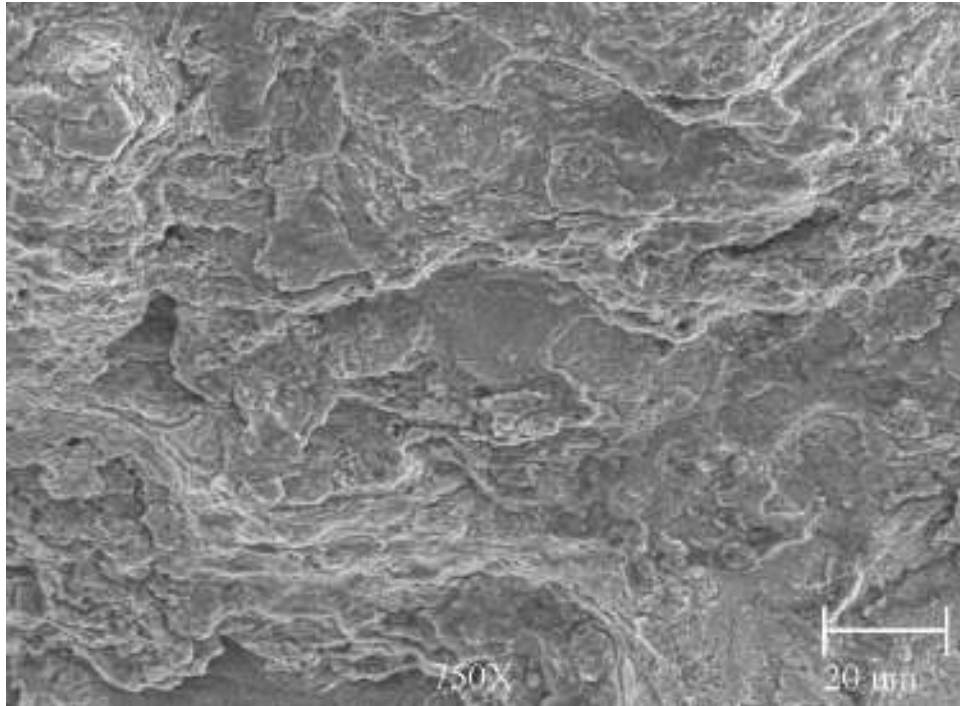
Area-C, Location-3C
Photograph No. 132

The SEM fractographs taken of the Area-C at Location-3C and Location-3D of the hook crack zone, as displayed in Photograph No. 129, reveal tightly adhered oxidation product.

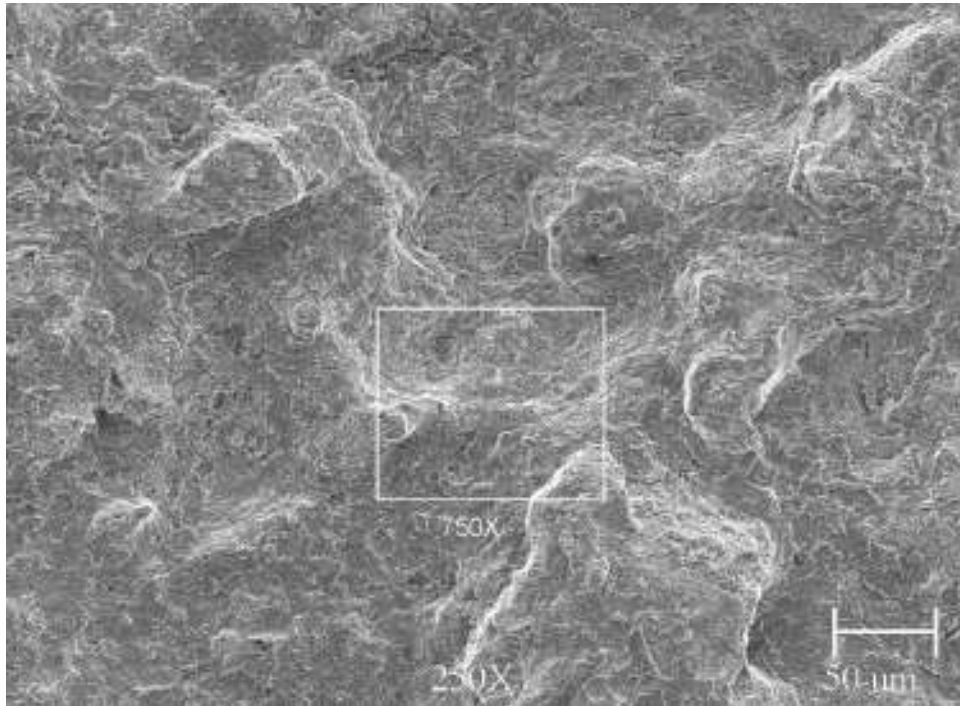
Area-D
Photograph No. 134

The SEM fractograph taken of the Area-D of the hook crack zone, as displayed in Photograph No. 123, reveals a nondescript, featureless fracture surface. The fracture location within the rectangle was examined at a higher magnifications to characterize the fracture morphology.

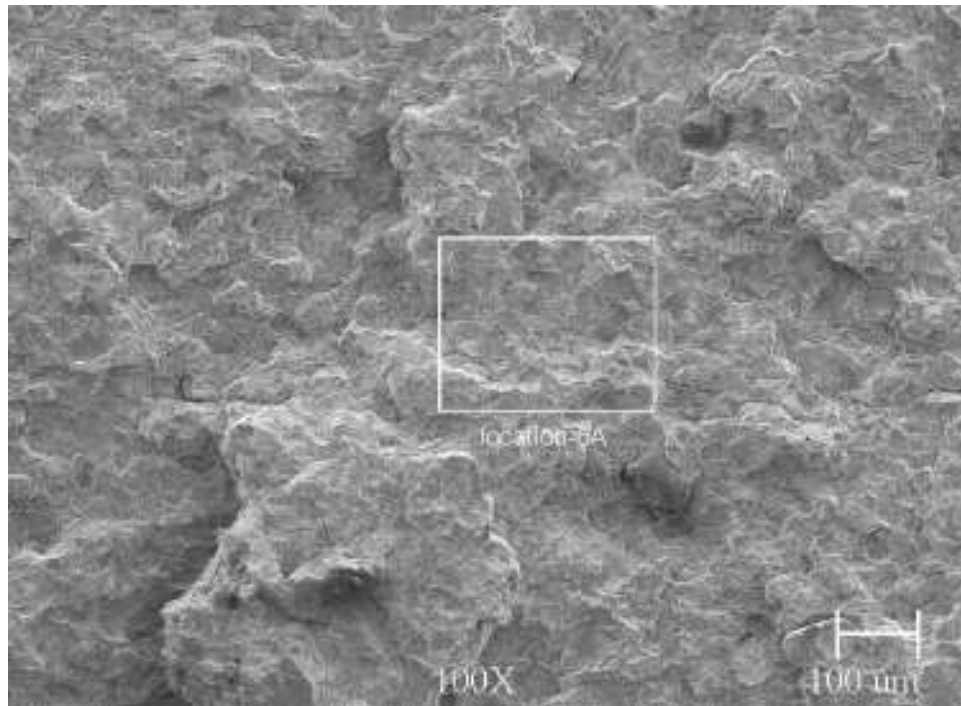
Area-F
Photograph No. 139

The SEM fractograph taken of the Area-F of the final fracture zone, as shown in Photograph No. 123, displays unresolved cleavage separation fracture features and faint evidence of ductile microvoid coalescence.

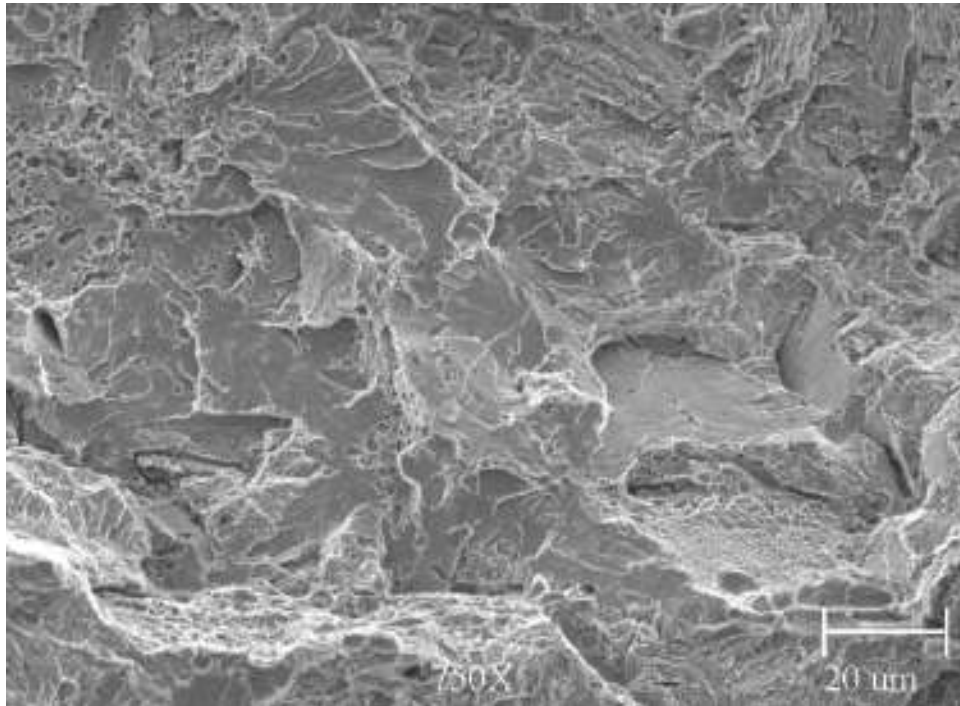
Area-F, Location-6A
Photograph No. 140

The SEM fractograph taken of the Area-F at Location-6A of the final fracture zone confirm the presence of predominantly brittle failure with some isolated areas of ductile failure, as indicated by the presence of cleavage separation and patches of microvoid coalescence, respectively.

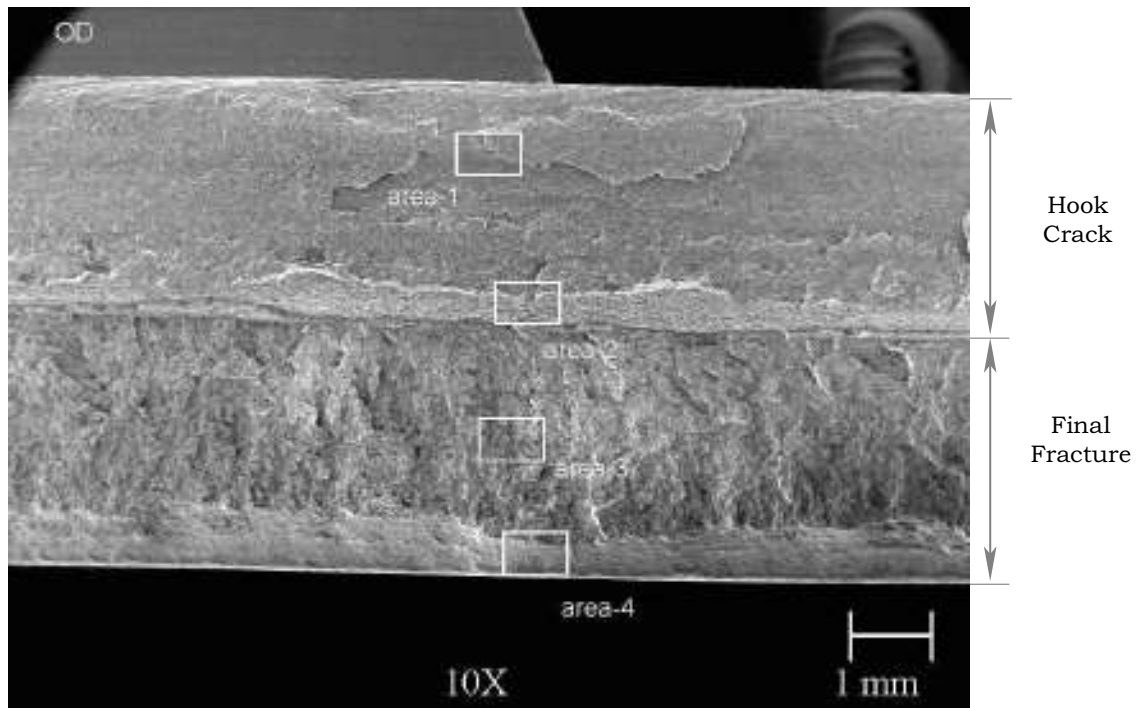
Photograph No. 141

The SEM fractograph taken of the several fracture origin sites at a distance of 20' 6-3/4" from the north girth weld shows an hook crack and the final fracture zone. The fracture areas within the rectangles were examined at higher magnifications to further characterize the fracture morphologies.

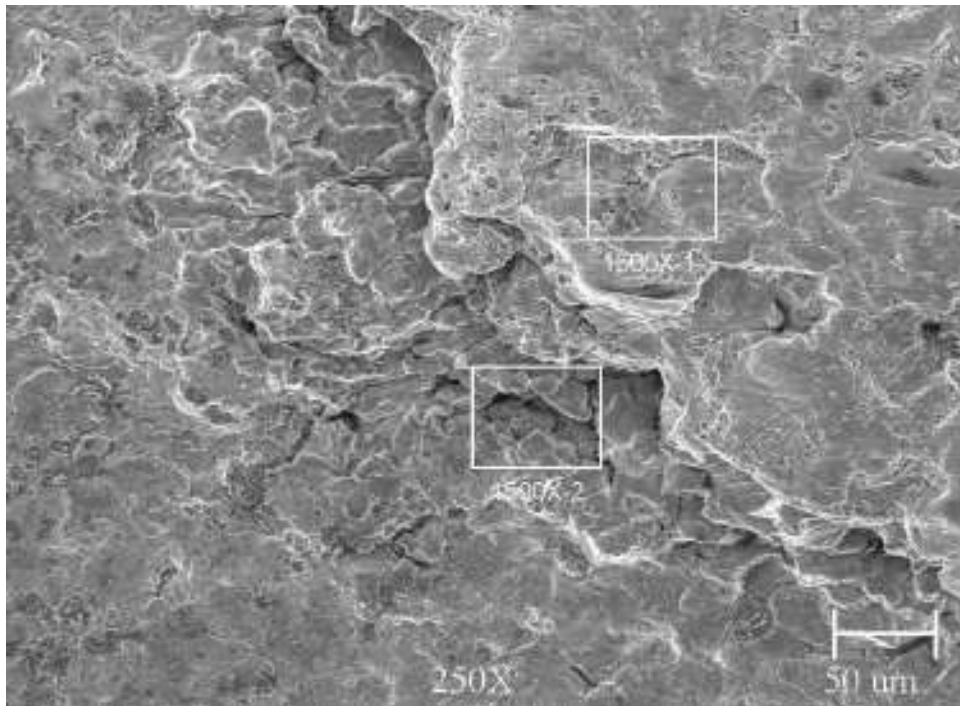
Area-1
Photograph No. 142

The SEM fractograph taken of the Area-1 of the hook crack fracture zone, as displayed in Photograph No. 141, reveals a highly oxidized fracture surface. The fracture areas, labeled as 1 and 2, were examined at higher magnification to further characterize the fracture morphologies.

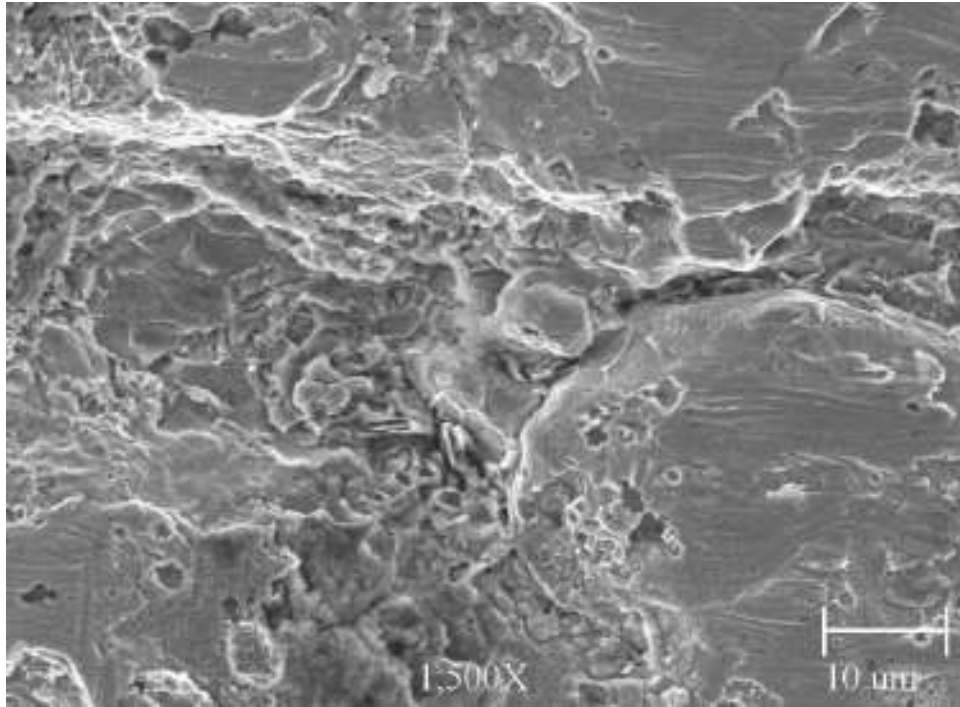
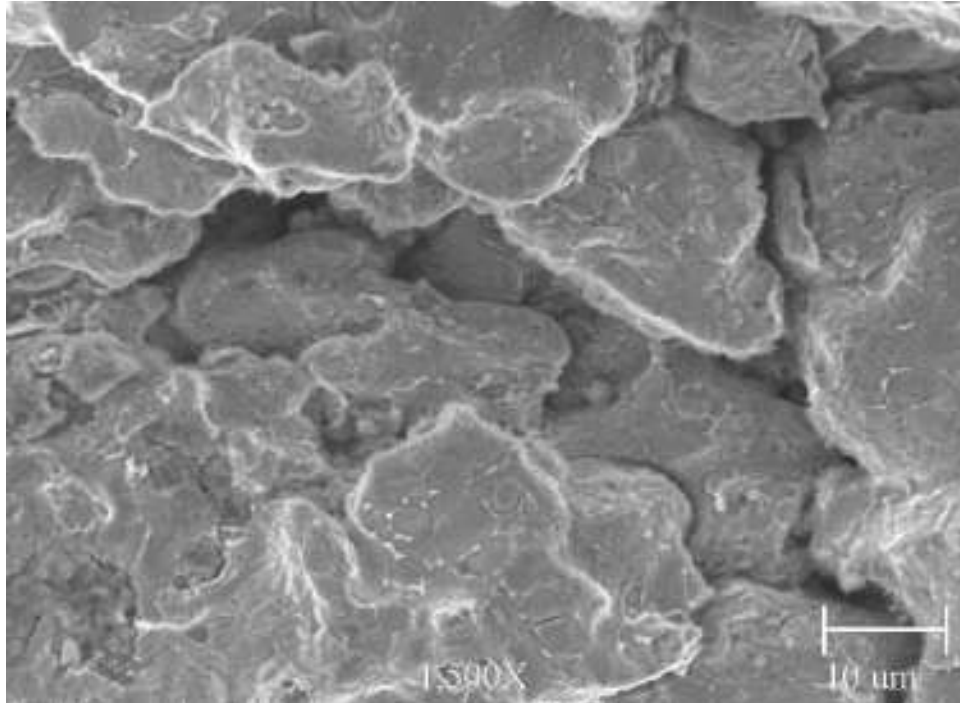
Area-1, Location-1
Photograph No. 143

The SEM fractographs taken of the fracture zones labeled as Location-1 and Location-2 in Area-1 of the hook crack reveal a highly oxidized surface and evidence of what appears to be intergranular fracture in a very small fracture zone, respectively. The intergranular fracture may have resulted along the ferrite grain boundaries.

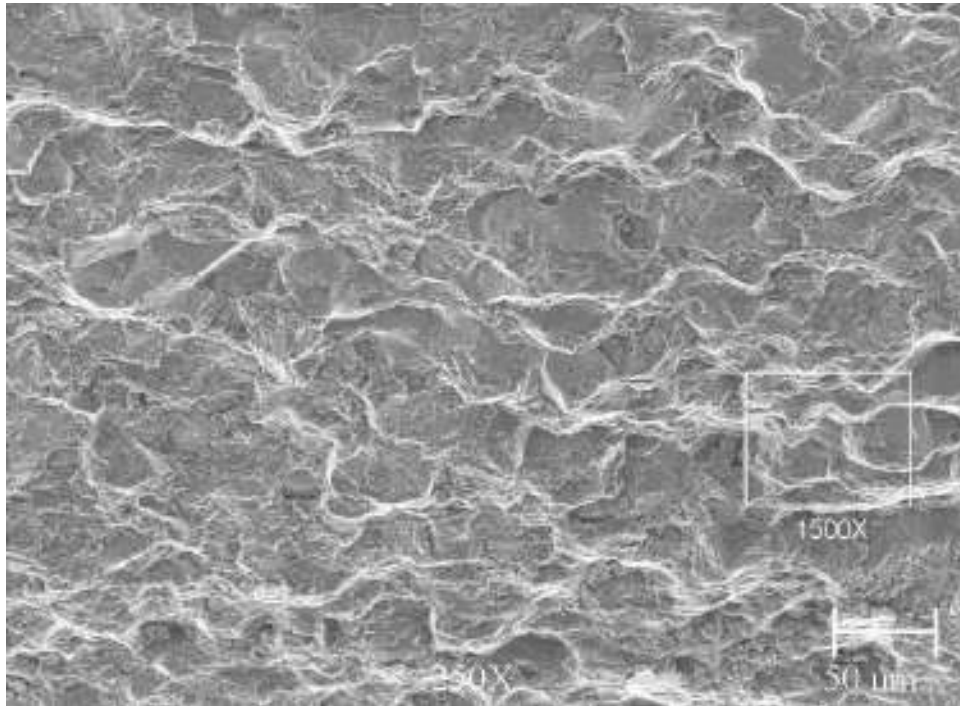
Area-2
Photograph No. 145

The SEM fractograph taken of the Area-2 of the hook crack, as displayed in Photograph No. 141, reveals the tightly adhered oxidation product. The area within the rectangle was examined at higher magnification to further characterize the fracture morphology.

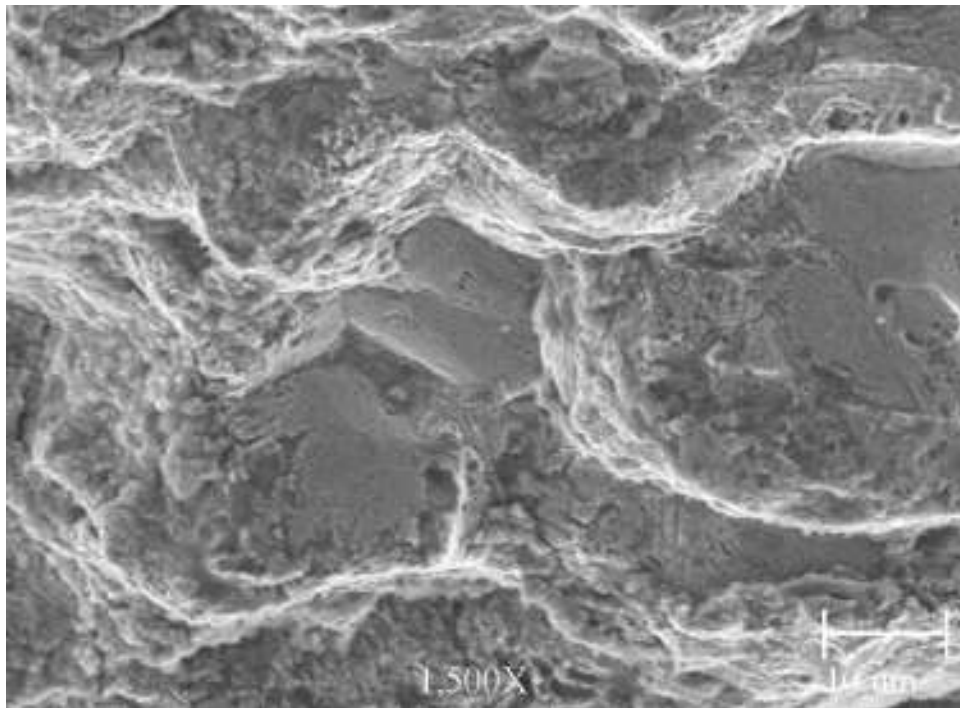
Area-2, within the rectangle
Photograph No. 146

The SEM fractograph taken of the Area-2 within the rectangle in the hook crack, as displayed in Photograph No. 145, reveals a nondescript, featureless fracture surface covered with tightly adhered oxidation product.

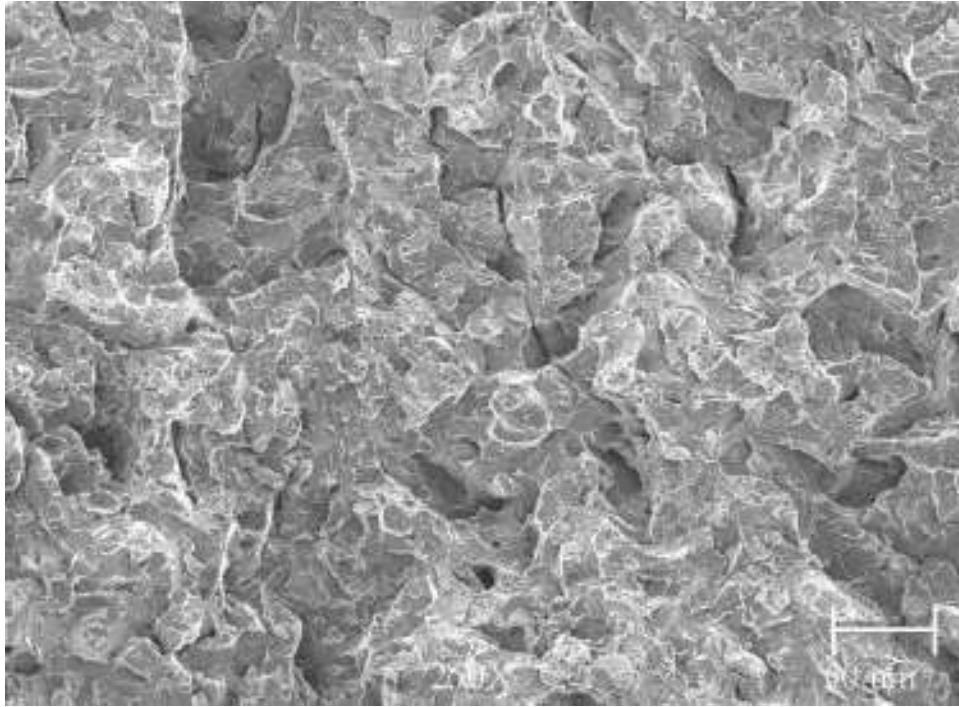
Area-3
Photograph No. 147

The SEM fractographs taken of the Area-3 of the final fracture zone, as displayed in Photograph No. 141, reveal cleavage separation, indicative of brittle failure.

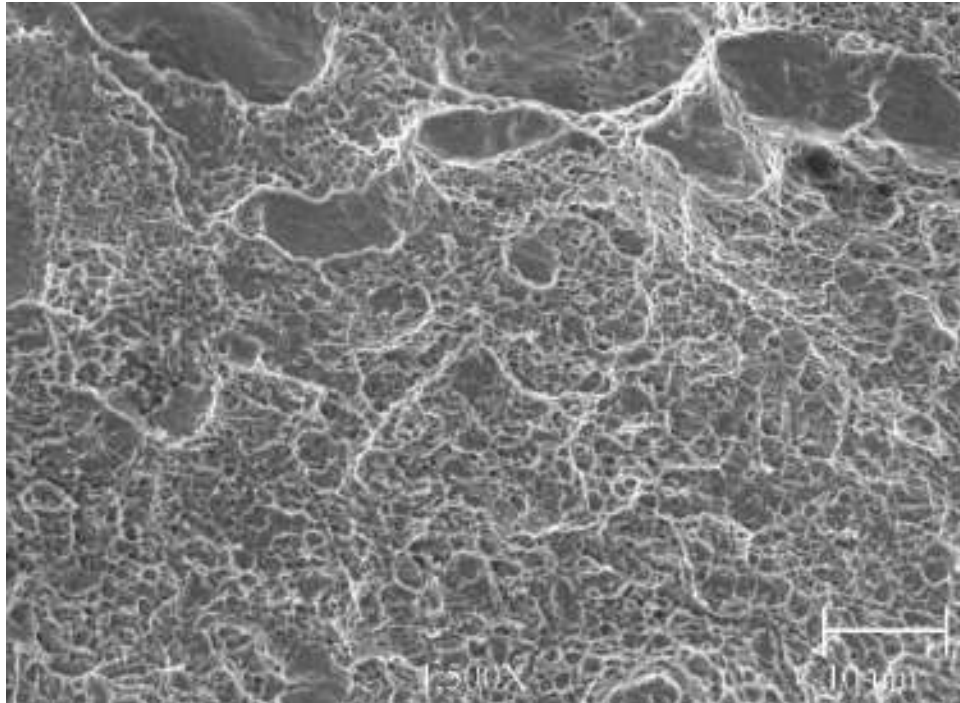
Area-4
Photograph No. 150

The SEM fractographs taken of the Area-4 of the final shear fracture zone at the I.D. of the pipe reveal evidence of microvoid coalescence, indicative of rapid ductile failure.

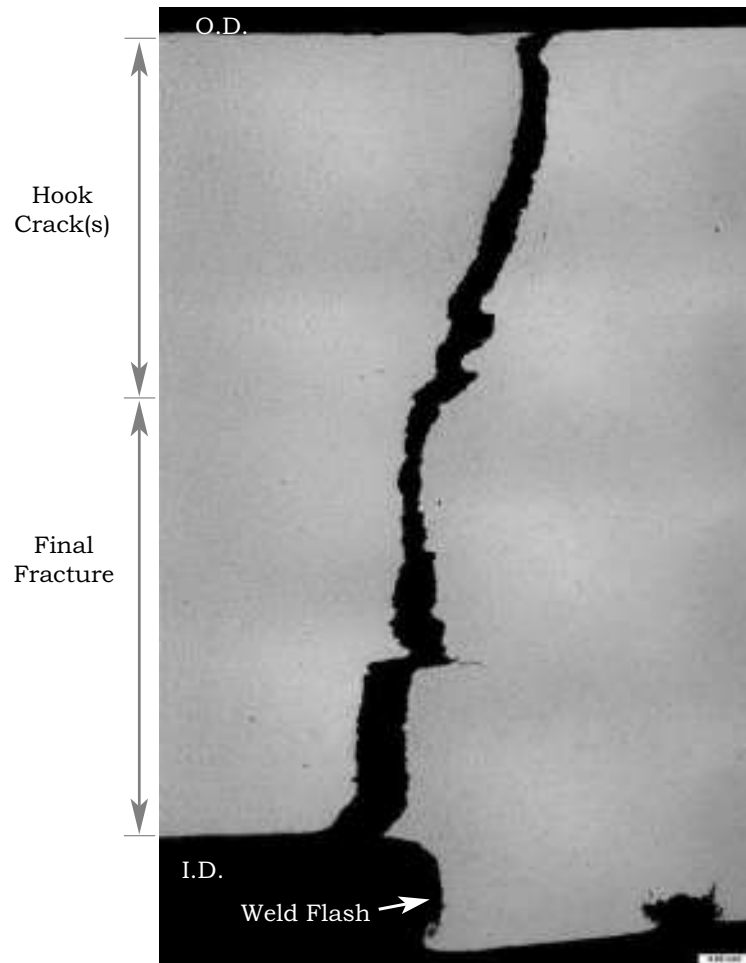
20' 4-7/8" from the North Girth Weld
As-polished, ~25x
Photograph No. 151

A composite view of the mating cross-sections removed through the fracture origins area at a distance of 20' 4-7/8" from the north girth weld and prepared for metallographic examination displays evidence of nonmetallic inclusions along the fracture faces and also parallel to the fusion line near the upper half of the pipe wall. Note that the weld flash on the I.D. surface of the pipe was not trimmed off flush with the I.D. surface.

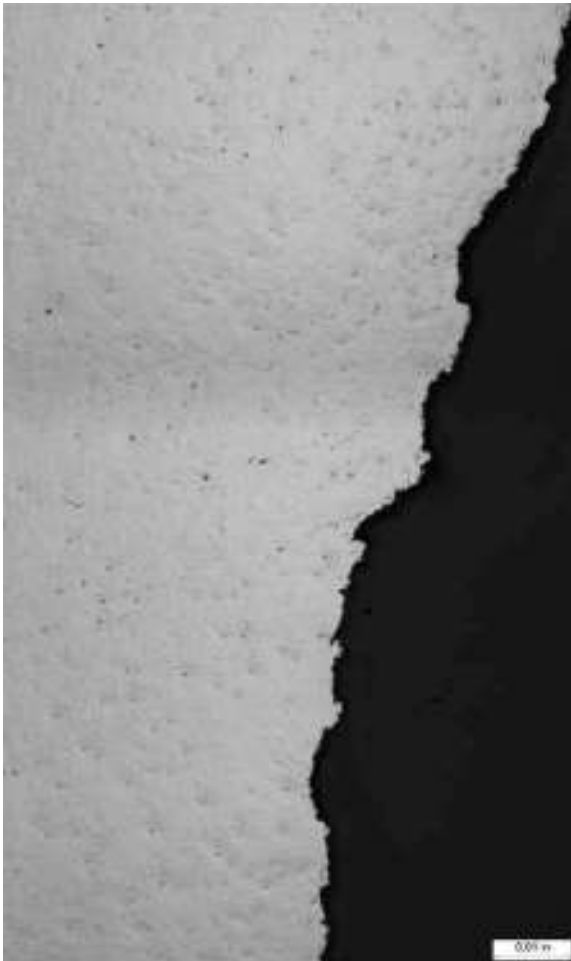
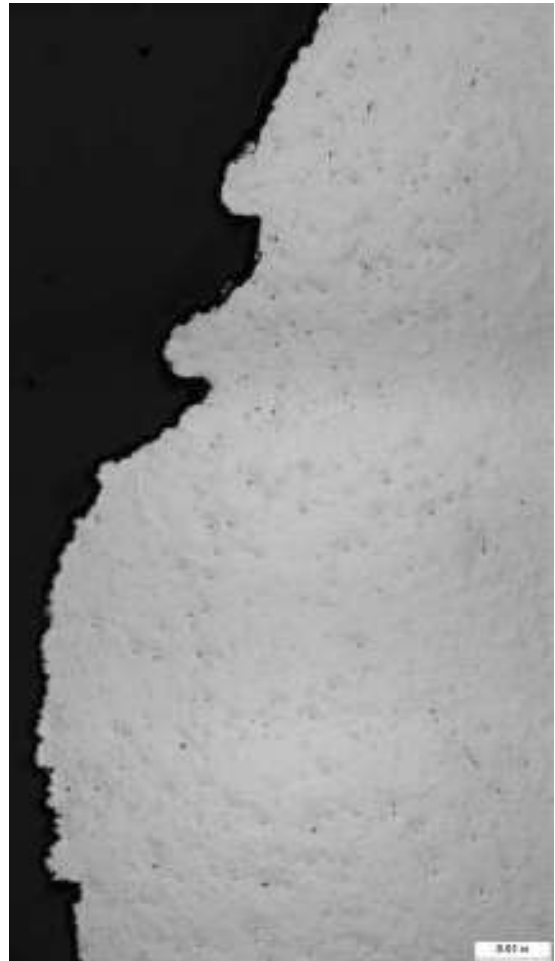
20' 4-7/8" from the North Girth Weld
As-polished, ~50x
Photograph No. 153

The micrographs display the upturned inclusions essentially parallel to the fusion line in the ERW upset/HAZ area, as well as along the fracture faces. Note that vertically aligned inclusions are one of the main contributing factors to the formation of hook cracks.
