*METALLURGICAL INVESTIGATION OF A
FRACTURED SECTION OF THE 20" O.D.
PIPELINE AT MILEPOST 314.77 IN THE
CONWAY TO CORSICANA SEGMENT OF
THE PEGASUS CRUDE OIL PIPELINE*

REPORT NO. 64961, REV. 1

Prepared for
ExxonMobil Pipeline Company and the
Pipeline and Hazardous Materials Safety Administration
pursuant to Corrective Action Order CPF 4-2013-5006H

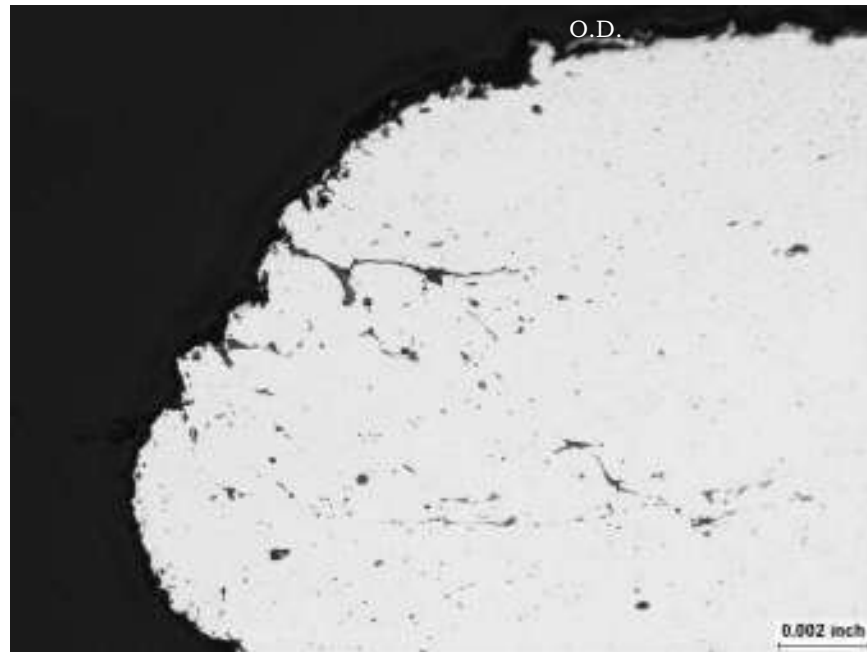
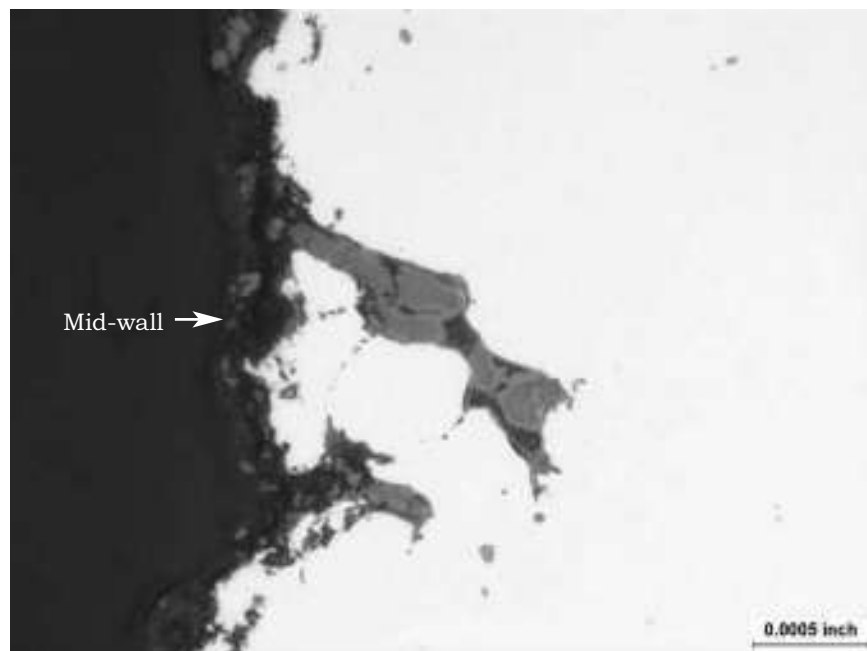
20' 4-7/8" from the North Girth Weld
As-polished, ~1000x
Photograph No. 155

The micrographs display evidence of folds at the O.D. surface at the fusion line, which was apparently not fully fused, and the presence of post-fracture oxidation at the mid-wall area along the hook crack fracture face.

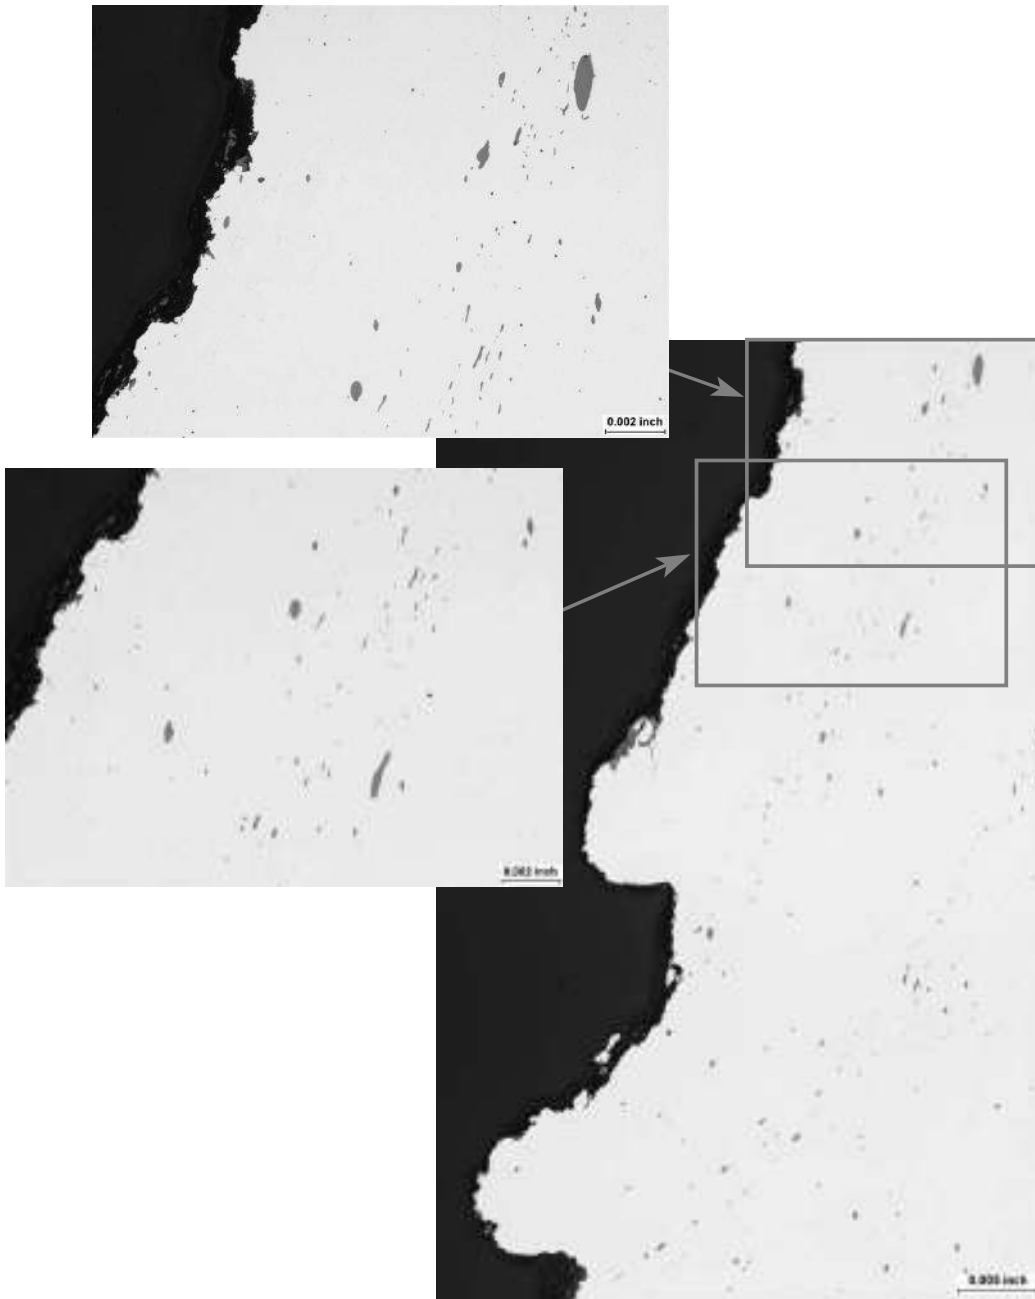
20' 4-7/8" from the North Girth Weld
As-polished, ~100x
Photograph No. 156

The micrographs display an excessive amount of elongated manganese sulfide inclusions in the diagonal and vertical planes in the upset/HAZ area of the ERW seam. Note the hook crack along and through the realigned inclusions.

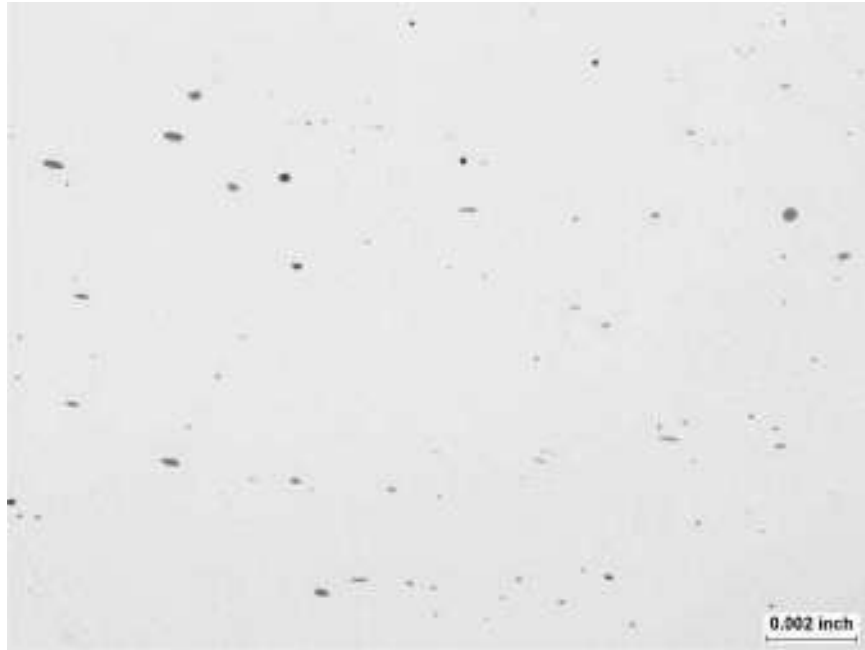
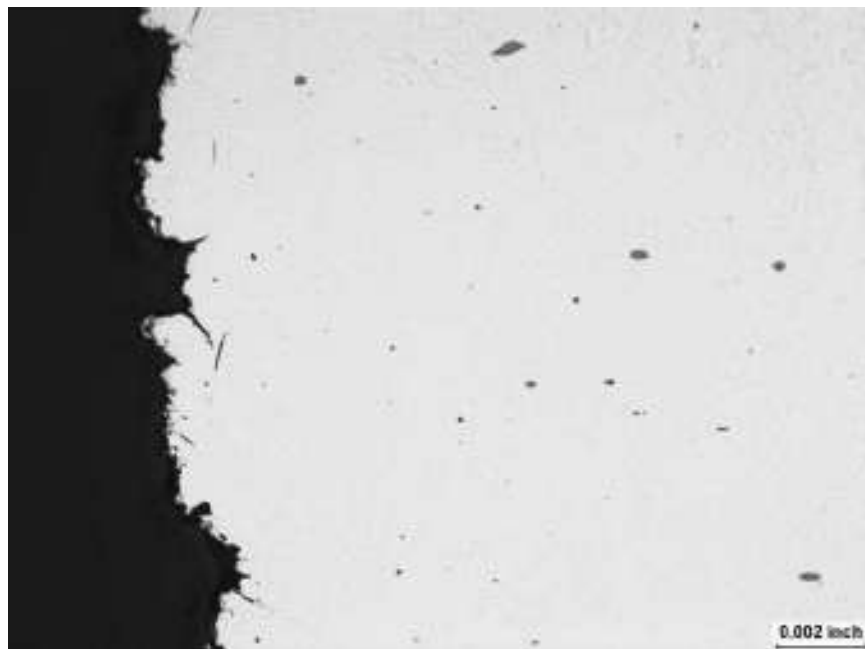
20' 4-7/8" from the North Girth Weld
As-polished, ~200x
Photograph No. 158

The micrographs display the manganese sulfide inclusions in the axial direction of the pipe near the I.D. surface of the ERW, which were not affected by the welding process.

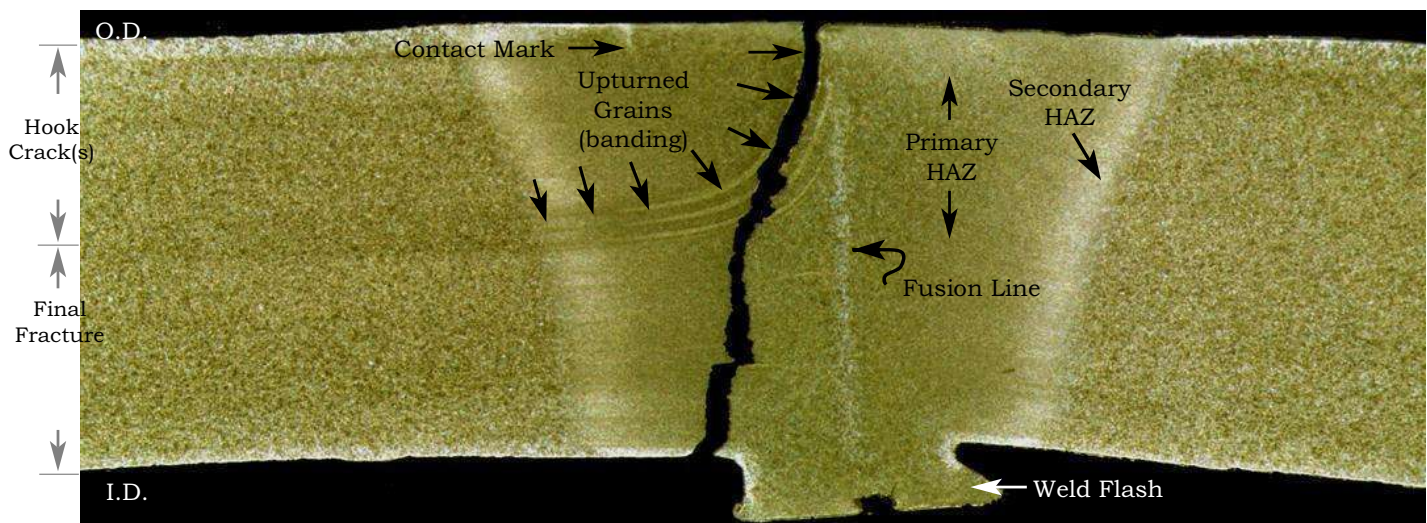
20' 4-7/8" from the North Girth Weld
2% Nital etch, ~20x
Photograph No. 159

A composite view of the mating cross-sections removed through the fracture origins area at a distance of 20' 4-7/8" from the north girth weld and prepared for metallographic evaluation shows hook cracks along the brittle upturned bands in the upset/HAZ area, and the final failure from the tip(s) of the hook crack(s). Again, note that the weld flash was not trimmed off flush with the I.D. surface.

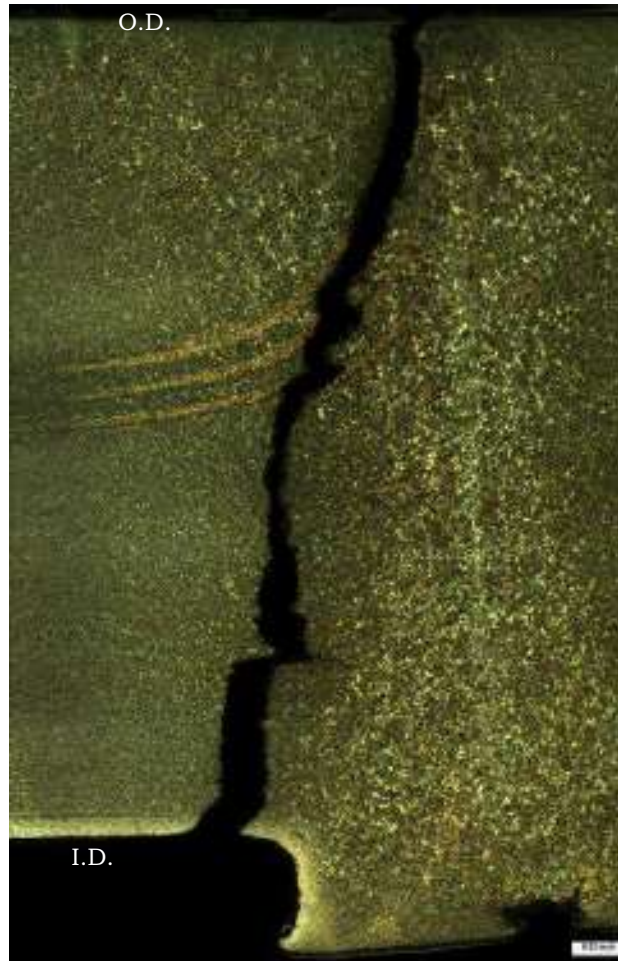
20' 4-7/8" from the North Girth Weld
2% Nital etch, ~25x
Photograph No. 160

The micrograph displays a hook crack through the upturned bands, which consists of untempered brittle martensite in the upset/HAZ of the ERW seam.

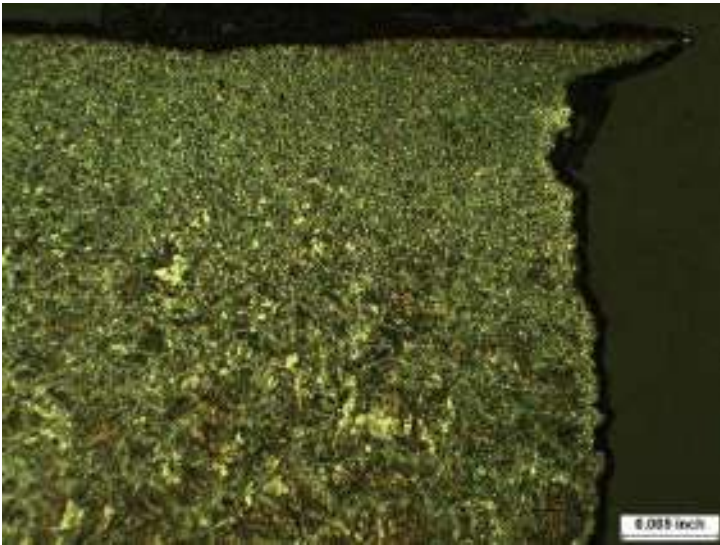
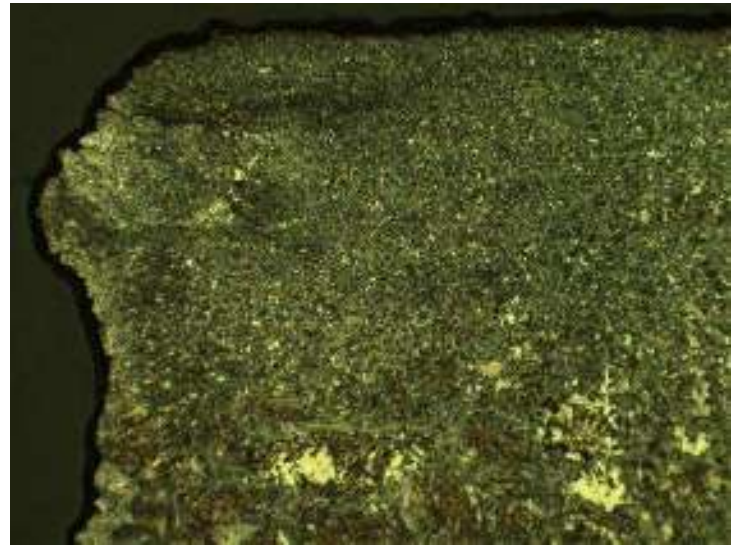
20' 4-7/8" from the North Girth Weld
2% Nital etch, ~100x
Photograph No. 162

The micrographs display the mating fracture faces of hook cracks near the O.D. of the ERW joint. The microstructure consists of grain boundary ferrite and unresolved bainite with some acicular martensite.

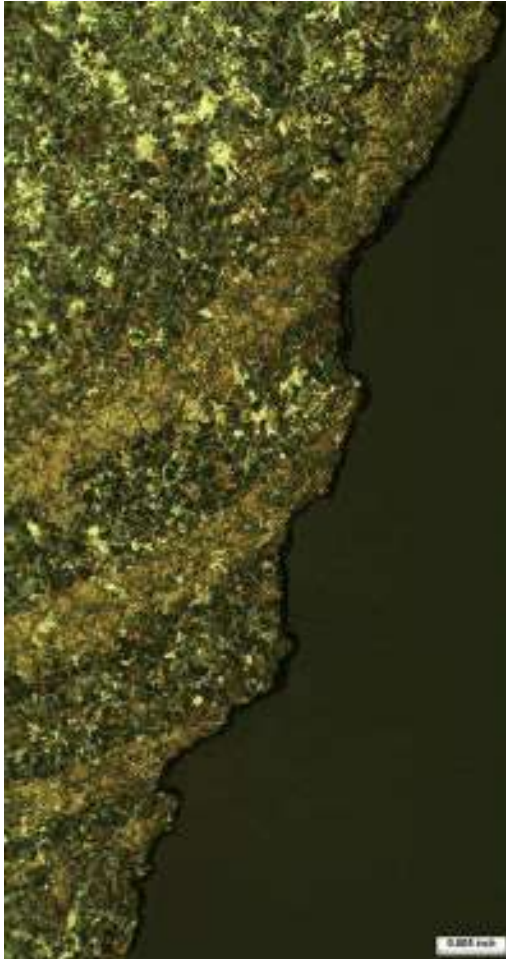
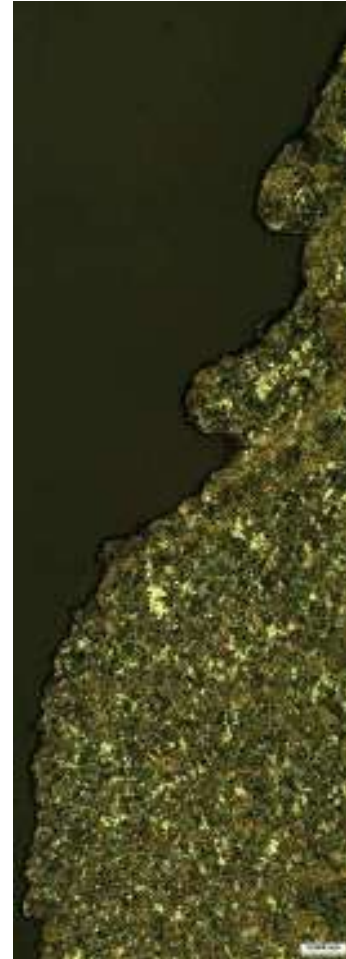
20' 4-7/8" from the North Girth Weld
2% Nital etch, ~100x
Photograph No. 164

The micrographs display the mating fracture faces of the hook cracks near the mid-wall of the ERW joint. Note the presence of mix-microstructure in the upset/HAZ of the ERW seam. The upturned bands consist of essentially untempered brittle martensite and the matrix outside of the bands consists of ferrite and unresolved bainite.

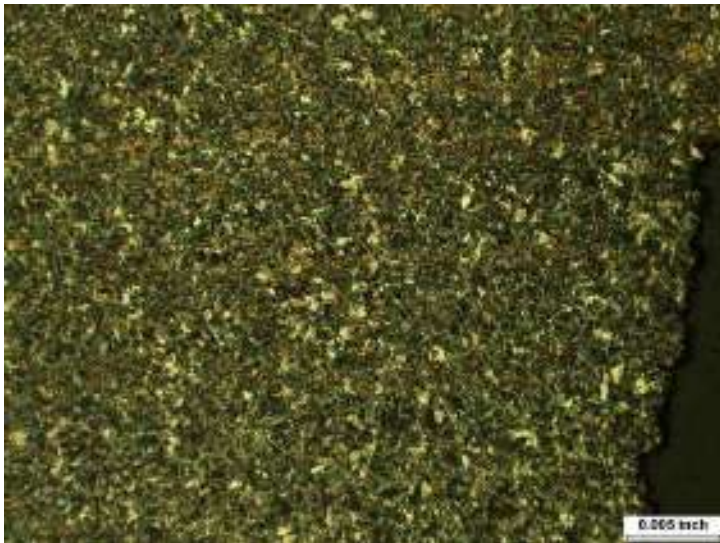
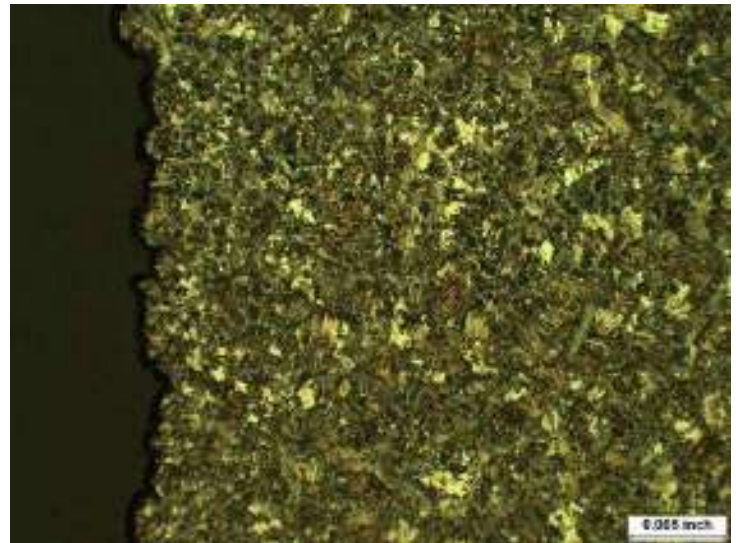
20' 4-7/8" from the North Girth Weld
2% Nital etch, ~100x
Photograph No. 166

The micrographs display the mating fracture faces of the final crack near the I.D. of the ERW joint. Note the presence of mix-microstructure in the HAZ of the ERW seam consisting of patches of untempered acicular martensite, grain boundary ferrite, and unresolved bainite.

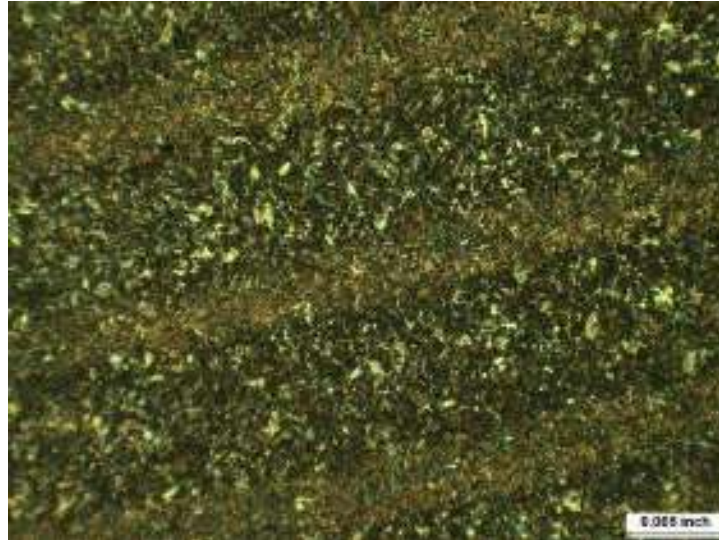
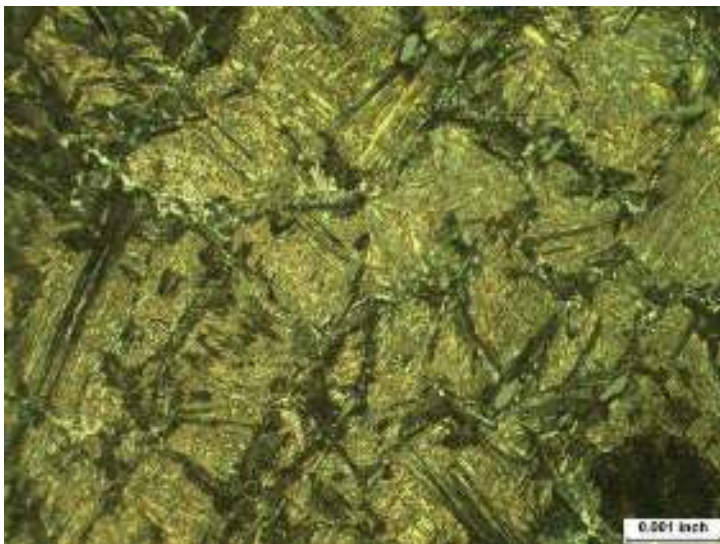
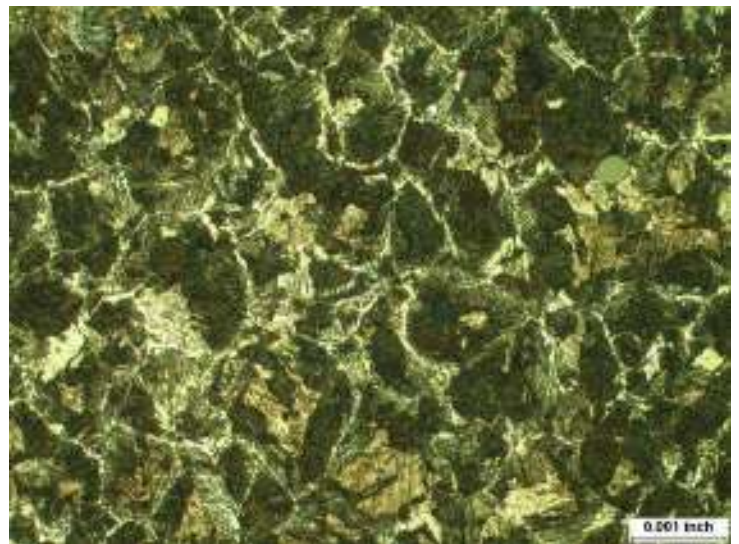
20' 4-7/8" from the North Girth Weld
2% Nital etch, ~500x
Photograph No. 169

The micrographs display the microstructure of the material in the upset/HAZ between the O.D. and the mid-wall where the upturned bands were formed during the ERW seam manufacturing, consisting of the untempered brittle martensite in the banded area and essentially grain boundary ferrite and unresolved bainite with some patches of untempered martensite in the non-banded area.

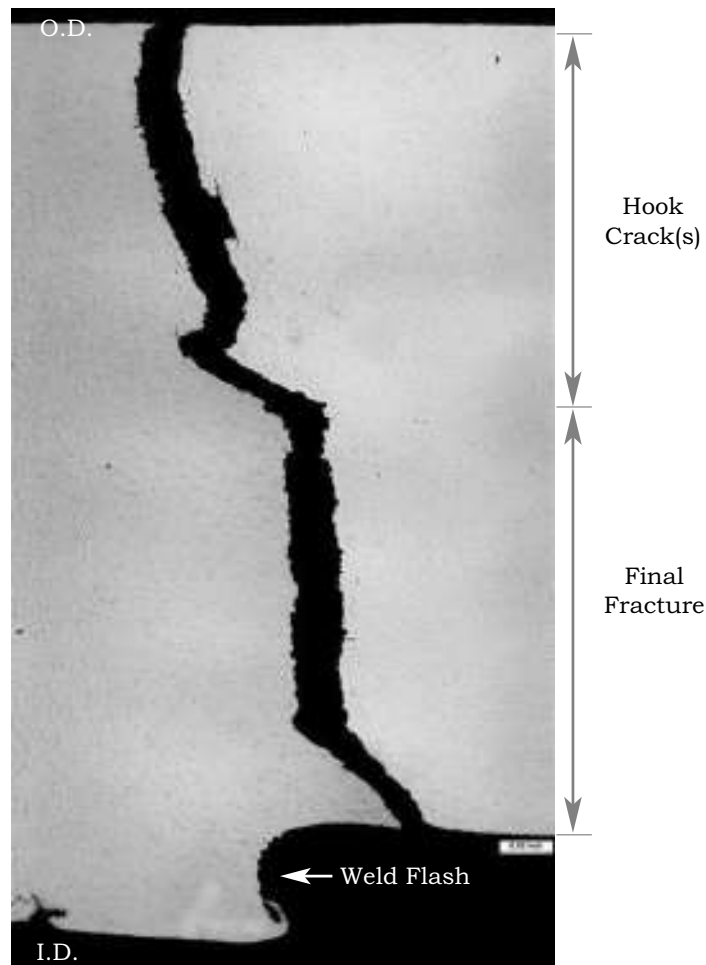
20' 6-13/16" from the North Girth Weld
As-polished, ~25x
Photograph No. 170

A composite view of the mating cross-sections removed through the fracture origins area at a distance of 20' 6-13/16" from the north girth weld and prepared for metallographic examination displays evidence of nonmetallic inclusions along the fracture faces, and also parallel to the fusion line near the upper half of the pipe wall. Note that the weld flash on the I.D. surface was not trimmed off flush with the I.D. surface of the pipe.

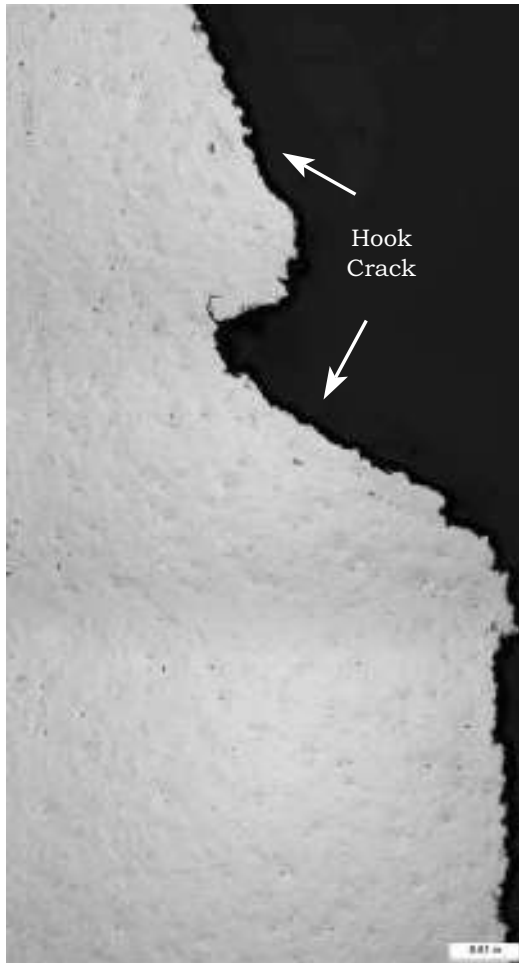
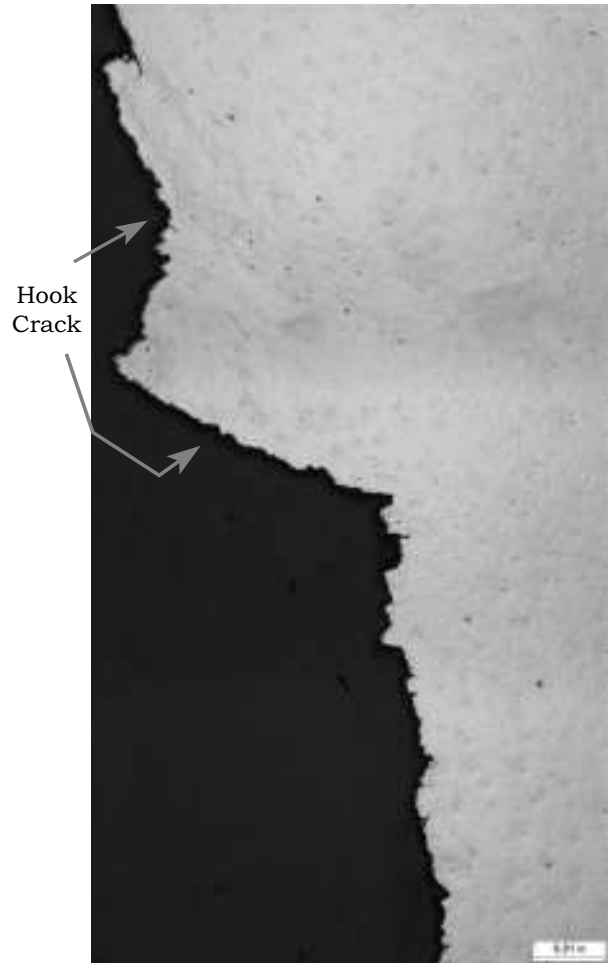
20' 6-13/16" from the North Girth Weld
As-polished, ~50x
Photograph No. 172

The micrographs display the upturned inclusions essentially parallel to the fusion line in the ERW upset/HAZ area, as well as along the fracture faces.

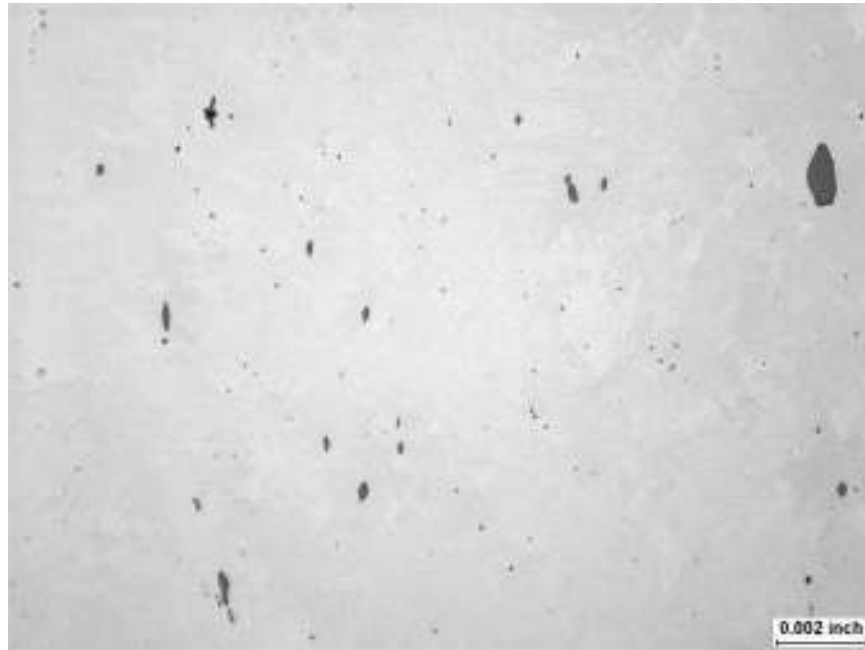
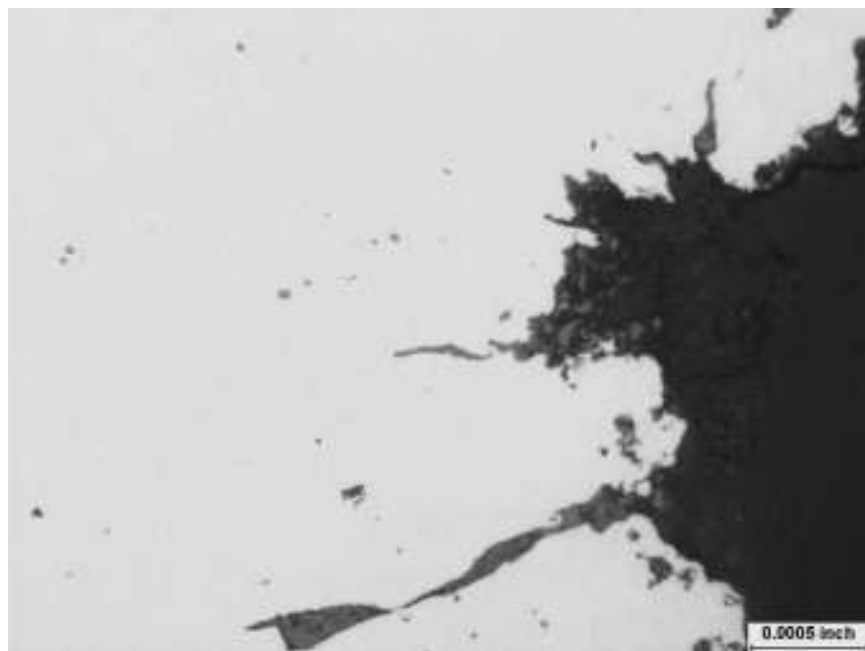
20' 6-13/16" from the North Girth Weld
As-polished, ~1000x
Photograph No. 174

The micrographs display the presence of several manganese sulfide inclusions aligned parallel to the fusion line and evidence of some post-hook crack oxidation along the fracture face near the mid-wall.

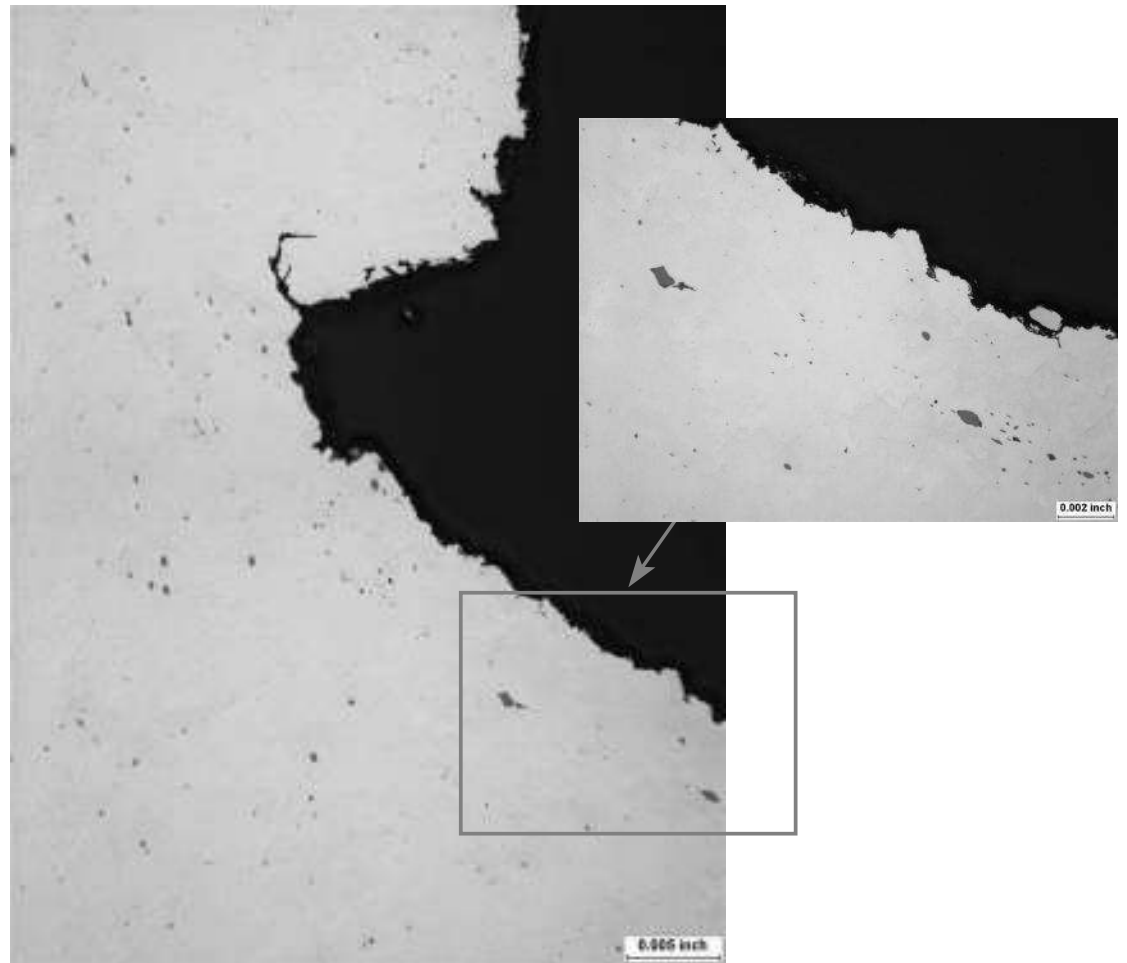
20' 6-13/16" from the North Girth Weld
As-polished, ~100x
Photograph No. 175

The micrographs display an excessive amount of elongated manganese sulfide inclusions aligned in the diagonal and vertical planes in the upset/HAZ area of the ERW seam. Note the hook crack(s) along and through the realigned inclusions.

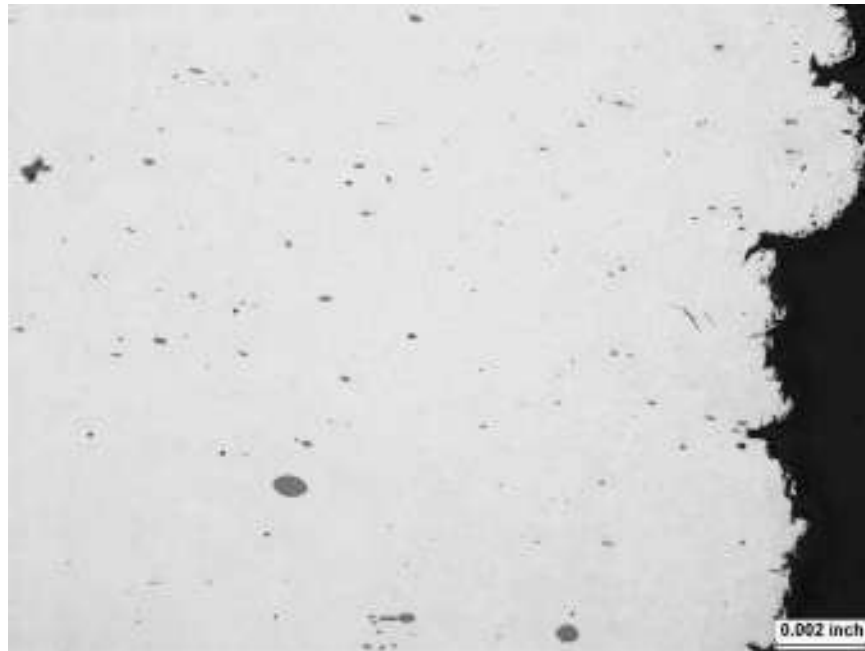
20' 6-13/16" from the North Girth Weld
As-polished, ~200x
Photograph No. 176

The micrograph displays the manganese sulfide inclusions in the axial direction of the pipe near the I.D. surface of the ERW, which were not affected by the welding process.

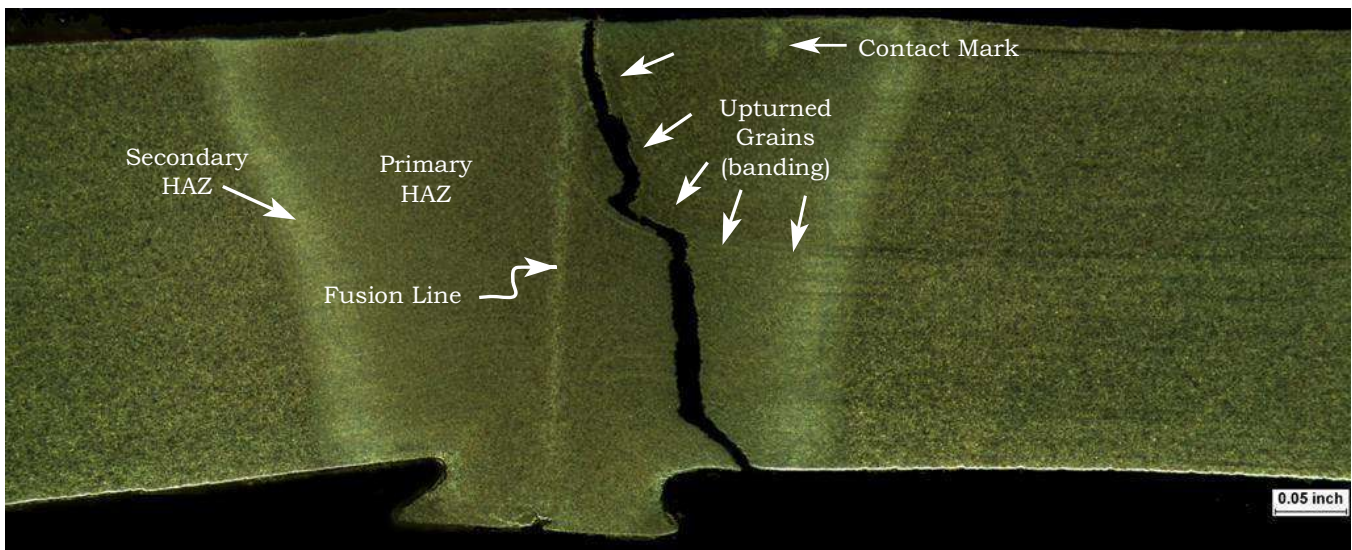
20' 6-13/16" from the North Girth Weld
2% Nital etch, ~20x
Photograph No. 177

The composite view of the mating cross-sections removed through the fracture origins area at a distance of 20' 6-13/16" from the north girth weld and prepared for metallographic evaluation shows hook crack(s) following the upturned grains and inclusions in the upset/HAZ area.

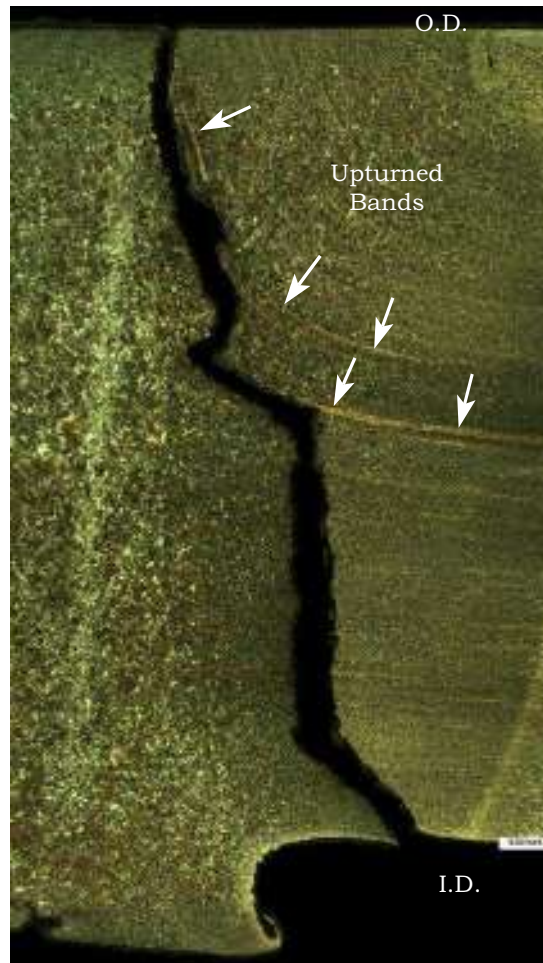
20' 6-13/16" from the North Girth Weld
2% Nital etch, ~25x
Photograph No. 178

The micrograph displays the hook crack(s) following the upturned bands, which consists of untempered brittle martensite.

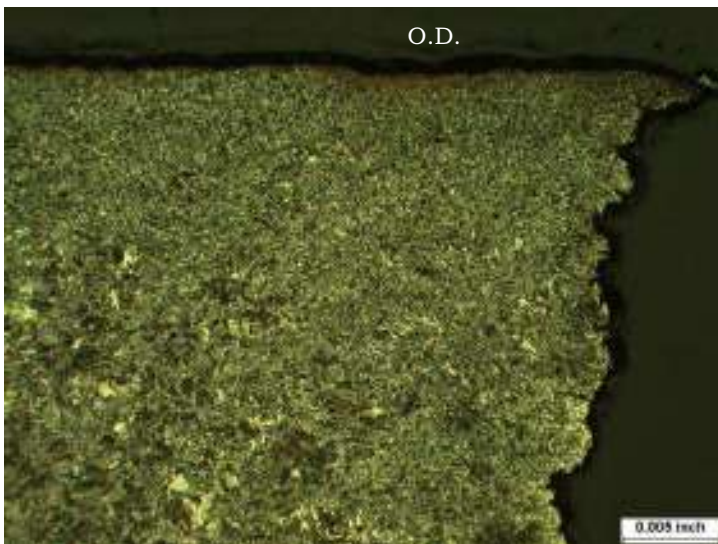
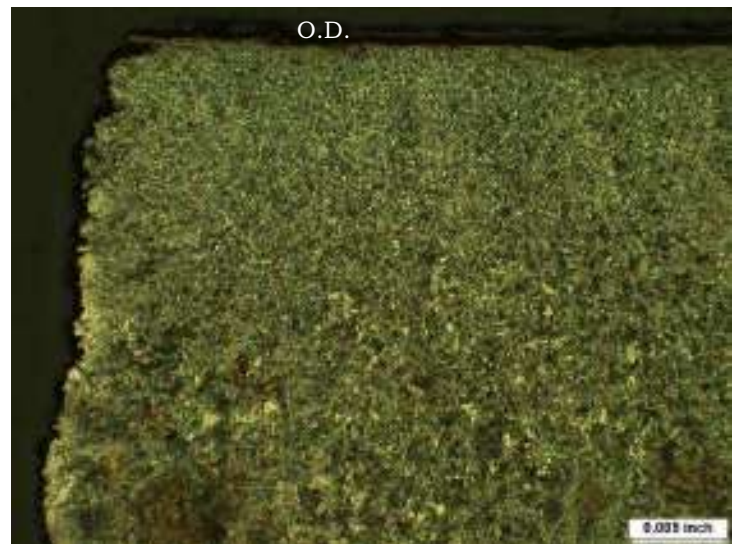
20' 6-13/16" from the North Girth Weld
2% Nital etch, ~100x
Photograph No. 180

The micrographs display the mating faces of the hook crack(s) at the O.D. in the ERW seam. The microstructure consists of grain boundary ferrite and unresolved bainite with some acicular martensite.

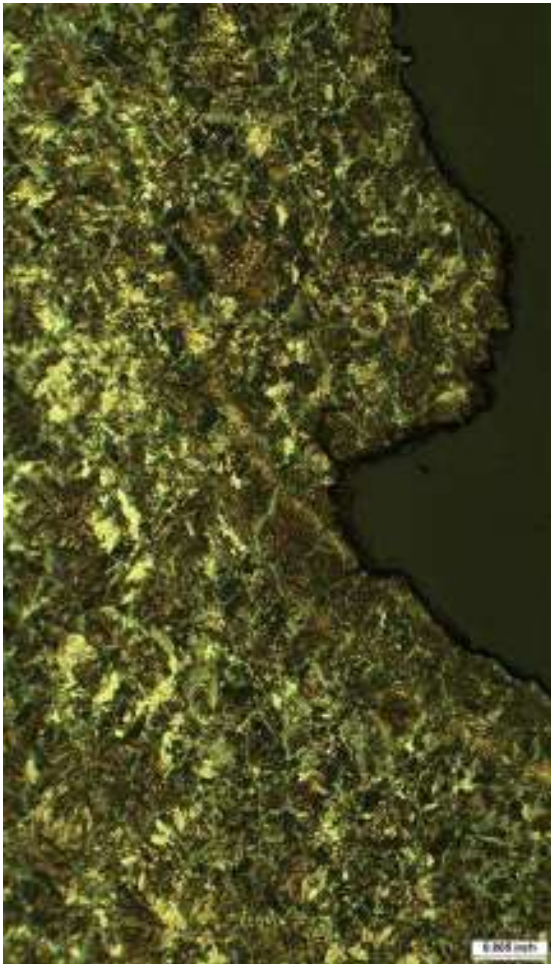
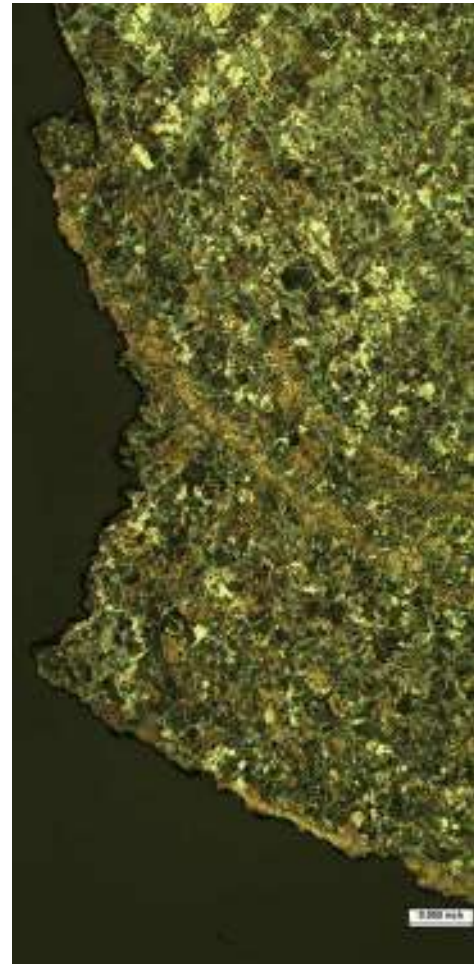
20' 6-13/16" from the North Girth Weld
2% Nital etch, ~100x
Photograph No. 182

The micrographs display hook crack(s) following the upturned bands of acicular martensite and manganese sulfide inclusions.

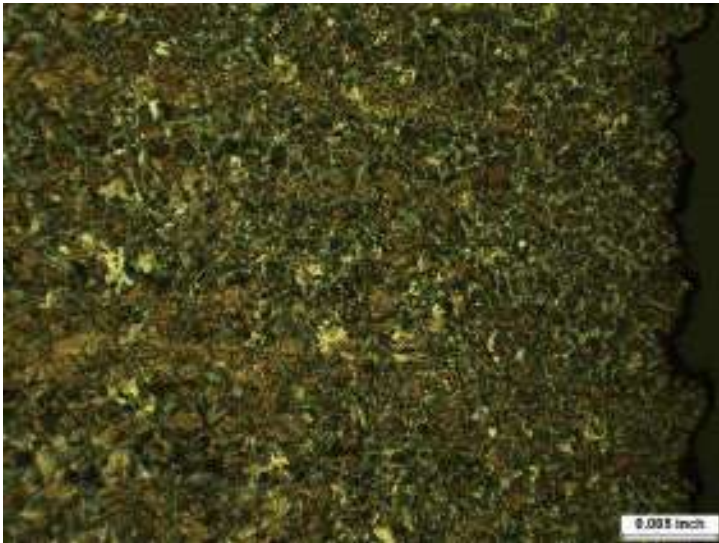
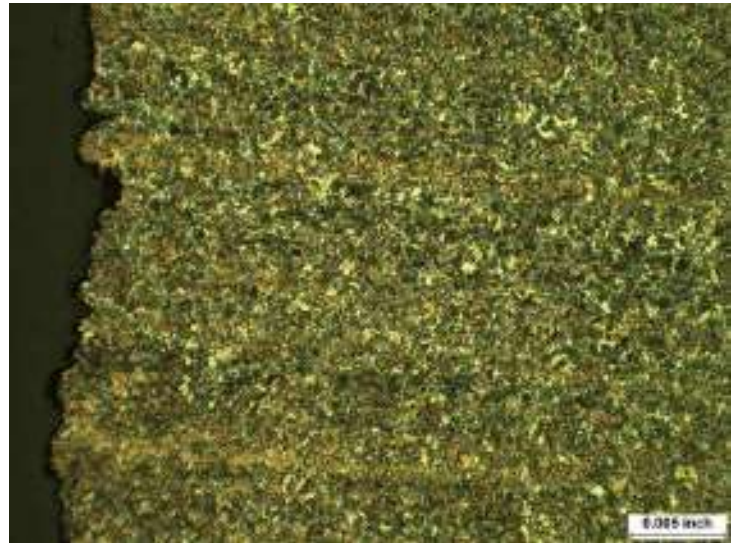
20' 6-13/16" from the North Girth Weld
2% Nital etch, ~100x
Photograph No. 184

The micrographs display the mating fracture faces of the final fracture near the I.D. of the ERW joint. The microstructure consists of grain boundary ferrite, unresolved bainite, and bands of acicular untempered martensite.

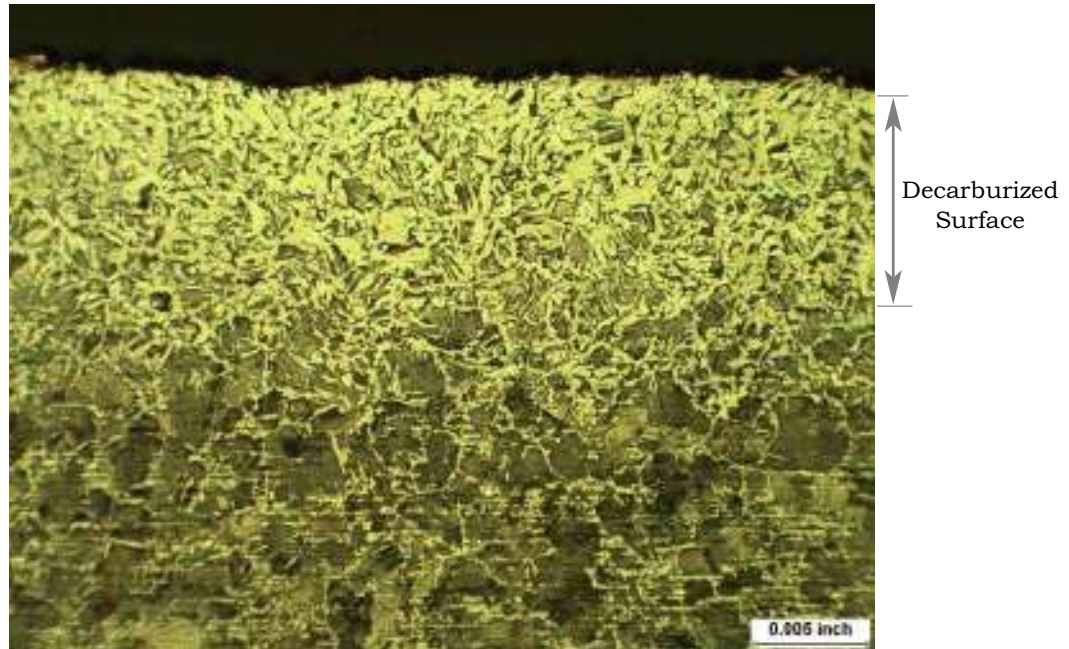
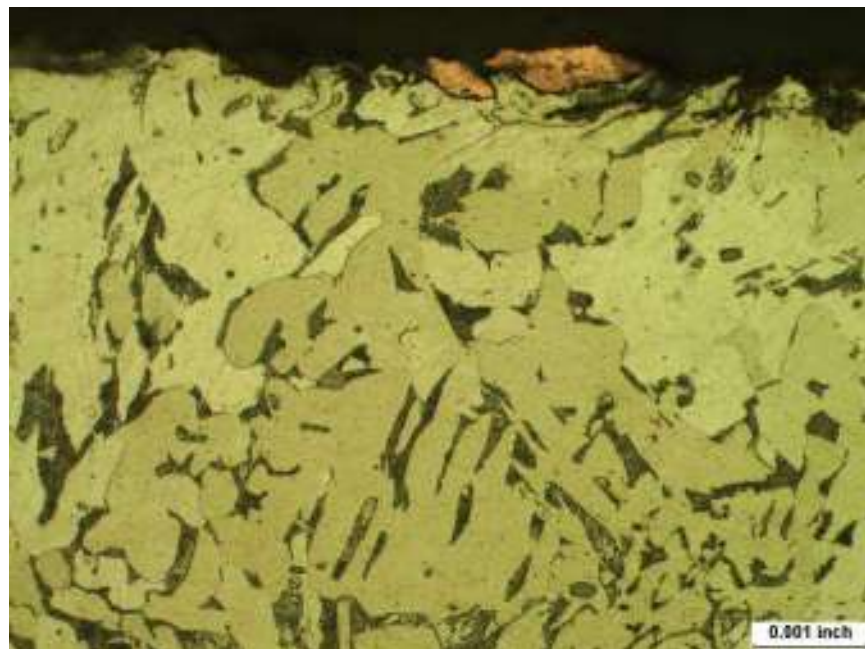
20' 6-13/16" from the North Girth Weld
2% Nital etch, ~500x
Photograph No. 186

The micrographs display the evidence of surface decarburization along the O.D. surface near the ERW seam and the presence of copper from the electrode contact during the initial seam welding of the pipe.

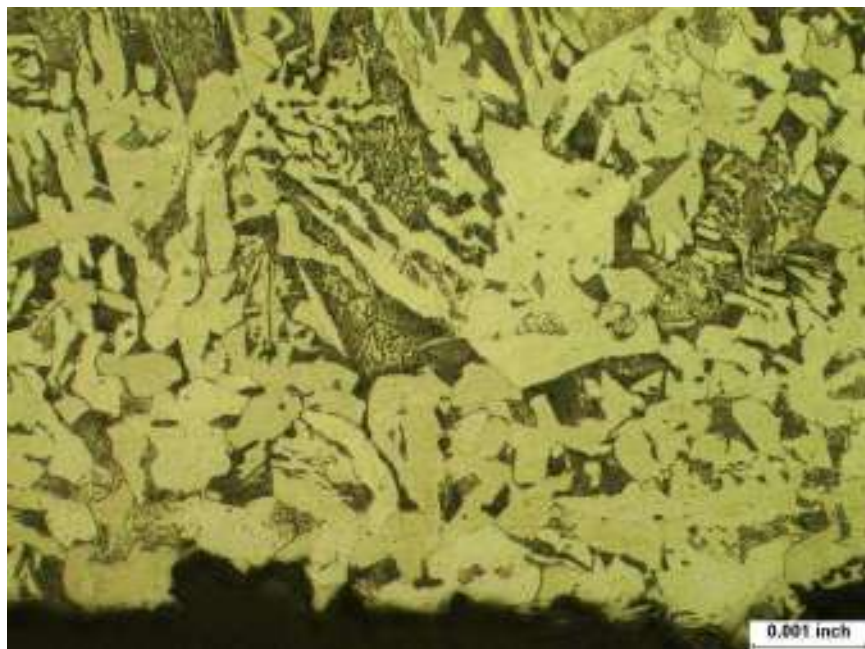
20' 6-13/16" from the North Girth Weld
2% Nital etch, ~500x
Photograph No. 188

The micrographs display the evidence of surface decarburization along the I.D. surface near the ERW seam.

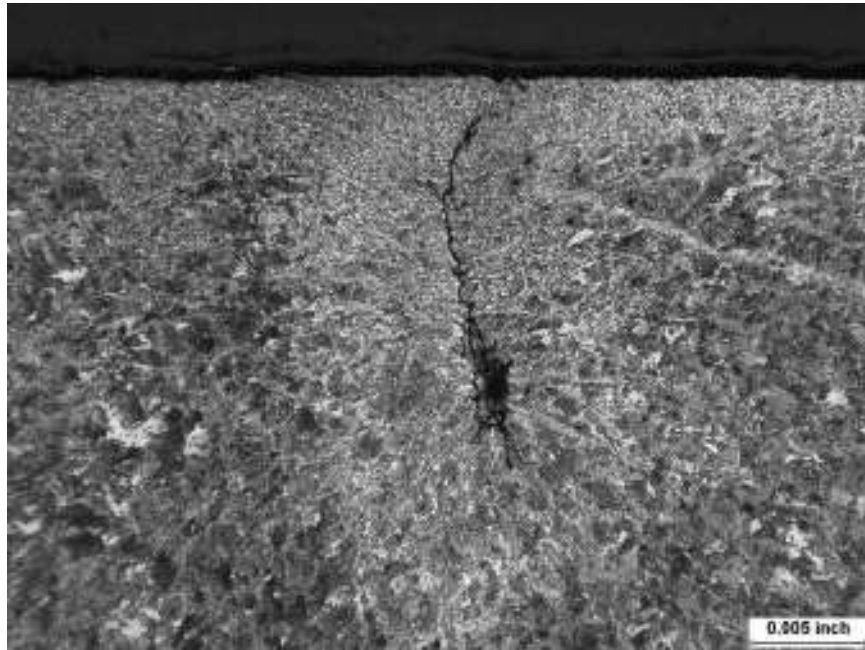
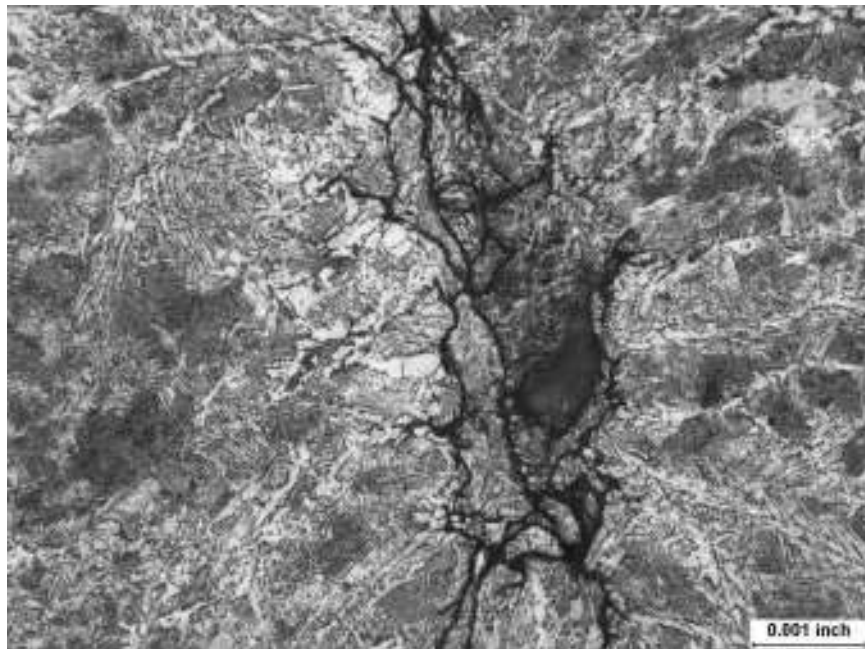
The micrographs display one of the contact marks which resulted from the electrical contact between the electrode supplying the welding current and the pipe surface. Note cracks through resolidified metal near the ERW seam within the primary HAZ.

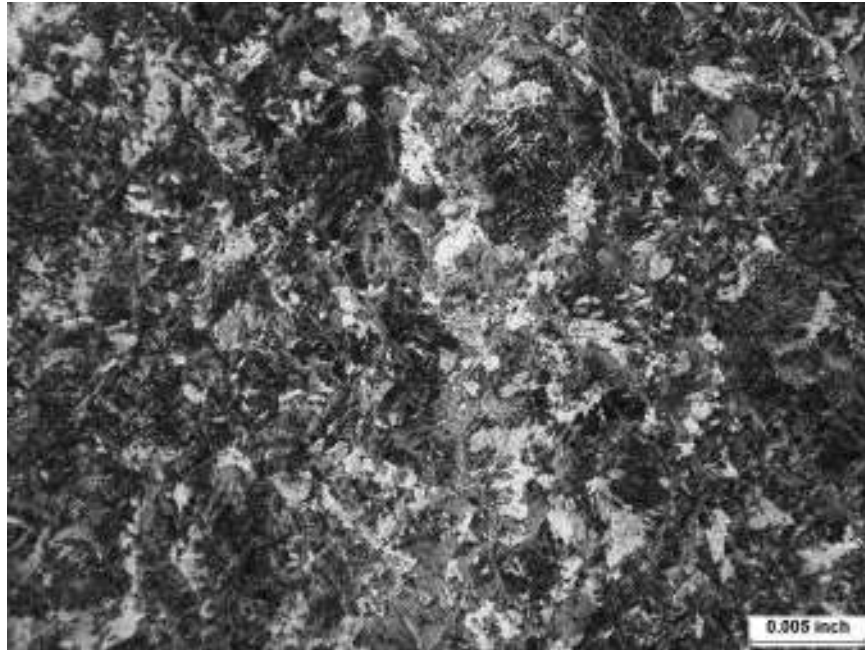
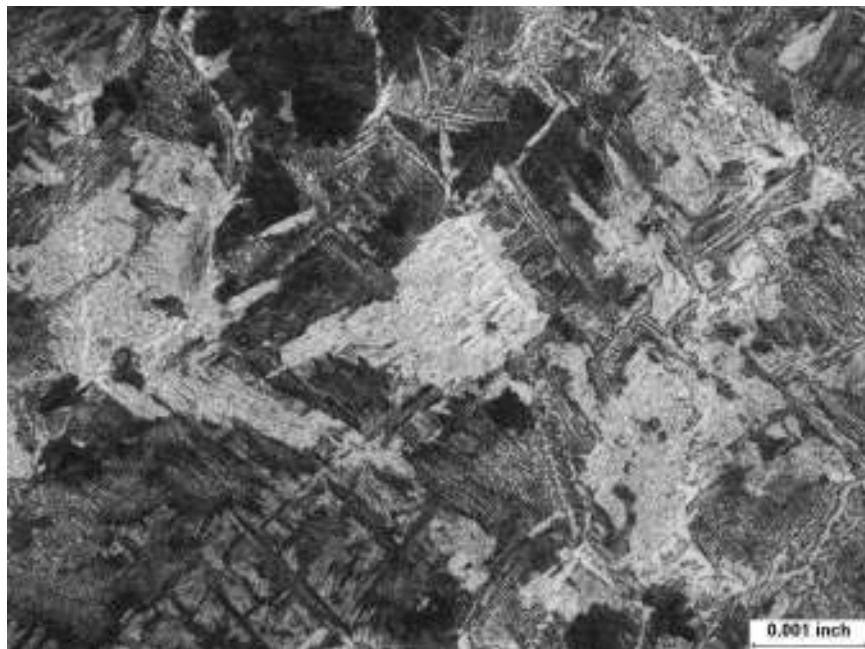
The micrographs display untempered bainitic/martensitic microstructure at the fusion line of the ERW seam.
