*METALLURGICAL INVESTIGATION OF A
FRACTURED SECTION OF THE 20" O.D.
PIPELINE AT MILEPOST 314.77 IN THE
CONWAY TO CORSICANA SEGMENT OF
THE PEGASUS CRUDE OIL PIPELINE*

REPORT NO. 64961, REV. 1

Prepared for
ExxonMobil Pipeline Company and the
Pipeline and Hazardous Materials Safety Administration
pursuant to Corrective Action Order CPF 4-2013-5006H

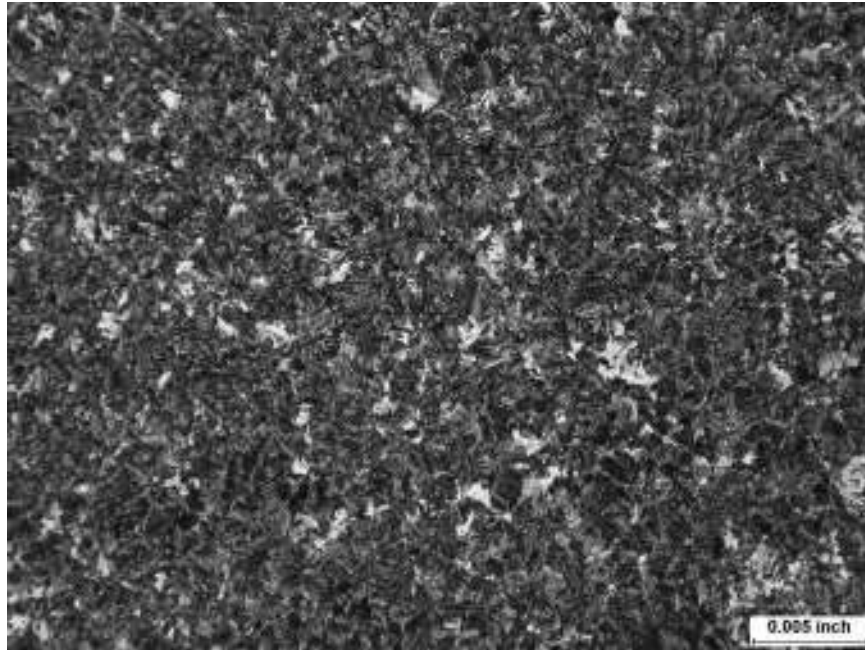
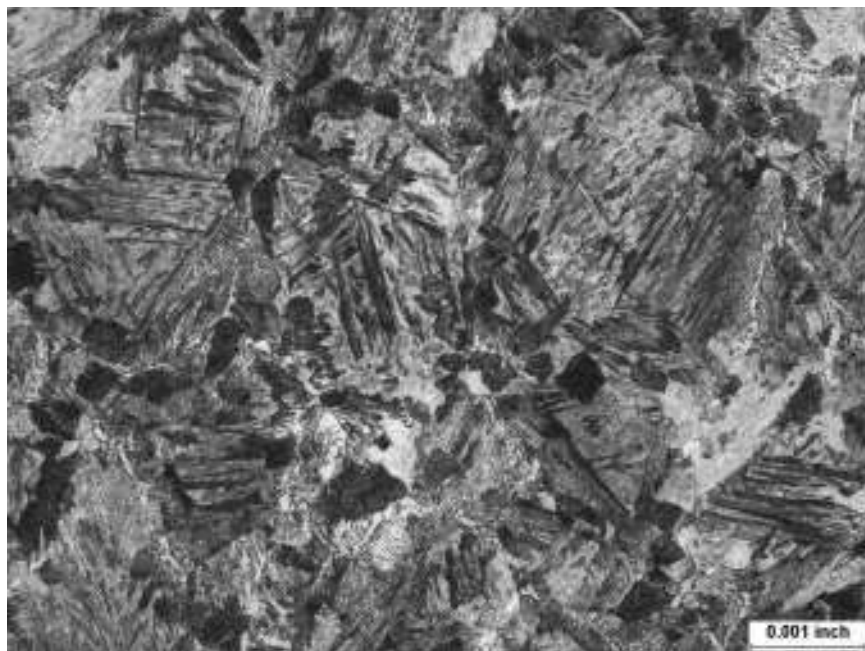
The micrographs of the primary HAZ display mix-microstructure consisting of grain boundary ferrite and untempered acicular martensite.

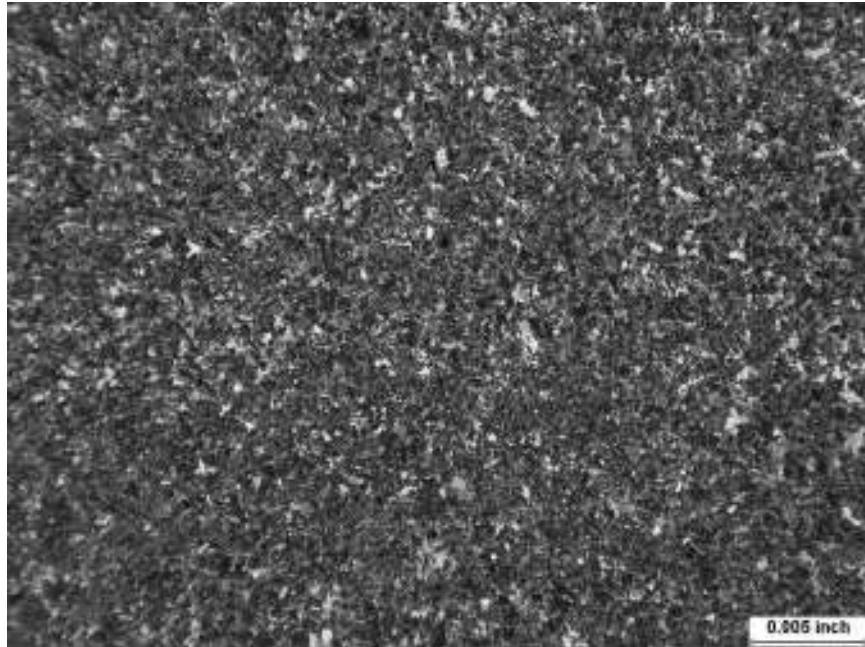
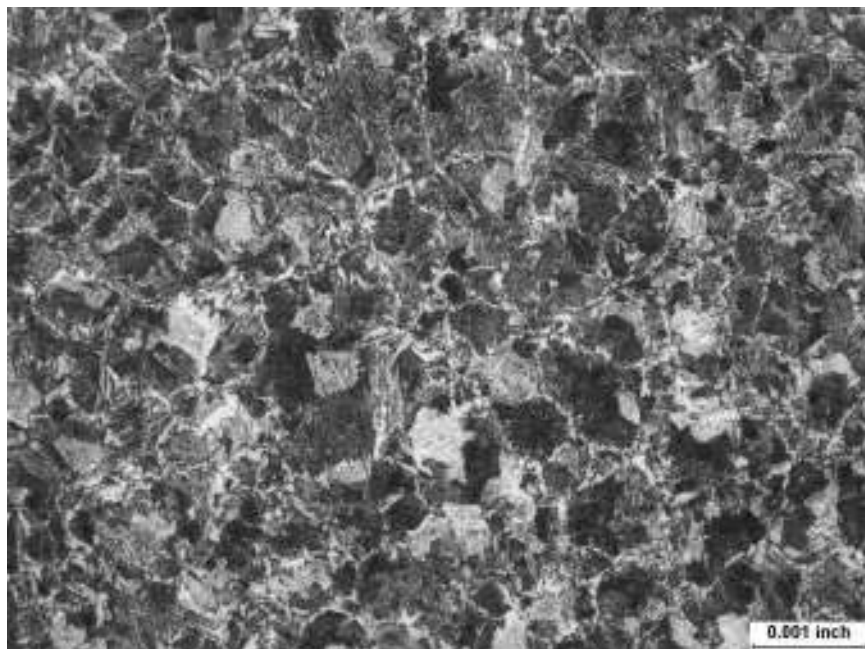
The micrographs of the secondary HAZ display essentially the grain boundary ferrite and unresolved pearlite.

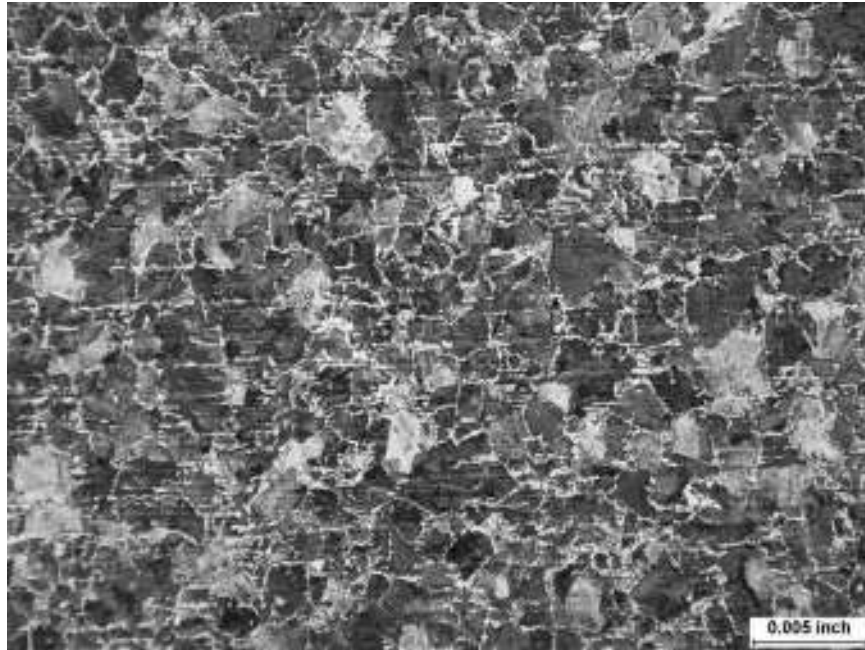
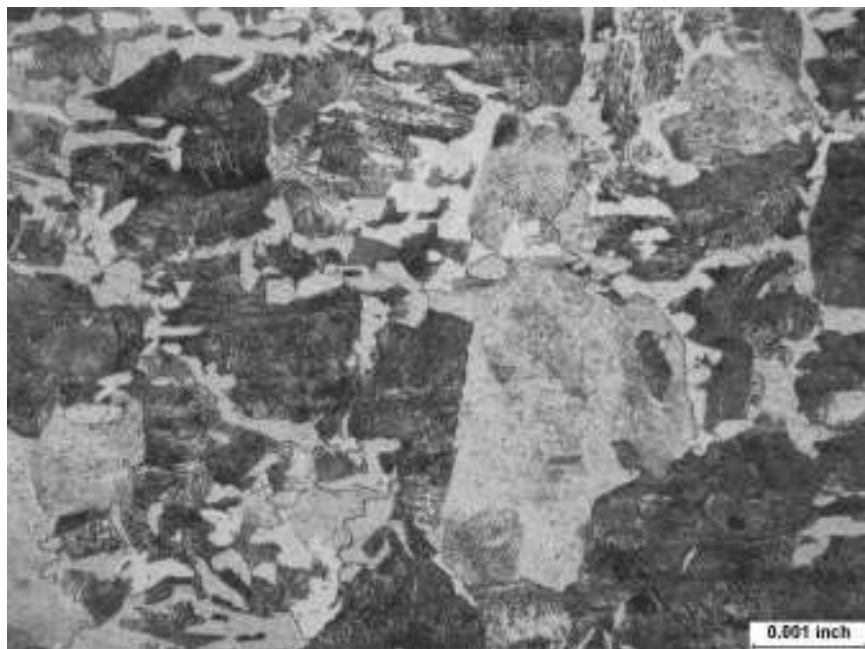
The micrographs of the base metal display the grain boundary ferrite and lamellar pearlite.

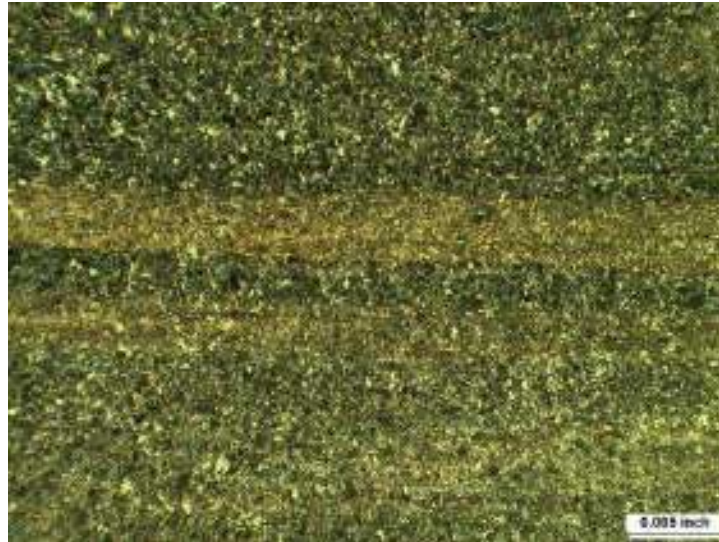
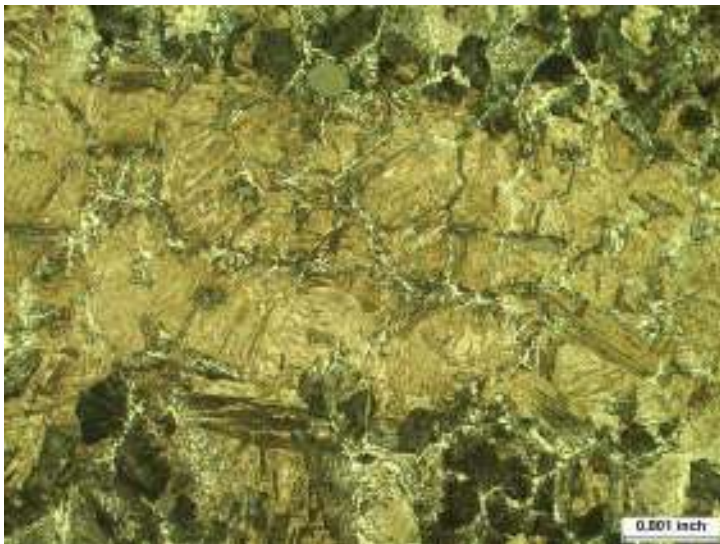
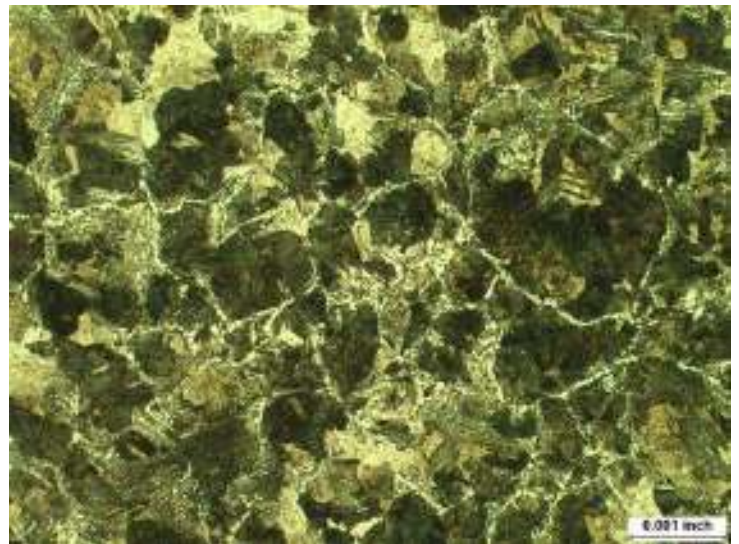
The photographs display banded microstructure in the ERW upset area adjacent to the fusion line, consisting of untempered acicular martensite with entrapped ferrite and ferrite with unresolved bainite in the adjacent non-banded matrix.

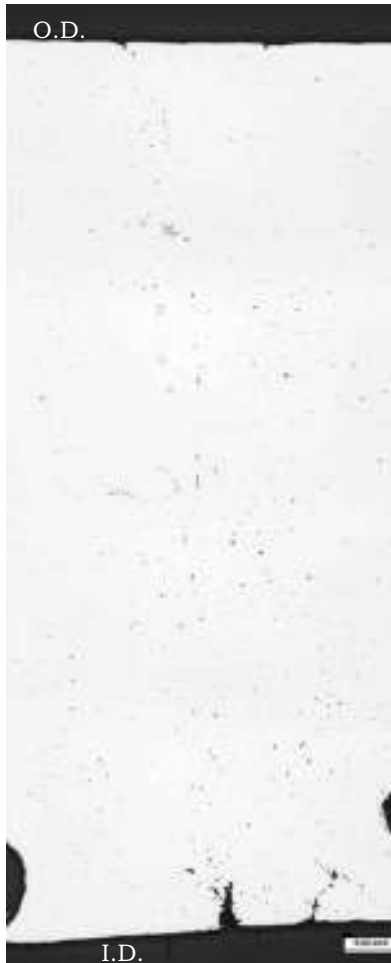
35' 8-1/2" from the North Girth Weld
As-polished, ~25x
Photograph No. 203

The micrograph of a cross-section removed from the intact ERW seam at a distance of 35' 8-1/2" from the north girth weld displays an excessive amount of manganese sulfide inclusions, some aligned parallel and diagonal to the fusion line during the seam welding process.

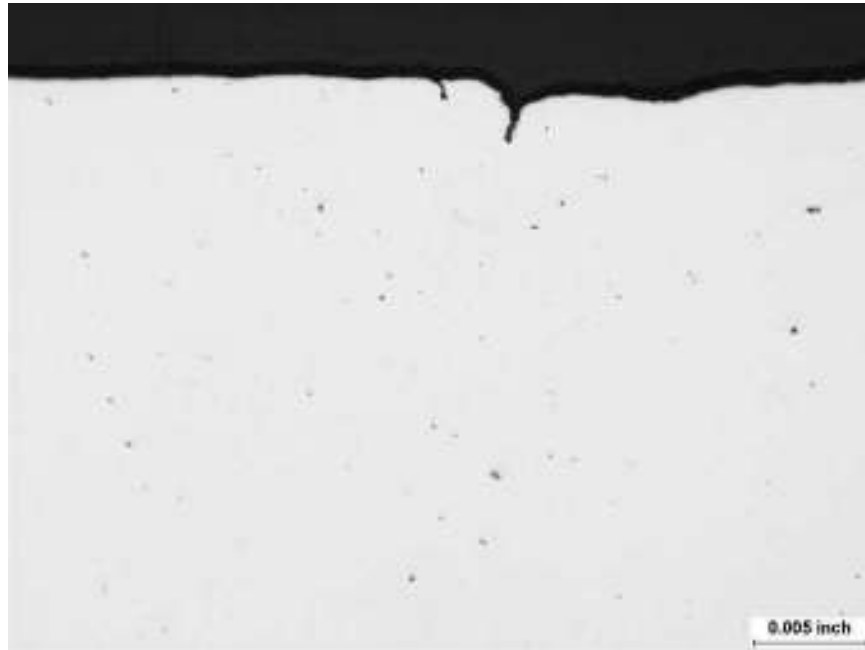
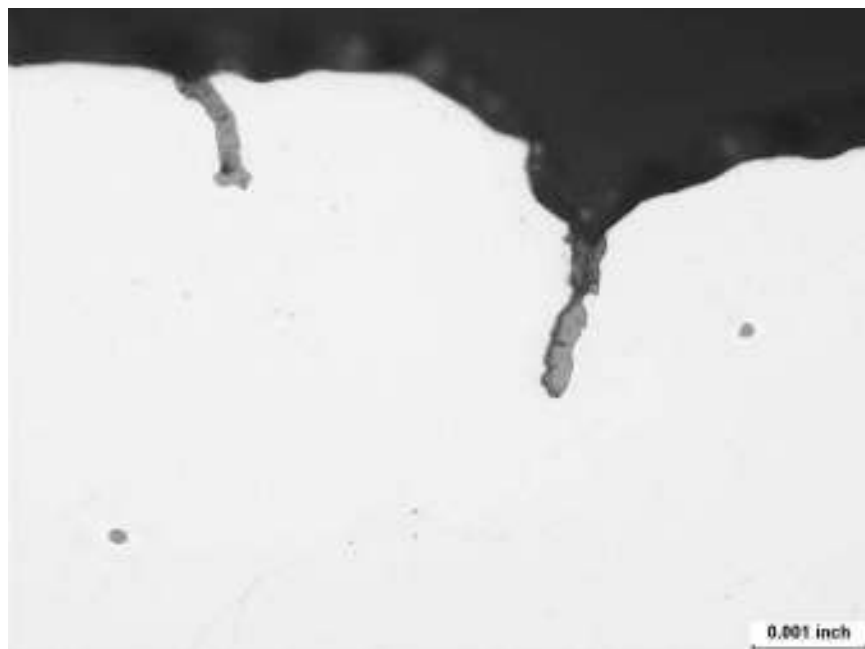
The micrographs display evidence of some oxidation to a shallow depth of 0.0015" in the upset/HAZ.

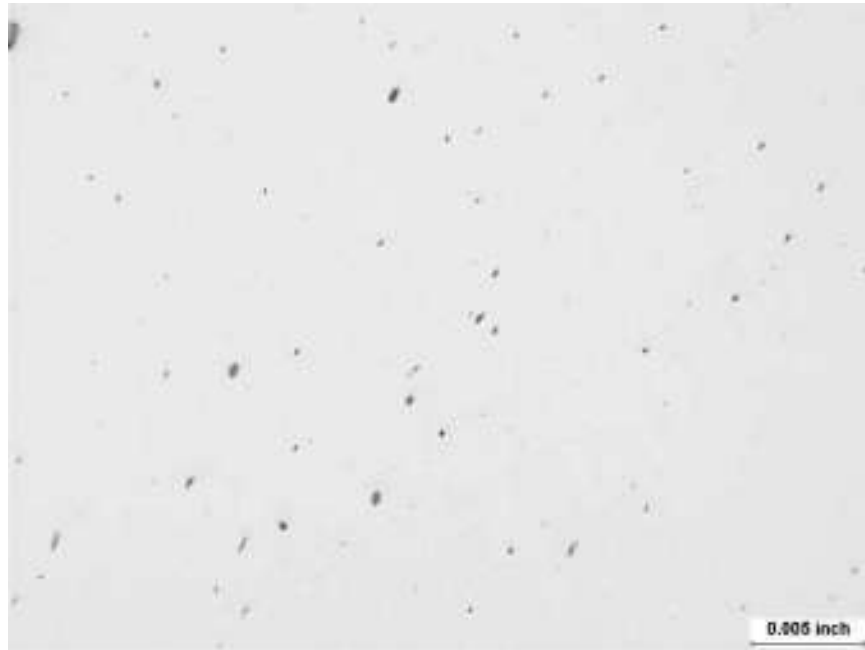
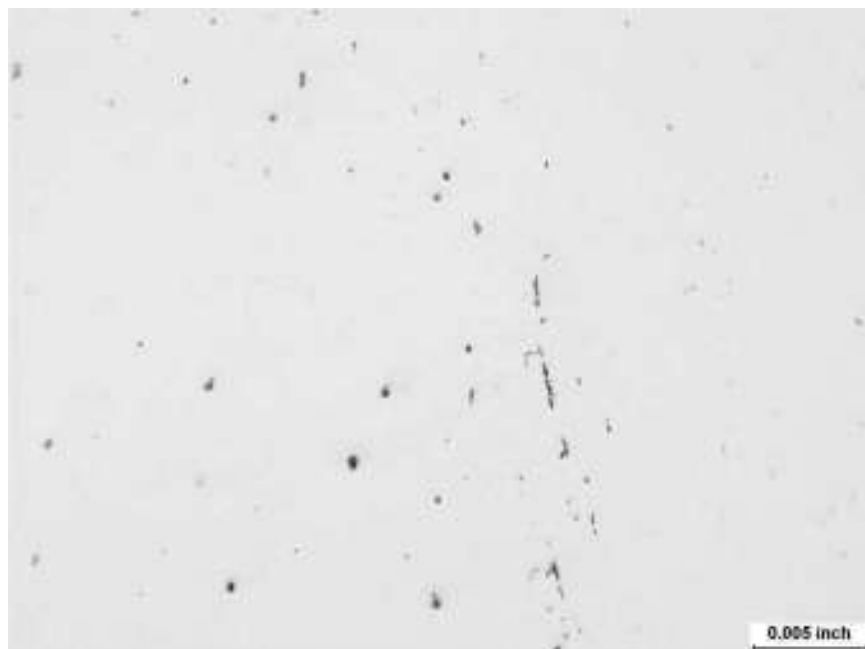
The micrographs display an excessive amount of manganese sulfide inclusions aligned parallel and diagonal to the fusion line in the upset/HAZ near the O.D. of the ERW seam joint.

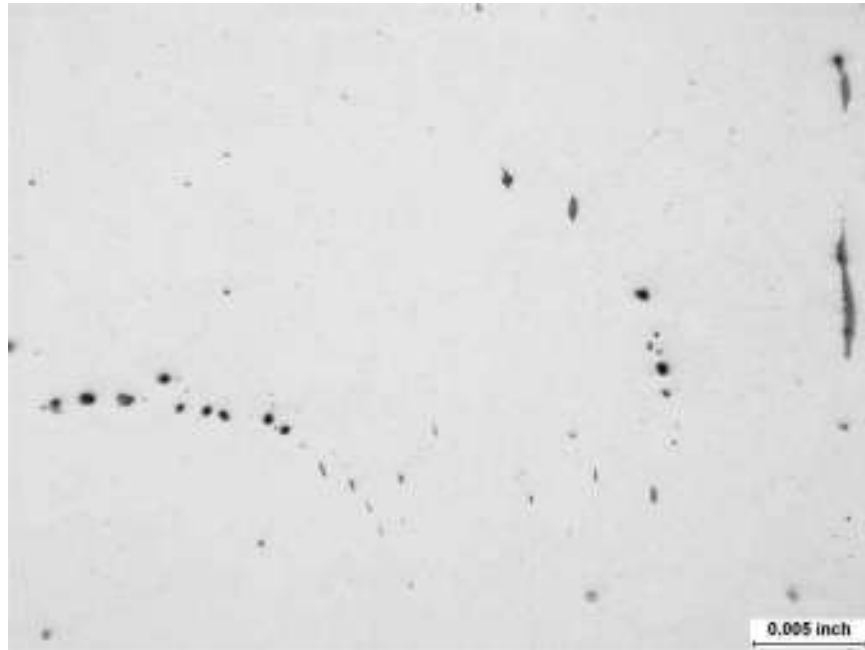
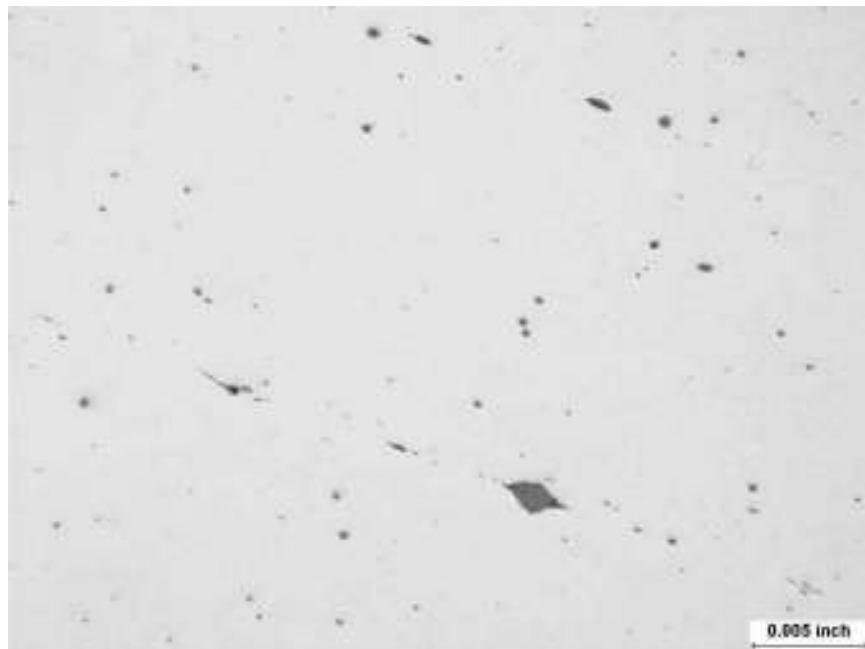
The micrographs display an excessive amount of manganese sulfide inclusions aligned parallel and diagonal to the fusion line in the upset/HAZ near the mid-wall of the ERW seam joint.

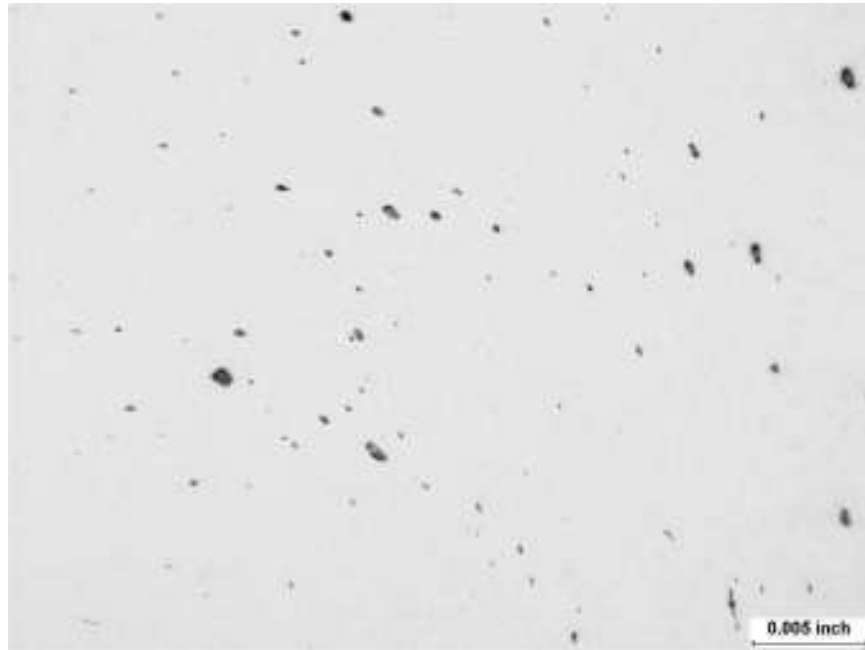
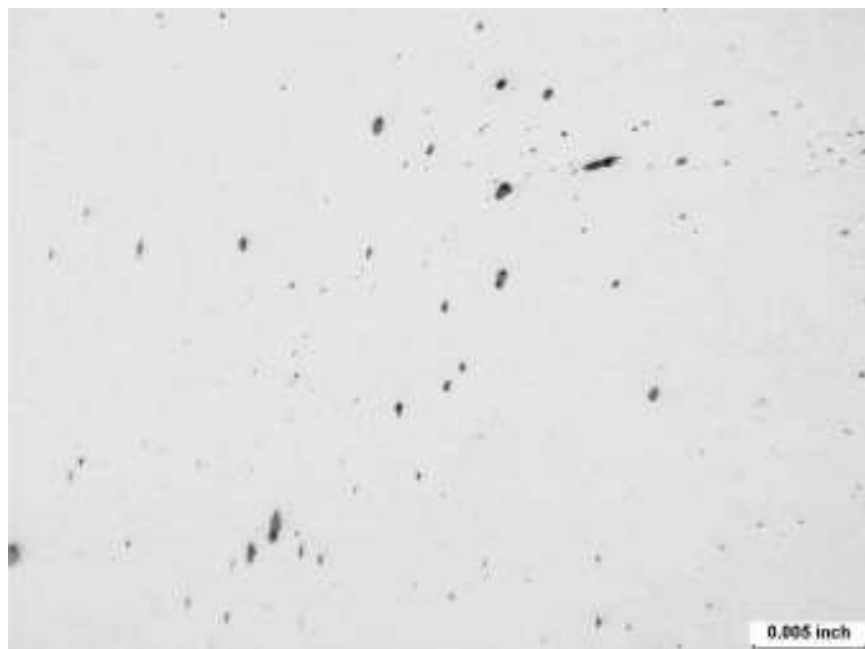
The micrographs display an excessive amount of manganese sulfide inclusions, many of them aligned parallel and diagonal to the fusion line in the upset/HAZ near the I.D. of the ERW seam joint.

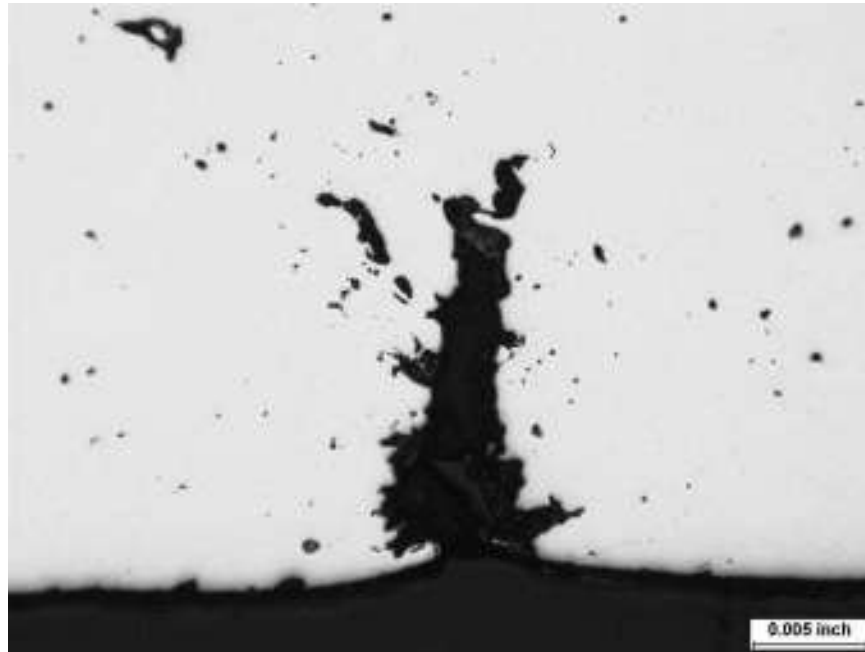
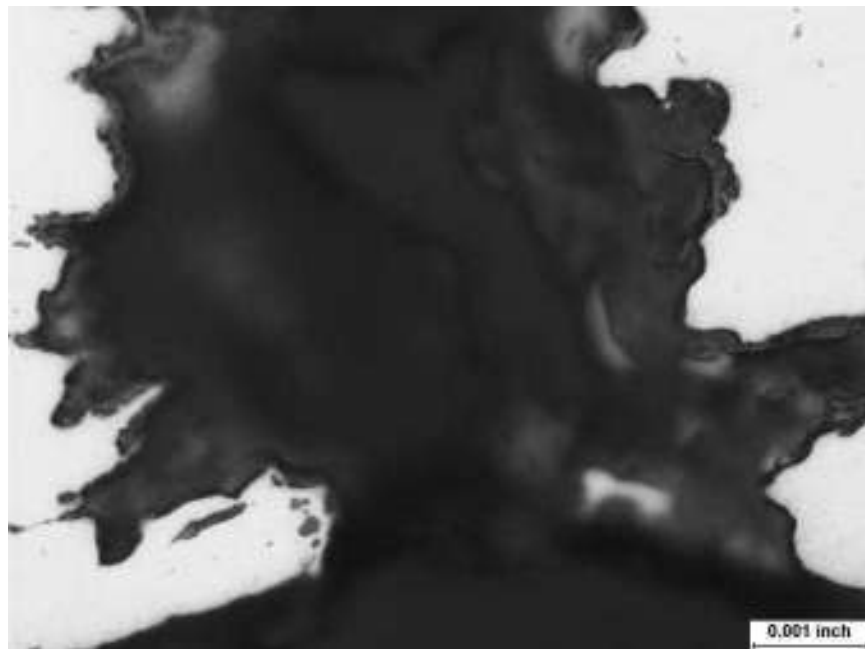
The micrographs display unfused, expelled weld flash near the I.D. of the ERW seam joint.

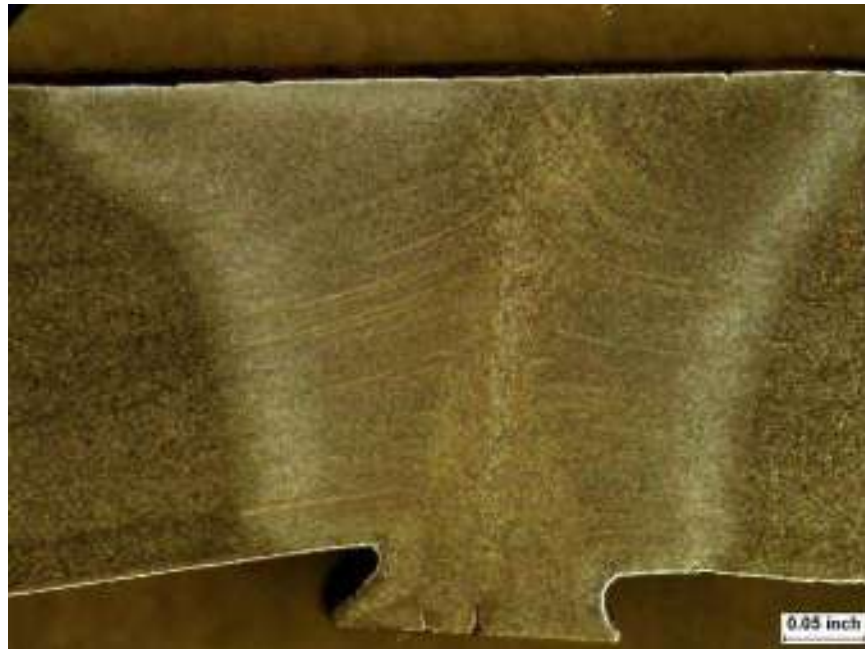
35' 8-1/2" from the North Girth Weld
2% Nital etch, ~20x
Photograph No. 214

The micrograph of the cross-section removed through the intact ERW seam at a distance of 35' 8-1/2" from the north girth weld and prepared for metallographic examination shows upturned as well as downturned bands in the upset/HAZ, with some bands aligned parallel to the fusion line.

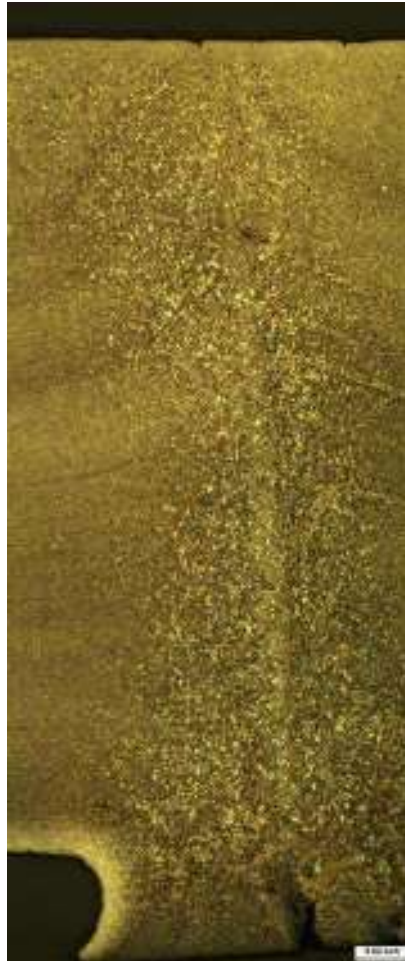
35' 8-1/2" from the North Girth Weld
2% Nital etch, ~25x
Photograph No. 215

The micrograph displays a composite view of the ERW seam cross-section following etching in a 2% Nital solution revealing some upturned grains parallel to the fusion line.

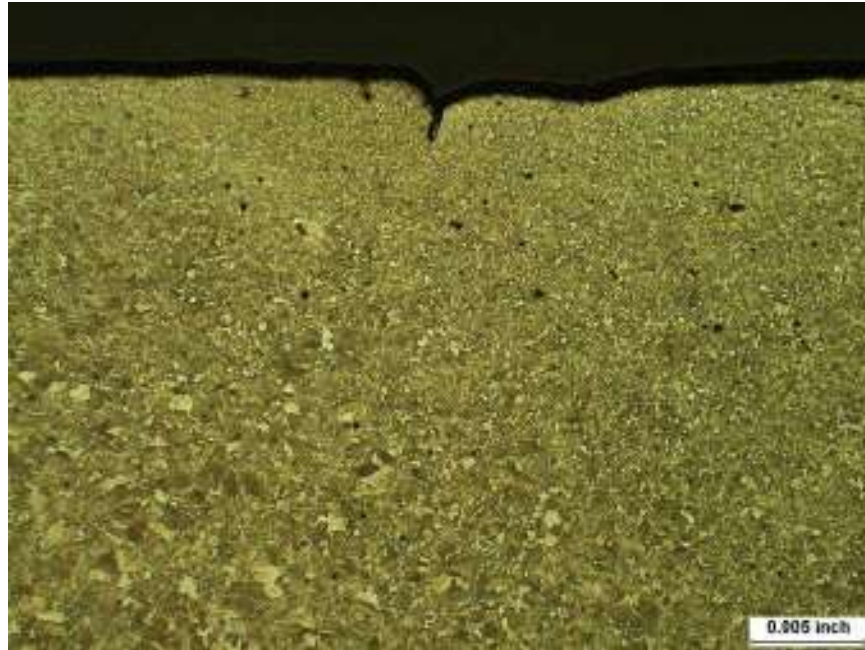
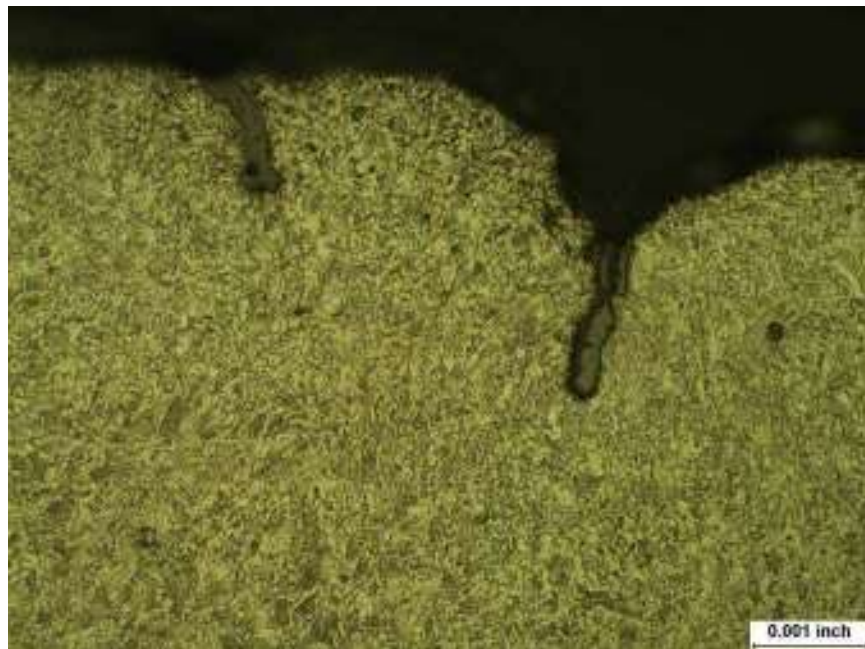
The micrographs display evidence of some oxidation near the O.D. in the upset/HAZ of the ERW seam joint. The microstructure near the O.D. consists of essentially ferrite and pearlite.

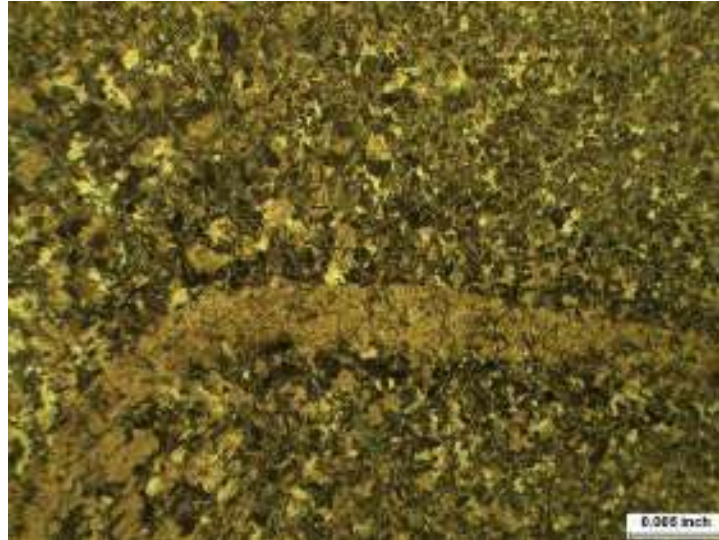
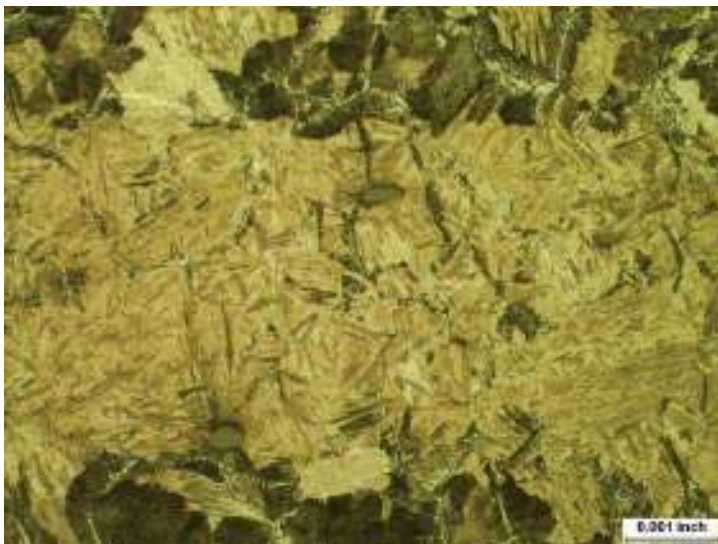
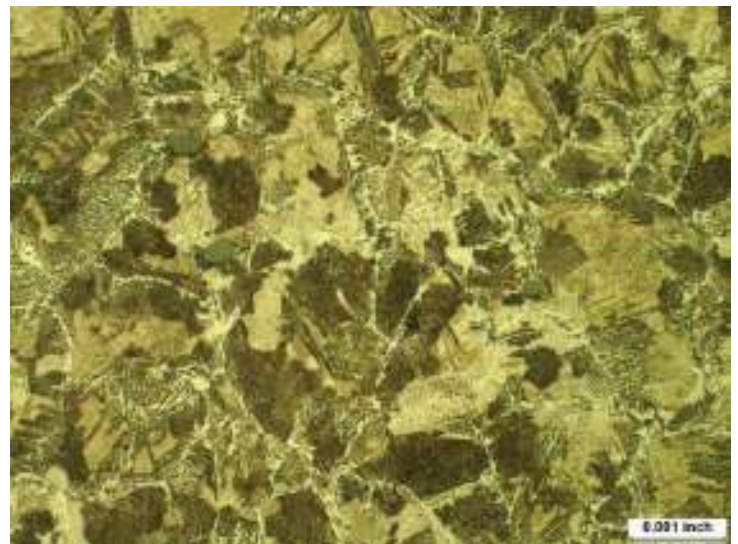
The micrographs display untempered brittle martensite in the bands in the upset/HAZ of the ERW seam joint.

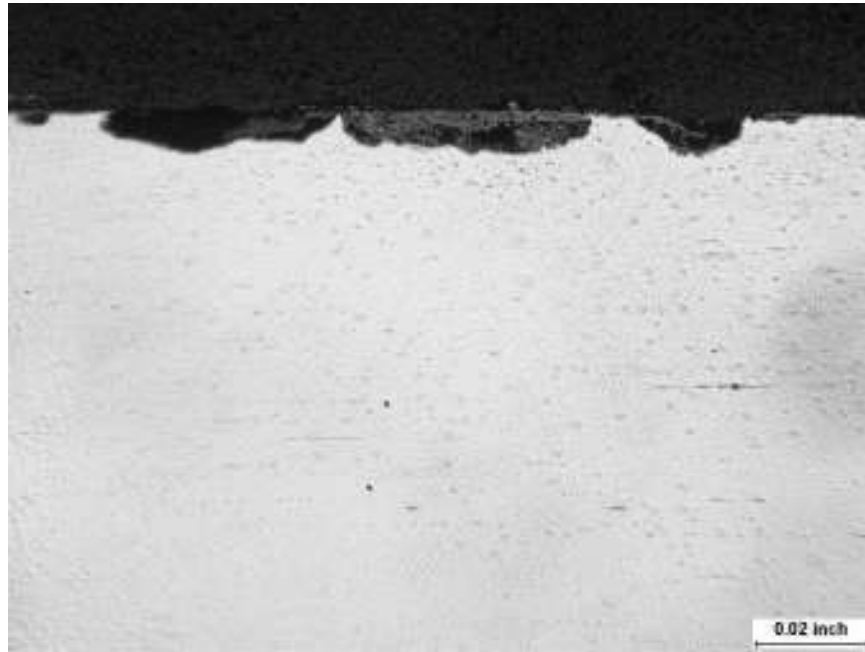
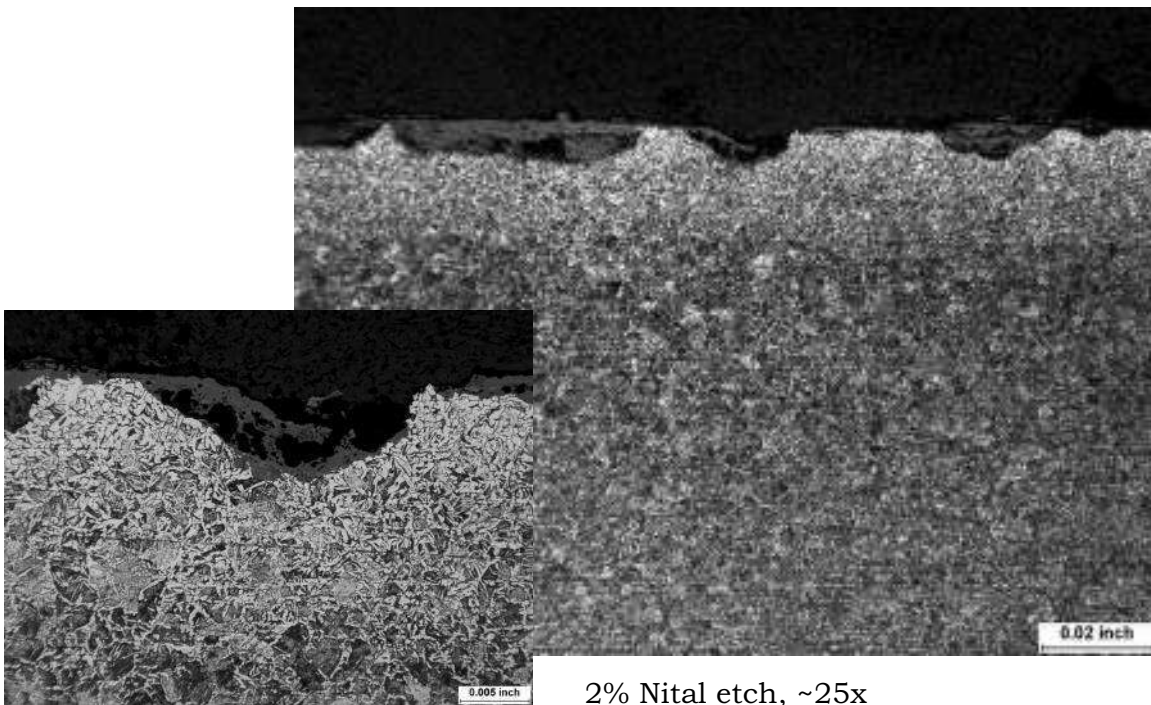
The micrographs display the microstructural condition at a representative area of the O.D. surface of the pipe, showing the loss of material due to pitting corrosion and the corrosion products adhered to the surface. The insert photograph shows a higher magnification view of a single corrosion pit. The maximum depth of the corrosion pits at this location measured 0.008".

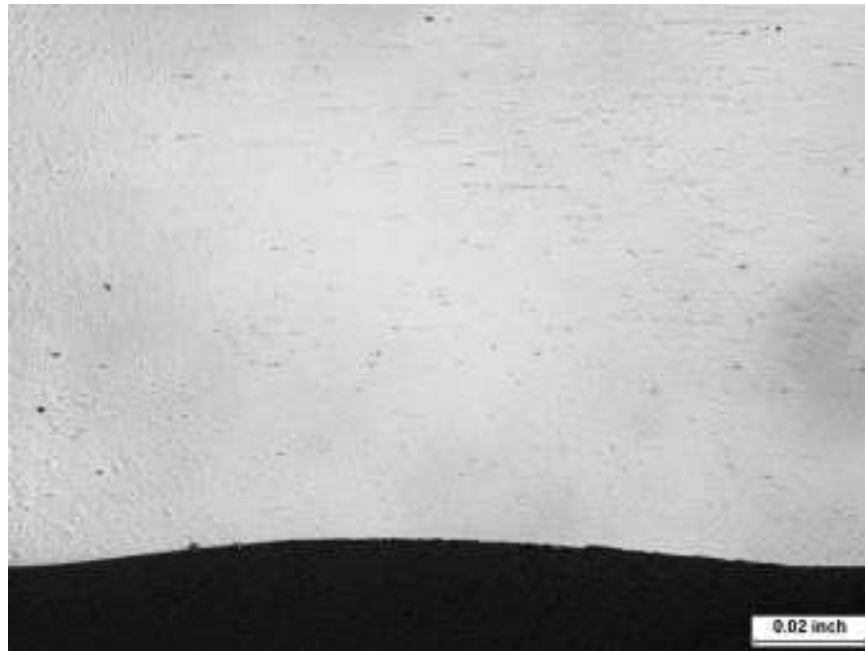
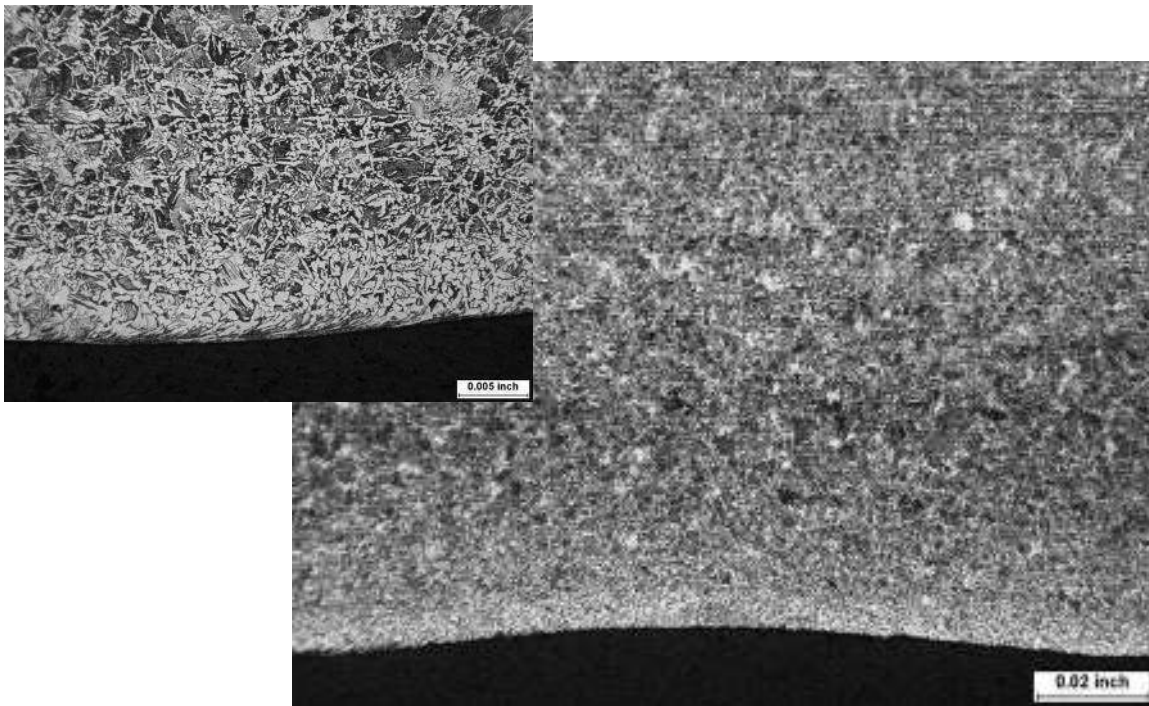
Examination of the I.D. surfaces on the metallographically prepared cross-sections revealed that the shallow depressions were smooth indentations, between 0.137" and 0.189" wide and up to 0.007" deep. The I.D. surface and the surfaces of the indentations were smooth, with no visible oxide scale, and in the etched condition some grain deformation was visible at the edges of the indentations, indicating mechanical damage. However, the thickness of the microstructural band containing partial decarburization on the I.D. surface remained constant, indicating that the impressions occurred most likely during the hot-rolling of the steel or manufacturing of the pipe and not during service. The I.D. surface indentations did not contribute to the pipeline failure. Photographs No. 221 through No. 226 display representative areas of the O.D. and I.D. surfaces on the metallographically prepared longitudinal cross-sections in both the as-polished condition and following etching in a solution of 2% Nital.

The micrographs display the microstructural condition at a representative area of the I.D. surface of the pipe, showing one of the shallow indentations observed during the visual examination. Note the uniform layer of partial decarburization on the I.D. surface and the grain flow deformation shown in the insert photograph, both indicating that the shallow depression is due to a mechanical indentation, most likely when the pipe was manufactured, and not corrosion pitting. The impression measured 0.137" wide and 0.005" deep.

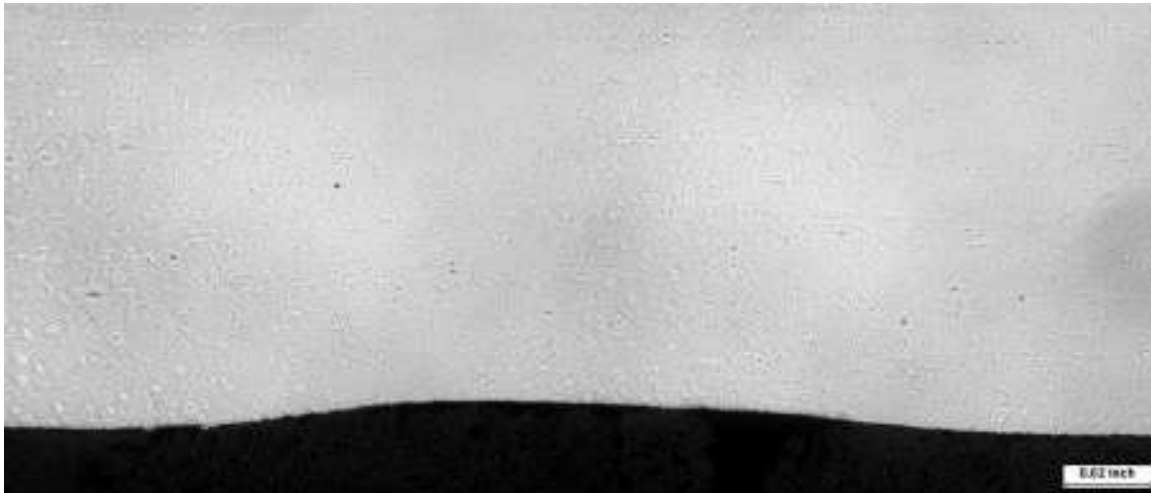
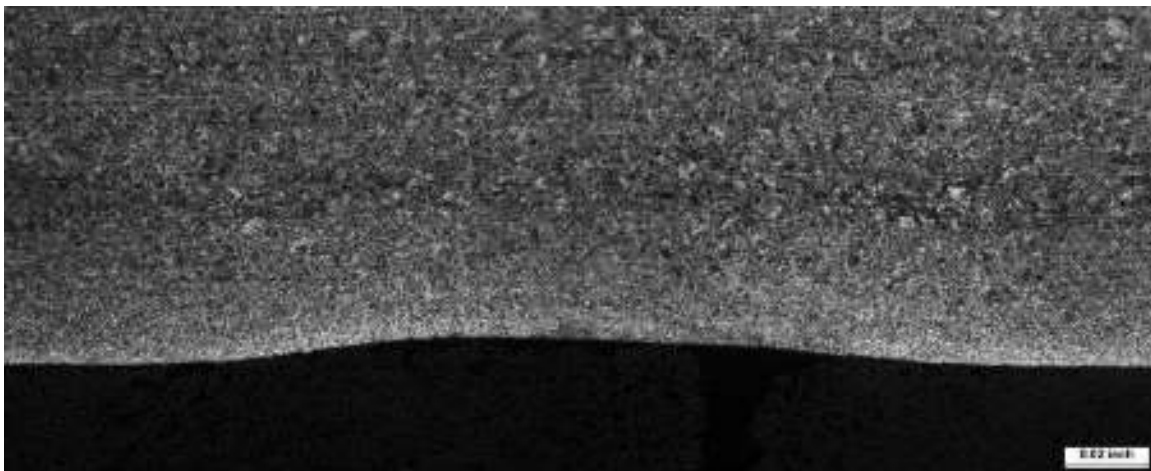
The composite micrographs display the microstructural condition at another representative area of the I.D. surface of the pipe, showing one of the shallow indentations observed during the visual examination. Note the uniform layer of partial decarburization on the I.D. surface, indicating that the shallow depression is due to a mechanical indentation, most likely when the pipe was manufactured, and not corrosion pitting. The impression measured 0.189" wide and 0.007" deep.

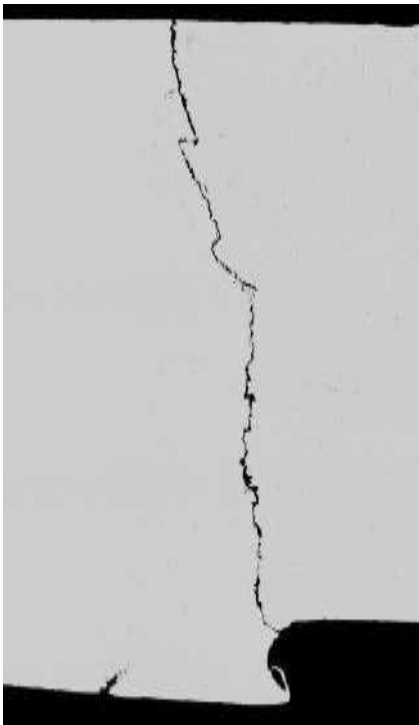
Distance from the North Gird Weld	Hook Crack Width			Hook Crack Depth
	Minimum	Average	Maximum	
20' 3-3/4"	0.0008"	0.0013"	0.0023"	0.145"
20' 4-7/8"	0.0018"	0.0028"	0.0038"	0.145"
20' 5-1/2"	0.0006"	0.0016"	0.0031"	0.133"

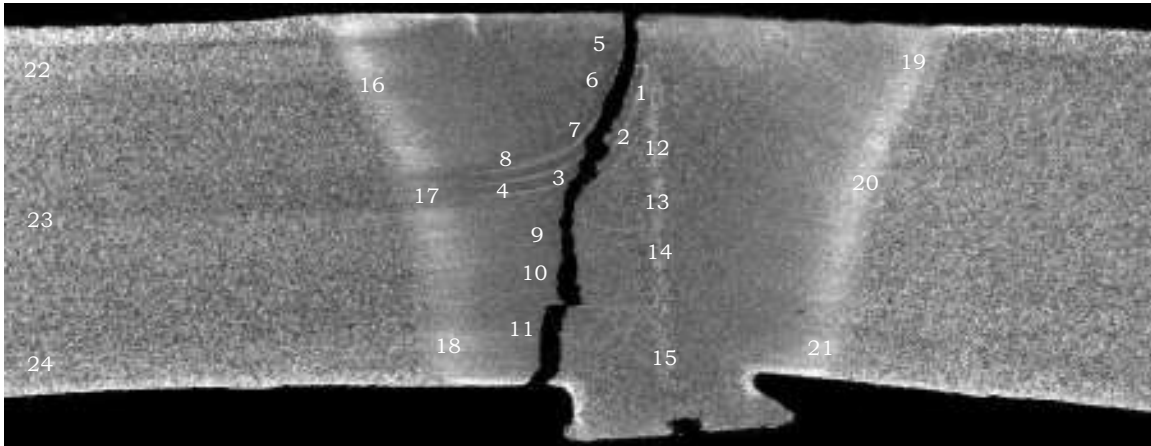
33' 11-1/2" long Fractured Section of a 20" O.D. x 0.312" wall Pipe; Removed from Milepost 314.77 in the Conway to Corsicana Pegasus Crude Oil Pipeline after it Failed in Service in Mayflower, Arkansas; Installed in 1947 to 1948; Test Location: 20' 4-7/8" from the North Girth Weld

Indentation Number	Test Location	Hardness, HV500g	Conversion to Rockwell Scale	Indentation Number	Test Location	Hardness, HV500g	Conversion to Rockwell Scale	
1	Hardened	549	52 HRC	12	ERW Fusion Line	408	42 HRC	
2	Upturned	560	53 HRC	13		492	49 HRC	
3	Martensitic Grains	574	54 HRC	14		399	41 HRC	
4		509	50 HRC	15		335	34 HRC	
5		279	27 HRC	16	Secondary HAZ	225	97 HRB	
6	Hook	285	28 HRC	17		240	20 HRC	
7	Crack(s)	308	31 HRC	18		226	98 HRB	
8		295	29 HRC	19		248	22 HRC	
9	Final	280	27 HRC	20		240	100 HRB	
10	Fracture	298	29 HRC	21		240	100 HRB	
11	(Primary HAZ)	280	27 HRC	22		Base Metal	206	94 HRB
				23			228	98 HRB
				24	218		96 HRB

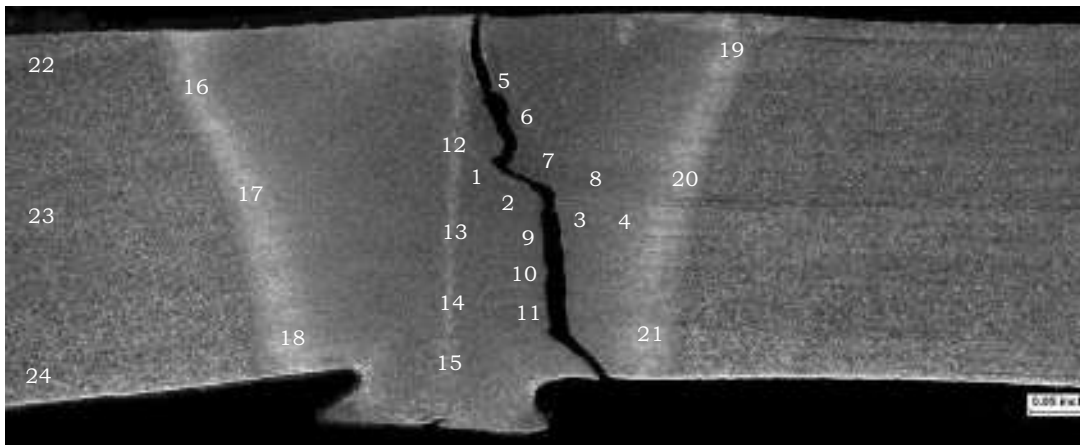
33' 11-1/2" long Fractured Section of a 20" O.D. x 0.312" wall Pipe; Removed from Milepost 314.77 in the Conway to Corsicana Pegasus Crude Oil Pipeline after it Failed in Service in Mayflower, Arkansas; Installed in 1947 to 1948; Test Location: 20' 6-13/16" from the North Girth Weld

Indentation Number	Test Location	Hardness, HV500g	Conversion to Rockwell Scale	Indentation Number	Test Location	Hardness, HV500g	Conversion to Rockwell Scale	
1	Hardened	483	48 HRC	12	ERW Fusion Line	303	30 HRC	
2	Upturned	483	48 HRC	13		342	35 HRC	
3	Martensitic Grains	499	49 HRC	14		330	33 HRC	
4		502	49 HRC	15		299	30 HRC	
5		281	27 HRC	16	Secondary HAZ	255	23 HRC	
6	Hook	293	29 HRC	17		231	98 HRB	
7	Crack(s)	310	31 HRC	18		246	22 HRC	
8		297	29 HRC	19		233	99 HRB	
9	Final	338	34 HRC	20		258	24 HRC	
10	Fracture	265	25 HRC	21		231	98 HRB	
11	(Primary HAZ)	298	29 HRC	22		Base Metal	223	97 HRB
				23			250	22 HRC
				24	237		100 HRB

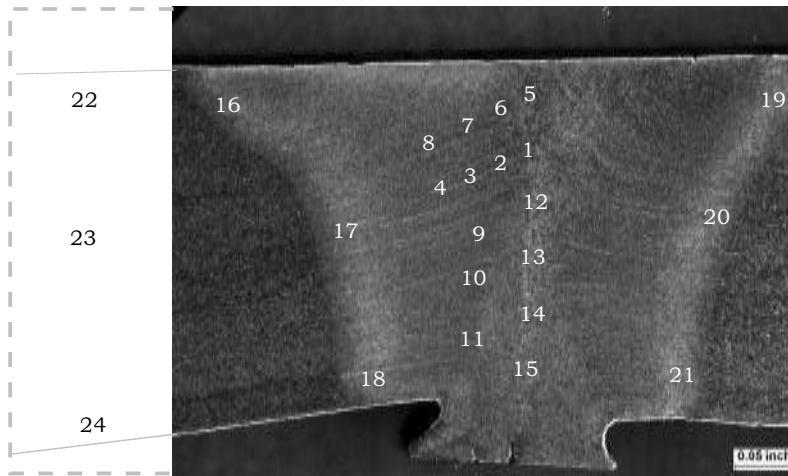
19' 10" long Intact Section of a 20" O.D. x 0.312" wall Pipe; Removed from Milepost 314.77 in the Conway to Corsicana Pegasus Crude Oil Pipeline after it Failed in Service in Mayflower, Arkansas; Installed in 1947 to 1948; Test Location: 35' 8-1/2" from the North Girth Weld

Indentation Number	Test Location	Hardness, HV500g	Conversion to Rockwell Scale	Indentation Number	Test Location	Hardness, HV500g	Conversion to Rockwell Scale	
1	Hardened	580	54 HRC	12	ERW Fusion Line	334	34 HRC	
2	Upturned	586	54 HRC	13		295	29 HRC	
3	Martensitic Grains	391	40 HRC	14		374	38 HRC	
4		444	45 HRC	15	516	50 HRC		
5	Primary HAZ	256	23 HRC	16	Secondary HAZ	237	100 HRB	
6		253	23 HRC	17		241	21 HRC	
7		276	27 HRC	18		228	98 HRB	
8		269	26 HRC	19		253	23 HRC	
9		283	28 HRC	20		234	99 HRB	
10		241	21 HRC	21		219	97 HRB	
11		254	23 HRC	22		Base Metal	232	99 HRB
				23			231	99 HRB
				24			249	22 HRC

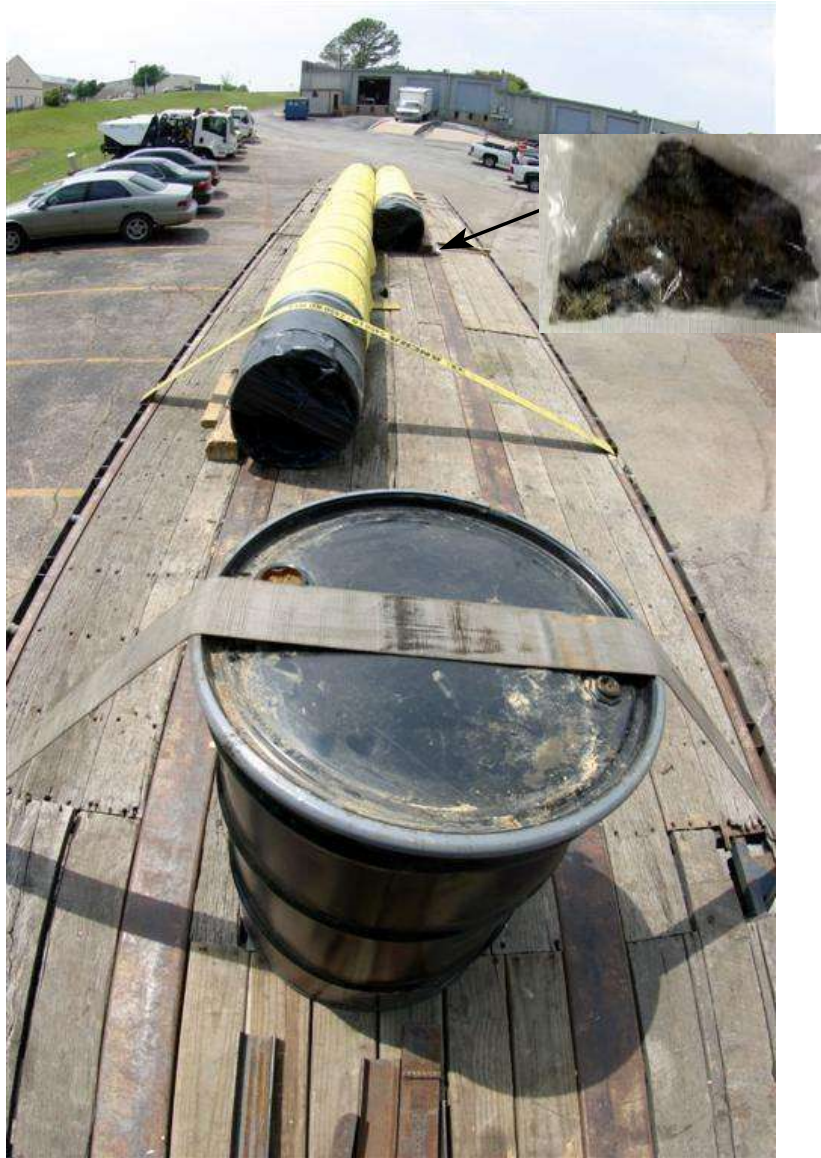
The photograph displays the pipe section, a drum containing the coating material that was removed in the field prior to sectioning of the cracked pipe and a bag containing possible calcareous deposit.
