*METALLURGICAL INVESTIGATION OF A
FRACTURED SECTION OF THE 20" O.D.
PIPELINE AT MILEPOST 314.77 IN THE
CONWAY TO CORSICANA SEGMENT OF
THE PEGASUS CRUDE OIL PIPELINE*

REPORT NO. 64961, REV. 1

Prepared for
ExxonMobil Pipeline Company and the
Pipeline and Hazardous Materials Safety Administration
pursuant to Corrective Action Order CPF 4-2013-5006H

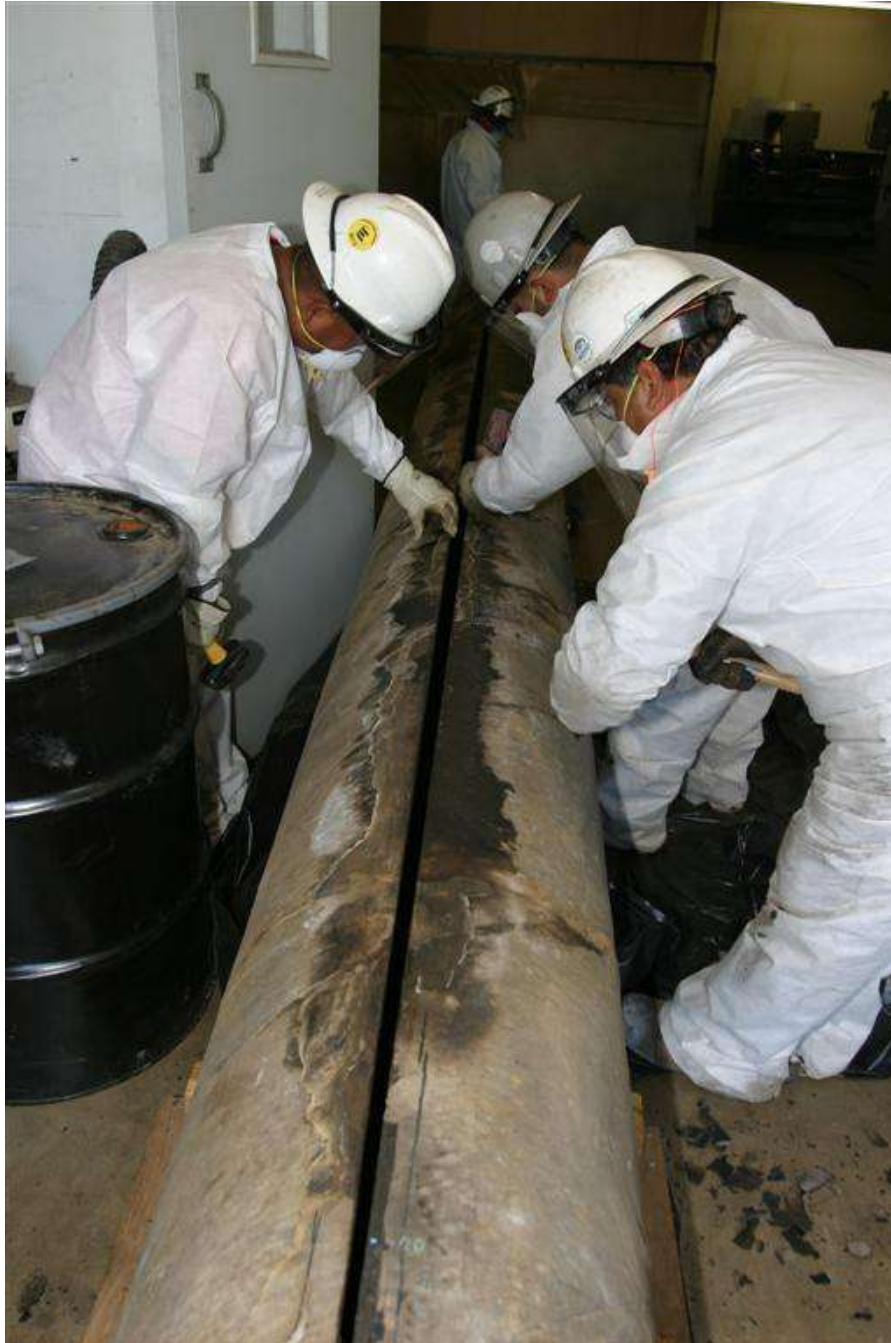
The photograph displays the careful hand removal process of the coating adjacent to the crack.

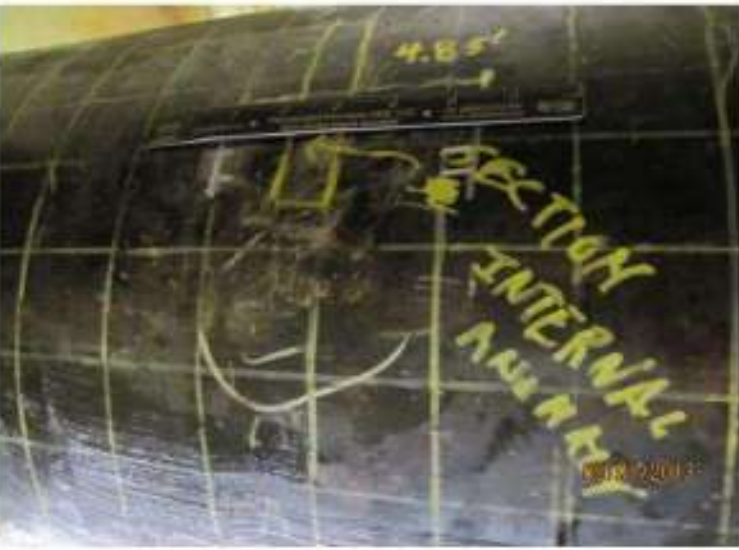
Description of photograph Anomaly 1 Area Marked on Pipe for Sectioning	
Date of Exam	Technician	Certification(s)	
5/1/2013	Jeff Hecht	Lvl III

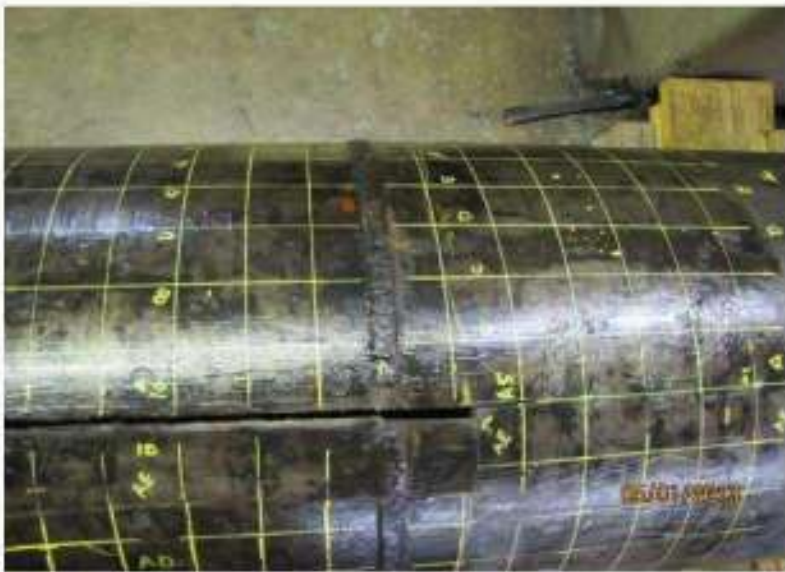
<small>PIPELINE INSPECTION TECHNOLOGIES</small>	ExxonMobil Pipeline Inline Inspection Tool Correlation NDE Report GE (PIITFI) / Run Date: July 2012	US Reference: 16310 + 25.62ft Distance to US Reference: 4501.09 ODO to Primary Anomaly: 81627.98	ODO to U/S GW: 81602.14 Dig #: 12 Upstream Girth Weld #: 17290
	 		<p>Description of photograph</p> <p>Gridded Pipe looking upstream (pipe gridded 12" downstream of rupture).</p>

<p>Description of photograph</p> <p>Downstream Girthweld End of pipe (pipe gridded 12" upstream of girthweld)</p>	
Date of Exam 4/28/2013 to 5/1/2013	Technician Jeff Hecht	Certification(s) Level III

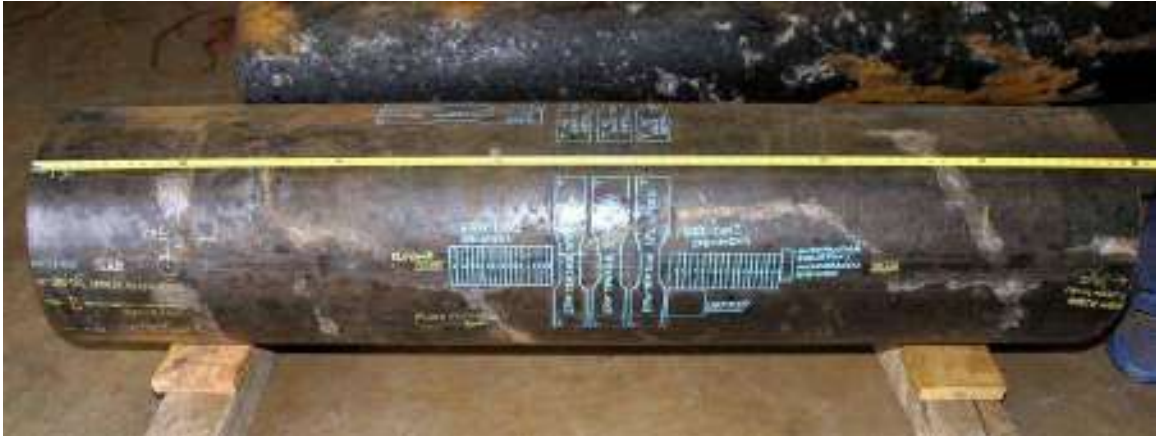
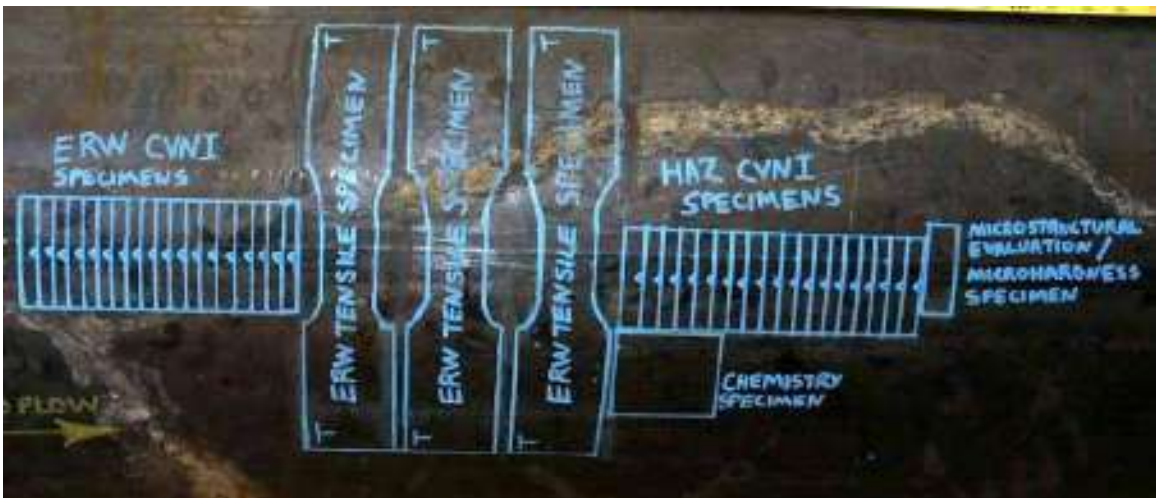
The photographs display an overall view of the area along the ERW seam on the intact 19' 10" long section of the pipe, and a closer view of the area where the ERW seam test specimens were removed from.

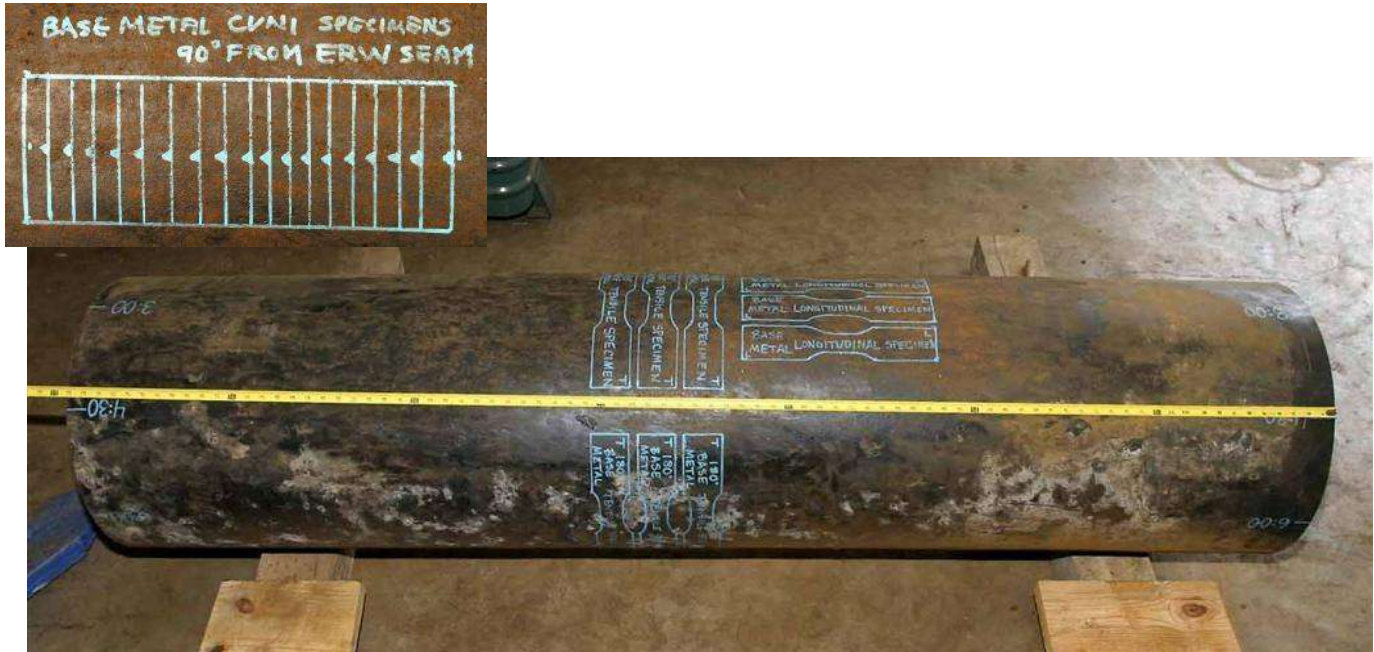
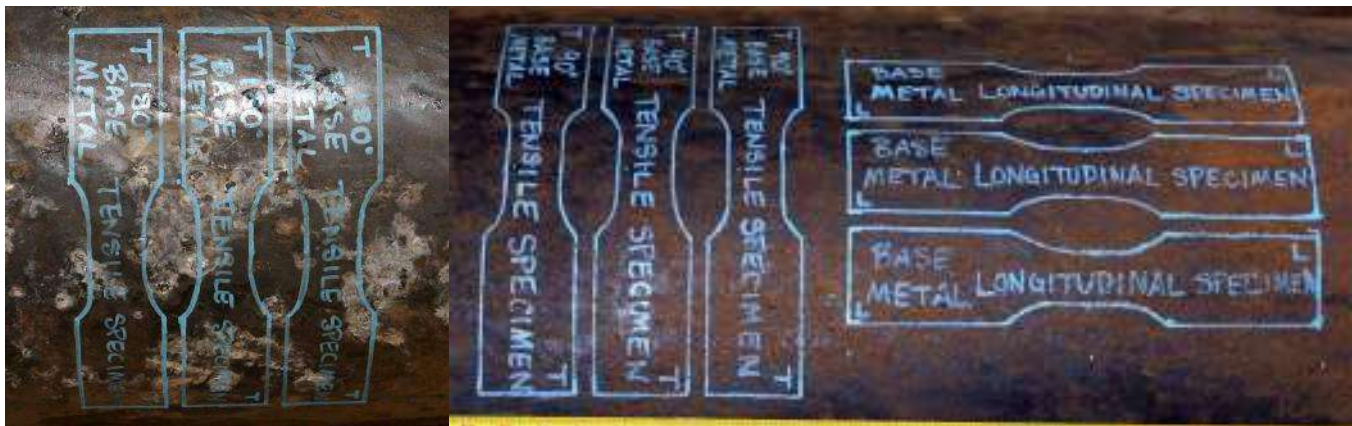
The photographs display an overall view of the area opposite the ERW seam on the intact 19' 10" long section of the pipe, showing where the longitudinal and transverse base metal test specimens were removed from. The insert photograph shows the location of the base metal CVN impact test specimens.

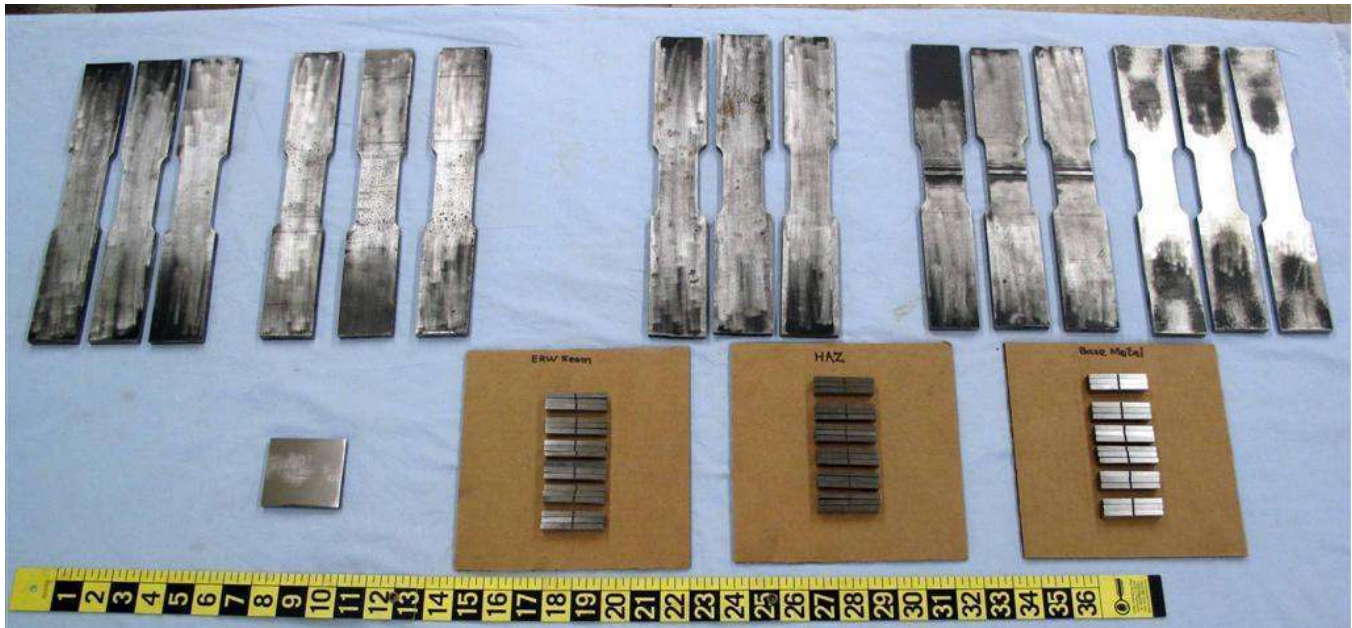
The photograph displays the test specimens that were removed from the intact 19' 10" long section of pipe, after machining and prior to testing. The various test specimens were machined and tested in accordance with ASTM A370-12a and the applicable sections of each edition of API 5L.

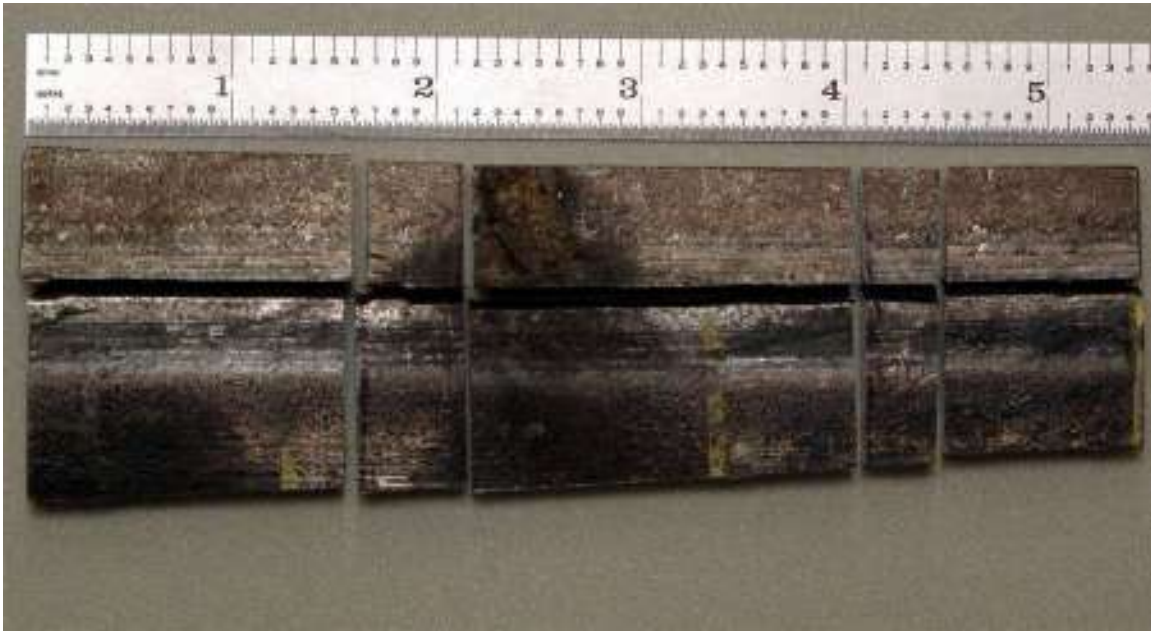
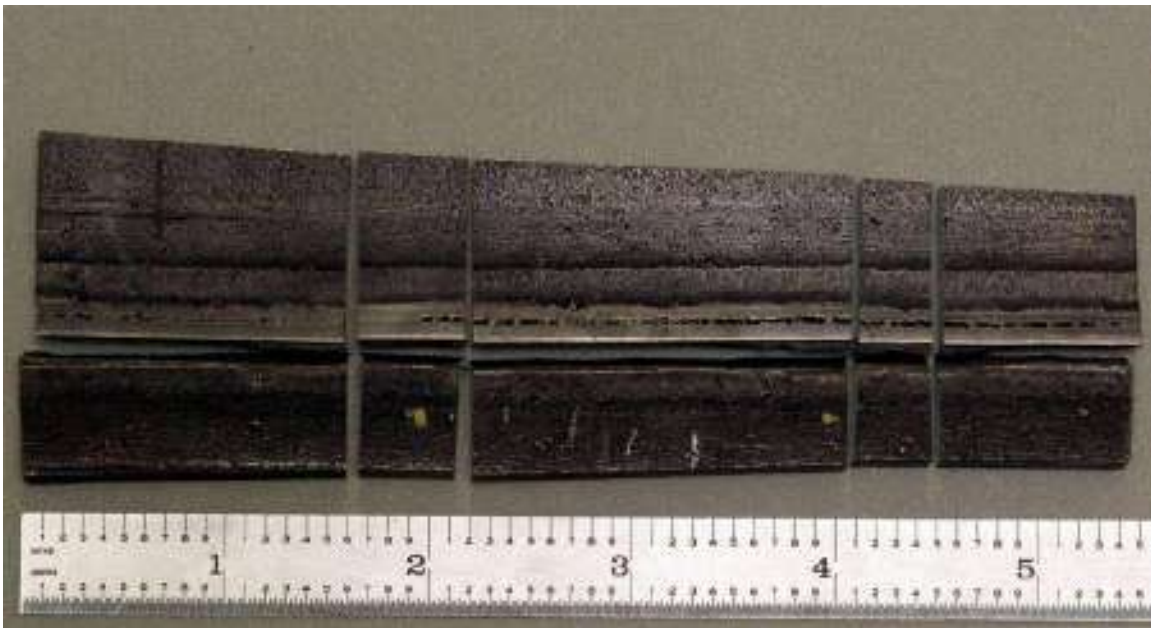
The photographs display the O.D. and I.D. surface, respectively, at the locations where the cross-sections were removed through the fractured area of the ERW seam and metallographically prepared for microstructural evaluation.
