**CCW IMPOUNDMENTS
INSPECTION REPORT**

**DAN RIVER STEAM STATION
ROCKINGHAM COUNTY,
NORTH CAROLINA**

**PROJECT No. 09-4157
SEPTEMBER 2009**

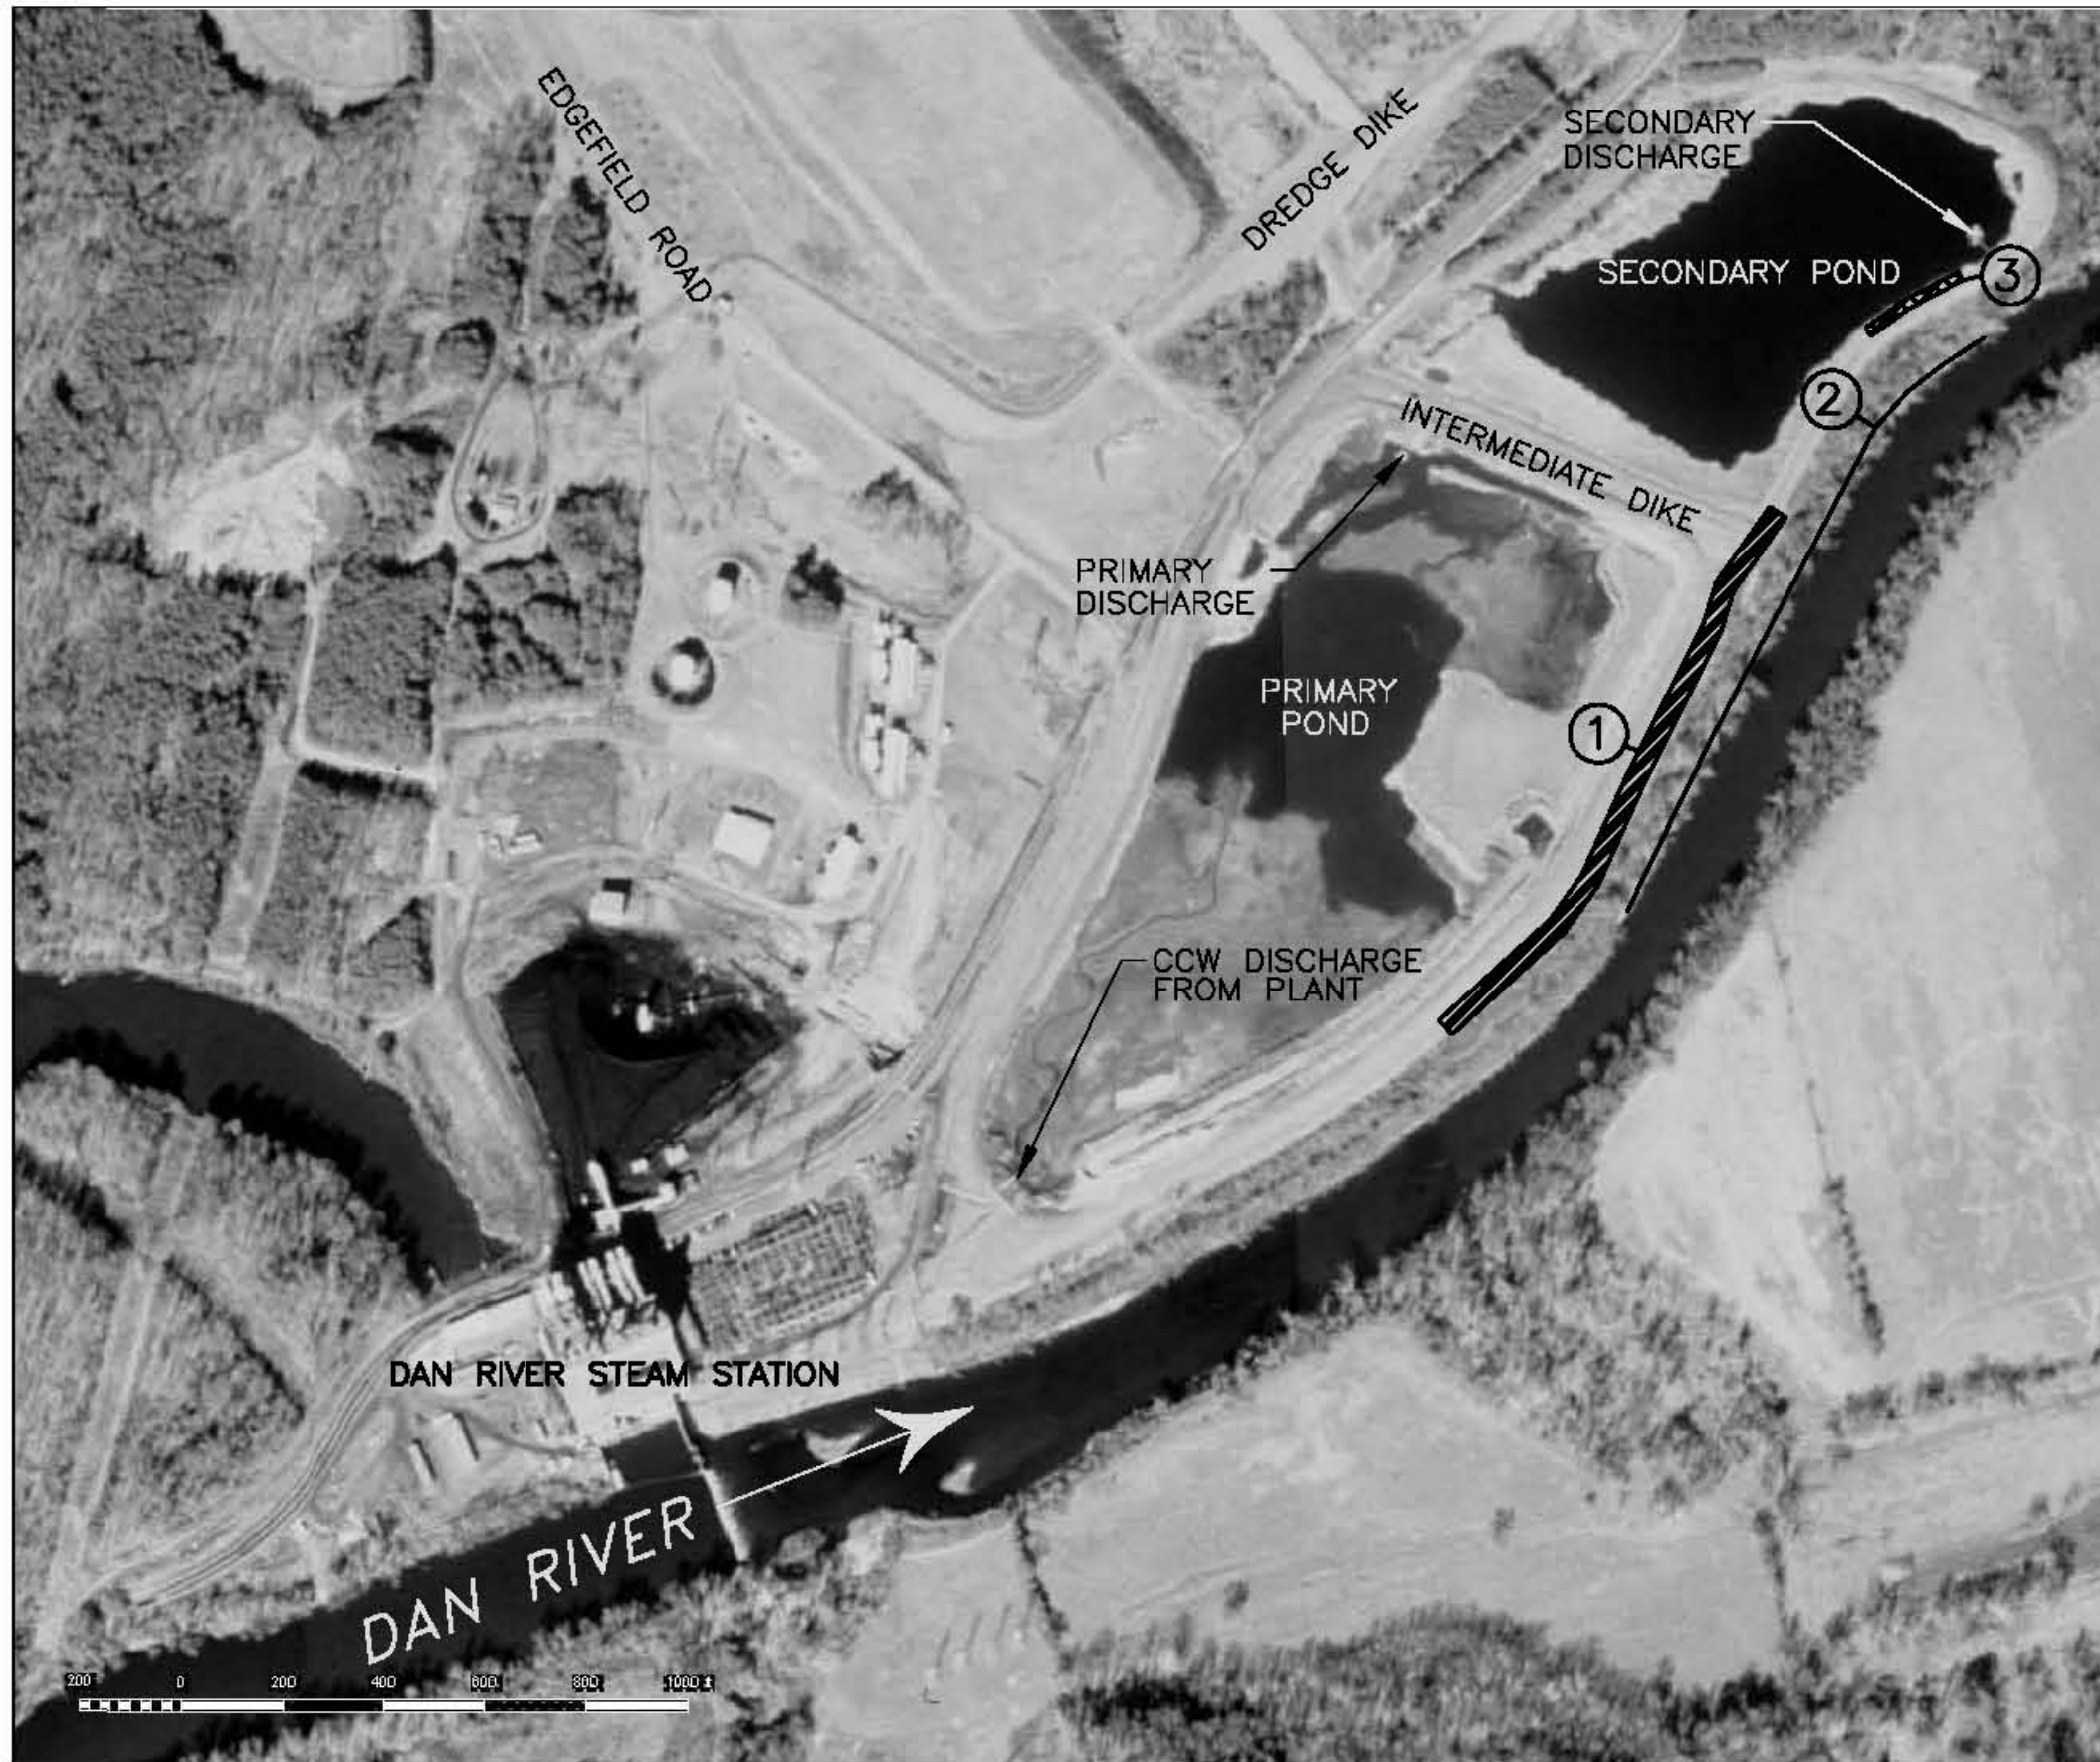
- ① SEEPAGE ZONE ALONG SOUTHERN EMBANKMENT. NUMEROUS SURFICIAL SLIDES AND LOW VOLUME SEEPAGE.
- ② ZONE OF RIVER BANK EROSION. MONUMENTS IN PLACE ALONG RIVERBANK TO MONITOR LOSS OF MATERIAL.
- ③ ANIMAL BURROWS NOTED DURING INSPECTION.

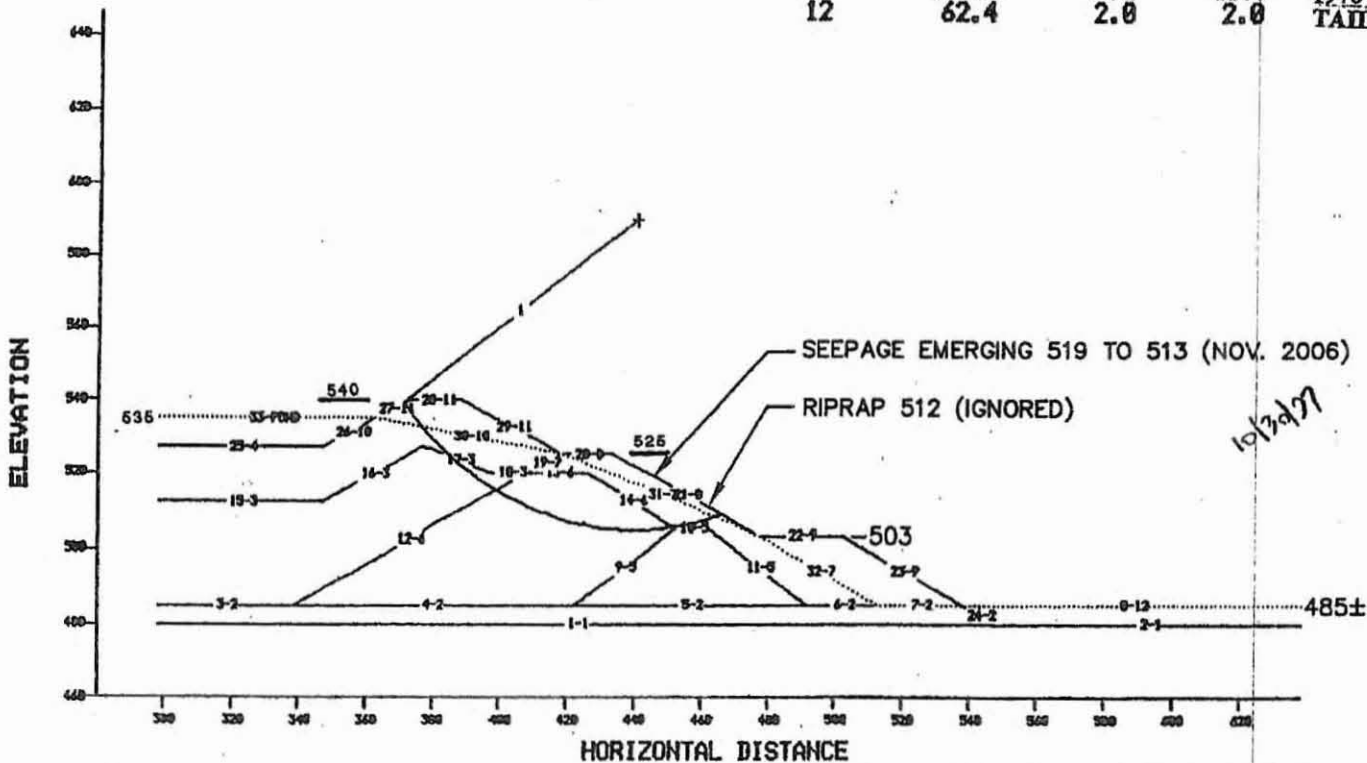
The 1997 analysis on Figure 8 showed a safety factor of 1.45 for deep failure surfaces in the downstream embankment, down from greater than 1.50 safety factor on comparable surfaces in the 1984-1985 analyses.

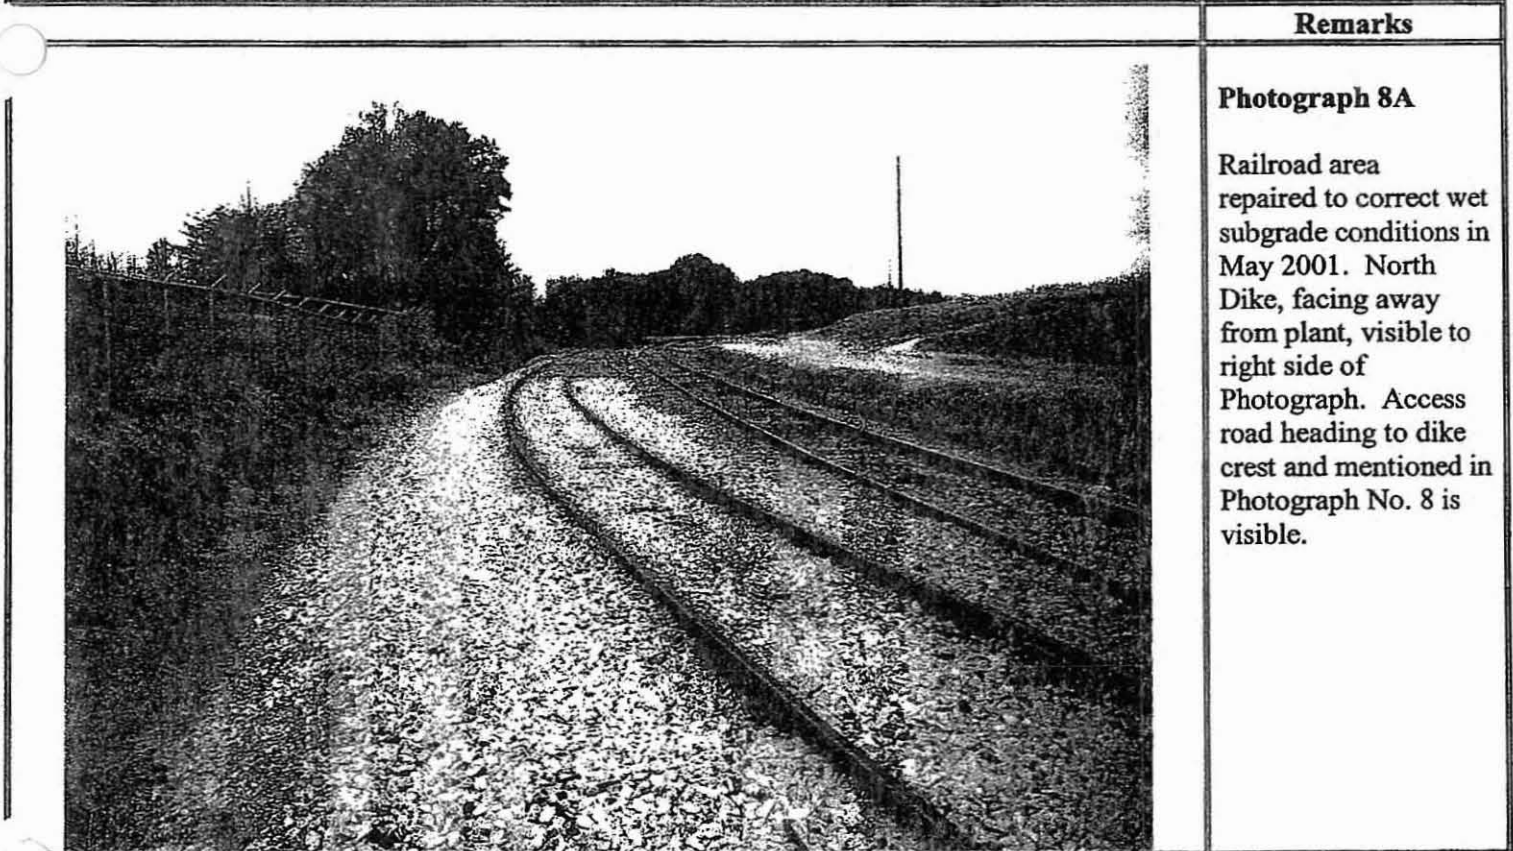
Photograph 8A

1. Monthly monitoring of basin level and piezometer/observation wells should be continued. *
2. The former wet area in the slope above the access road (see caption of Photograph 8) should be visually monitored. The railroad subgrade repair undertaken in May 2001 appeared to have dried up this area, but it has now apparently returned. *X

Railroad area repaired to correct wet subgrade conditions in May 2001. North Dike, facing away from plant, visible to right side of Photograph. Access road heading to dike crest and mentioned in Photograph No. 8 is visible.

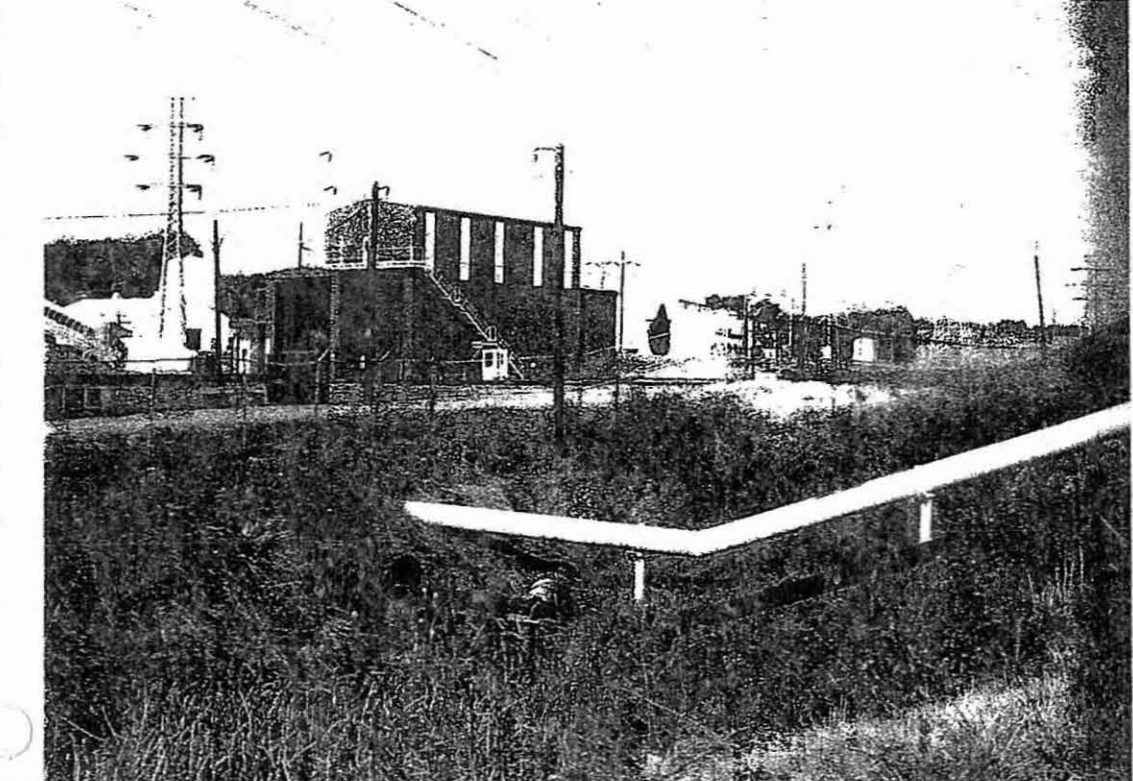
<p>Photograph 14</p> <p>Valley between access road and toe of dike.</p>

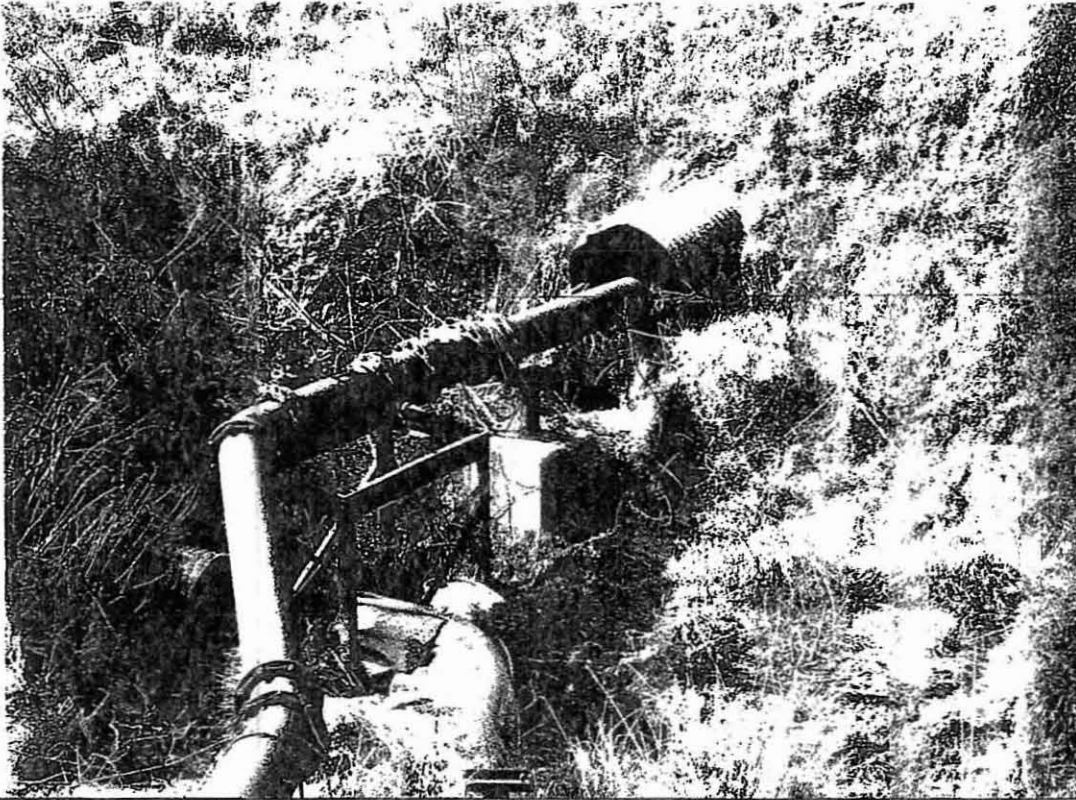
Photograph 15

Valley facing west.
Piping may have been
realigned at bottom of
picture since 2001.

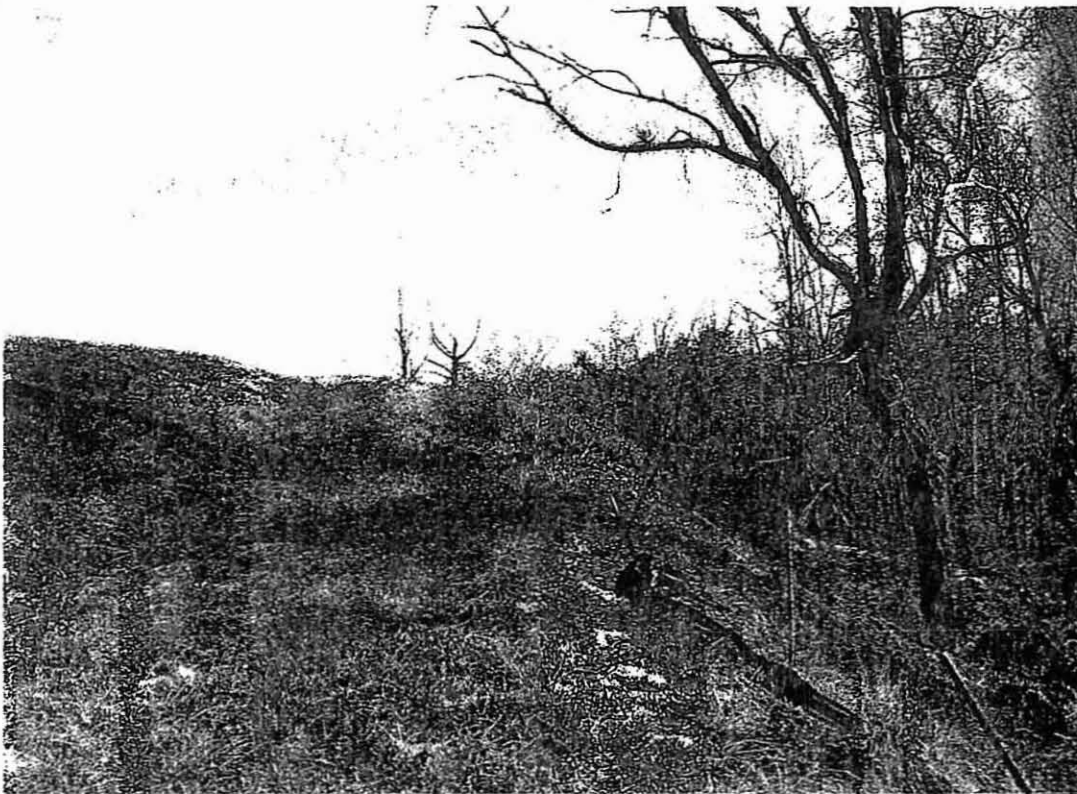
Photograph 16

Downstream slope of
southern section of
primary basin adjacent
to Dan River. No
groundhog burrows
observed in this area.

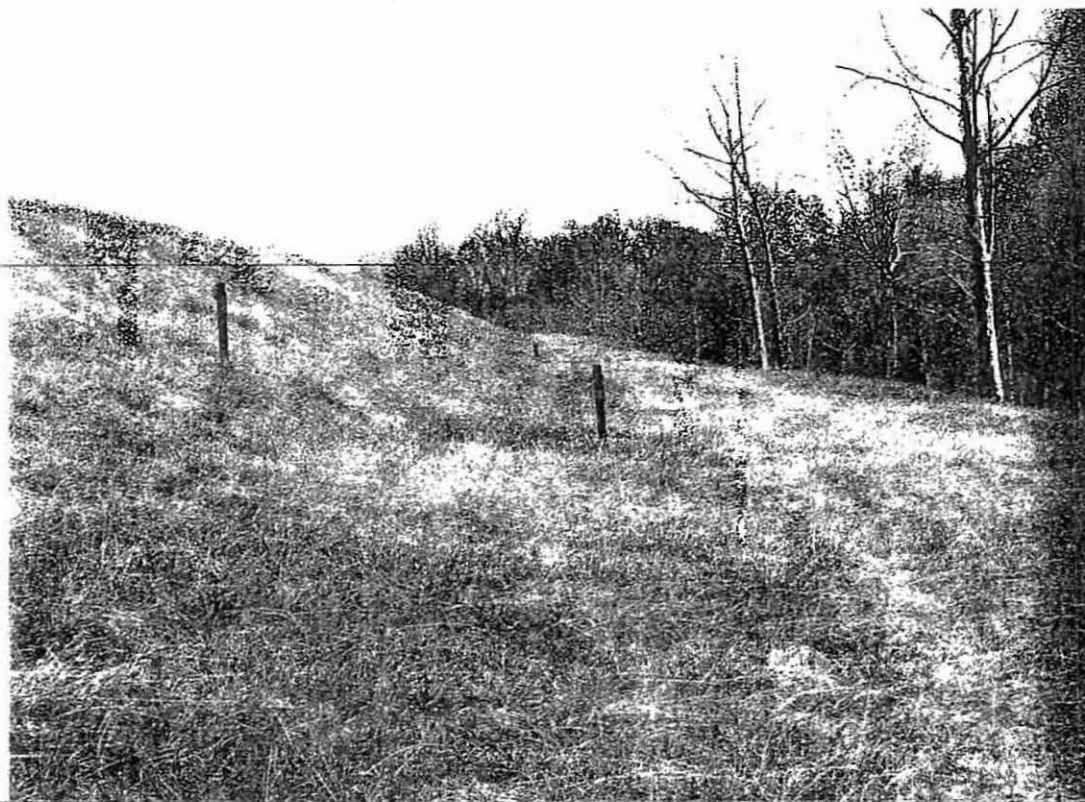
Photograph 17

Downstream slope of primary basin dike adjacent to Dan River.

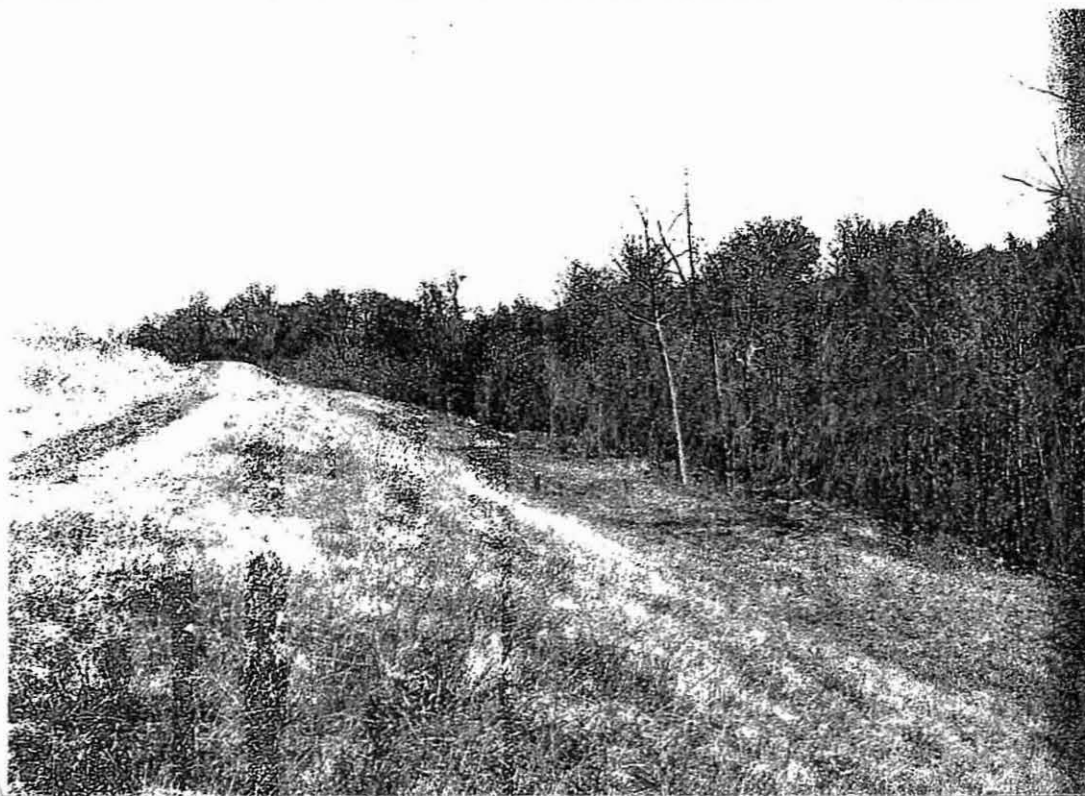
Photograph 18

Crest of southern embankment for primary ash basin.

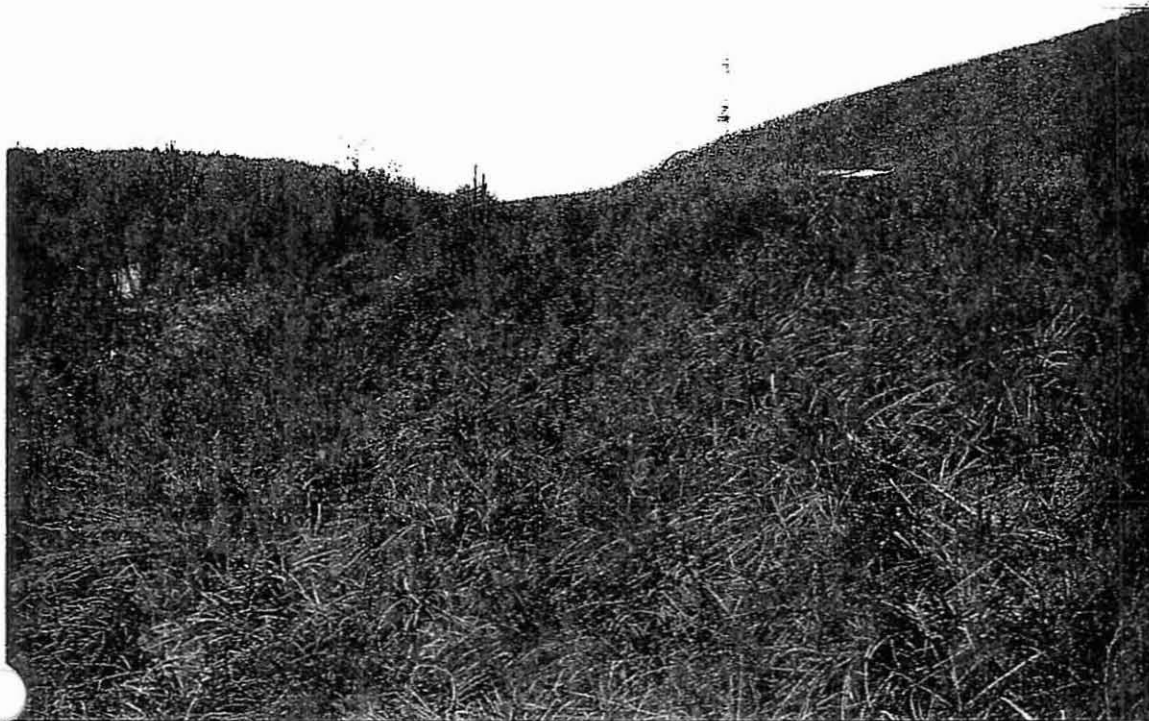
Vicinity of Photograph 19A, 19B	Slump has moved since 2001.

5. The slump in the slope below the elevation 525 berm on the southern embankment of the primary ash basin. (See Photographs 19A and 19B) facing the river has shown continued movement, along with seepage on the slope. This fresh movement and appearance of seepage in this slump and elsewhere along this slope are cause for an engineering investigation, including a soil test boring made on the elevation 525 berm for SPT and UD soil samples for laboratory testing and fitted with piezometers and/or an observation well. Also, we specifically recommend two additional borings with undisturbed samples for lab testing and installation of observation wells be performed on the 525 berm at seepage areas located about 80 ft south and 240 ft south of Piezometer No. 2. *

Slump in slope below elevation 525 berm looking S-SW. Slump has moved since 2001.

Photograph Nos. 16, 17, 18, 19, 20, and 21 provide views of the crest and downstream slopes for the primary basin dike, adjacent to the Dan River. Groundhog burrows, observed on the downstream slope near Photograph 16 in 2001, were not evident in 2006. A good grass cover exists over this dike above the rip rap. Signs of instability were observed; the shallow slump visible in 2001 Photograph 19A and 19B below the elevation 525 berm has moved since 2001. Observation of this locality should be continued in future routine and annual inspections to see if it continues to enlarge. The slump is located approximately 150 ft east of the slight bend in the dike alignment visible in Photograph 19. There is also new seepage emerging on the slope in this area since 2001, below the 525 berm. In the vicinity of Photograph No. 21, there is a significant seep about midway between the rip rap (512) and the 525 berm. About 80 ft south of piezometer 2, shown in Photograph No. 21 in a direction toward the photographer's position, there is a 4 ft diameter by 1.5 ft deep depression at the top of the rip rap (which is at about elevation 512, as depicted on sections on Figure 4). About 240 ft south of piezometer 2, behind the photographer's location in Photograph No. 21, there is a wet area at and above the top of the rip rap with a slump in the rip rap. About 360 feet south of piezometer 2, there is a low place in the 525 berm and a wet slope above the rip rap. As discussed later in the Recommendations section 7.2 of this report, geotechnical exploratory work is recommended to evaluate the wet slump area in Photographs 19A and 19B and described above.

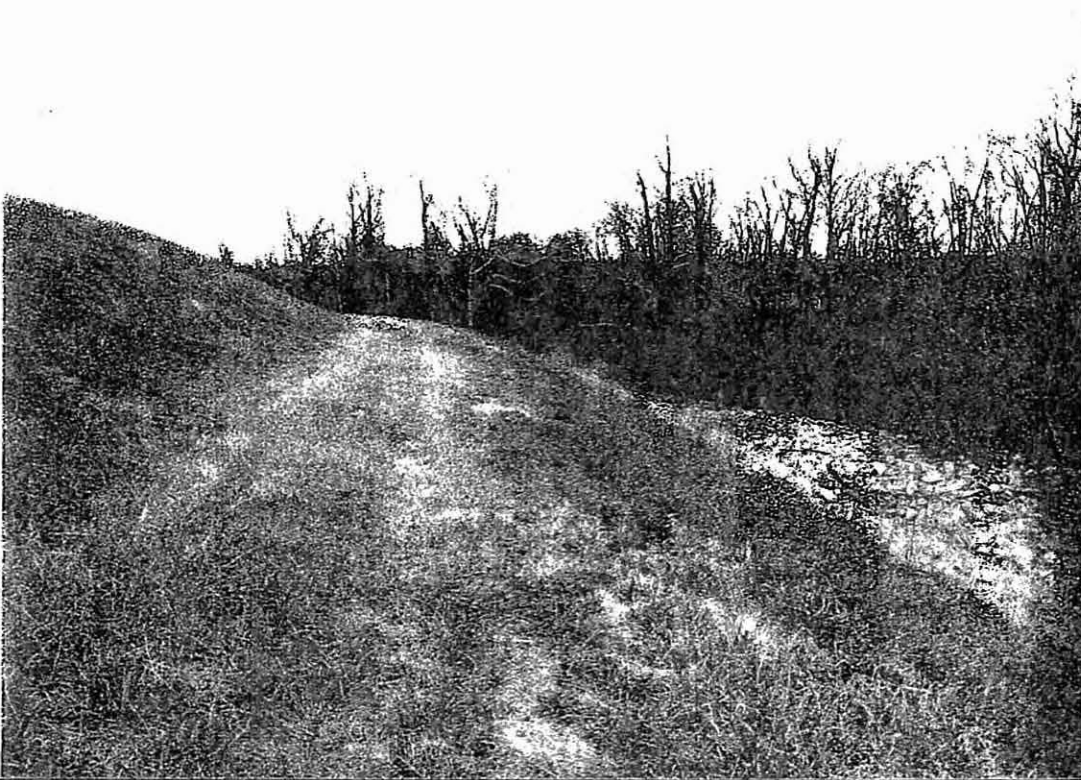
<p>Photograph 20</p> <p>Downstream slope of primary basin facing N-NE adjacent to Dan River. Photographer was standing approximately 900 ft south of piezometer P-2.</p>

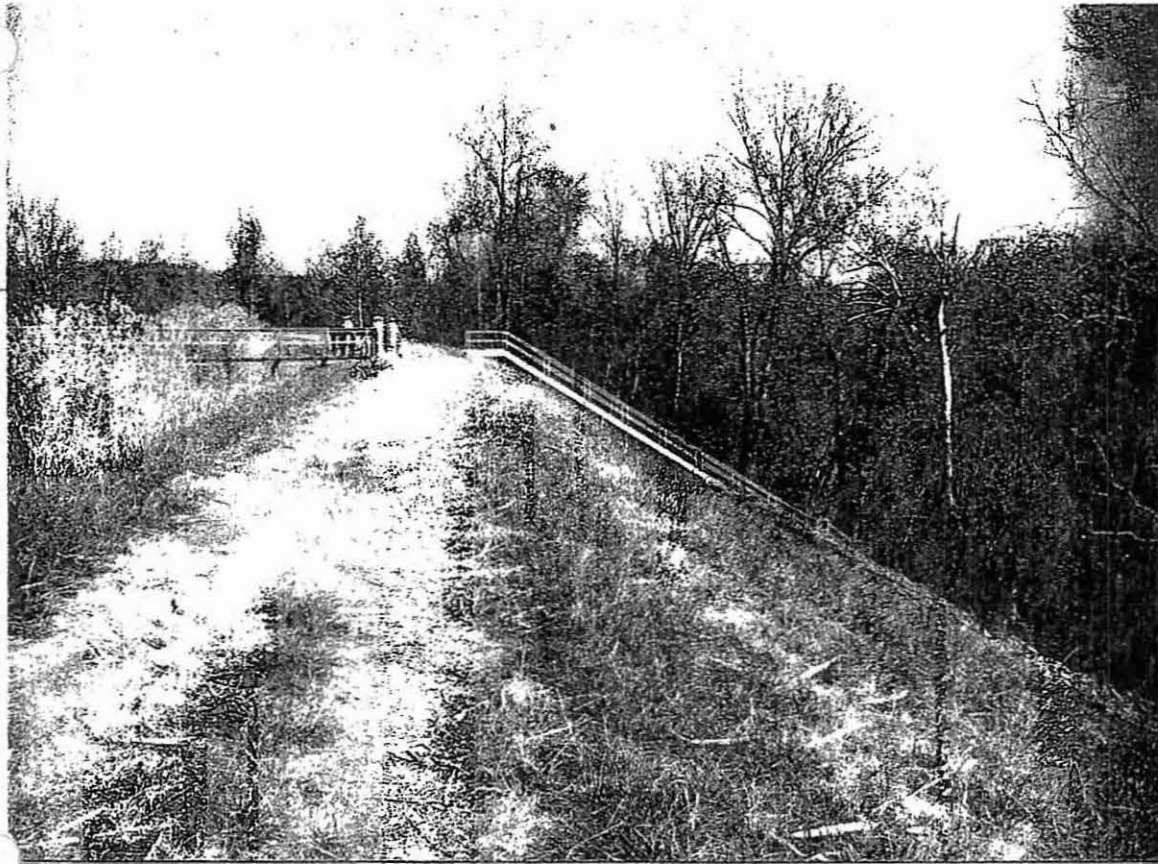
Photograph 23

Crest and downstream slope of secondary basin adjacent to Dan River. Steps leading to secondary basin pipe outfall have been replaced since 2001.

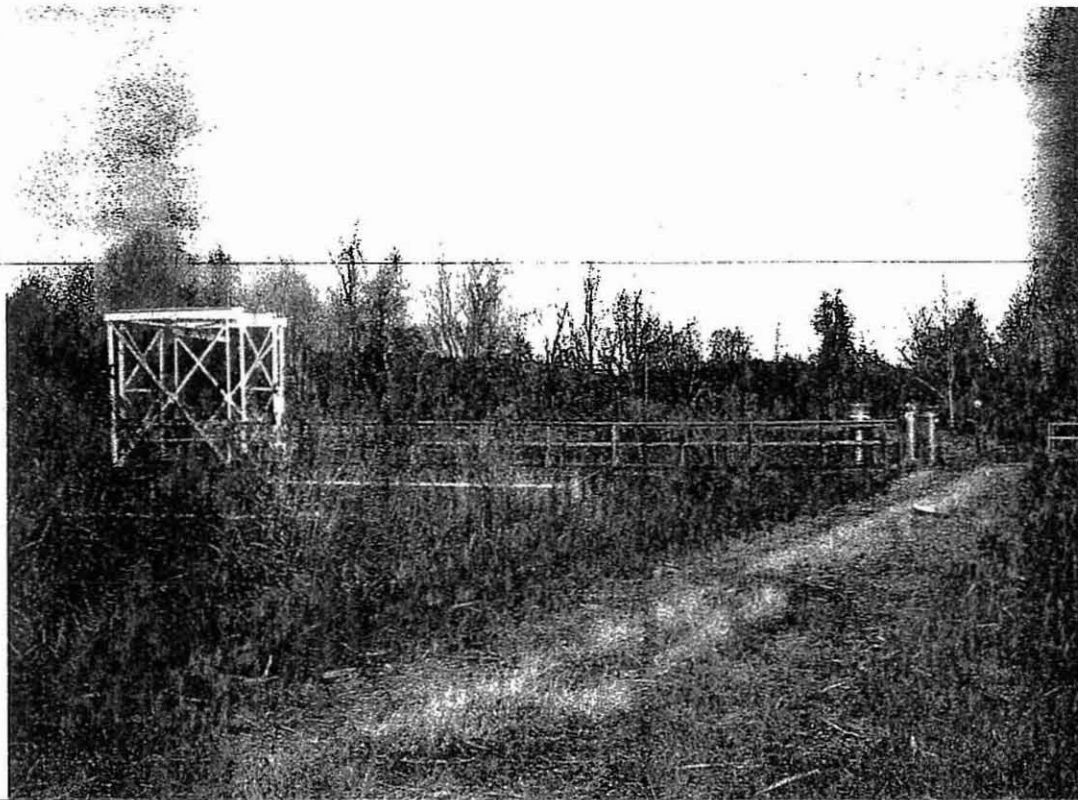
Photograph 24

Discharge tower for
the secondary basin.

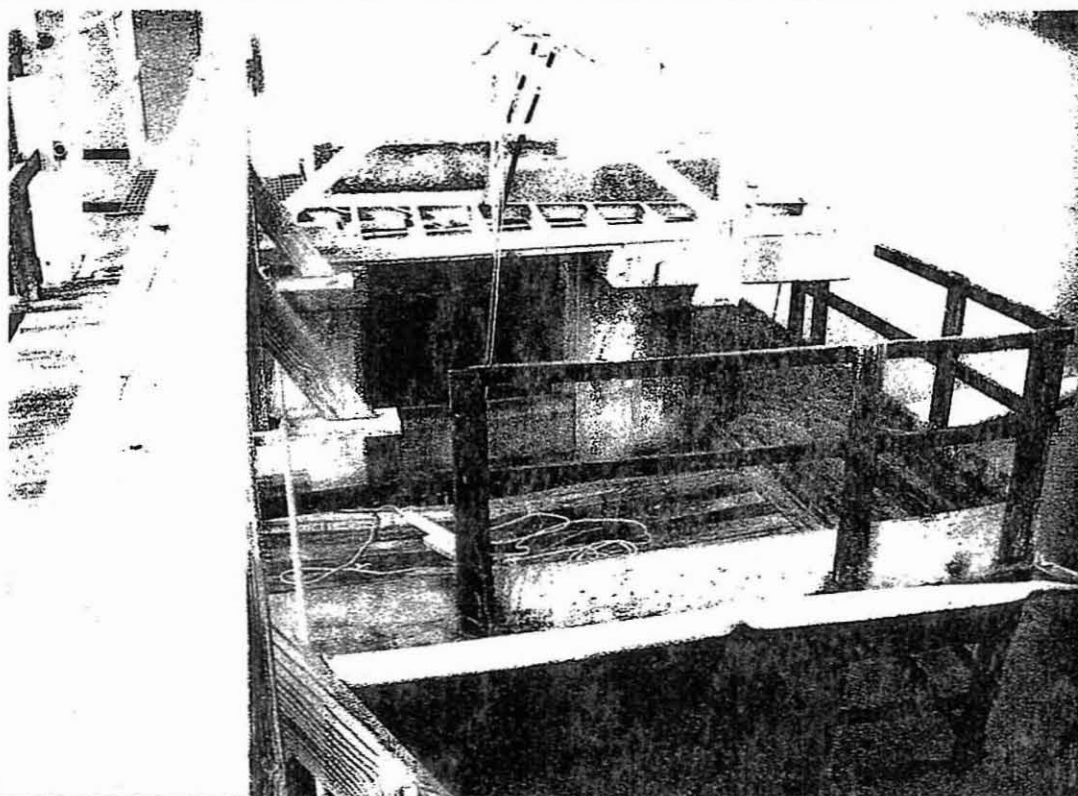
Photograph 25

Discharge tower for
the secondary basin.

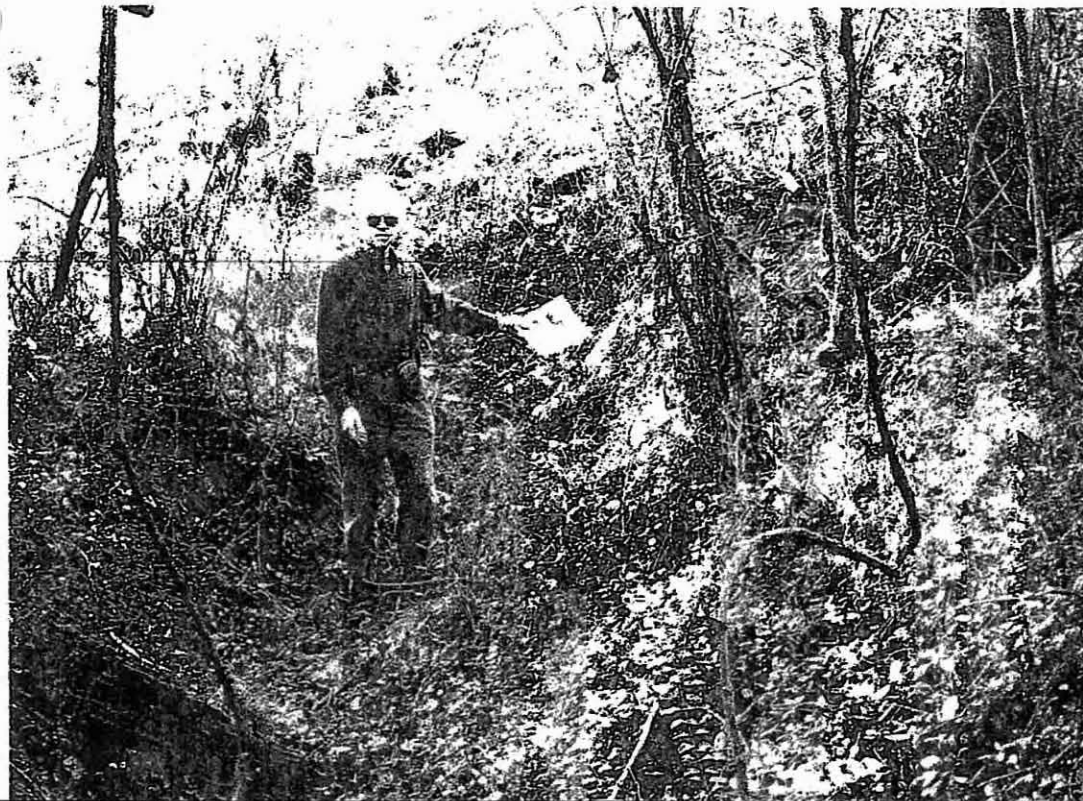
Photograph 28B

Further along this toe to the east (or north), a deep gully (leading to the nearby "Railroad Branch" before it enters the Dan River) heads at about the toe of the dike in approximately the middle of the curve forming the northeast corner of the secondary basin; this gully (Photograph No. 28B) appeared the same as it did in 1996 and 2001. There was no change in the appearance of this gully or the dike downstream slope above this gully.

Gully begins at toe of dike. No apparent change since 2001.

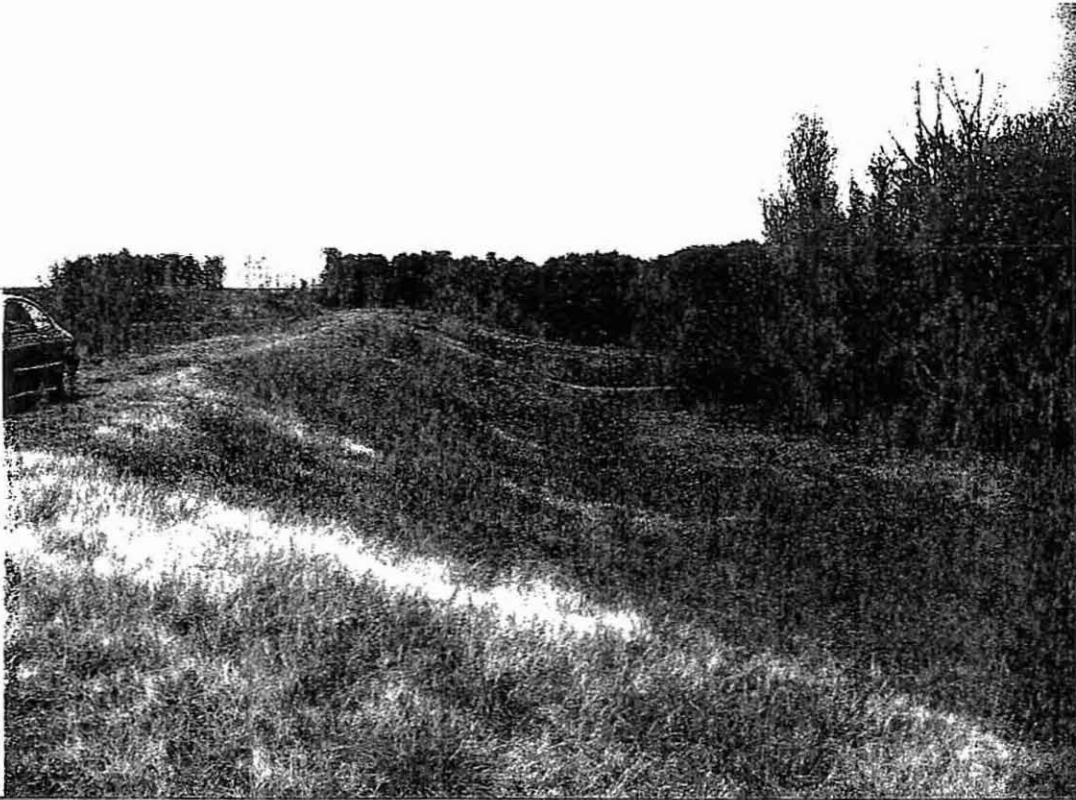
Photographs No. 30 and No. 31 provide views of the dry storage basin dike. This dike contains a good grass cover and shows no signs of instability. A low place in the crest, visible in Photograph 30 and present in 2001, had developed apparently as a result of settlement. Photograph No. 32 is a view of the former dredge pond dike and dredge pond which is currently filled with dry ash. No signs of instability were observed along this embankment; the clear seepage along its toe observed in 1996 was not obvious in 2001 or 2006. The undermined reverse filters observed in the 1996 inspection were not inspected.

Main dike for dry pond basin, E-NE view. Note continued presence of low place in crest apparently due to settlement.

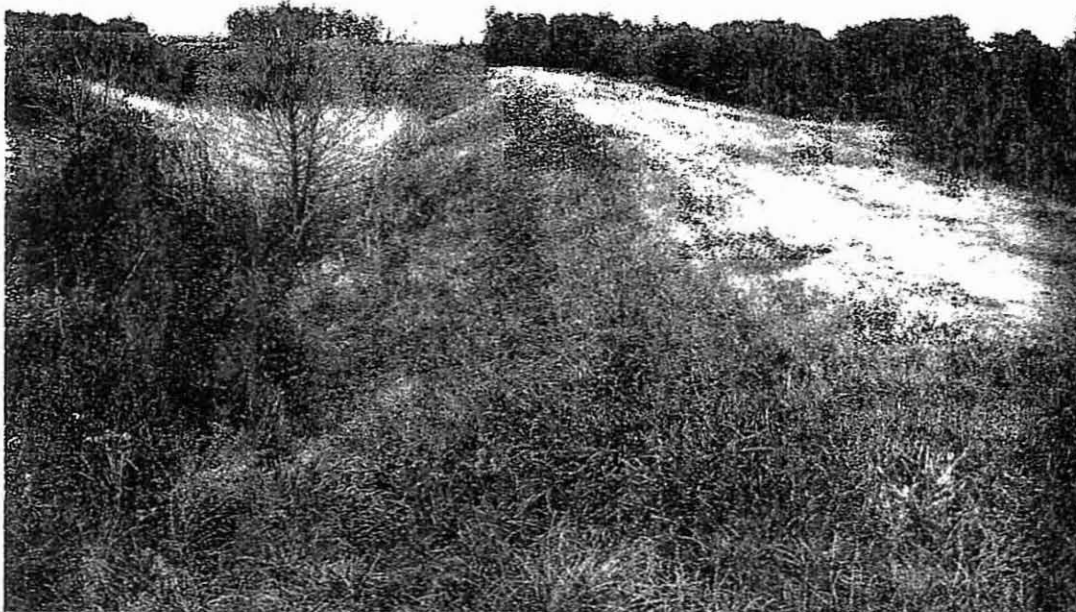
Photograph 31

Upstream slope of dry storage basin, E view.

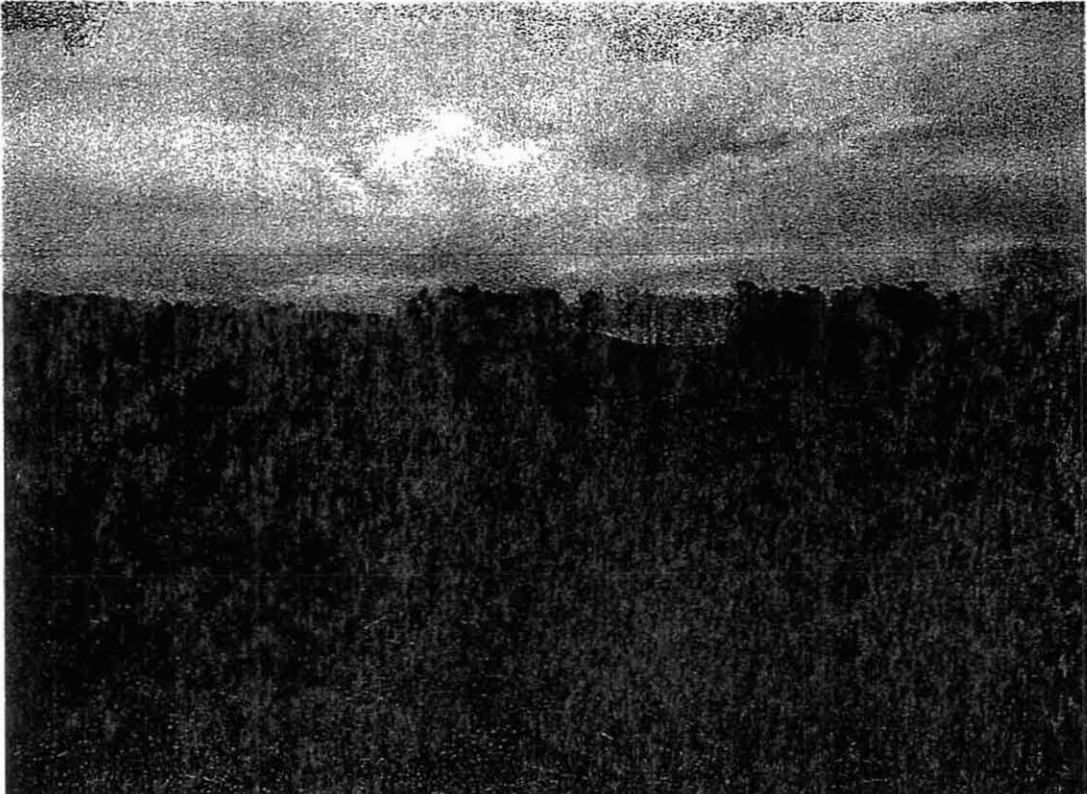
<p>Remarks</p> <p>Photograph 32</p> <p>Former dredge pond, E-NE view; now filled with dry ash.</p>
	<p>Remarks</p>
