NOAA Abandoned Vessel Program Removal Case Study: *Nago No. 15*

Contributing Agency: CNMI Coastal Resources Management Office

NOAA AVP #: 1253

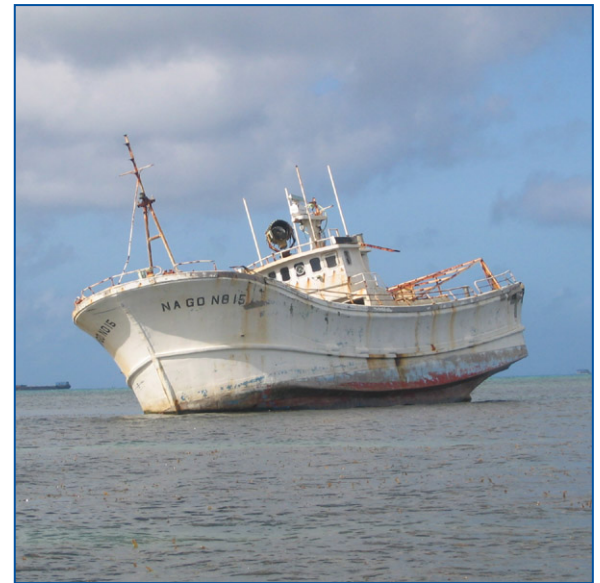
Name: Tanapag Lagoon
Location: Saipan, CNMI
Coordinates: 15.23463'N 145.74295'E
Land: Above OLW – CNMI Public Land
Below OLW – United States

Situation: Grounded during Typhoon Winnie
Incident Date: August 1997
Total Duration: 8 ½ Years, Aug. 1997 – Feb. 2006
Actual Operations: 2 months, Dec 14, 2005 – Feb 20, 2006
Cost: \$49,100
Funding: \$19,100 – CNMI Coral Reef Initiative
\$30,000 – NOAA Coral Reef Conservation Program
Agencies Involved: NOAA, USCG, US Army Corp of Engineers, CNMI Department of Lands and Natural Resources-Division of Fish and Wildlife, Historical Preservation Office (HPO), CNMI Division of Environmental Quality (DEQ), and CNMI CRMO
Primary Threats: Environment
