# Surveys of Abandoned Vessels: U.S. Caribbean Region

Jacqueline Michel, Scott Zengel, Christine Lord, and Zach Nixon  
Research Planning, Inc.  
Columbia, South Carolina 29202

September 2002

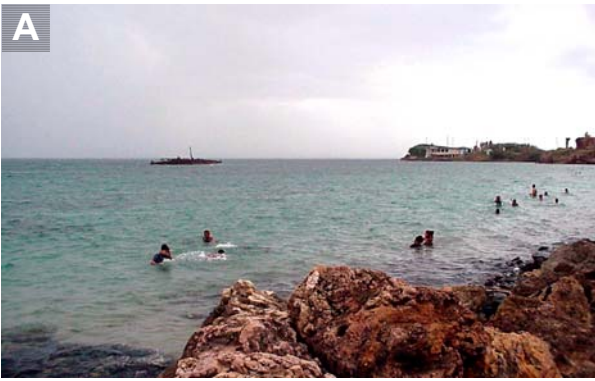
**Vessel Information:** The *El Canuelo* is a 200 ft liquid fuel oil barge that has been hard aground since at least 1976. The steel deck plates are starting to break up and there are many holes in the side plates. The cargo area is open to the sea. No information is known about the previous owners.

- A. View to the NW from the municipal park to the barge offshore. Note the swimmers.
- B. Barge deck condition.
- C. Unvegetated scour area that extends 15-30 ft around the vessel.
- D. Seagrass habitat.
- E. Hardbottom habitat 35 ft NE of barge with about 1% live coral present.

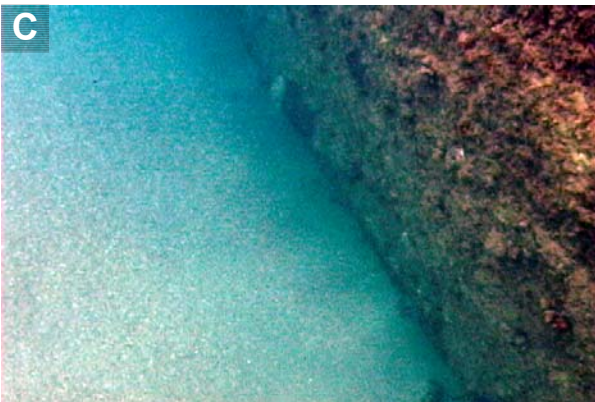
**Comparison to Other Vessels:** Most vessels grounded on seagrass habitats had a scour area around the vessel that was unvegetated and 1-2 ft lower in depth than the adjacent vegetated areas.

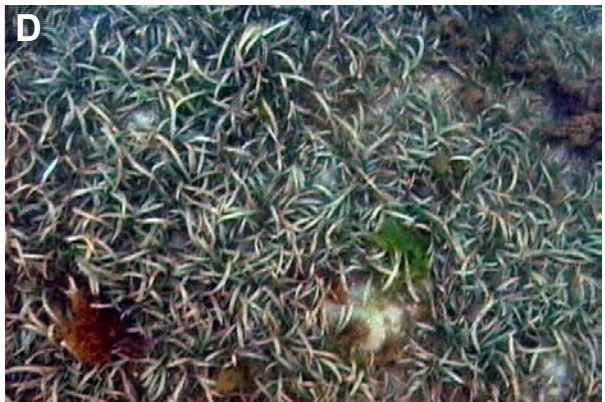
**Environmental Characterization:** Seagrasses (shoal and turtle grass) were sparse and patchy surrounding much of the vessel scour area, but denser and mixed with fleshy macroalgae away from the vessel. There was a patch of hardbottom colonized mainly by macroalgae, (live hard coral cover was <1% and colonies were small) within 35 ft.

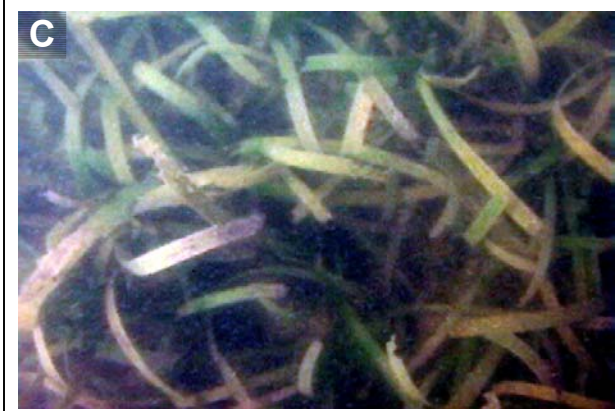
**Environmental Characterization:** A red mangrove stand, including some black mangroves landward, fringes the shore. The stand is large and mature but shows evidence of storm damage, as well as possible damage caused by the vessel. The nearshore benthic habitat around the vessel is composed of sparse shoal and turtle grass that becomes denser with increasing distance offshore. The vessel could move during future storms, causing more damage to adjacent seagrass and mangrove habitats.

- A. View looking north of the vessel lodged against the mangrove fringe.
- B. View looking west showing the vessel position relative to the mangroves.
- C. Seagrass habitat.
- D. Inside mangrove stand.
- E. Mangrove habitat.

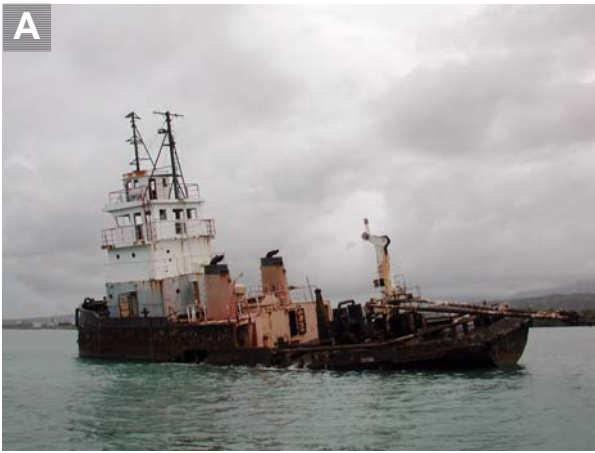
**Vessel Information:** The *Princess I* grounded when it was being moved to a shoreline site to be used as a restaurant. The salvage tug *Pawnee* grounded nearby during salvage efforts. Both vessels grounded in the early 1990s. The *Pawnee* has holes in its sides and the USCG thinks that there may be fuel in the deeper tanks. The *Princess I* burned to the waterline and only the steel hull remains. The USCG removed oily bilge water, and they believe there may be some fuel in deep tanks.

- A. The *Pawnee*.
- B. The *Princess I*.
- C. 1-ft high eroding scarp at edge of seagrass bed around the *Pawnee*.
- D. Seagrass habitat.
- E. Fire coral growing on vessel debris.

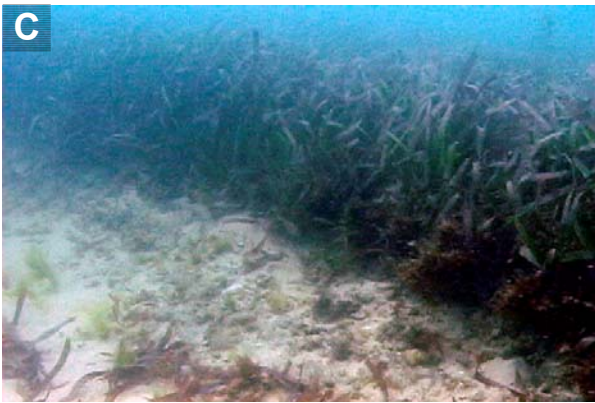
**Environmental Characterization:** Both vessels are grounded in seagrass habitat composed of dense turtle grass mixed with manatee grass and *Halimeda* macroalgae in places. The substrate is carbonate sand. Large areas around each vessel are now devoid of seagrass and signs of active scour are apparent. The edge of the grass bed around each vessel also has a 1-2 ft high eroding scarp where seagrass rhizomes are exposed and the root mat is undercut to 2 ft or more in places. Further loss of seagrass around each vessel is likely, particularly during hurricanes.

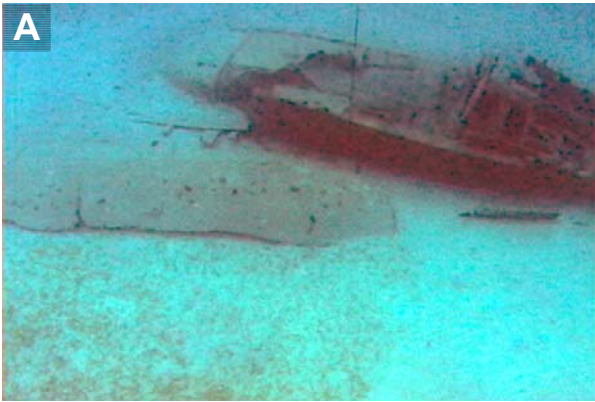
**Vessel Information:** The *Karma* is a wood and fiberglass sailboat that was intentionally sunk in April 2001 by the owner to create a diving site/artificial reef in a bay that is a popular diving and boating site. The vessel has already broken into two main pieces, and several small pieces have moved towards shore.

- A. Overview of vessel.
- B. Horizontal view of vessel.
- C. Vessel debris in sparse seagrass habitat.
- D. Detail of remaining vessel structure.
- E. Nearby coral reef habitat.

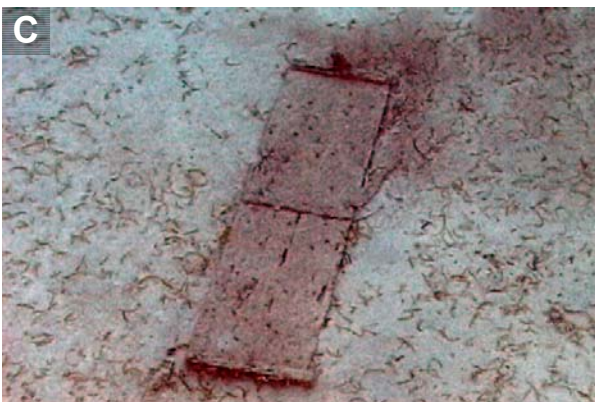
**Environmental Characterization:** The vessel is sunk in an area with dense turtle grass. Coral patch reef and a narrow fringing reef occur roughly 50-75 ft from the vessel. A large area around the vessel is now devoid of seagrass. Seagrass cover is sparse surrounding the bare area, with lower shoot density and shorter blades than in the surrounding grass bed. The site falls within Designated Critical Habitat for the federally threatened green sea turtle, which includes seagrass habitat damaged by the vessel.

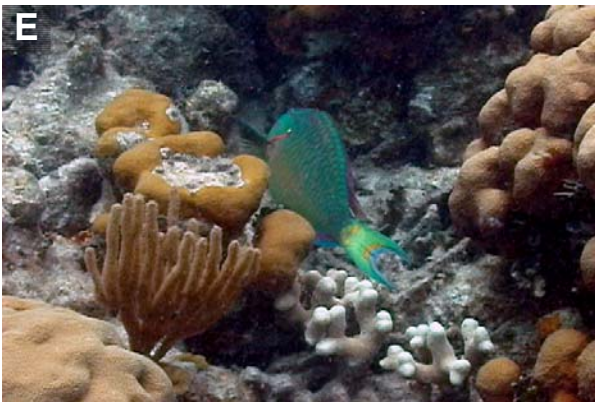
**Comparison to Other Vessels:** This site is unique in that the vessel was intentionally sunk. This vessel is also one of the deeper sites surveyed, and it is adjacent to the highest quality coral reef habitat encountered during this project. This site also had the most direct damage to Designated Critical Habitat for threatened and endangered species observed during the project.

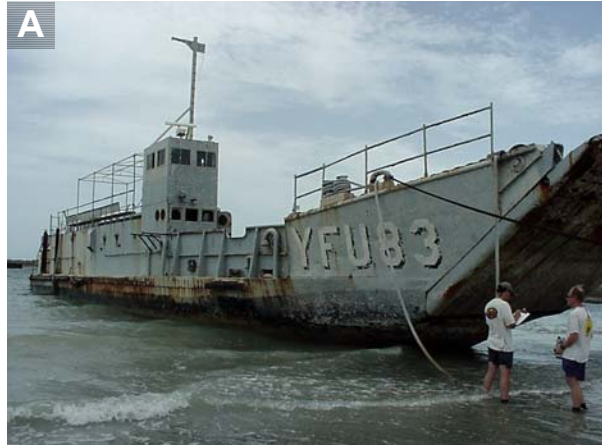
**Vessel Information:** There are three LCUs partially sunk in the intertidal zone. Two vessels are awash up to the top deck. The other vessel (YFU83) had apparently sunk for a while and been re-floated; it had barnacles on the deck and housing. The bow of this vessel is resting on the sand and gravel beach at low water.

**Environmental Characterization:** Dense to patchy turtle grass mixed with calcareous macroalgae extend around all vessels. There is a scour at least 140 ft x 30 ft around YSU83, the only vessel that could be safely surveyed during the site visit because of moderate wave energy and high water turbidity. A steep scarp in the seagrass bed, indicating active erosion, occurs near the two partially submerged vessels. The adjacent mangrove forest is designated critical habitat for the federally endangered yellow-shouldered blackbird, which uses mangroves and coastal fringe habitats. Mangroves could be damaged if the vessels moved onshore during a major storm.

- A. This LCU was covered with barnacles, indicating that it had previously sunk and then was re-floated and grounded. There is extensive scouring of the adjacent seagrass beds.
- B. The two partially submerged LCUs; photo taken from the YFU83.

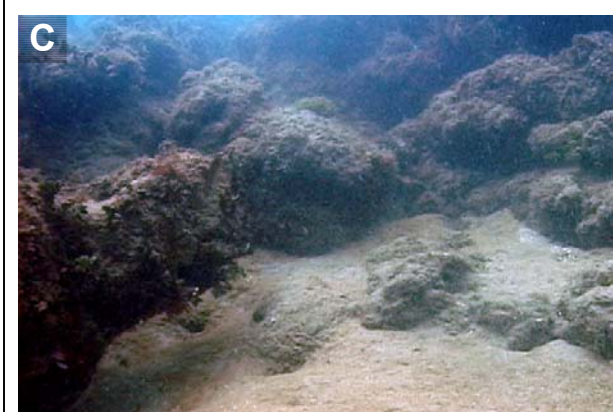
**Environmental Characterization:** This is the only vessel in Puerto Rico that rests directly on hardbottom habitat. Calcareous macroalgae, some large soft corals, and mat anemones colonize the hardbottom. Live hard coral is present (<1% cover) with an average size of 10 cm diameter and a maximum size of 20 cm diameter. The adjacent shoreline is composed of a mixed sand and gravel beach, and the benthic habitat between the beach and vessel consists of a subtidal rock platform. The barge is hard aground and unlikely to move during a storm or hurricane.

- A. View looking west showing the stern.
- B. View looking east of the starboard side
- C. Hardbottom habitat adjacent to the barge.
- D. Soft coral growing on hardbottom
- E. Vessel contact with substrate.

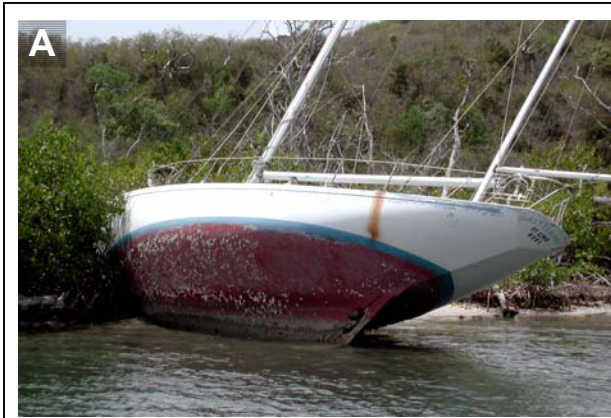
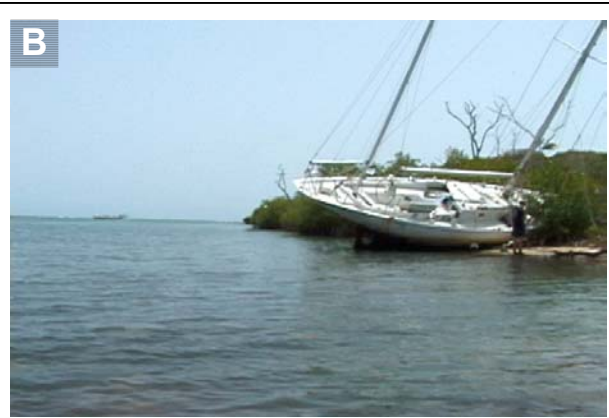
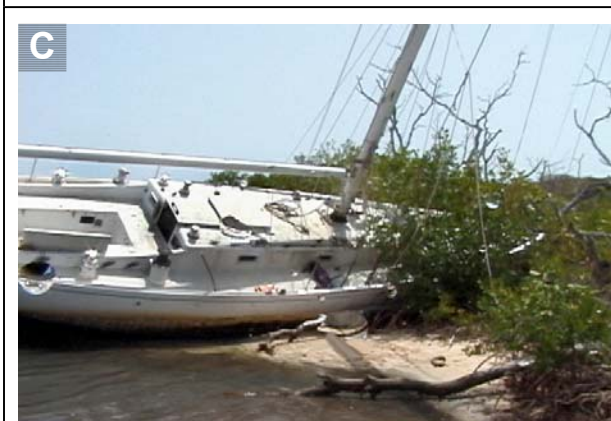
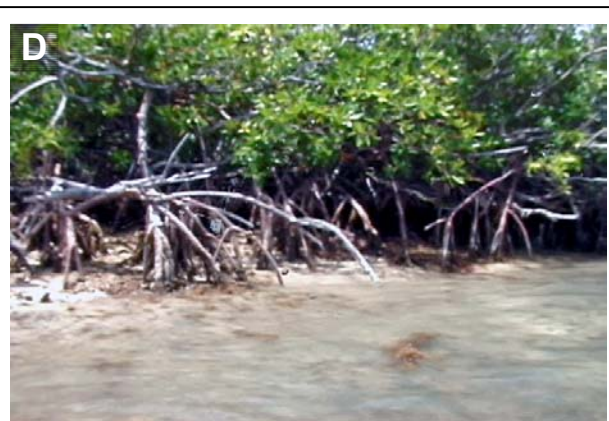
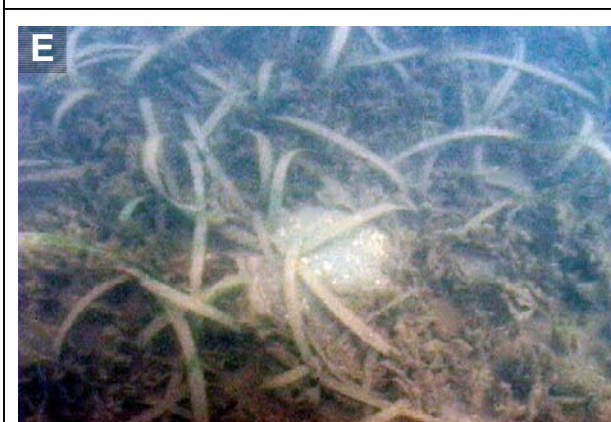
**Photographs of the *Kittiwake* (25 June 02):**

**Vessel Information:** The *Kittiwake* is a 48 ft sailboat that most likely grounded during a hurricane. It is aground and ashore. The vessel is in good condition with no obvious hull damage. The cost estimate for removal was reported to be \$4,800.

**Environmental Characterization:** The vessel is aground on mangroves, sand beach, and seagrasses (proceeding from bow to stern, landward to seaward). The red mangrove forest is 30+ ft wide, and the sand beach is about 7 ft wide. A patch of dense turtle grass with infauna burrows roughly 10 feet wide runs adjacent and parallel to the beach. Dense cover of *Halimeda* macroalgae with infauna burrows occurs seaward of the seagrasses and extends into deeper water. Intertidal sediments are sandy. Muddier sediments occur in the subtidal area with increasing depth. Physical mangrove damage was observed extending roughly 15-20 ft into the forest, and was caused at least in part by this vessel. Unrelated hurricane damage was also present. Seagrasses were damaged directly under the vessel and along a 3 ft-wide unvegetated strip along the port side of vessel. Additional mangrove and seagrass damage is possible if the vessel moved during major storms or hurricanes.

- A. View of vessel from port side.
- B. View of vessel from starboard side.
- C. Vessel deck; beach and mangrove habitat.
- D. Mangrove habitat.
- E. Seagrass and macroalgae habitat.

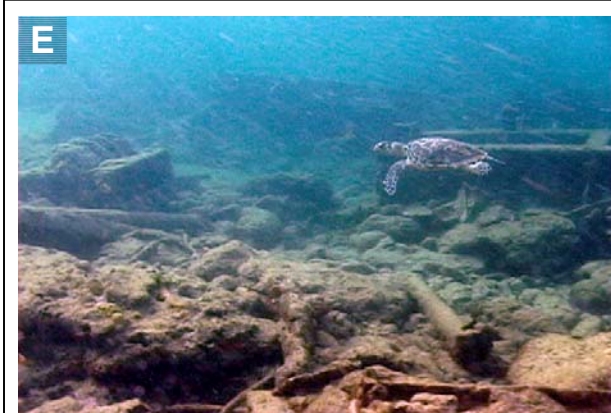
**Photographs of Unk2431 barge (25 June 02):**

**Vessel Information:** Unknown 2431 is a steel barge surrounded by a large debris field. The vessel and debris are very rusted. No information is known about the previous owners.

**Environmental Characterization:** The vessel is grounded on hardbottom and coral reef habitat near Whitehorse Reef. Limited live coral was observed. An extensive debris field extends over 100 ft around the barge. *Diadema* and fish were relatively abundant, and lobster and a juvenile hawksbill sea turtle were observed.

- A. View of barge from shore.
- B. View of barge underwater.
- C. Debris field.
- D. Soft coral on hardbottom.
- E. Juvenile hawksbill sea turtle swimming around debris field.

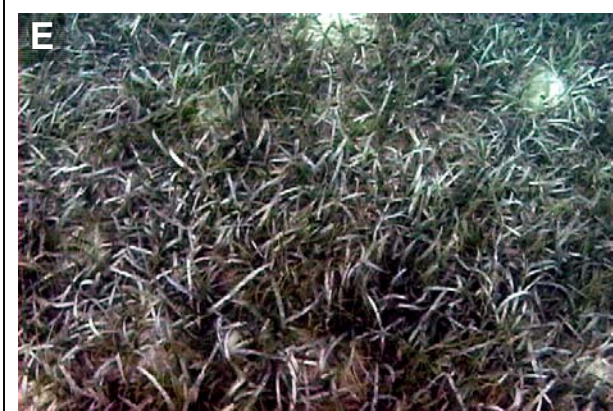
**Photographs of Unk1949 sailboat (26 June 02):**

**Vessel Information:** Unknown 1949 is a 50 ft ferro-cement sailboat that sunk at its mooring. The hull is mostly intact, and two masts, several booms, rigging, wiring, and other debris are present. It is completely submerged in ~ 8 ft of water. An estimate of \$7,000 has been quoted for removal.

**Environmental Characterization:** A large area under and around the vessel is devoid of seagrass and signs of active scour are apparent. Several blowout areas were observed around the port side near the bow and stern. Small eroding scarps were observed at the edge of the seagrass beds along the entire port and stern sides. Dense turtle grass and large infauna burrow mounds surround the vessel scour, and dense coverage of a mixture of turtle and manatee grass occur off of the stern. Sparser coverage occurs adjacent to sand blowout area between 6-10 ft off of the port side. Approximately 90 feet beyond the starboard side of vessel is a 10-12 ft deep unvegetated channel. Some fire coral and soft coral are growing on the vessel. The substrate is coarse-grained sand of calcareous origin with some shell material. Debris remains within the vessel, and two masts extend well beyond the hull into seagrass habitat.

- A. View of vessel as navigation hazard.
- B. Scour in seagrass habitat.
- C. Wheelhouse and debris.
- D. Vessel as artificial reef habitat.
- E. Seagrass habitat.

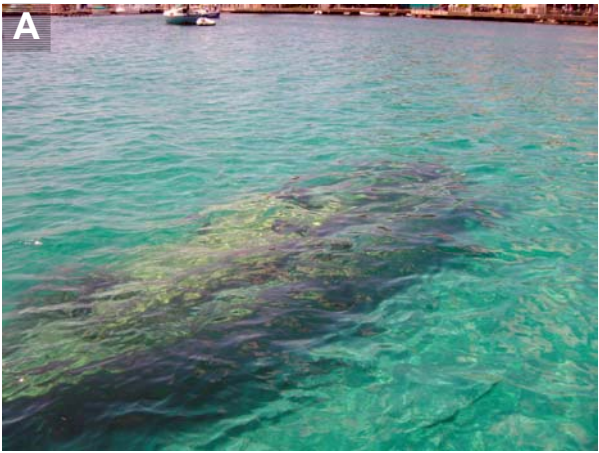
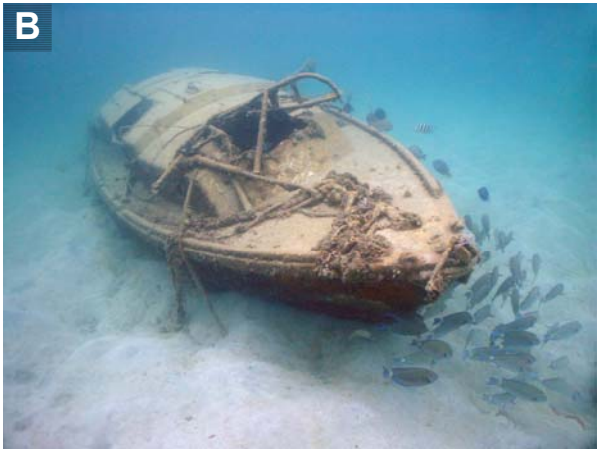
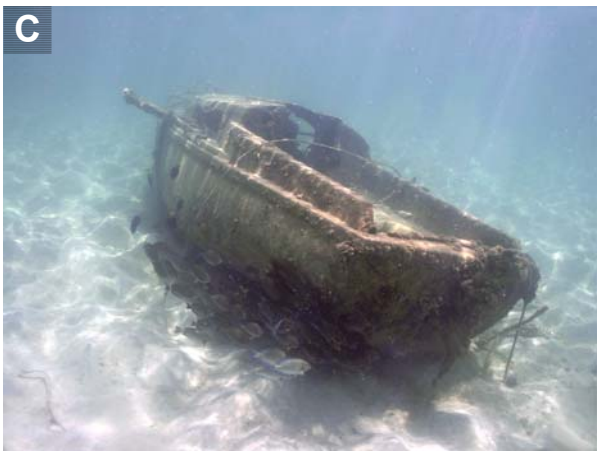
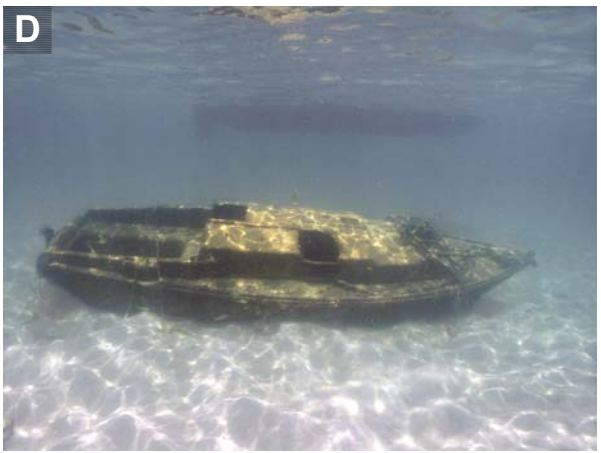
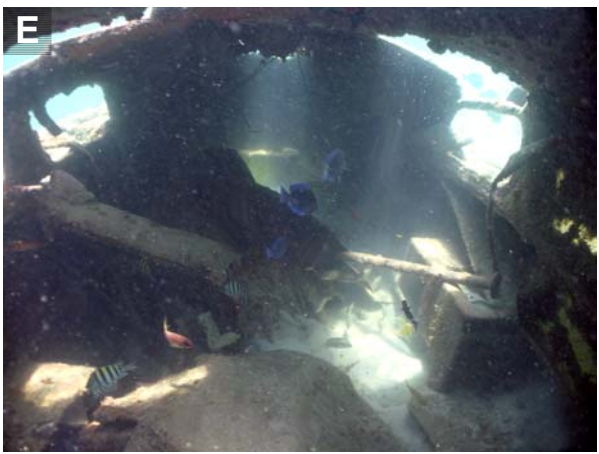
**Photographs of Unk2435, sailboat (26 June 02):**

**Vessel Information:** Unknown 2435 is a 25-28 ft fiberglass sailboat. This vessel sank at its mooring during Hurricane Hugo in 1989. The vessel hull is fairly intact, but there are no masts and it is beginning to deteriorate. No information is known about the previous owners.

**Environmental Characterization:** The vessel is grounded on unconsolidated sediment (sand bottom) in a harbor. If the vessel moved during a large storm or hurricane, it is possible that nearby benthic habitats, most likely seagrass or macroalgae, could be impacted.

- A. Aerial view of vessel.
- B. View of vessel from bow.
- C. View of vessel from stern.
- D. Sand bottom habitat.
- E. Vessel interior.

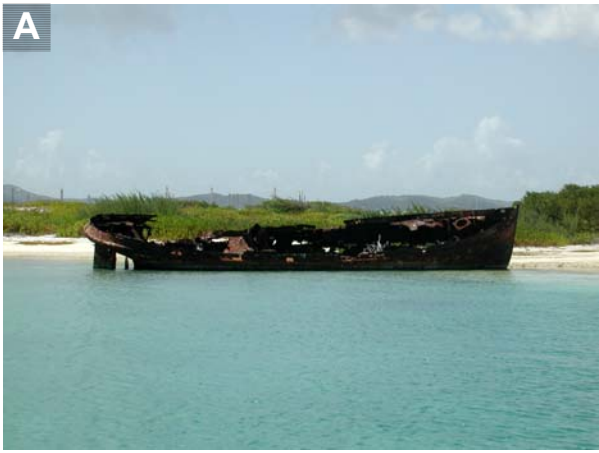
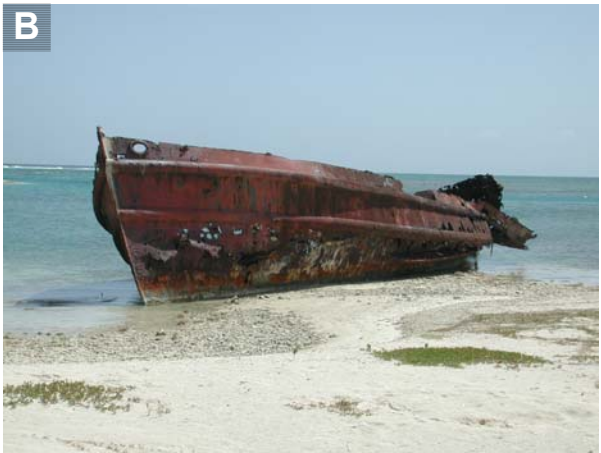
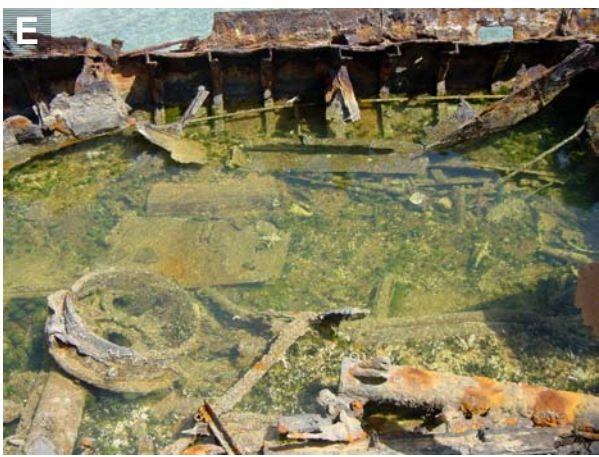
**Photographs of Unk2440, an ex-Navy supply boat (26 June 02):**

**Vessel information:** Unknown 2440 is a 67 ft, steel, U.S. ex-Navy supply boat, aground and ashore. The vessel is deteriorating, and there are several large holes and a lot of debris in the hull. Vegetation is growing in it.

**Environmental Characterization:** The vessel is grounded primarily in seagrass and macroalgae habitat on coarse-grained sand substrate, but a portion of the port side is aground on mixed sand and gravel beach. A patch of turtle grass occurs in the subtidal area on the starboard side of the bow. There is dense coverage of a mixture of turtle grass, *Halimeda*, and other macroalgae off of the starboard and stern sides. A scour hole the same width as the vessel occurs around the stern. There is some patchy hardbottom habitat in the bay. Seagrasses are damaged directly under the vessel, and additional injury is possible if it moved during major storms or hurricanes.

- A. View of vessel from starboard side.
- B. Port side of vessel and sand beach habitat.
- C. Bow of vessel and sparse intertidal seagrass habitat.
- D. Vegetation growing in vessel.
- E. Vessel debris.

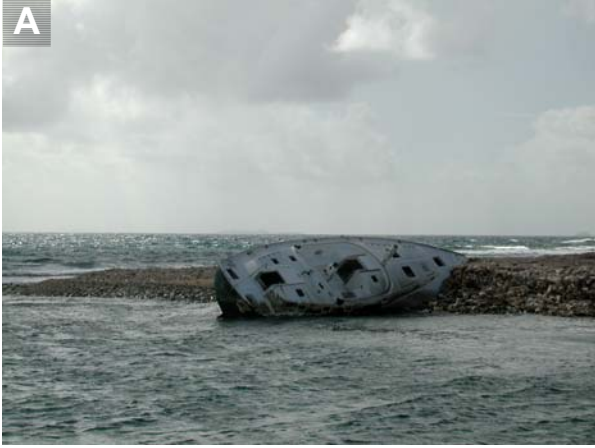
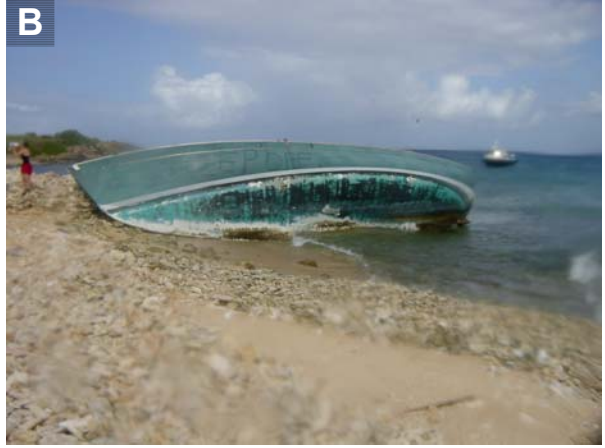
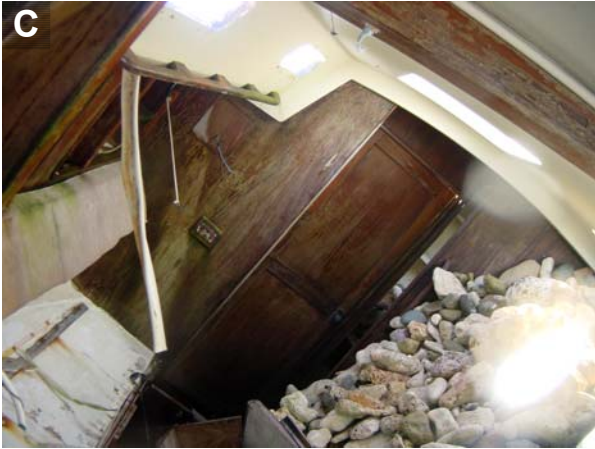
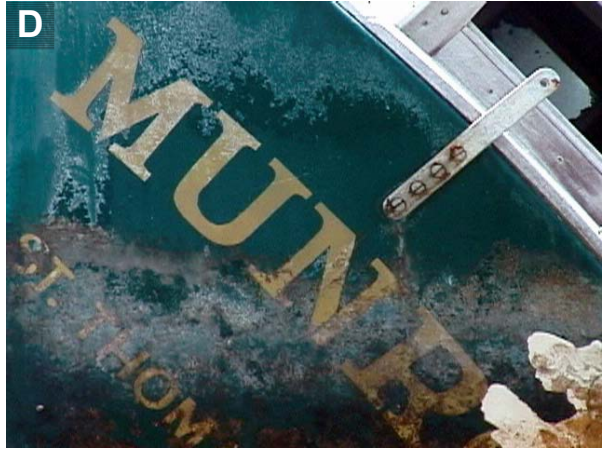
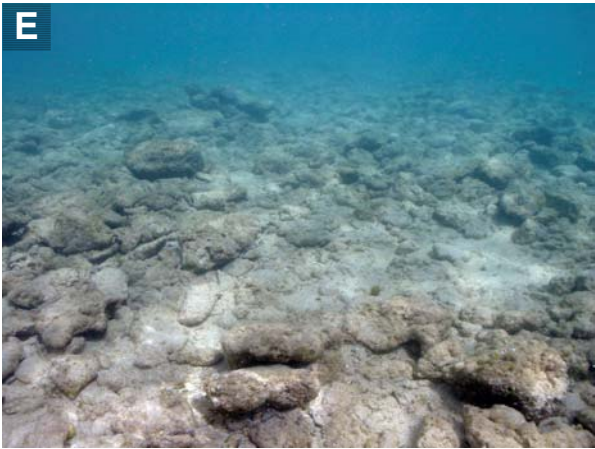
**Photographs of *Munro* (27 June 02):**

**Vessel Information:** The *Munro* is a 46 ft fiberglass sailboat aground and ashore. The vessel's mooring broke in Honeymoon Bay on Water Island and it drifted to Saba Island in 2000. The hull is intact, but is approximately one-quarter filled with rubble and there is no mast. No information is known about the owners.

**Environmental Characterization:** The stern is grounded on hardbottom habitat and coral rubble with calcareous sand, and the bow is ashore on a mixed sand gravel beach with some cobble to boulder-sized sediments. Sparse macroalgae occurs on the substrate, and very little live coral was observed. The vessel is located in a high-energy environment, and its presence onshore is causing a high gravel berm (3-6 ft) to form on the starboard side, and erosion to occur on the port side. Damage to benthic habitats is not evident, but is possible if the vessel was to move during a storm event.

A. Gravel beach habitat.  
 B. View of vessel and beach from port side.  
 C. Cabin interior.  
 D. View of stern.  
 E. Hardbottom habitat.

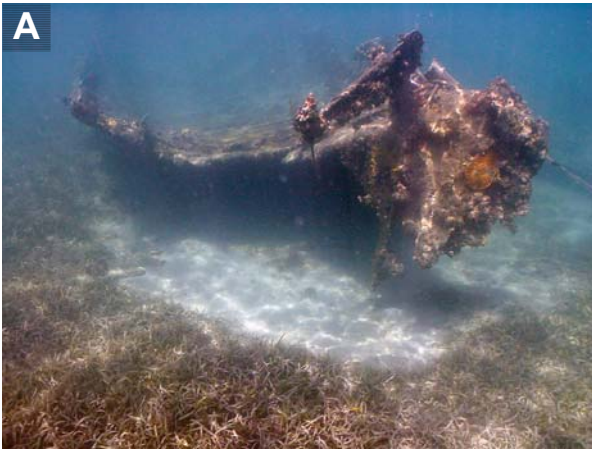
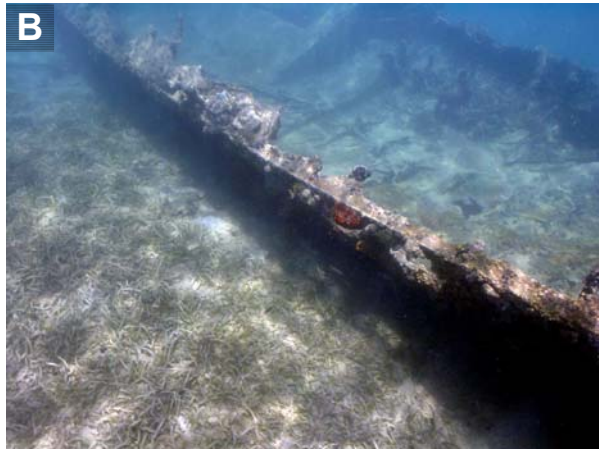
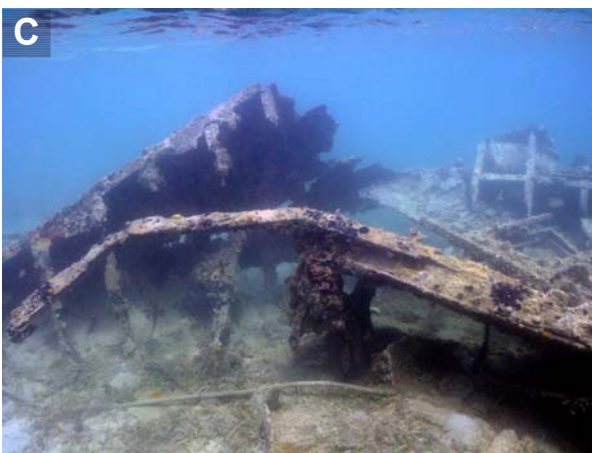
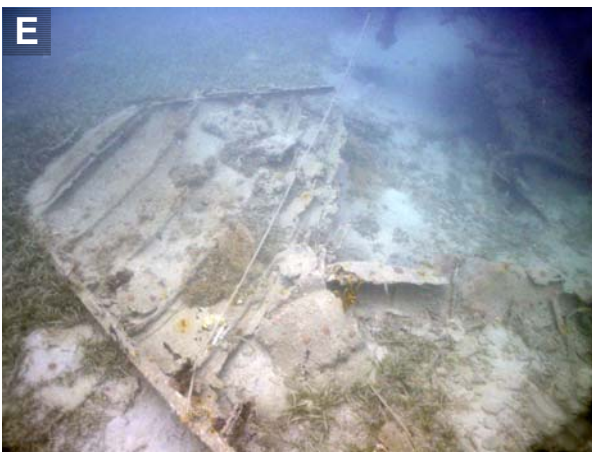
**Photographs of Unk2443, sailboat (27 June 02):**

**Vessel Information:** Unknown 2443 is a 66 ft, steel-framed sailboat with wood planking. The vessel caught fire and burned at its mooring sometime between 1983-1985. The steel hull remains, but the vessel is mostly burned. No information is known about the owners.

**Environmental Characterization:** A large area under and around the vessel is devoid of seagrass, and signs of active scour are present. The scour area is wider around the bow and on the starboard side. Dense turtle grass occurs surrounding the vessel scour on all sides. Approximately 30 feet to the port side of the bow is an area of sand and gravel bottom with some soft coral. The vessel could cause additional seagrass damage, and/or possibly soft coral damage, if it moved during major storms or hurricanes.

- A. Scour area in seagrass habitat.
- B. Vessel on seagrass.
- C. Burned hull.
- D. Live coral growing on hull.
- E. Overview of hull.

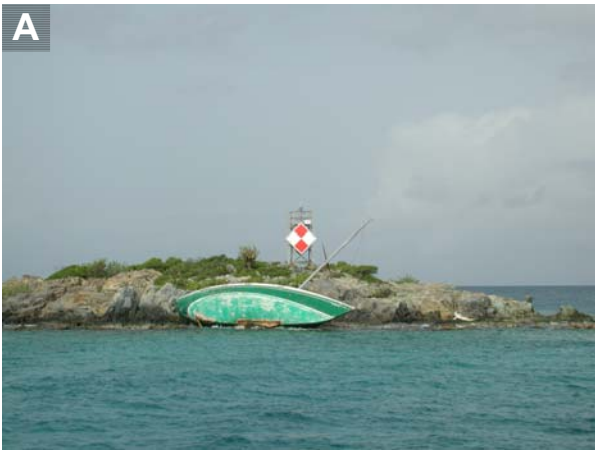
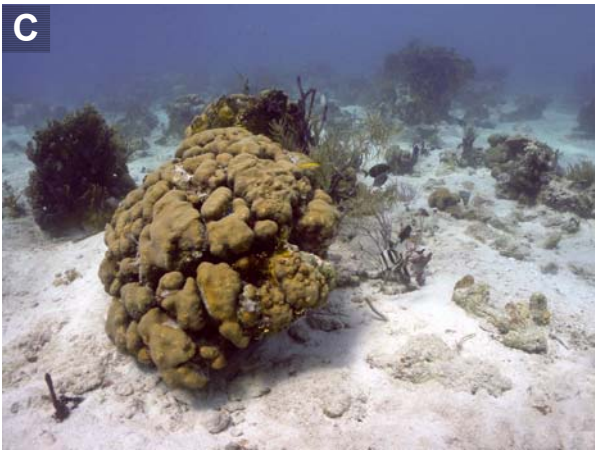
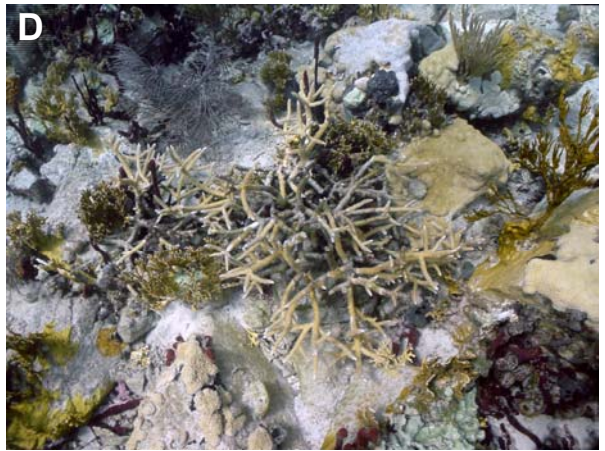
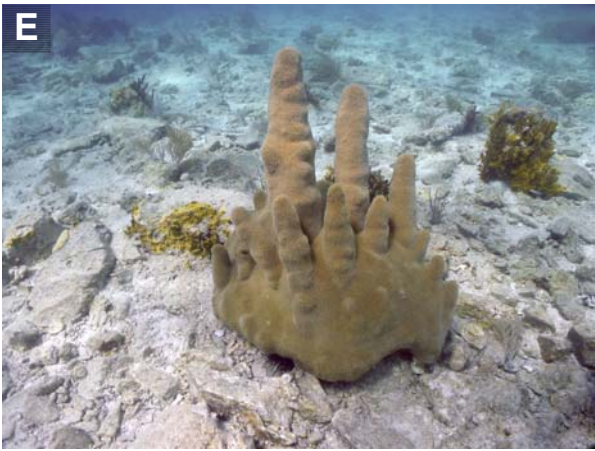
**Environmental Characterization:** The vessel is aground on a rock platform. The adjacent benthic habitat is hardbottom and coral reef. From the shoreline to approximately 65 feet offshore, the habitat is fire coral, some hard coral (brain coral, elkhorn), and soft coral on bedrock and large boulders. *Diadema* are abundant. Further offshore are higher density patch reefs on coarse-grained sand and coral rubble with abundant soft corals, sponges, massive corals, fire coral, *Diadema*, and small colonies of staghorn and pillar coral. Damage to live coral, invertebrates, coral reef, and hardbottom habitat is likely if the vessel moved during a large storm or hurricane.

**Photographs of *Serendipity* (28 June 02):**  
 A. View of vessel from starboard side.  
 B. View of deck.  
 C. Reef habitat.  
 D. Staghorn coral.  
 E. Pillar coral.

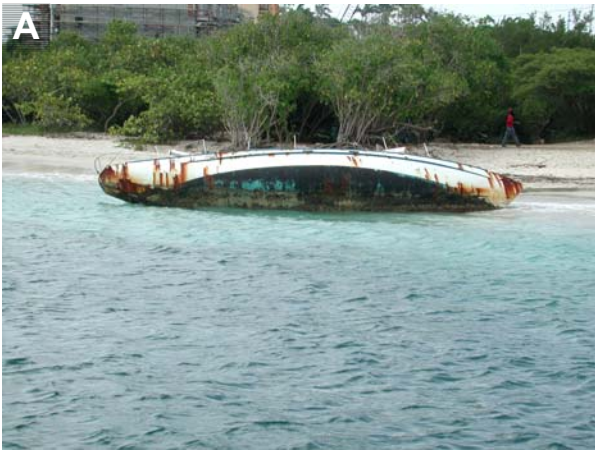
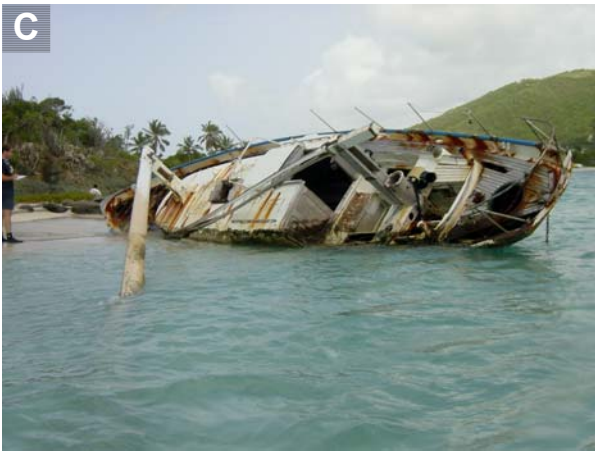
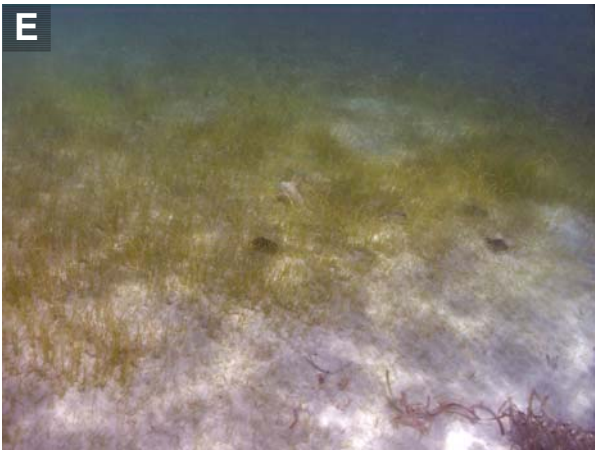
**Vessel Information:** The *Orca* is a 41 ft steel sailboat aground and ashore since 1995. The vessel was likely grounded during Hurricane Marilyn. The vessel is rusting and the mast is broken, but the hull is mostly intact. No information is known about the owners.

**Environmental Characterization:** The vessel is aground in the intertidal zone on seagrass and sand. Approximately 15 ft from the starboard side of the vessel is a 30 cm seagrass scarp, and a roughly 15 ft wide manatee grass bed of moderate coverage extends along the starboard and stern sides of the vessel. Offshore from the manatee grass bed is dense coverage of mixed turtle and manatee grass and macroalgae. There is an unvegetated intertidal and subtidal sandy zone surrounding the vessel. The vessel could cause seagrass damage if it moved during major storms or hurricanes.

**Photographs of ORCA (28 June 02):**  
 A. View of vessel from starboard side.  
 B. Sand beach habitat.  
 C. Vessel deck.  
 D. Sandy intertidal zone.  
 E. Seagrass habitat.

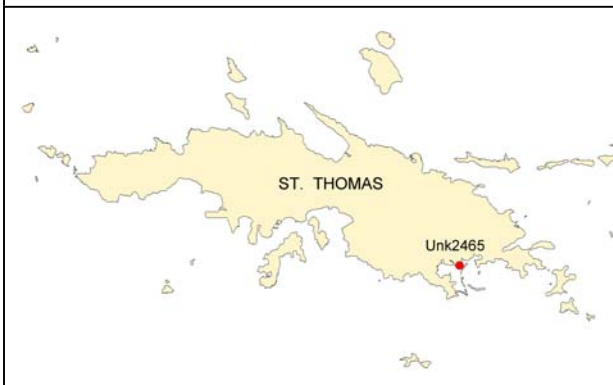
**Vessel Information:** Unknown 2465 (VI 12870-T) is a fiberglass houseboat. The vessel is damaged and at a 45° port list and tied to the mangroves. No information is known about the owners.

**Environmental Characterization:** Physical mangrove damage was observed along the port side of the vessel, including dead trees, open canopy, and attached vessel lines. The vessel may have caused injury to the mangroves, at least in part, although storm damage is also a possibility. Additional mangrove damage is likely if the vessel moved during large storms or hurricanes.

**Photographs Unk2465, houseboat in Benner Bay (26 June 02):**

- A. View of two houseboats tied to mangroves.
- B. View of dilapidated vessel.

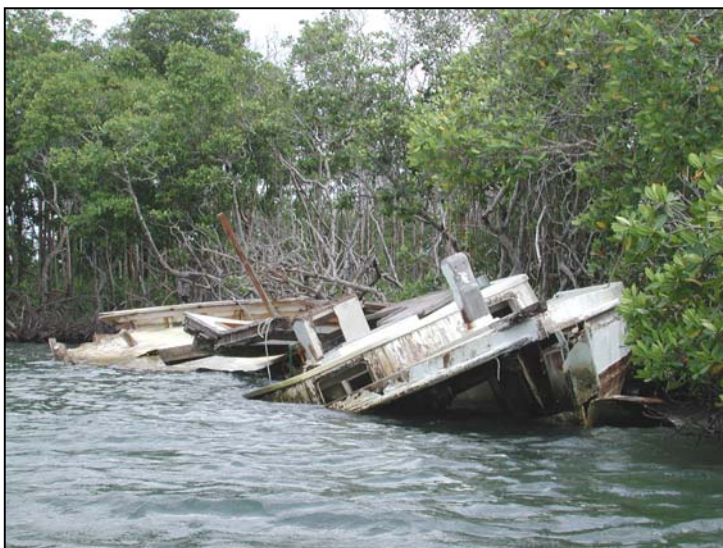
- a) **General status of vessel:** Partially submerged.
- b) **Nature of casualty (preliminary cause if known):** Grounded during Hurricane Georges.
- c) **What were the circumstances of the grounding or abandonment?** Abandoned after the hurricane.
- d) **Date of grounding/length of time the vessel has been "abandoned":** September 1998.
- e) **General description of vessel damage:** Only the fiberglass hull remains; most of cabin is gone. What appears to be the wooden deck cover is floating on the seaward side of the vessel, partially trapped under the hull.
- f) **Vessel Cargo:** None.

- e) **Substrate:** Sand mixed with some finer material.
- f) **Damage Observations:** Roughly 15 ft-wide area of un-vegetated substrate occurs on starboard side of vessel where seagrasses were likely present. Two smaller un-vegetated areas near the

vessel, roughly 5 ft in diameter each, may be seagrass blowout areas. Substantial physical mangrove damage observed, along port side of vessel, as well as in larger area roughly 20-30+ ft in diameter, occurring several feet off the stern of the vessel and extending inside the forest interior (dead trees, open canopy, and understory mangrove regeneration observed). Mangrove damage may have been caused by this vessel, at least in part, although unrelated hurricane damage also a possibility. Vessel could cause additional mangrove and seagrass injury if it moved or broke up during a major a storm or hurricane.

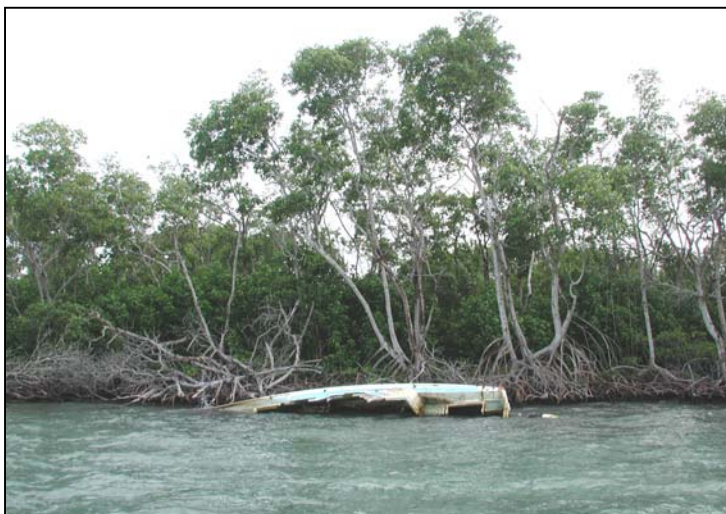
- a) **General status of vessel:** Partially submerged and ashore.
- b) **Nature of casualty (preliminary cause if known):** Grounded during Hurricane Georges.
- c) **What were the circumstances of the grounding or abandonment?** Abandoned after the hurricane.
- d) **Date of grounding/length of time the vessel has been "abandoned":** September 1998.
- e) **General description of vessel damage:** Only the fiberglass hull remains; most of cabin is gone.
- f) **Vessel Cargo:** None.

- f) **Damage Observations:** Possible seagrass damage directly under and adjacent to vessel. Physical mangrove damage observed, possibly caused by this vessel, although unrelated hurricane damage also a possibility. Vessel could injure mangroves and seagrasses if it moved during major storms or hurricanes.

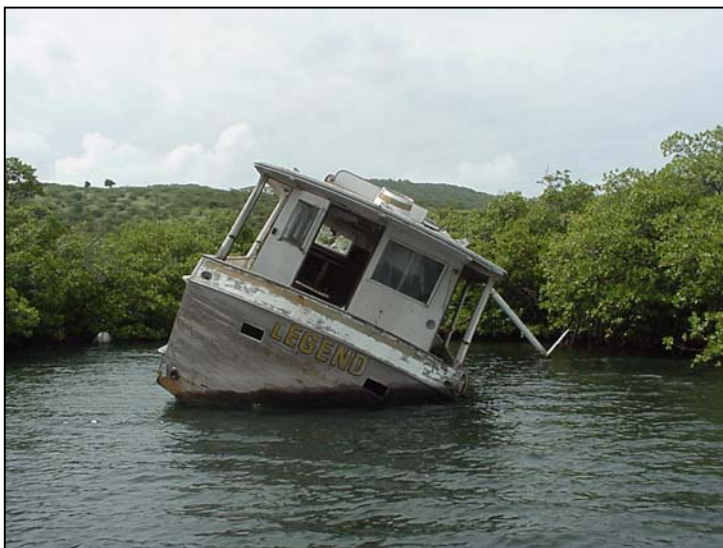
- a) **General status of vessel:** Aground and tilted to starboard by about 30 degrees.
- b) **Nature of casualty:** Sank at its mooring.
- c) **What were the circumstances of the grounding or abandonment?** Due to negligence by the owner, who lives out of the country, the vessel sank at its mooring, several times.
- d) **Date of grounding/length of time the vessel has been "abandoned":** Last sinking was in 1998.
- e) **General description of vessel damage:** The wood is starting to deteriorate. The hull is flooded. The vessel is grounded at a steep (30 degrees) angle on starboard side.
- f) **Vessel Cargo:** None.

- a) **Dimensions of vessel grounding footprint:** Not measured.
- b) **Dimensions of debris field:** Not examined.
- c) **Primary Habitat(s):** Mangrove. Vessel bow against red mangroves at head of small bay.
- d) **Secondary Habitat(s):** N/A.
- e) **Substrate:** Mud.
- f) **Damage Observations:** None directly observed. Vessel could cause mangrove damage if it moved during future hurricanes.

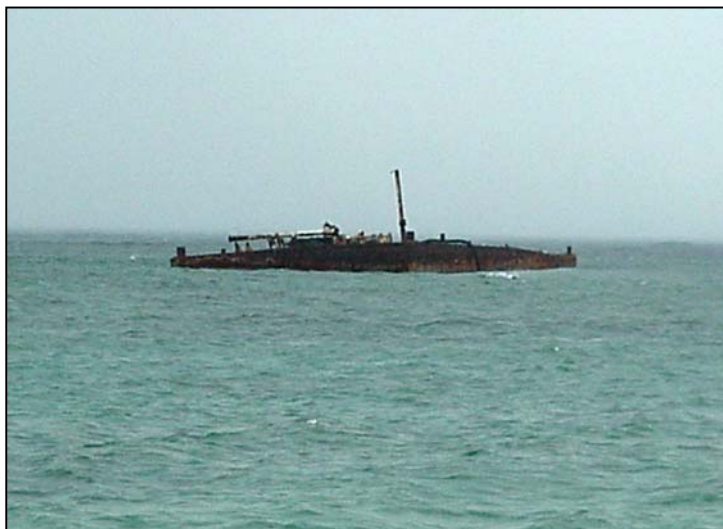
- a) **General status of vessel:** Aground.
- b) **Nature of casualty (preliminary cause if known):** Unknown.
- c) **What were the circumstances of the grounding or abandonment?** Unknown.
- d) **Date of grounding/length of time the vessel has been "abandoned":** Unknown. First mention in history section of USCG database in 1976.
- e) **General description of vessel damage:** Deck plates are starting to break up; many holes in sides and open to the sea.
- f) **Vessel Cargo:** None at this time; was used for liquid petroleum.

- e) **Substrate:** Sand with some finer materials and pebble-sized coral rubble.
- f) **Damage Observations:** Large area around vessel devoid of seagrass (bare sand). Active scour observed. No eroding scarp observed at edge of bare area. In most places only sparse seagrass coverage occurs around the bare area. Seagrasses will not likely colonize the bare and sparse areas around the vessel with any permanence due to continuing scour. Additional seagrass damage could occur during major storms or hurricanes.

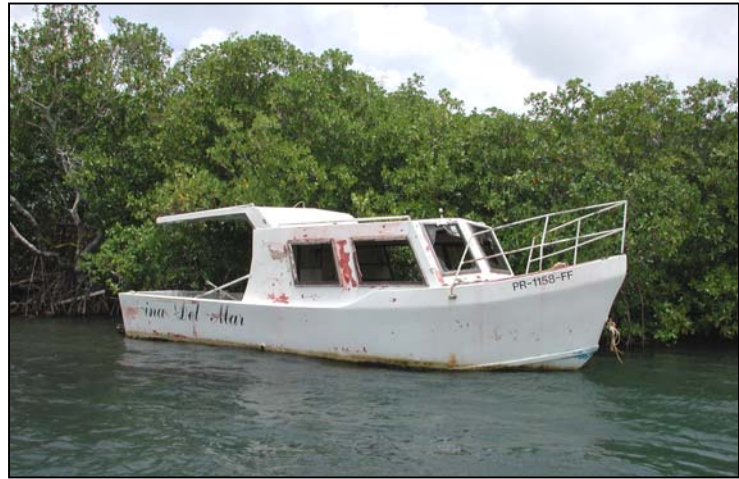
Vessel tied to and floating against mangrove forest edge, over soft mud bottom. Vessel could cause mangrove damage during a major storm or hurricane.

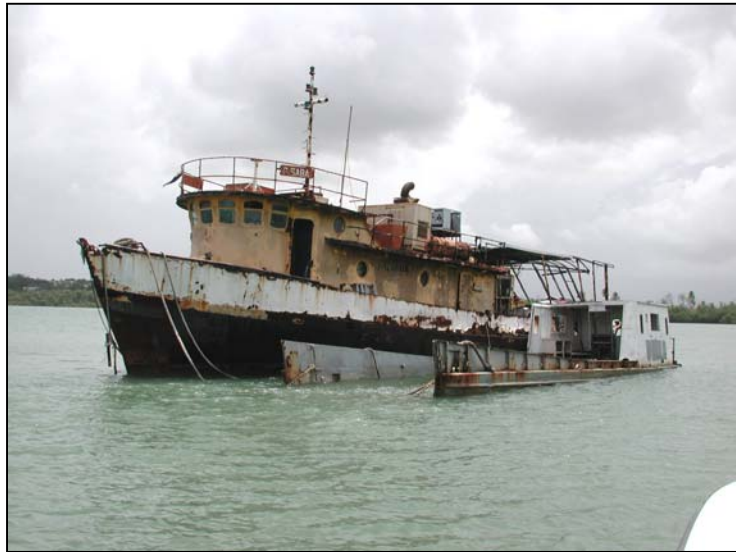
Slip/fall hazard, possible entrapment hazard.

Vessels grounded on soft mud bottom in middle of bay. No expected habitat damage unless vessels were to move into seagrass or mangrove habitats during a major storm or hurricane, which may be unlikely.

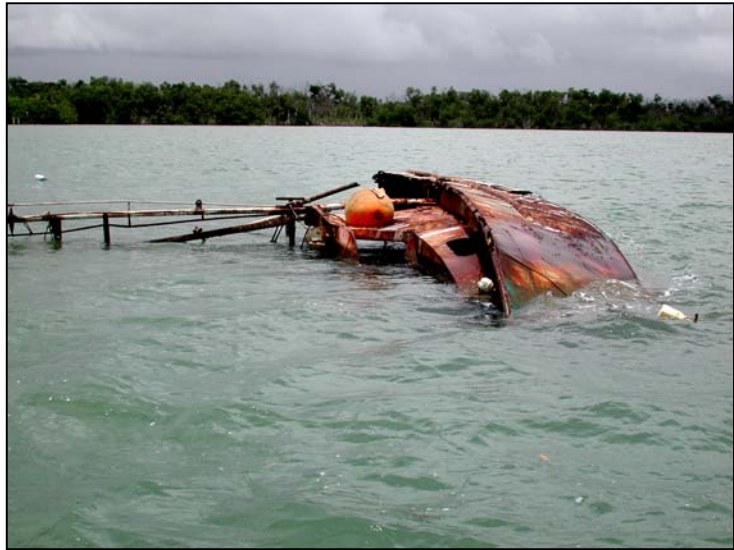
No pollution hazard. Could be a navigational hazard, though it is out of main traffic areas.

Slip/fall hazard, possible entanglement and entrapment hazards.

Vessel on soft mud bottom in middle of bay. No expected habitat damage unless vessel was to move into seagrass or mangrove habitats during a major storm or hurricane, which may be unlikely. Possible wildlife entanglement issues associated with rigging and lines.

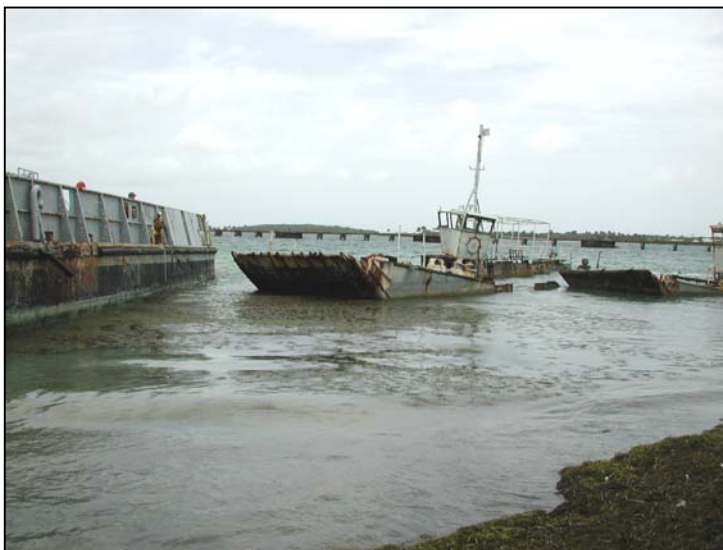
Slips and trips hazard if the public boards the vessel.

Vessel occurs in seagrass habitat, mainly turtle grass mixed with calcareous macroalgae. Seagrass has likely been damaged underneath and around the vessel. Additional damage could occur from scour or if the vessel moved during a major storm or hurricane. Vessel occurs adjacent to designated critical habitat for the federally endangered yellow-shouldered blackbird, which uses mangroves and coastal fringe habitats. See Code of Federal Regulations, Title 50, Chapter I, Part 17.95, 1 October 2001, <http://www.access.gpo.gov/>. Mangroves are the primary nesting habitat for this species. Mangroves could be damaged if the vessel moved onshore during a major storm or hurricane.

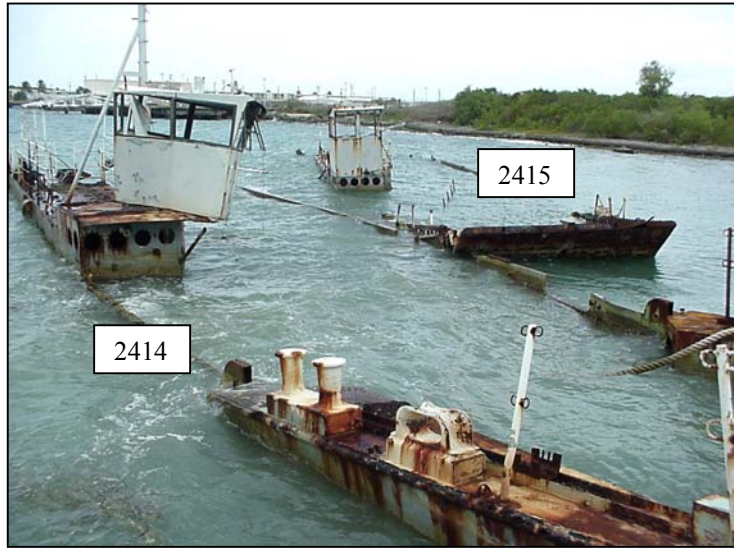
Slips and trips hazard if the public boards the vessel.

Vessel occurs in seagrass habitat, mainly turtle grass mixed with calcareous macroalgae. Seagrass has likely been damaged underneath and around the vessel. Additional damage could occur from scour or if the vessel moved during a major storm or hurricane. Vessel occurs adjacent to designated critical habitat for the federally endangered yellow-shouldered blackbird, which uses mangroves and coastal fringe habitats. See Code of Federal Regulations, Title 50, Chapter I, Part 17.95, 1 October 2001, <http://www.access.gpo.gov/>. Mangroves are the primary nesting habitat for this species. Mangroves could be damaged if the vessel moved onshore during a major storm or hurricane.

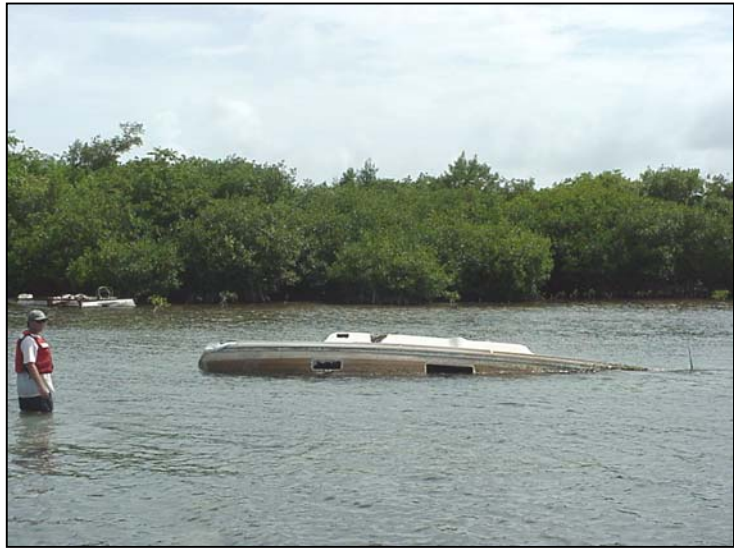
Sailboat, 35 ft x 8 ft fiberglass hull, with two (broken) masts and part of the sails present. Submerged and tilting by 15 degrees to port in 3 ft of water and 100 ft from a mangrove-fringed shoreline. Scour pit 5 ft deep and 6 ft wide all around vessel.

Vessel occurs in shallow seagrass habitat with dense turtle grass. Seagrass has been damaged by vessel and scour in an area roughly 50 ft x 20 ft in maximum length and width. Additional seagrass damage could occur from scour or if the vessel moved during a major storm or hurricane. Vessel occurs adjacent to designated critical habitat for the federally endangered yellow-shouldered blackbird, which uses mangroves and coastal fringe habitats. See Code of Federal Regulations, Title 50, Chapter I, Part 17.95, 1 October 2001, <http://www.access.gpo.gov/>. Mangroves are the primary nesting habitat for this species. Mangroves could be damaged if the vessel moved onshore during a major storm or hurricane.

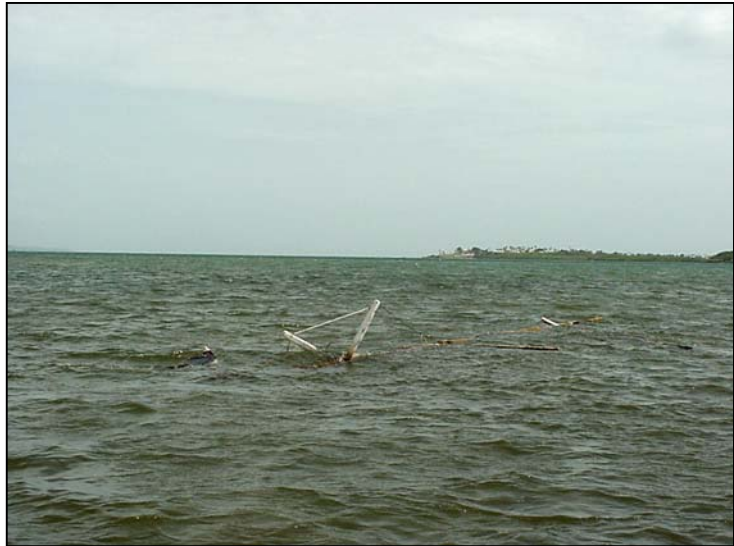
Vessel occurs in shallow seagrass habitat, dense turtle grass mixed with manatee grass. Seagrass has been damaged by vessel and scour. Scour around vessel is about 3 ft wide. Additional seagrass damage could occur from scour or if the vessel moved during a major storm or hurricane. Vessel occurs adjacent to designated critical habitat for the federally endangered yellow-shouldered blackbird, which uses mangroves and coastal fringe habitats. See Code of Federal Regulations, Title 50, Chapter I, Part 17.95, 1 October 2001, <http://www.access.gpo.gov/>. Mangroves are the primary nesting habitat for this species. Mangroves could be damaged if the vessel or parts of the vessel moved ashore during a major storm or hurricane.
