# Surveys of Abandoned Vessels: U.S. Caribbean Region

Jacqueline Michel, Scott Zengel, Christine Lord, and Zach Nixon  
Research Planning, Inc.  
Columbia, South Carolina 29202

September 2002

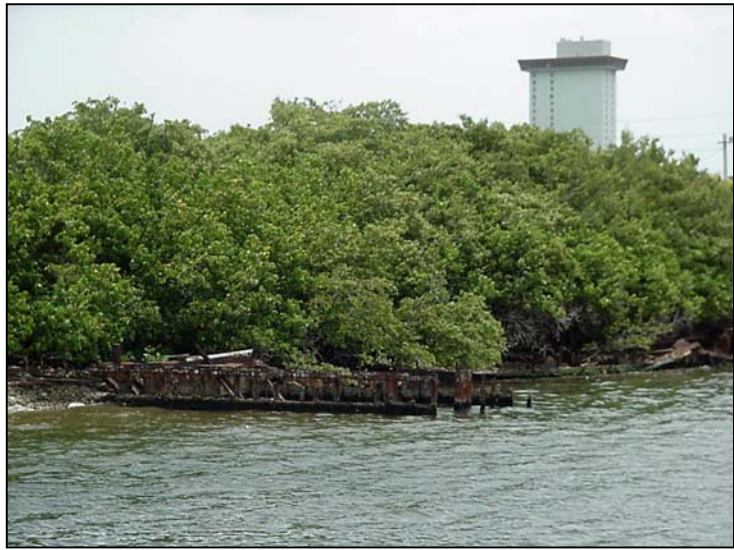
Rusted metal remnants of 3 vessels.  
Unable to identify vessel types.

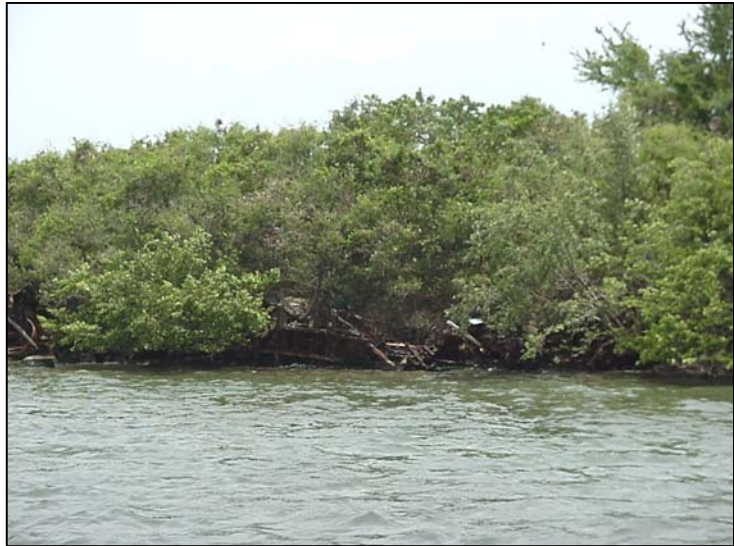
Rusted metal remnants of 1 vessel.  
Unable to identify vessel type.

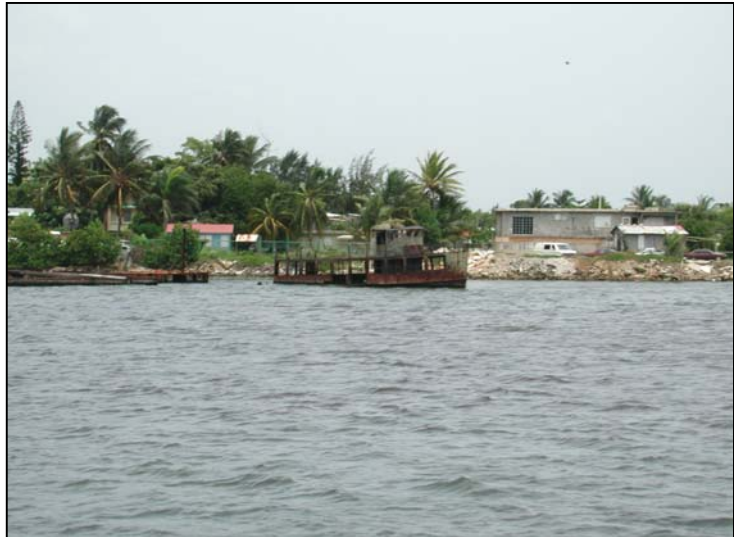
Rusted metal party boat or small  
fishing vessel. Grounded and  
partially submerged.

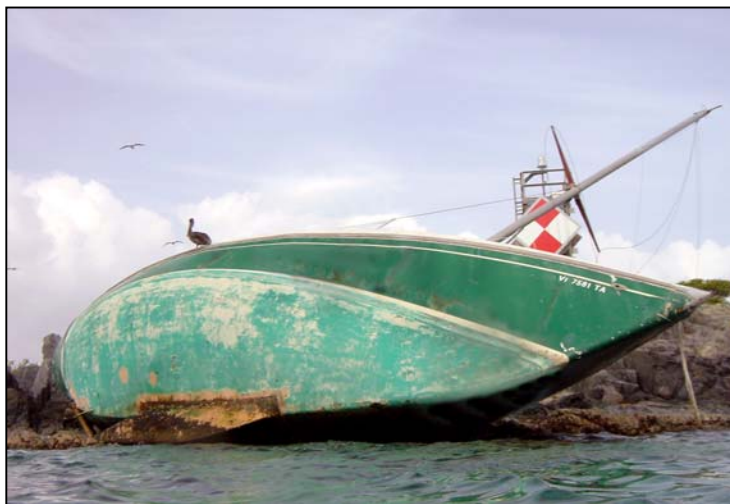
- a) **General status of vessel:** Aground.
- b) **Nature of casualty:** Storm.
- c) **What were the circumstances of the grounding or abandonment?** Vessel was anchored and tossed onshore by storm.
- d) **Date of grounding/length of time the vessel has been "abandoned":** 2001 or earlier.
- e) **General description of vessel damage:** Vessel mostly intact, keel broken.
- f) **Vessel Cargo:** None.

- a) **Is there fuel or hazmat onboard? Estimated quantities?** Unknown.
- b) **Evidence of releases? Sheens?** No.
- c) **Evidence of illegal dumping?** No.
- d) **Condition of fuel tanks:** Onboard, tank holed.
- e) **Other equipment and supplies that may pose their own threats:** No.
- f) **What new or continuing harm to natural resources might result by removing oil/hazardous substances but leaving the vessel?** N/A.

- a) **Location of vessel relative to navigation channel(s):** Vessel is ashore.
- b) **Depth and visibility of the vessel:** N/A.
- c) **Is the vessel properly marked?** N/A.
- d) **Type of navigation in the area:** Varied.
- e) **Has the vessel moved over time? Might it move in the future?** It has not moved over time. It is possible it could move into the channel during a storm.
- f) **Would other structures be endangered if the vessel were to shift or move?** Beacon may be damaged by mast.

- a) **Public uses in the area:** Small island, not publicly used.
- b) **Evidence of people boarding the vessel?** No.
- c) **Entrapment or slip/fall hazards?** Yes, slip/fall hazard.

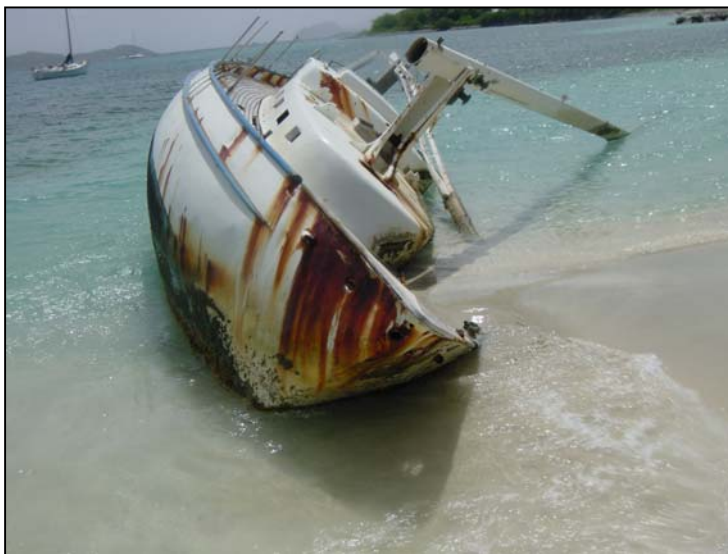
- a) **General status of vessel:** Aground.
- b) **Nature of casualty:** Storm, possibly Hurricane Marilyn.
- c) **What were the circumstances of the grounding or abandonment?** Storm.
- d) **Date of grounding/length of time the vessel has been "abandoned":** Possibly 1995.
- e) **General description of vessel damage:** Vessel rusted, mast in water.
- f) **Vessel Cargo:** None.

- a) **Public uses in the area:** Recreational beach, mooring area.
- b) **Evidence of people boarding the vessel?** Yes, "not abandoned, keep off" written on deck.
- c) **Entrapment or slip/fall hazards?** Yes, slip/fall hazard.

- e) **Substrate:** Coarse-grained sand.
- f) **Damage Observations:** Vessel could cause seagrass damage if it moved during major storms or hurricanes.

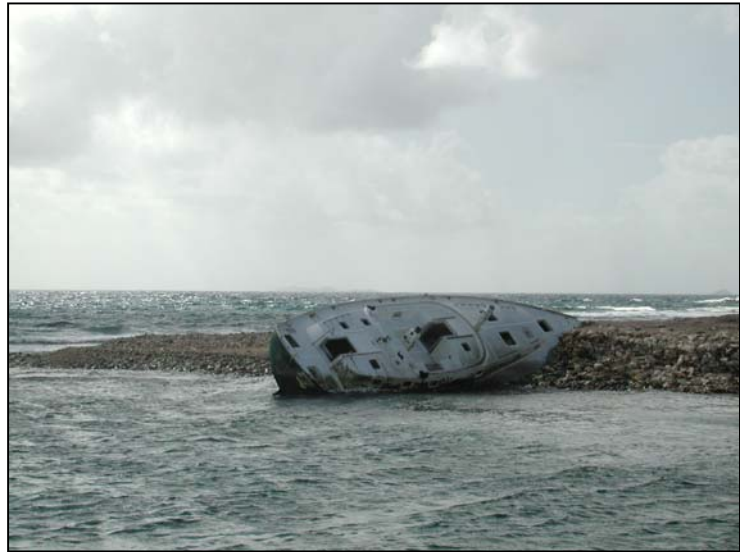
- a) **General status of vessel:** Aground and ashore.
- b) **Nature of casualty:** Mooring broke in Honeymoon Bay (Water Island) and drifted to Saba Island.
- c) **What were the circumstances of the grounding or abandonment?** Grounded after mooring broke.
- d) **Date of grounding/length of time the vessel has been "abandoned":** 2000.
- e) **General description of vessel damage:** The hull is intact, but is approximately  $\frac{1}{4}$  filled with gravel.
- f) **Vessel Cargo:** None.

- a) **Dimensions of vessel grounding footprint:** Similar to principal vessel dimensions.
- b) **Dimensions of debris field:** N/A.
- c) **Primary Habitat(s):** Hardground and coral rubble. Some macroalgae occurs on substrate, but very little live coral.
- d) **Secondary Habitat(s):** The bow is grounded on a mixed sand gravel beach with some cobble to boulder sized sediments.
- e) **Substrate:** Hardground coral and rubble with some calcareous sand.
- f) **Damage Observations:** The vessel is located in a high energy environment, and its presence onshore is causing a high gravel berm (3-6 ft) to form on the starboard side, and erosion to occur on the port side. Damage to benthic habitats is not evident, but is possible if the vessel was to move during a storm event.

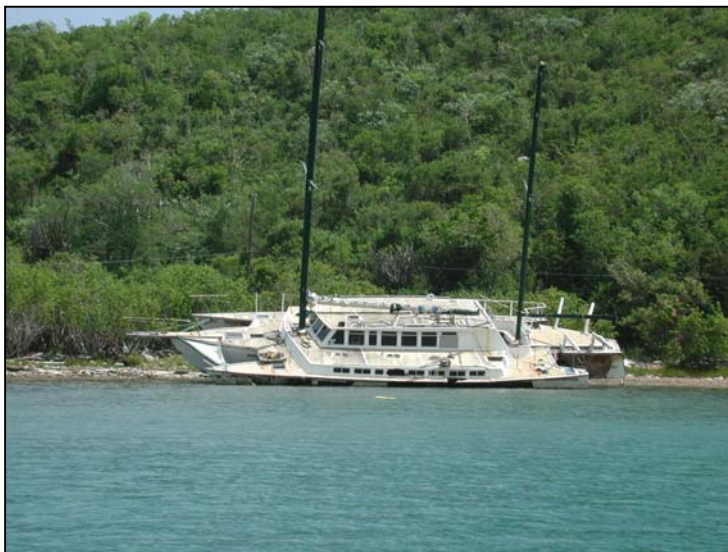
- a) **General status of vessel:** Ashore.
- b) **Nature of casualty:** Hurricane Marilyn.
- c) **What were the circumstances of the grounding or abandonment?** Unknown.
- d) **Date of grounding/length of time the vessel has been "abandoned":** 1995.
- e) **General description of vessel damage:** Holes in the hull, a lot of trash and debris onboard and near vessel.
- f) **Vessel Cargo:** Mostly trash and debris.

- a) **Public uses in the area:** Adjacent land tenant, area used as workshop, sailboat moorings in entrance to cove.
- b) **Evidence of people boarding the vessel?** No.
- c) **Entrapment or slip/fall hazards?** Yes, slip/fall hazard.

- e) **Substrate:** The benthic substrate is mud, the beach substrate is mixed coarse-grained sand and gravel.
- f) **Damage Observations:** Seagrass and macroalgae density are lower in the vicinity of the vessel than further offshore, and additional damage to these habitats is possible if the vessel moved during a large storm or hurricane.

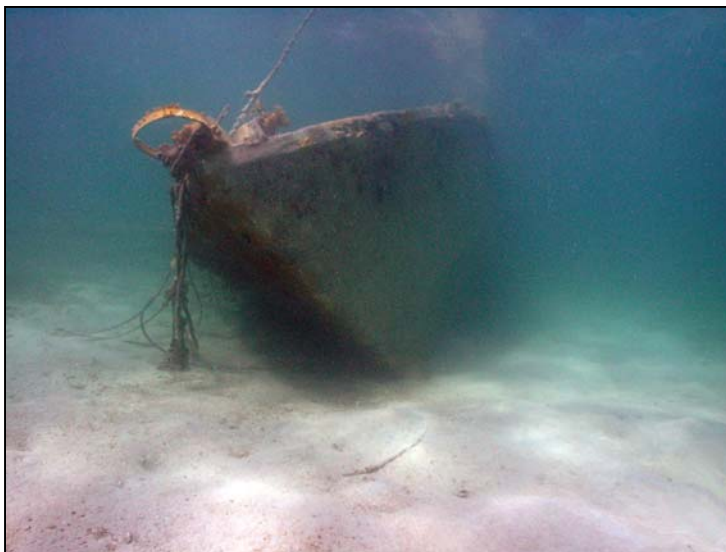
- a) **General status of vessel:** Submerged.
- b) **Nature of casualty:** Sank on mooring.
- c) **What were the circumstances of the grounding or abandonment?** Possibly negligence.
- d) **Date of grounding/length of time the vessel has been "abandoned":** 1995.
- e) **General description of vessel damage:** The interior of the vessel is mostly debris, wiring, etc., but the hull is mostly intact. Some coral is growing on the vessel.
- f) **Vessel Cargo:** None.

- f) **Damage Observations:** Un-vegetated area was present around entire vessel. Several blowout areas were observed around the port side near the bow and stern. Small eroding scarps were observed at the edge of the seagrass beds along the entire port and stern sides.

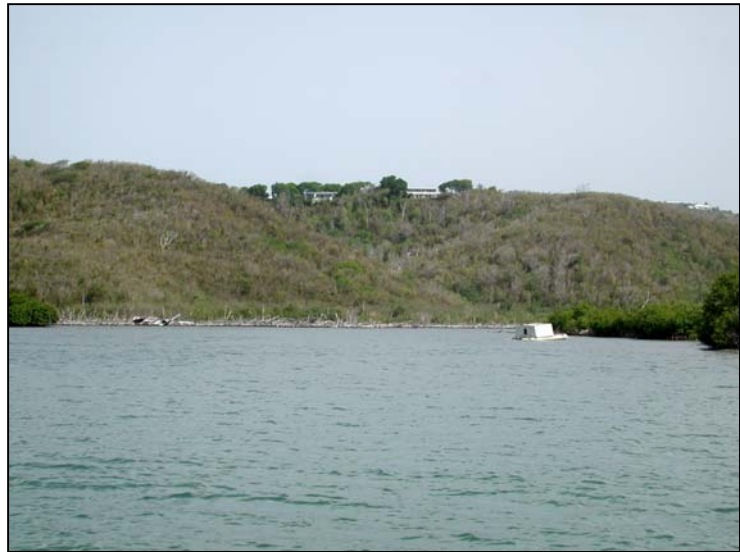
The land surrounding the bay is part of the Salt River Bay National Historic Park and Ecological Preserve, managed by the National Park Service. The site is also designated as a USVI Marine Reserve and Wildlife Sanctuary, under authority of DPNR. The vessel is aground and mostly exposed.

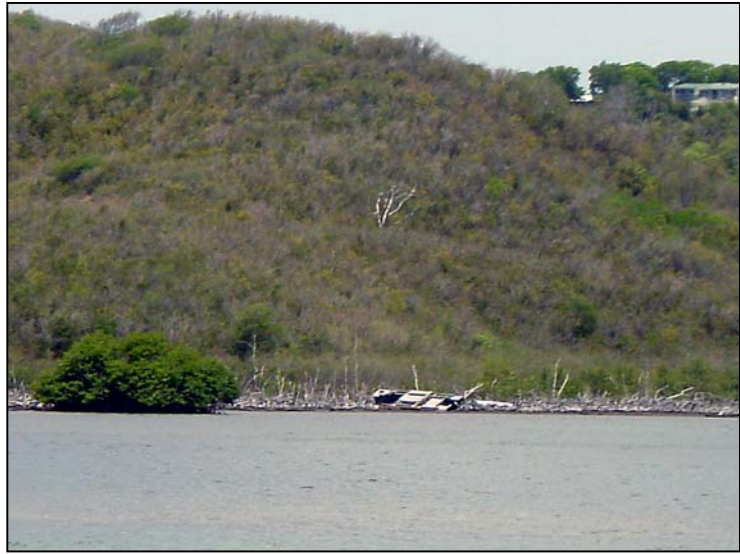
The land surrounding the bay is part of the Salt River Bay National Historic Park and Ecological Preserve, managed by the National Park Service. The site is also designated as a USVI Marine Reserve and Wildlife Sanctuary, under authority of DPNR. The vessel is ashore in dead mangroves.

Extensive physical mangrove damage observed, but may be due to hurricanes or other factors. Nearby benthic habitat not surveyed, but may be macroalgae. Vessel could cause macroalgae damage if it moved during major storms or hurricanes.

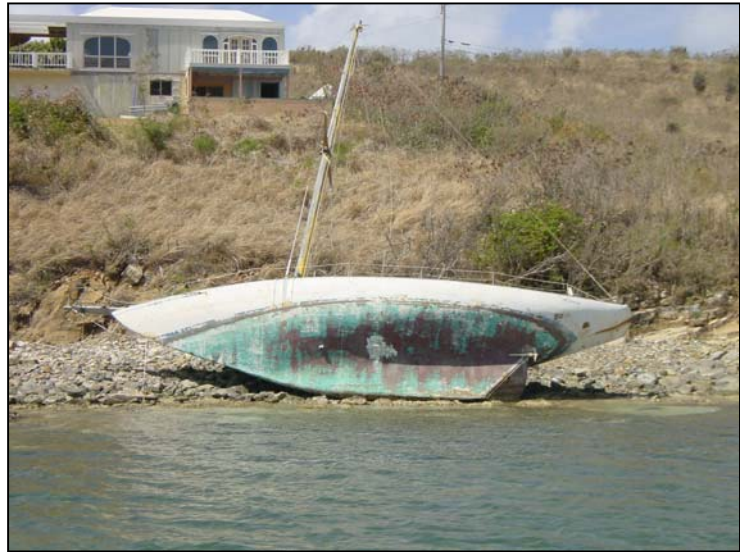
The vessel occurs on a gravel beach adjacent to a sheltered rocky shore. Seagrass occurs in intertidal and subtidal areas adjacent to shore, and damage to this habitat could occur if the vessel moved during a major storm or hurricane.

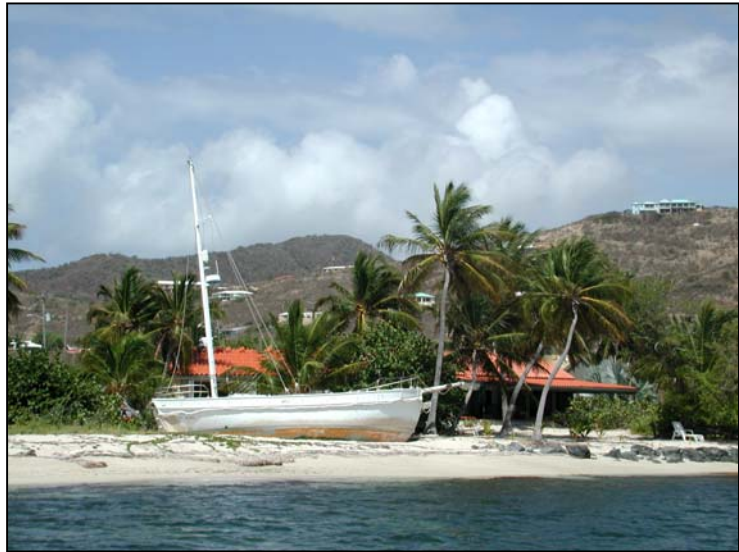
Fiberglass sailboat, sitting upright, fairly good condition, still has electrical equipment onboard.

The vessel is ashore on a sand beach. Seagrass occurs in adjacent subtidal areas. Damage to this habitat could occur if the vessel moved during a major storm or hurricane.

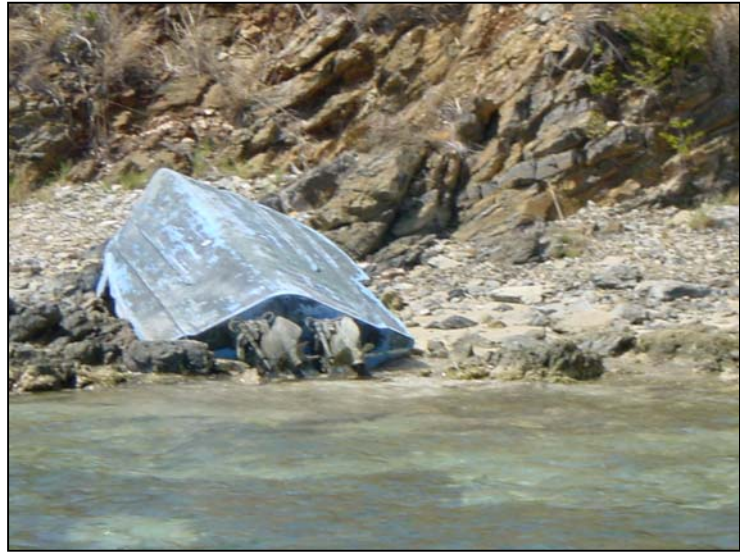
The vessel occurs on a gravel beach adjacent to a sheltered rocky shore. Seagrass occurs in intertidal and subtidal areas adjacent to shore, and damage to this habitat could occur if the vessel moved during a major storm or hurricane.

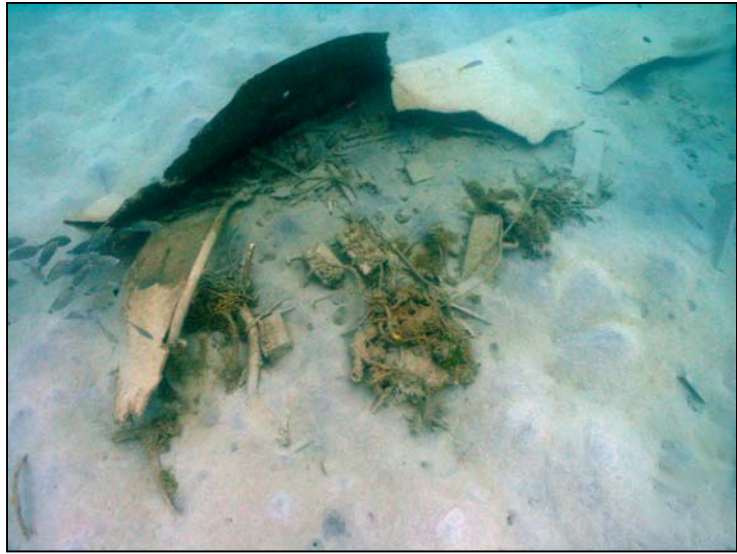
Some batteries and a buried fuel tank were observed. No navigation threat.

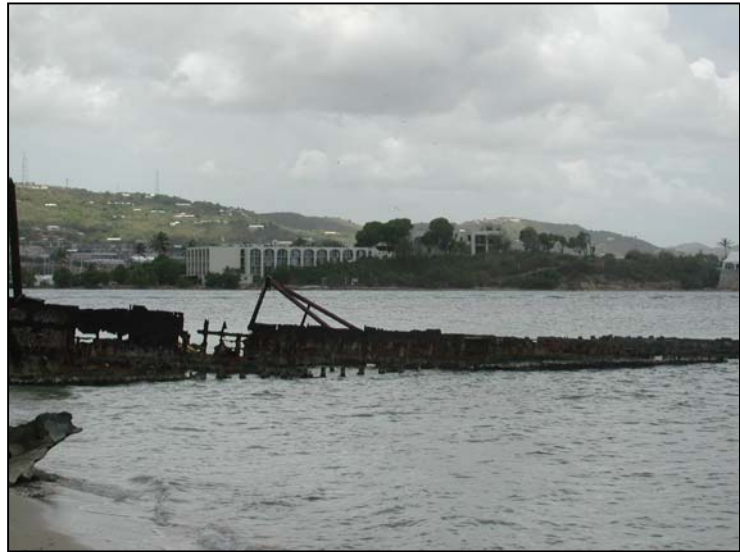
Slip/fall hazard, and a lot of rusty edges and debris onshore.

The bow of the vessel occurs on a mixed sand and gravel beach. The stern occurs on unconsolidated sediment with sparse seagrass and *Halimeda*. The vessel is currently serving as a breakwater to the adjacent marina. Pilings and pipes occur off of the starboard side. Seagrass and macroalgae has likely been damaged underneath and around the vessel. Additional damage could occur if the vessel moved during a major storm or hurricane.

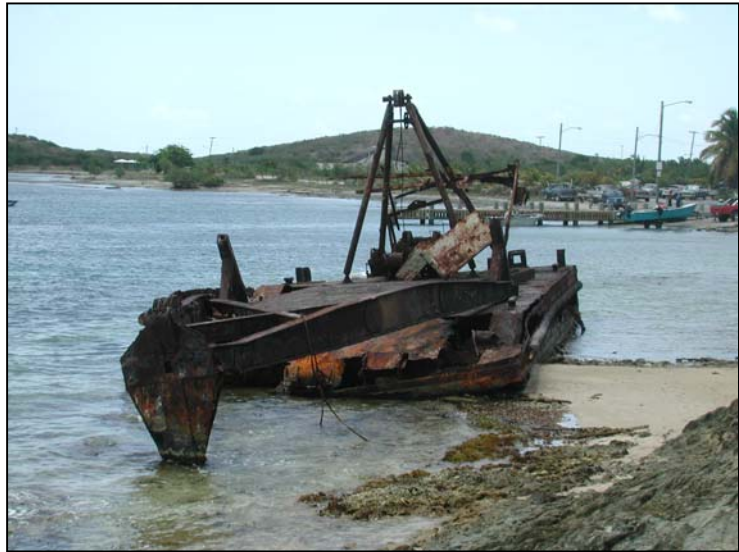
Slip/fall hazard and rusty parts.

The vessel occurs partially on a mixed sand and gravel beach and partially on unconsolidated sediment with sparse seagrass. The vessel may be interfering with circulation in and out of Altona Lagoon. Seagrass has likely been damaged underneath and around the vessel. Additional damage could occur if the vessel moved during a major storm or hurricane.

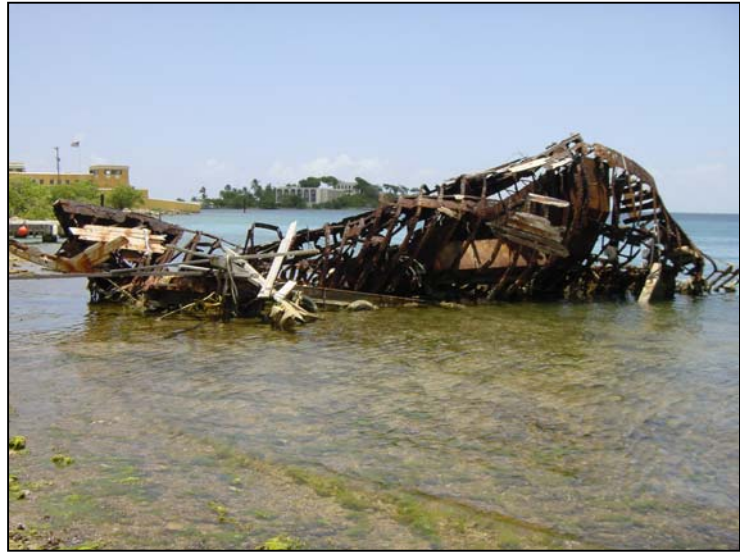
Burned sailboat on wheeled device for hauling out of water, steel frame and wood hull.

Burned.

Slip/fall hazard and rusty parts.

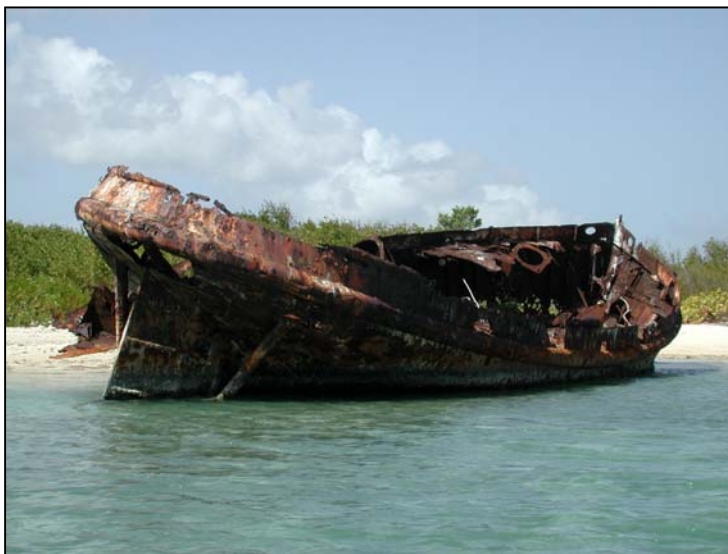
- a) **General status of vessel:** Aground and ashore.
- b) **Nature of casualty:** Unknown.
- c) **What were the circumstances of the grounding or abandonment?** Unknown.
- d) **Date of grounding/length of time the vessel has been "abandoned":** Unknown, possibly since the 1960's.
- e) **General description of vessel damage:** Vessel is deteriorating, several large holes in hull, debris inside.
- f) **Vessel Cargo:** None.

- a) **Public uses in the area:** Minimal fishing and conching.
- b) **Evidence of people boarding the vessel?** No.
- c) **Entrapment or slip/fall hazards?** Yes, the vessel is badly rusted.

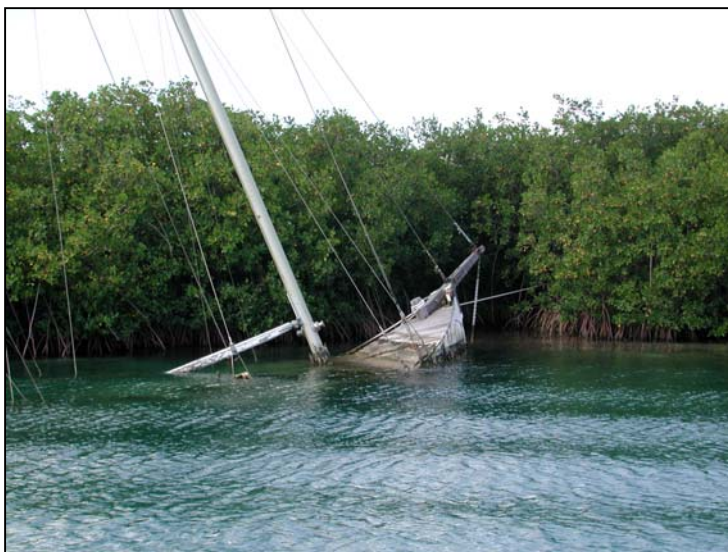
- a) **General status of vessel:** Partially submerged and tied in mangroves.
- b) **Nature of casualty:** Possibly Hurricane Lenny.
- c) **What were the circumstances of the grounding or abandonment?** Hurricane, or was left unattended on mooring and sunk for other reasons.
- d) **Date of grounding/length of time the vessel has been "abandoned":** Possibly 2000.
- e) **General description of vessel damage:** Vessel is rotting.
- f) **Vessel Cargo:** None.

f) **Damage Observations:** The area underneath the vessel is devoid of macroalgae. The vessel is tied to the mangroves. Additional damage to macroalgae or mangroves is possible if the vessel were to move during large storms or hurricanes.

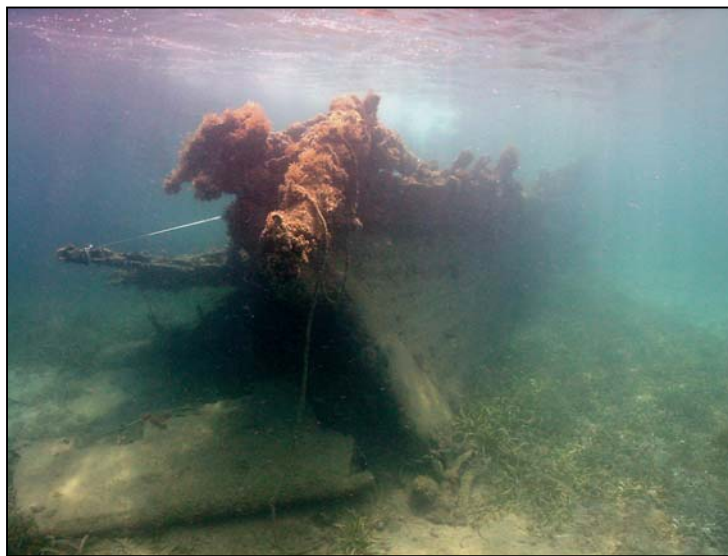
- a) **General status of vessel:** Submerged.
- b) **Nature of casualty:** Possibly Hurricane Marilyn.
- c) **What were the circumstances of the grounding or abandonment?** Unknown.
- d) **Date of grounding/length of time the vessel has been "abandoned":** Possibly 1995.
- e) **General description of vessel damage:** A lot of growth on vessel, hull fairly intact, but deteriorating in some places.
- f) **Vessel Cargo:** None.

- a) **Dimensions of vessel grounding footprint:** The area under and around the vessel devoid of seagrass was roughly 43 ft x 15 ft.
- b) **Dimensions of debris field:** N/A.
- c) **Primary Habitat(s):** Seagrass. Dense turtle grass occurs surrounding the vessel scour on all sides excluding approximately 2/3 of the starboard side.
- d) **Secondary Habitat(s):** The habitat off of the starboard side is mostly hardbottom with sand and boulders and some live coral on larger boulders.
- e) **Substrate:** Coarse-grained sand.
- f) **Damage Observations:** Un-vegetated area was present around entire vessel, and was larger on the port side of the bow and around the stern. Vessel could cause additional seagrass damage or damage to live coral if it moved during major storms or hurricanes.

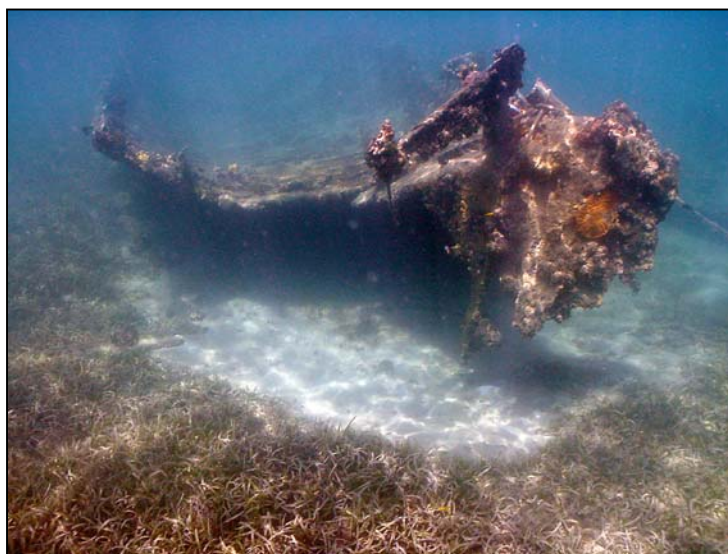
- a) **General status of vessel:** Submerged.
- b) **Nature of casualty:** Vessel caught on fire on mooring.
- c) **What were the circumstances of the grounding or abandonment?** Fire was extinguished, and vessel was not salvageable.
- d) **Date of grounding/length of time the vessel has been "abandoned":** Sometime between 1983-1985.
- e) **General description of vessel damage:** Vessel is burned, steel hull partially remaining.
- f) **Vessel Cargo:** None.

- a) **Dimensions of vessel grounding footprint:** The area under and around the vessel devoid of seagrass was roughly 72 ft x 33 ft.
- b) **Dimensions of debris field:** N/A.
- c) **Primary Habitat(s):** Seagrass. Dense turtle grass occurs surrounding the vessel scour on all sides.
- d) **Secondary Habitat(s):** Approximately 30 feet to the port side of the bow is an area of sand and gravel bottom with some soft coral.
- e) **Substrate:** Coarse-grained sand and gravel.
- f) **Damage Observations:** Un-vegetated area was present around entire vessel, but was wider around the bow and on the starboard side. Vessel could cause additional seagrass damage, or possibly soft coral damage, if it moved during major storms or hurricanes.

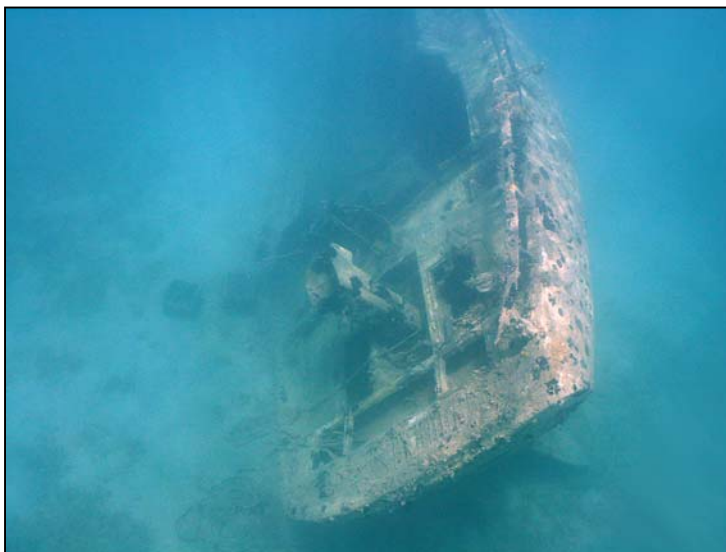
- a) **General status of vessel:** Submerged.
- b) **Nature of casualty:** Probably Hurricane Marilyn.
- c) **What were the circumstances of the grounding or abandonment?** Hurricane.
- d) **Date of grounding/length of time the vessel has been "abandoned":** 1995.
- e) **General description of vessel damage:** Vessel has port list, deteriorating, no mast or rigging.
- f) **Vessel Cargo:** None.

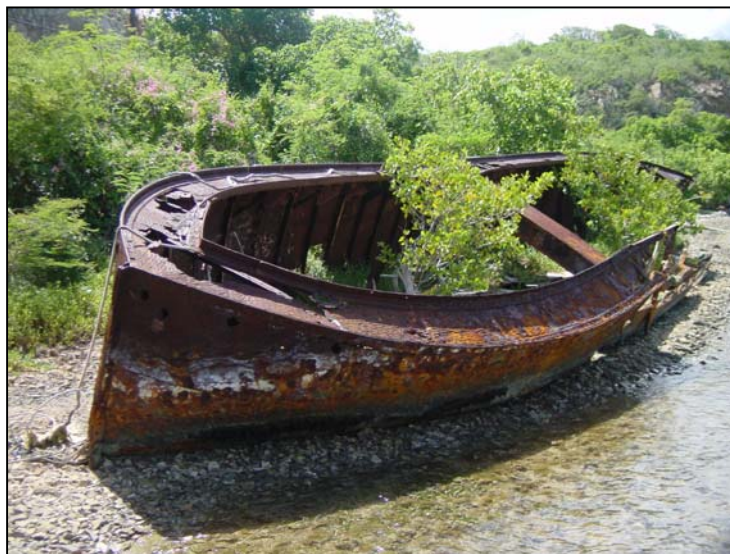
- a) **General status of vessel:** Ashore.
- b) **Nature of casualty:** Unknown.
- c) **What were the circumstances of the grounding or abandonment?** Unknown.
- d) **Date of grounding/length of time the vessel has been "abandoned":** Has been abandoned for a very long time.
- e) **General description of vessel damage:** Deck deteriorated, only steel hull remains, mangroves and vegetation growing in hull.
- f) **Vessel Cargo:** None.

- a) **Public uses in the area:** Adjacent land tenant, area used as workshop, sailboat moorings in entrance to cove.
- b) **Evidence of people boarding the vessel?** No.
- c) **Entrapment or slip/fall hazards?** Rusty parts.

- a) **Dimensions of vessel grounding footprint:** The footprint is similar to the vessel dimensions.
- b) **Dimensions of debris field:** N/A.
- c) **Primary Habitat(s):** Sand and gravel beach. The vessel is aground parallel to shore on coarse-grained sand and pebble to cobble sized gravel sediments
- d) **Secondary Habitat(s):** Sparse turtle grass and macroalgae on mud and some gravel occurs adjacent to the vessel.
- e) **Substrate:** The benthic substrate is mud, the beach substrate is mixed coarse-grained sand and gravel.
- f) **Damage Observations:** Seagrass and macroalgae density are lower in the vicinity of the vessel than further offshore, and additional damage to these habitats is possible if the vessel moved during a large storm or hurricane.

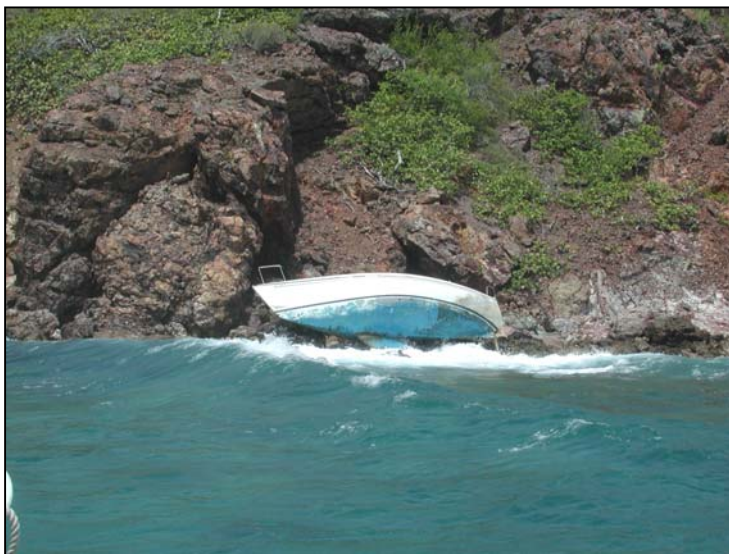
- a) **General status of vessel:** Ashore.
- b) **Nature of casualty:** Accident while motoring.
- c) **What were the circumstances of the grounding or abandonment?** Motoring at night.
- d) **Date of grounding/length of time the vessel has been "abandoned":** 2000.
- e) **General description of vessel damage:** Mast missing.
- f) **Vessel Cargo:** Unknown.

- b) **Evidence of people boarding the vessel?** Unknown, but unlikely.
- c) **Entrapment or slip/fall hazards?** Yes, slip/fall hazard.

- a) **Dimensions of vessel grounding footprint:** The footprint is similar to the principal dimensions of the vessel.
- b) **Dimensions of debris field:** N/A.
- c) **Primary Habitat(s):** Exposed rocky platform.
- d) **Secondary Habitat(s):** Unknown, but possibly hardbottom/coral reef.
- e) **Substrate:** Unknown.
- f) **Damage Observations:** Damage to coral reef and hardbottom habitat is possible if the vessel moved during a large storm or hurricane.

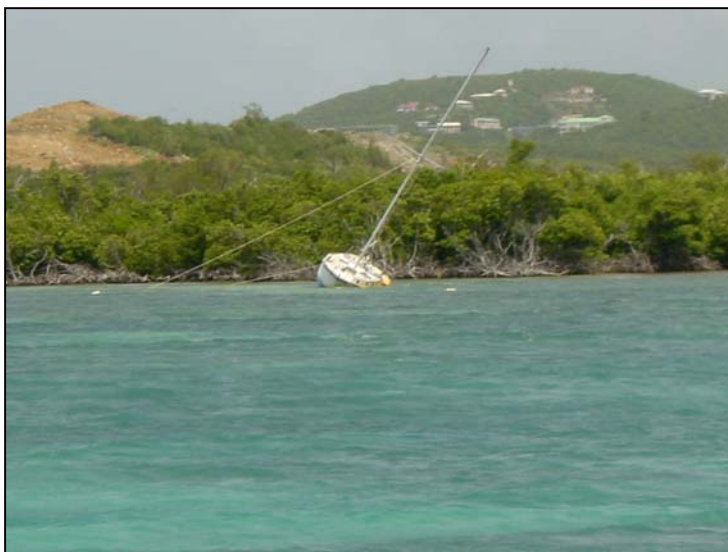
- a) **General status of vessel:** Aground.
- b) **Nature of casualty:** Blown off of mooring by wind.
- c) **What were the circumstances of the grounding or abandonment?** Not properly anchored.
- d) **Date of grounding/length of time the vessel has been "abandoned":** 2002.
- e) **General description of vessel damage:** Lots of lines on it, looks like someone may be in the process of trying to right the vessel.
- f) **Vessel Cargo:** Unknown.

- a) **Public uses in the area:** Limited use, in mangrove area.
- b) **Evidence of people boarding the vessel?** Unknown.
- c) **Entrapment or slip/fall hazards?** Yes, slip/fall hazard.

- a) **Dimensions of vessel grounding footprint:** Unknown, too shallow to approach in USCG vessel.
- b) **Dimensions of debris field:** N/A.
- c) **Primary Habitat(s):** Likely seagrass.
- d) **Secondary Habitat(s):** Mangroves are along the shoreline behind the vessel.
- e) **Substrate:** Unknown.
- f) **Damage Observations:** Vessel could cause additional mangrove and seagrass injury if it moved or broke up during a major a storm or hurricane.

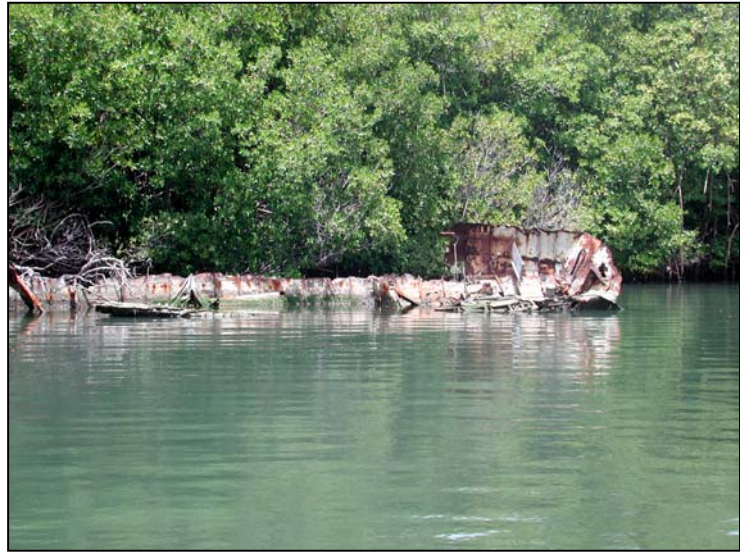
Steel hulled sailboat, badly deteriorated.

Slip/fall hazard.

Physical mangrove damage (dead trees) occurred along the starboard side of the vessel near the bow. Vessel could cause additional mangrove damage if it moved or broke up during a major storm or hurricane.

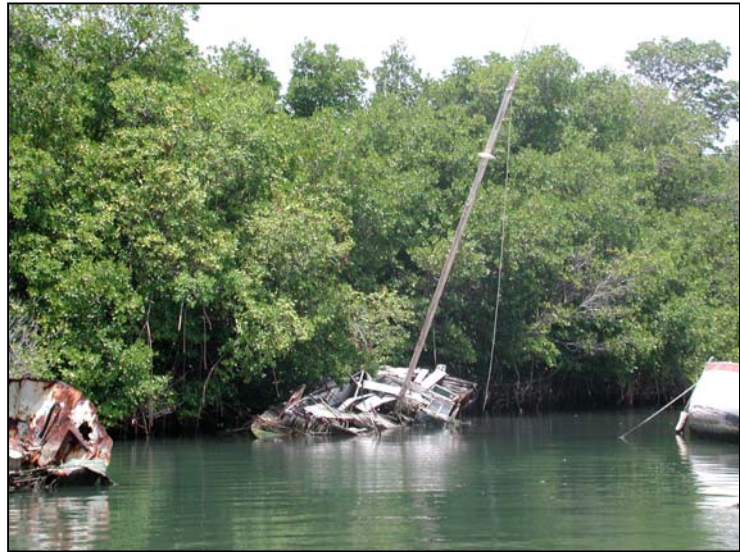
Wooden sailboat, badly deteriorated.

Slip/fall hazard.

Physical mangrove damage (dead trees) occurred along the starboard side of the vessel. Vessel could cause additional mangrove damage if it moved or broke up during a major storm or hurricane.

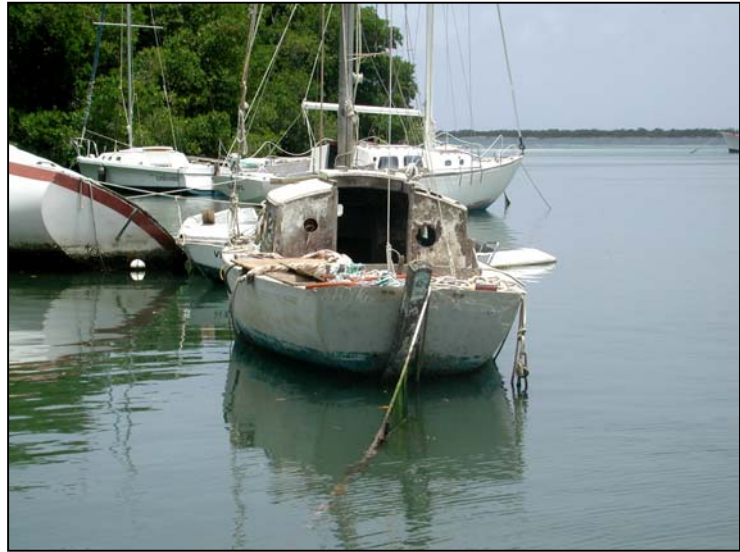
No benthic survey was done. The bottom is probably mud, with some possible seagrass or macroalgae. Vessel is near mangroves, and could cause damage if it moved or broke up during a major storm or hurricane.

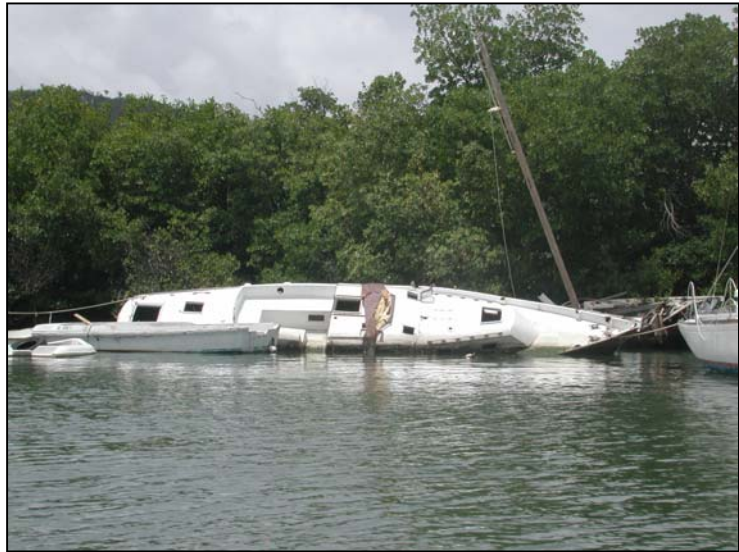
Slip/fall hazard.

No benthic survey was done. The bottom is probably mud, with some possible seagrass or macroalgae. Vessel is near mangroves, and it could cause damage if it moved or broke up during a major storm or hurricane.

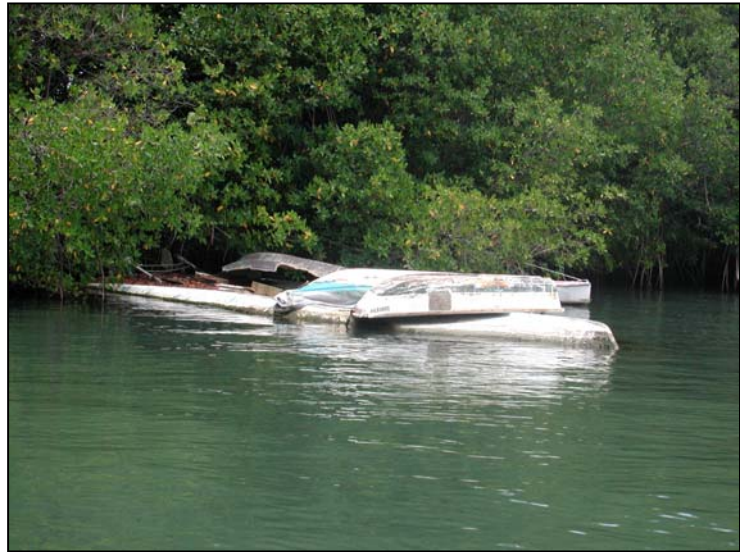
Fiberglass sailboat hull aground, likely damaged (inverted hull in center of photo).

Vessel is in the mangroves, so damage is possible, and additional damage may occur if the vessel moved or was broken up during a major storm or hurricane.

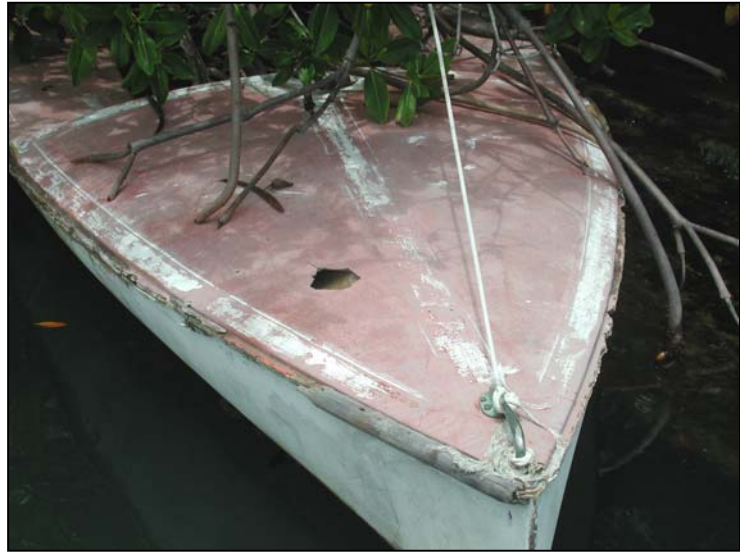
Vessel is in the mangroves, so damage is possible. Additional damage may occur if the vessel moved or was broken up during a major storm or hurricane.

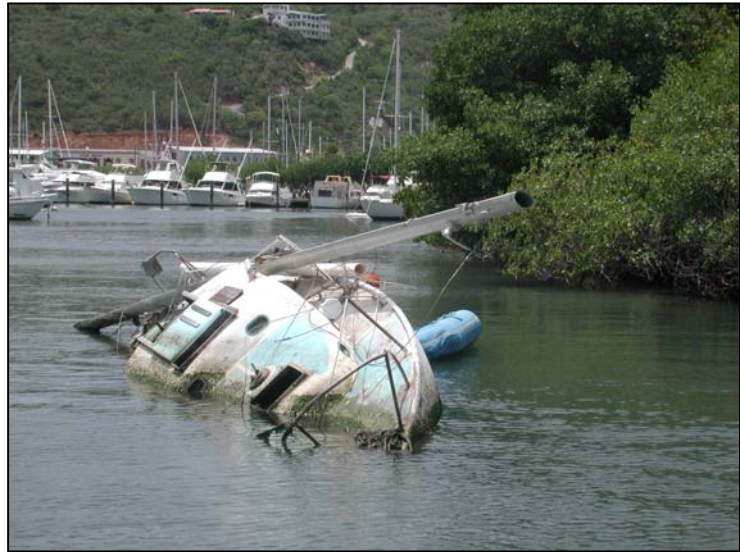
Slip/fall hazard.

No benthic survey was done. The bottom is probably mud, with some possible seagrass or macroalgae. Vessel is near mangroves and could cause damage if it moved or broke up during a major storm or hurricane.

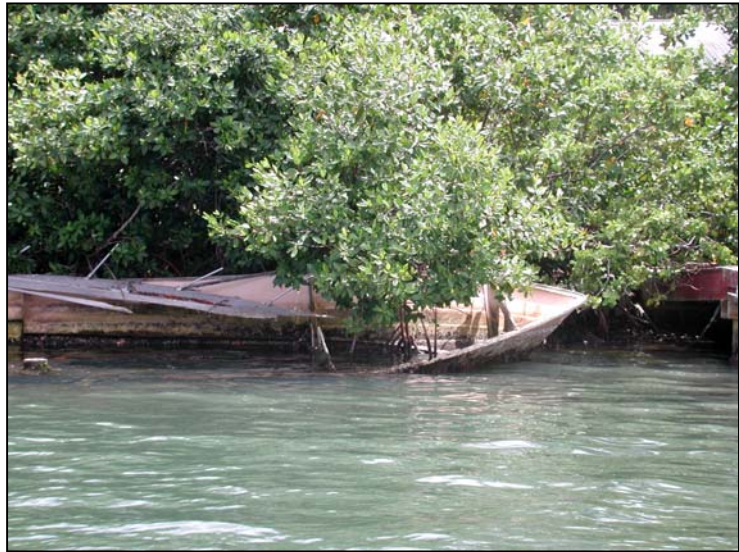
Fiberglass powerboat aground and damaged.

Vessel is in the mangroves, so damage is possible. Additional damage may occur if the vessel moved or was broken up during a major storm or hurricane.

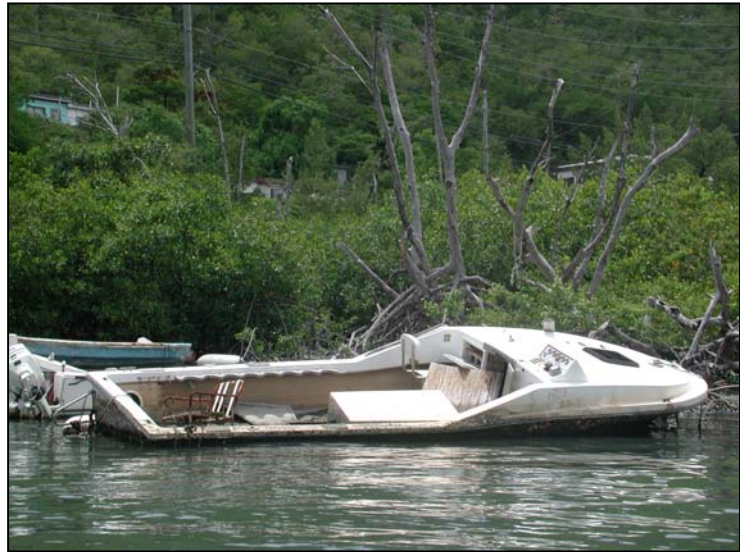
Substantial physical mangrove damage observed along port side of vessel, (dead trees, open canopy, some regeneration occurring). Mangrove damage may have been caused by this and other vessels, although unrelated storm damage also a possibility. Vessel could cause additional mangrove injury if it moved or broke up during a major storm or hurricane.

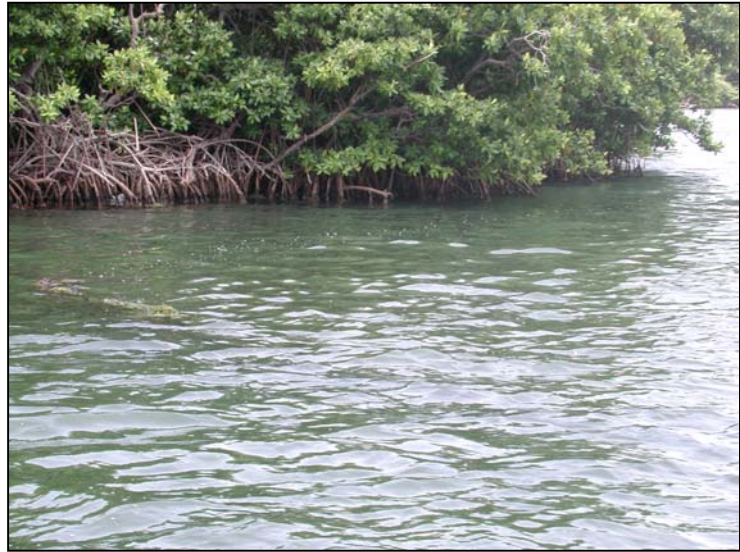
No benthic survey was done. The bottom is probably mud, with some possible seagrass or macroalgae. Vessel is near mangroves, and could cause damage if it moved.

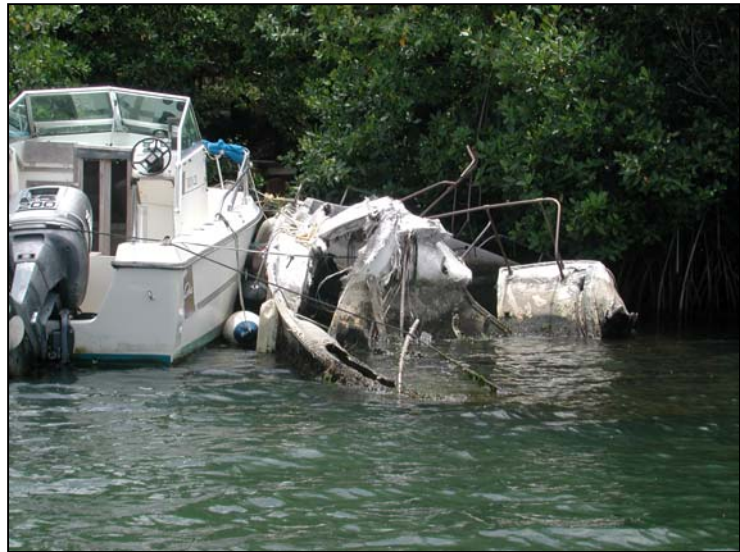
Fiberglass powerboat, aground, badly damaged.

Slip/fall hazard.

Vessel is in the mangroves, so damage is possible. Additional injury may occur if the vessel moved or was broken up during a major storm or hurricane.

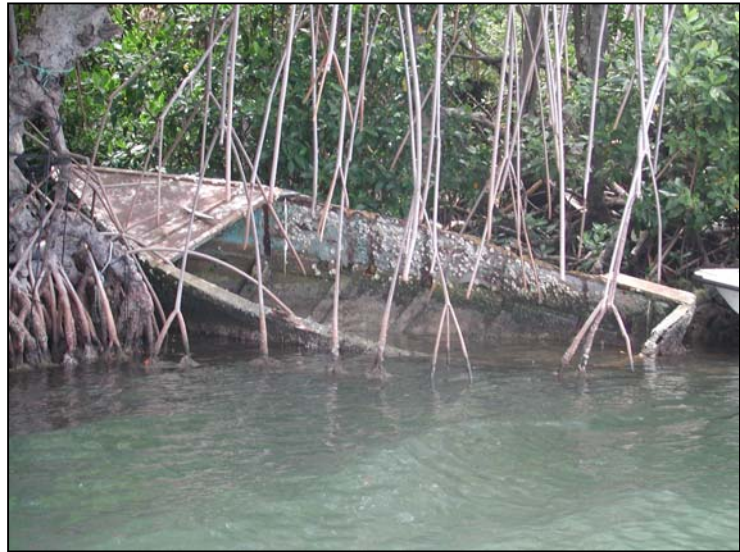
Substantial physical mangrove damage observed along entire vessel (dead trees, open canopy). Mangrove damage may have been caused by this vessel, at least in part, although unrelated hurricane damage also a possibility. Vessel could cause additional mangrove injury if moved during a storm.

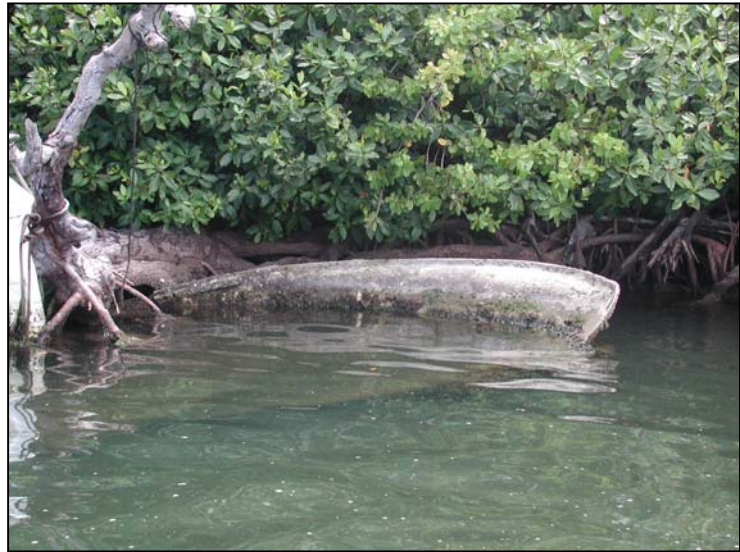
Physical damage to mangrove prop roots was observed. It is unlikely that the vessel would be re-mobilized during a storm, and therefore is unlikely to cause additional injury.

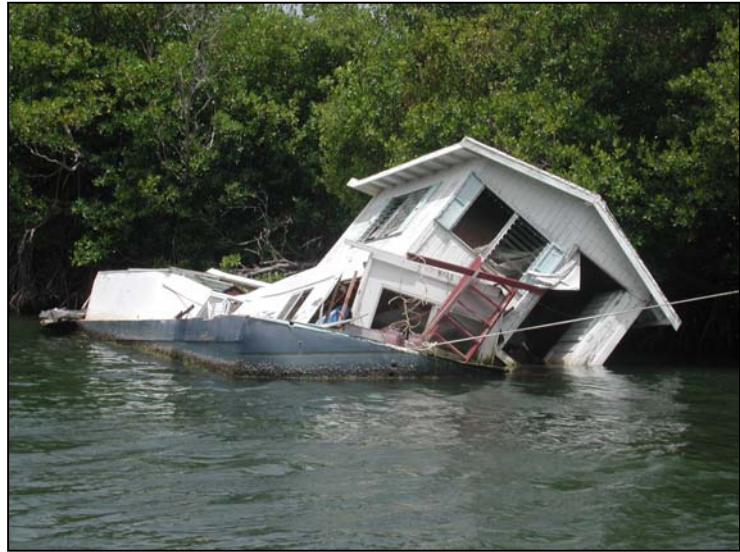
Slip/fall hazard.

Physical mangrove damage observed along port side of vessel (dead trees, open canopy), and vessel is tied to mangroves. Mangrove damage may have been caused by this vessel, at least in part, although storm damage also a possibility. Vessel could cause additional mangrove injury it moved during a storm.

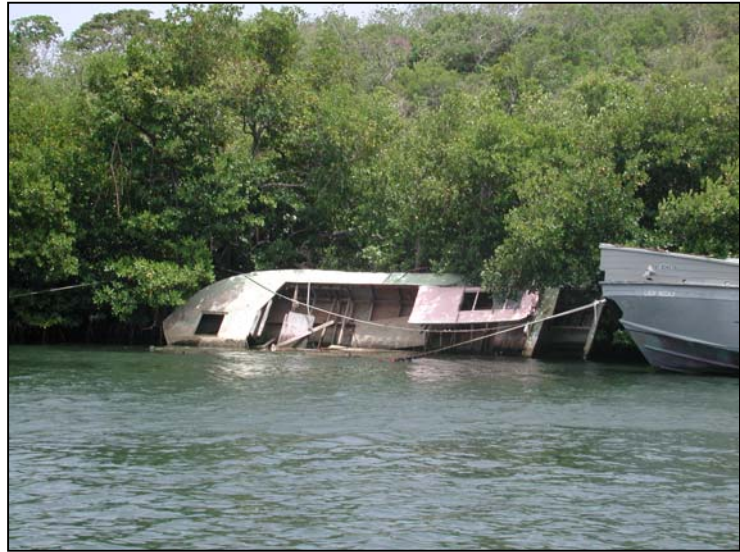
Slip/fall hazard.

Vessel is in the mangroves, so damage is possible. Vessel could cause additional mangrove injury if it moved or broke up during a storm.

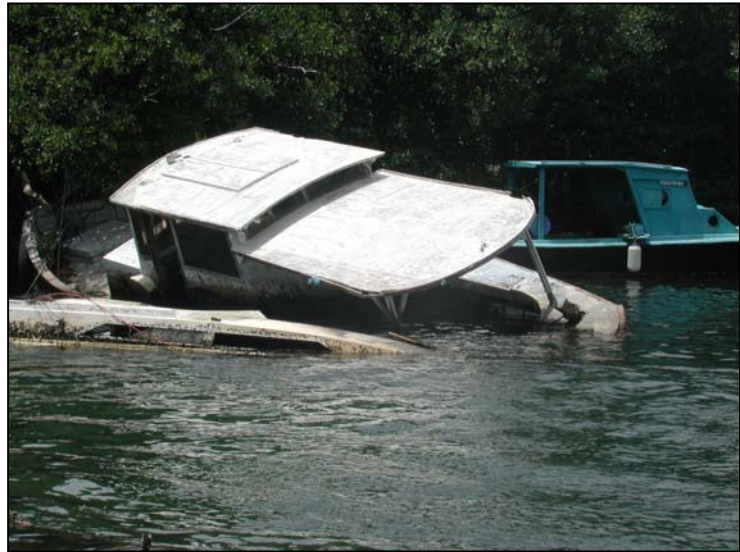
Slip/fall hazard.

Physical mangrove damage observed along port side of vessel (open canopy). Mangrove damage may have been caused by this and other vessels, although unrelated storm damage also a possibility. Vessel could cause additional mangrove injury if it moved or broke up during a major storm or hurricane.

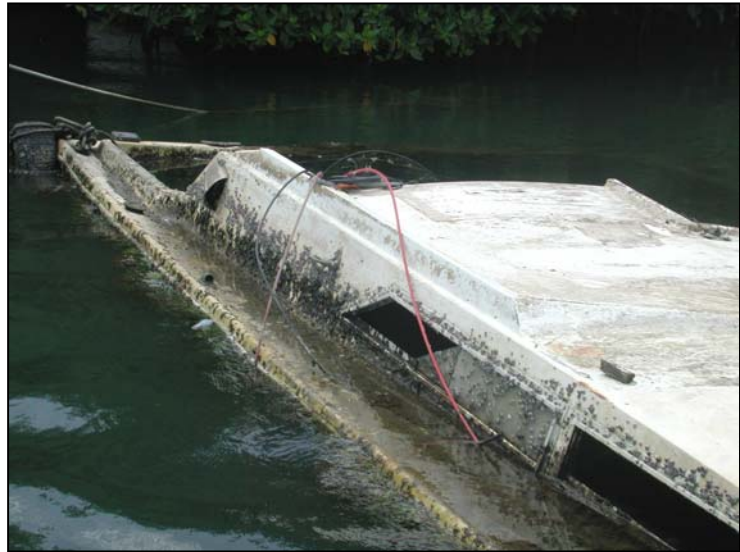
Unknown pollution hazard, possible navigation hazard.

Slip/fall hazard.

No benthic survey was done. The bottom is probably mud, with some possible seagrass or macroalgae. Vessel is near mangroves, and could cause damage if it moved or broke up during a major storm or hurricane.
