# Surveys of Abandoned Vessels: U.S. Caribbean Region

Jacqueline Michel, Scott Zengel, Christine Lord, and Zach Nixon  
Research Planning, Inc.  
Columbia, South Carolina 29202

September 2002

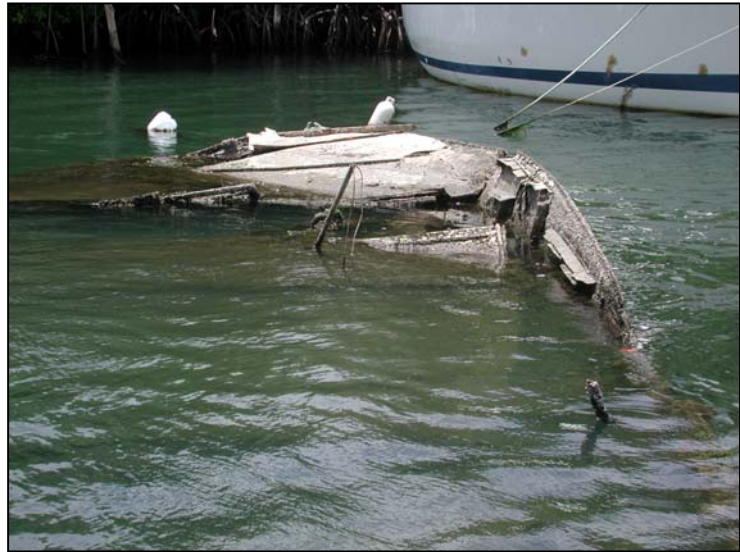
Unknown pollution hazard, possible navigation hazard.

No benthic survey was done. The bottom is probably mud, with some possible seagrass or macroalgae. Vessel is near mangroves, and could cause damage if it moved or broke up during a major storm or hurricane.

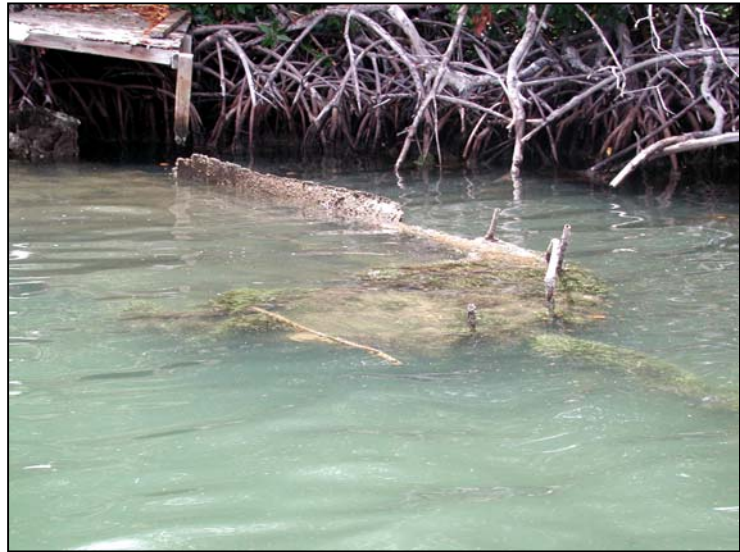
Unknown pollution hazard, possible navigation hazard.

Vessel is adjacent to prop roots, so damage to mangroves is possible. No benthic survey was done. The bottom is probably mud, with some possible seagrass or macroalgae. Injury to mangroves is possible if vessel moved or broke up during a major storm or hurricane.

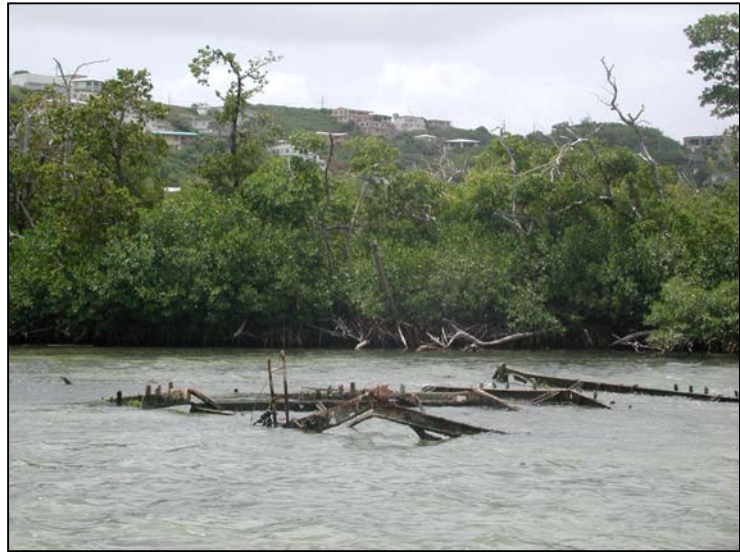
No pollution hazard, but could be a navigation hazard.

Slip/fall hazard.

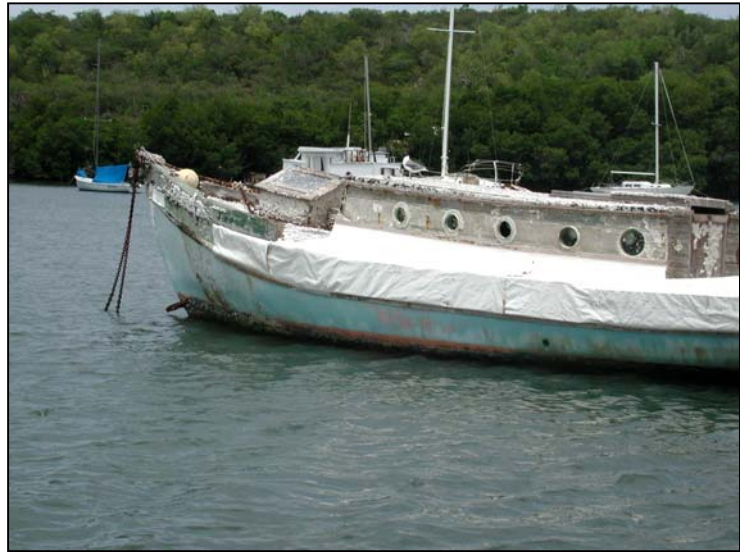
Slip/fall hazard.

No benthic survey was done. The bottom is probably mud, with some possible seagrass or macroalgae. Vessel is near mangroves, and could cause injury if it moved or broke up during a major storm or hurricane.

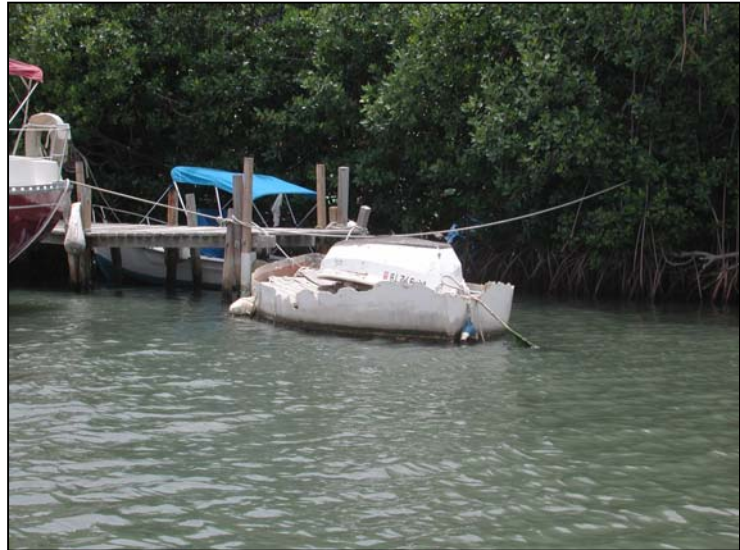
Slip/fall hazard.

Vessel is tied to mangroves, and could cause additional injury to mangroves if it moved or broke up during a major storm or hurricane. No benthic survey was done. The bottom is probably mud, with some possible seagrass or macroalgae.

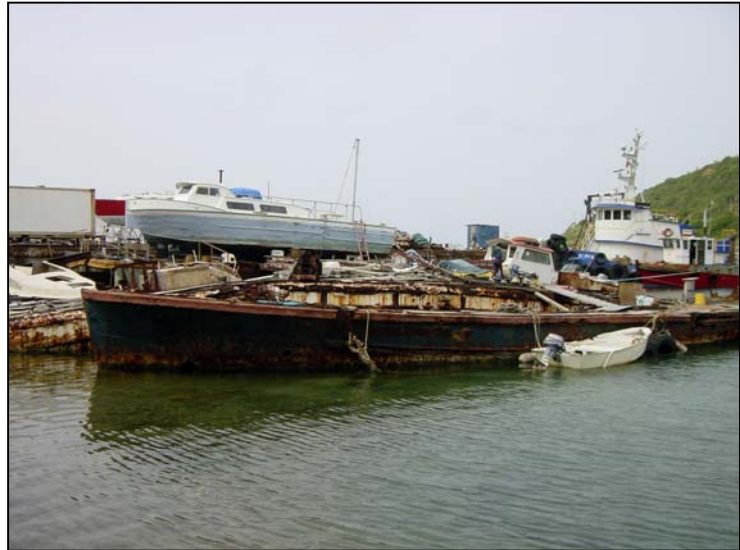
Slip fall/hazard and others.
