NOAA Abandoned Vessel Program Removal Case Study: *Seagull*

Contributing Agency: Guam Department of Agriculture

Vessel ID #: GU4962PU
NOAA AVP#: 2537

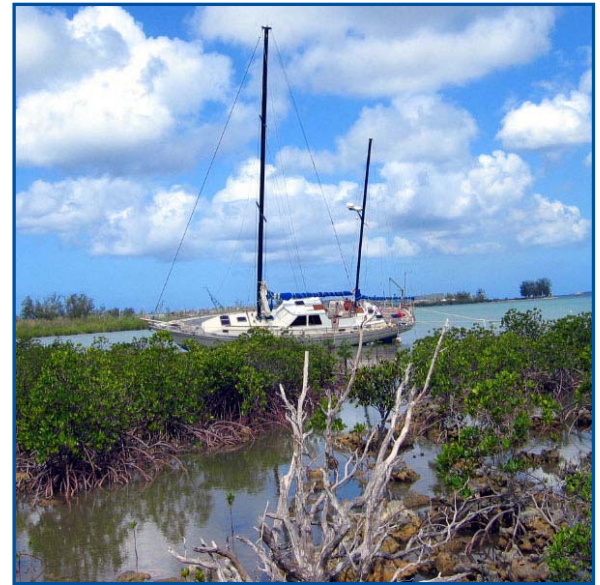
The *Seagull* is a 70' fiberglass ketch that grounded in Sasa Bay, Guam during Supertyphoon Pongsona in December, 2002. The vessel was moored at the nearby Marianas Yacht Club, broke free during the storm and wound up hard aground adjacent to the mangroves of Sasa Bay Marine Preserve. Typhoons and hurricanes commonly result in similar incidents. In most cases the vessels sustain significant damage and post-incident they are not worth enough to justify the cost of salvage. In this case, however, the *Seagull* sustained only minor keel damage, creating a situation where vessel removal was financially viable as long as the vessel did not sustain further damage and salvage costs were kept down.

While the vessel was in excellent condition, it did settle on very valuable habitat. It rested on the "dead coral pavement" immediately adjacent to one of the island's richest mangrove areas. The only shore side access was a small walking trail through the forest. Seaward of the vessel, there was a
