Reduce Dangers to Aircraft Flying in Icing Conditions

NTSB **MOST WANTED**

Cessna 560 **Pueblo, CO – February 16, 2005**

Saab 340B

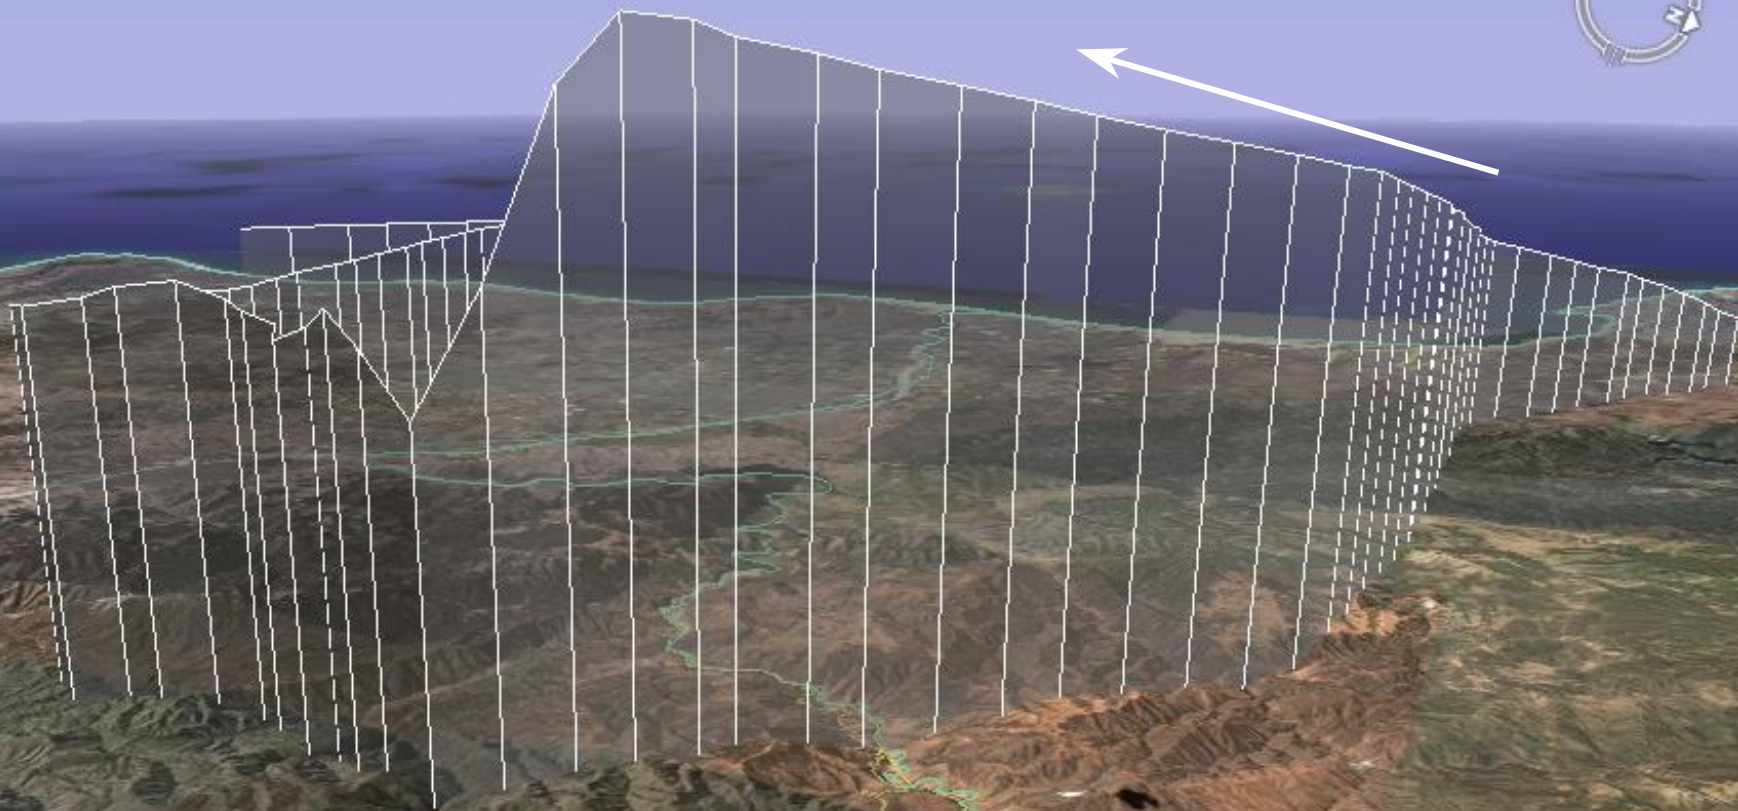
- Autopilot engaged during climb
- Aircraft continuously lost speed during last 2.5 minutes before entering stall (>55 kts in 2.5 minutes)
- Aircraft departed controlled flight at an indicated air speed of approximately 126 kts, concurrent with stick shaker
- Aircraft dropped from 11,700 ft-msl to 6500 ft-msl
