REPORT OF APOLLO 204 REVIEW BOARD

APPENDIX D

PANEL 5

**REPORT OF PANEL 5
ORIGIN AND PROPAGATION OF FIRE
APPENDIX D-5
TO
FINAL REPORT OF
COLLO 204 REVIEW BOARD**

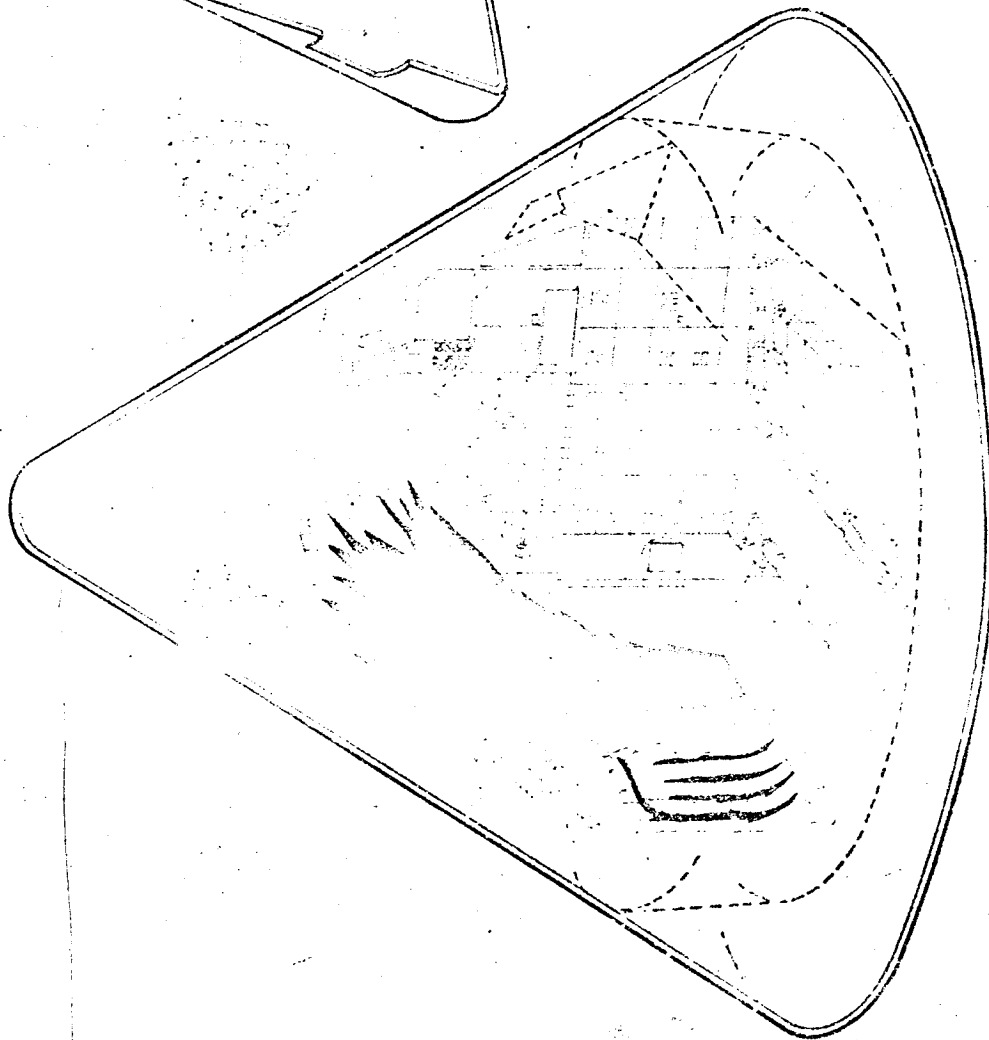
FIRST PHASE OF FIRE

**C/M FIRE
FIRST PHASE**

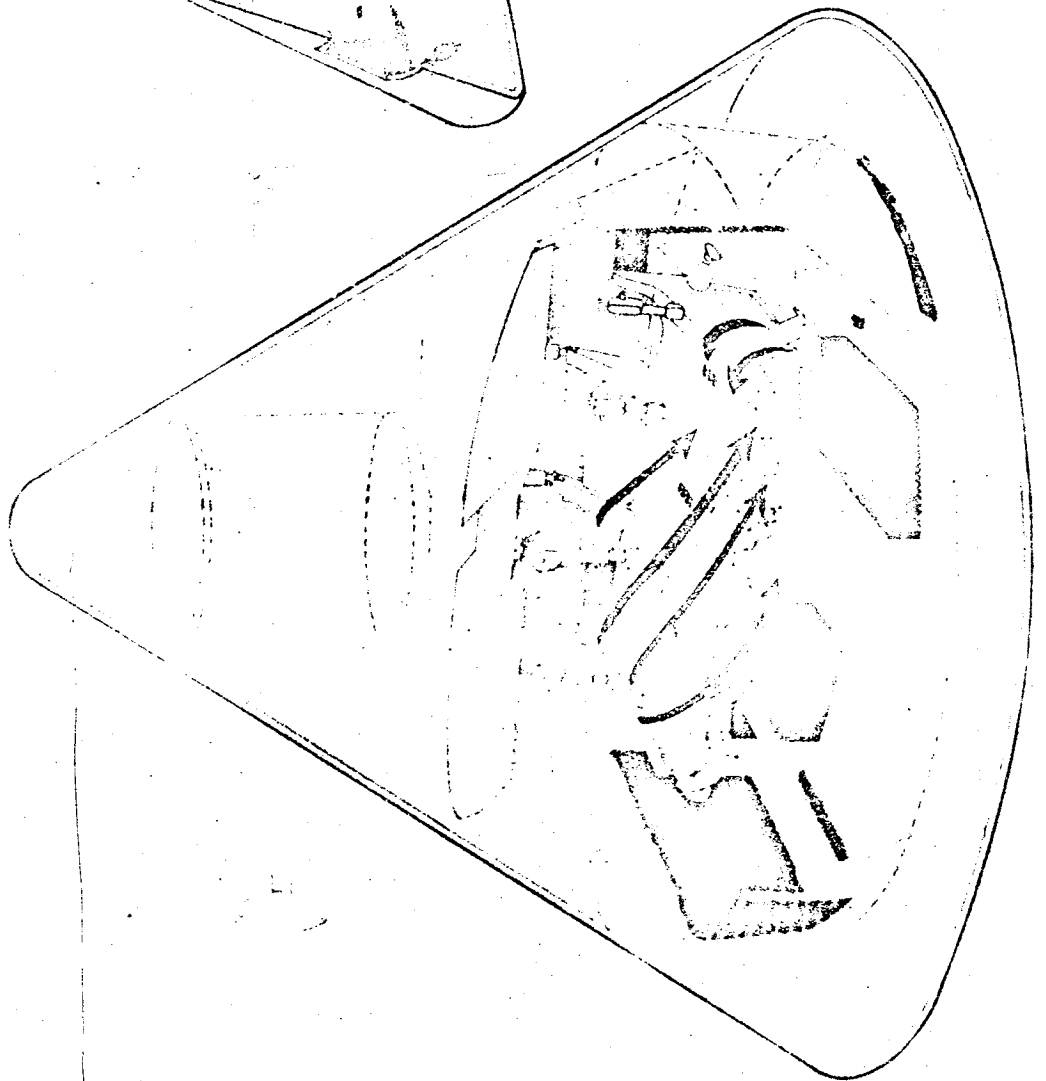
SECOND FIRE PHASE OVER COUCHES

**FIRE OVER COUCHES
2nd FIRE PHASE**
