**Investigation of Loss of Well Control
Eugene Island Block 107, Well B-1 Workover
OCS-G 15241
8 March 2003**

**Gulf of Mexico
Off the Louisiana Coast**

**U.S. Department of the Interior
Minerals Management Service
Gulf of Mexico OCS Regional Office**

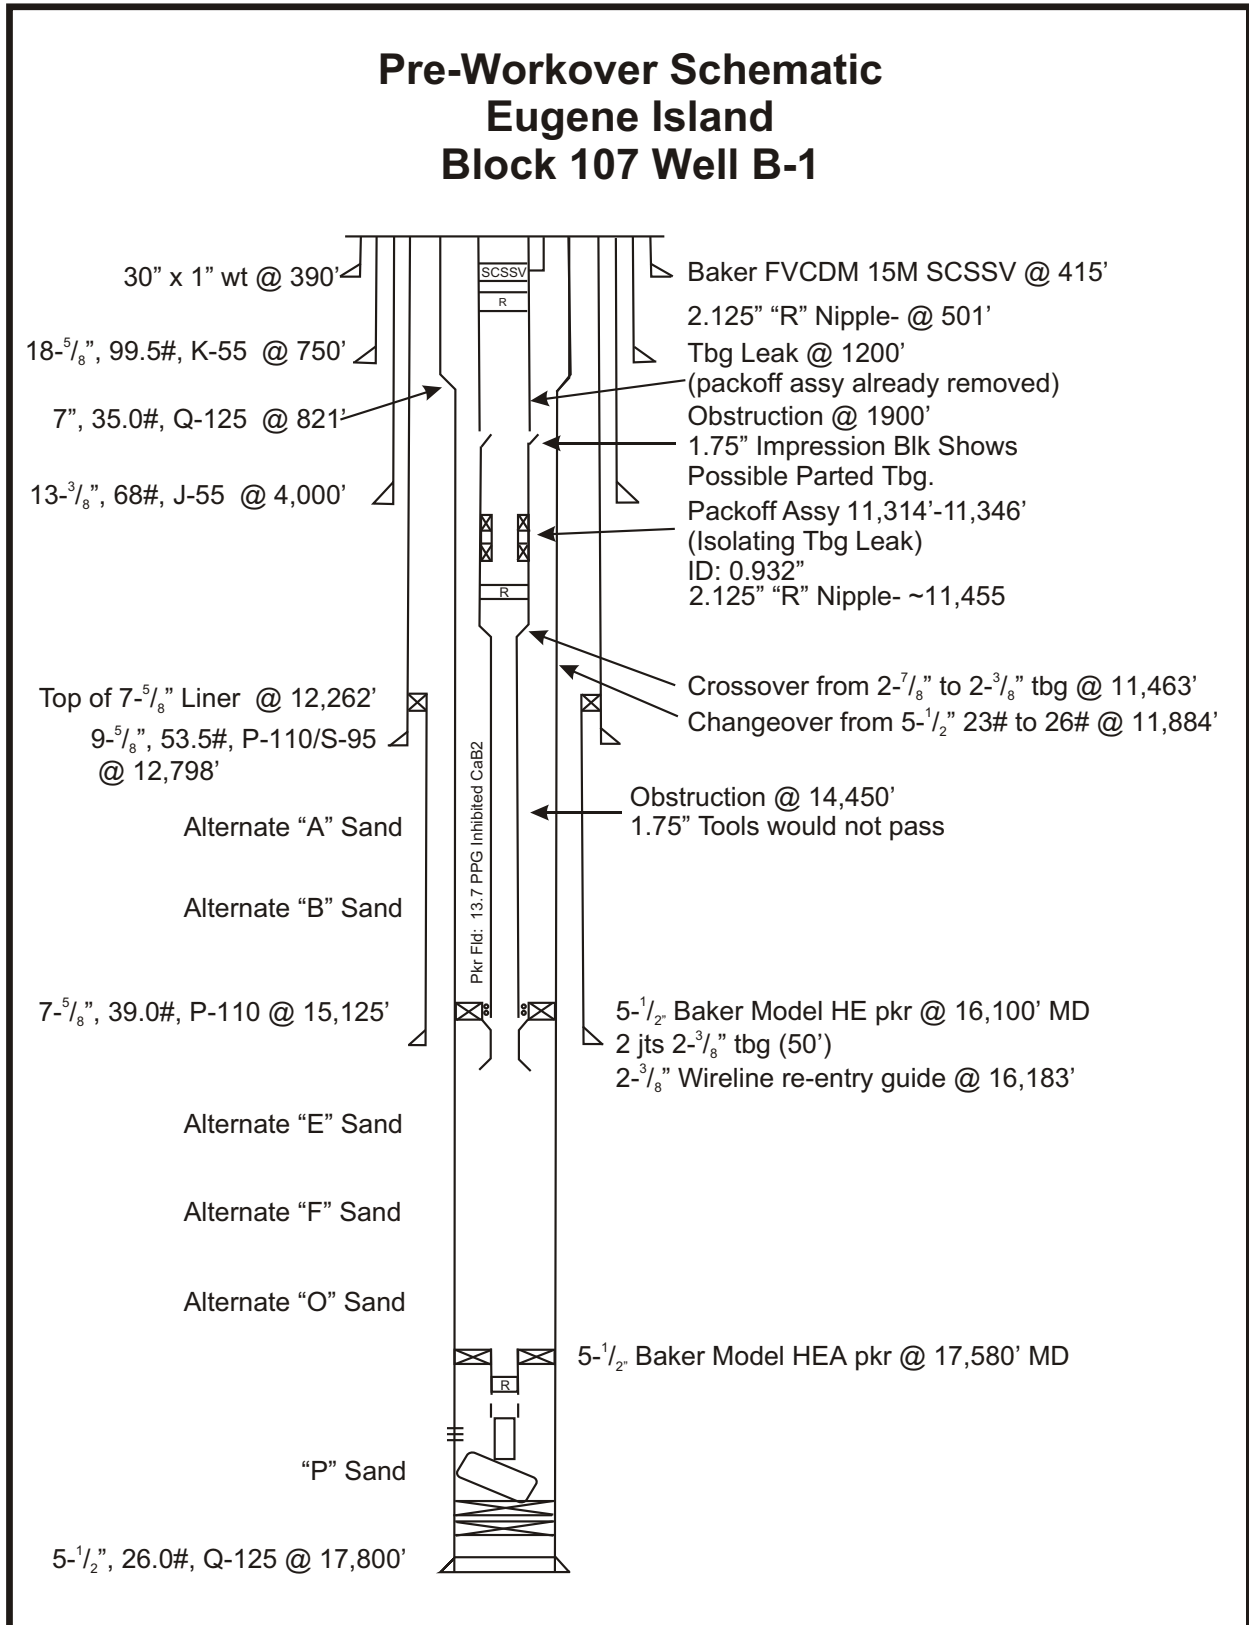
EI Block 107 B-1 Completion Schematic, Pre-workover

1. A workover of the Well was required because extensive CO₂ pitting and corrosion caused communication between the production tubing and the annulus. The pitting and corrosion were exacerbated because the tubing string originally installed was not designed to resist CO₂ corrosion.

2. In an attempt to isolate the holes in the tubing caused by the corrosion, a number of through-tubing pack-offs were set. While these pack-offs failed to end the communication, they remained an impediment to through-tubing operations during any workover.

3. Subsequent suspected parted tubing was found after the pack-offs had been set. The parted tubing made retrieving the pack-offs impossible and the presence of the pack-offs made it impossible to use through-tubing means to isolate the under-pressured “P” sand that was the target of the workover, until the tubing could be fished to a depth that allowed conventional well- control methods.

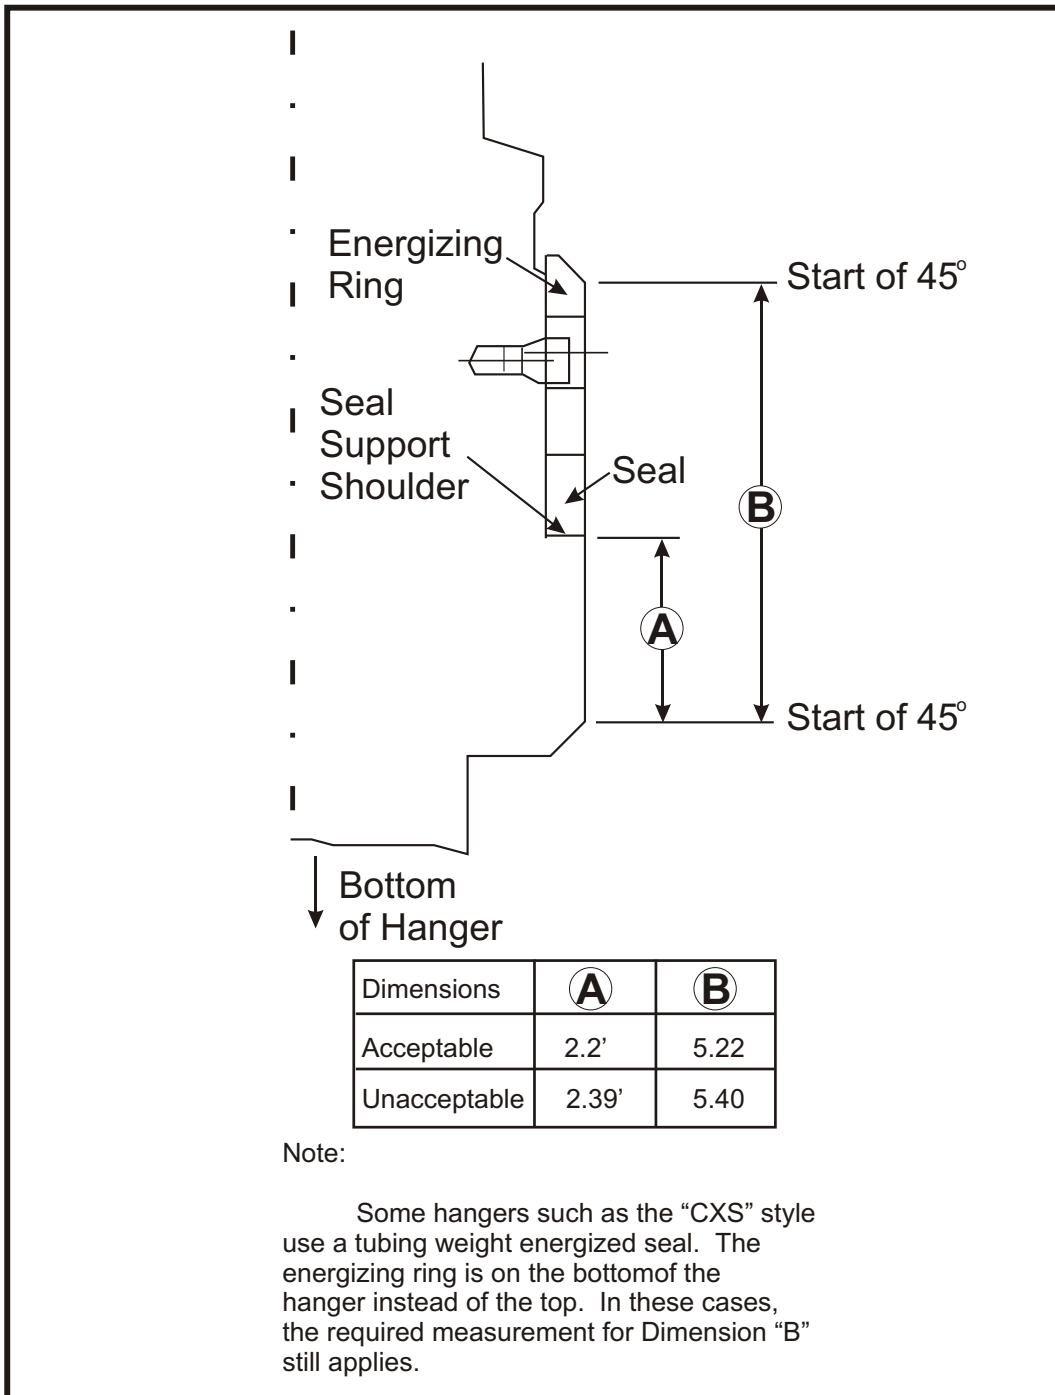
Schematic and Original Dimensions of Engagement of Hanger and Lock-down Pin.

6. Before initiating a direct attempt to pump an LCM pill and heavier mud into the annulus to kill the high pressure, the last containment of the pressure, the tubing hanger hold-down pins failed. This failure was due to a fundamental Manufacturer design flaw. The ejection of hanger and tubing and loss of control were caused by this design flaw, the lack of suspended tubing weight, and the removal of the tree. The fact that no shear rams were installed prevented any control of the Well by use of the BOP's, once tubing was lodged across the stack.

The tiedown screws used in the subject spool / hanger combinations having with certain hanger dimensions **may** not be capable of retaining the full rated working pressure acting across the tubing hanger annulus seal diameter. It should be noted that a tubing hanger will rarely see this set of operating conditions since high annulus pressures are uncommon and suspended tubing weight serves to counteract annulus pressure end loads.

The tubing hanger was originally installed in 1996. At the time of failure, the recorded annulus pressure was below the rated working pressure of the spool. Analysis of the returned parts as well as a review of the 1996-vintage manufacturing drawings indicates that the tiedown screws were not be capable of retaining the full rated working pressure below the hanger in the absence of additional tubing loads.
