NOAA/NWS METEOROLOGICAL ASSESSMENT FOR TYPHOON PONGSONA IN: POHNPEI STATE, FSM; CHUUK STATE, FSM; GUAM; AND, ROTA, CNMI

The National Oceanic and Atmospheric Administration (NOAA) National Weather Service (NWS) Meteorological Assessment Team for Typhoon Pongsona

April 2003

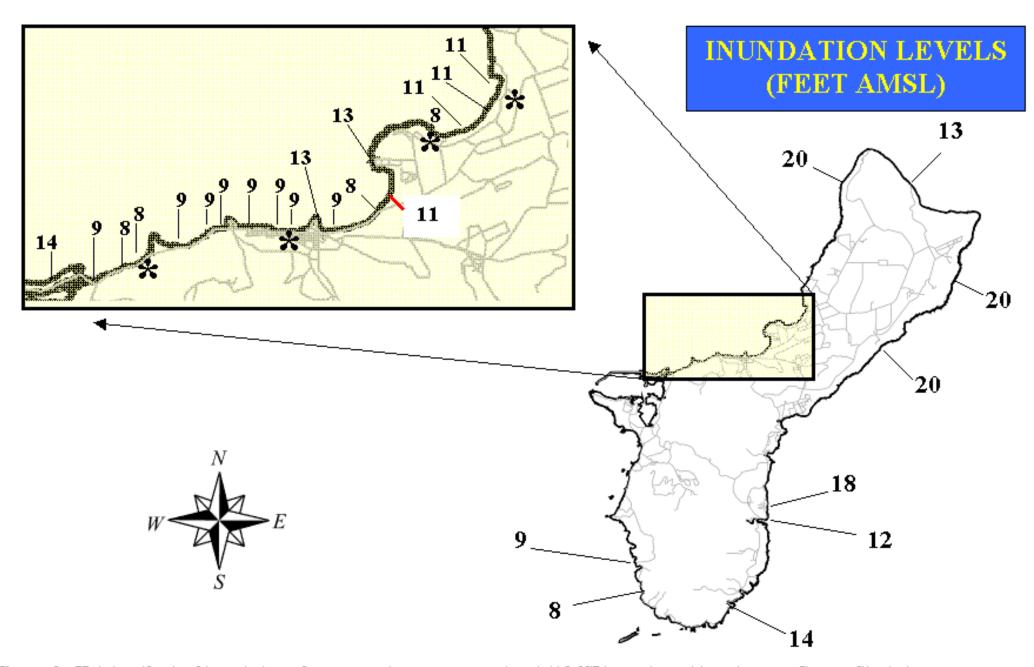
- **Figure 9.** Heights (feet) of inundation of seawater above mean sea level (AMSL) at selected locations on Guam. Shaded area expands the area from the Commercial Port (extreme left) to Upper Tumon Bay (upper right). Asterisks (*) indicate measurements are from marks left by still water; otherwise, measurements are from debris edge of wave run-up.

Figure 9. Heights (feet) of inundation of seawater above mean sea level (AMSL) at selected locations on Guam. Shaded area expands the area from the Commercial Port (extreme left) to Upper Tumon Bay (upper right). Asterisks (*) indicate measurements are from marks left by still water, otherwise, measurements are from debris edge of wave run-up.

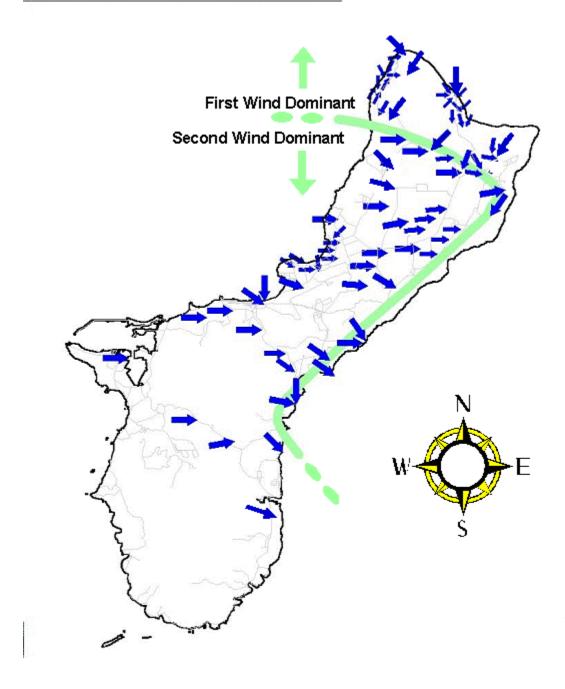
- **Figure 28.** Analysis of tree falls that occurred during Typhoon Pongsona. The green line separates areas where the "first wind" was dominant and areas where the "second wind" was dominant. Along the green line the two winds were equal in their dominance. Arrow size has no meaning.

Figure 28. Analysis of tree falls that occurred during Typhoon Pongsona. The green line separates areas where the "first wind" was dominant and areas where the "second wind" was dominant. Along the green line the two winds were equal in their dominance. Arrow size has no meaning.

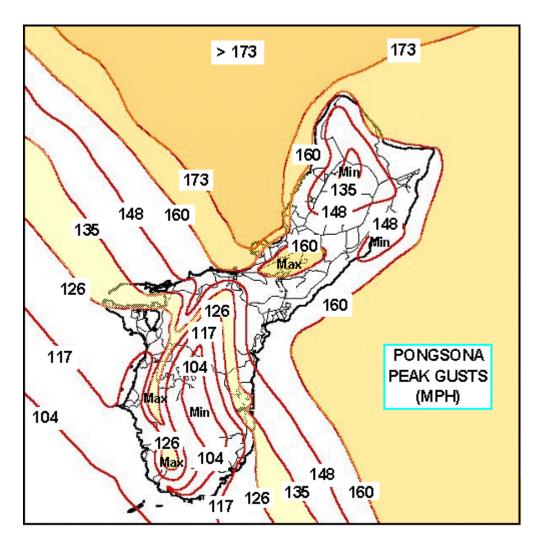
Figure 30. Analysis of peak gusts on Guam during the passage of Typhoon Pongsona on 8 December 2002. Winds are in miles per hour (MPH).

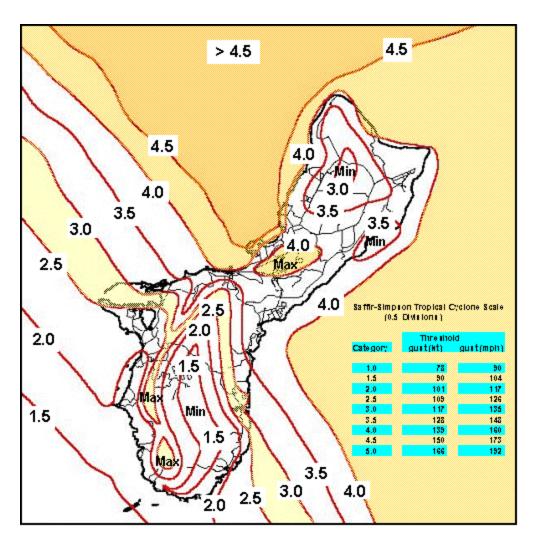
Figure 31. Pongsona peak wind distribution over Guam. Contours are in units of Saffir Simpson Tropical Cyclone Damage Scale (Guard and Lander 1999). Threshold gusts associated with each category are shown in the inset and in Appendix C.

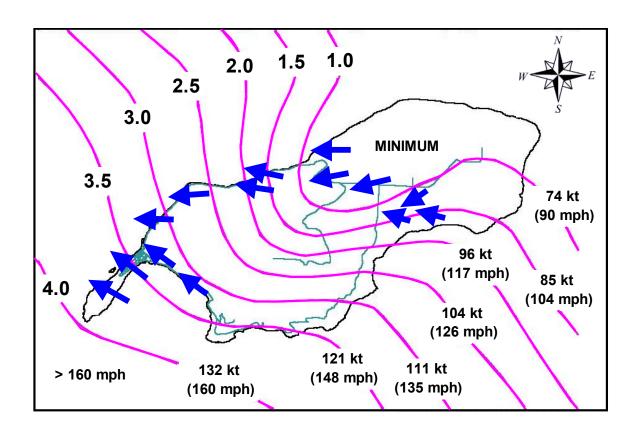
Figure 34. Analysis of peak gusts (lower numbers), damage in terms of 0.5 Saffir-Simpson Tropical Cyclone Scale Category (upper numbers), and tree fall direction (blue arrows) for Rota, CNMI during the passage of Typhoon Pongsona on 8 December 2002.
