Status of MIPP RICH

Rajendran Raja Fermilab

15-Mar-2004

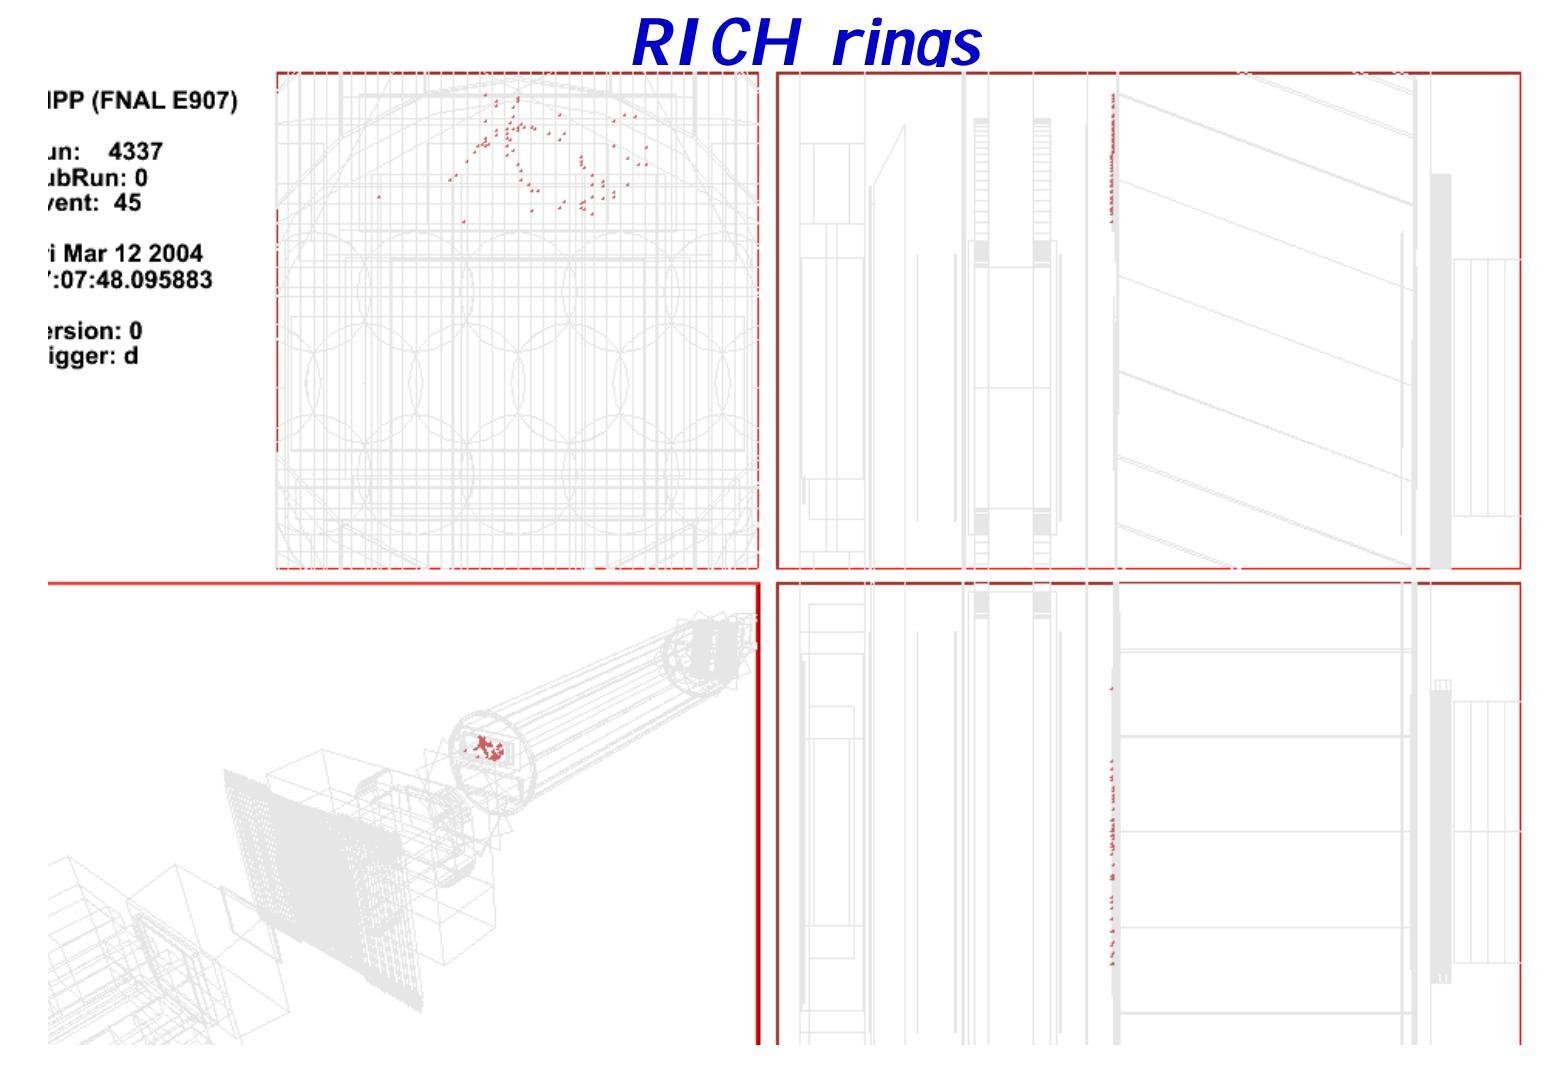
RICH was being read out successfully. We see rings.

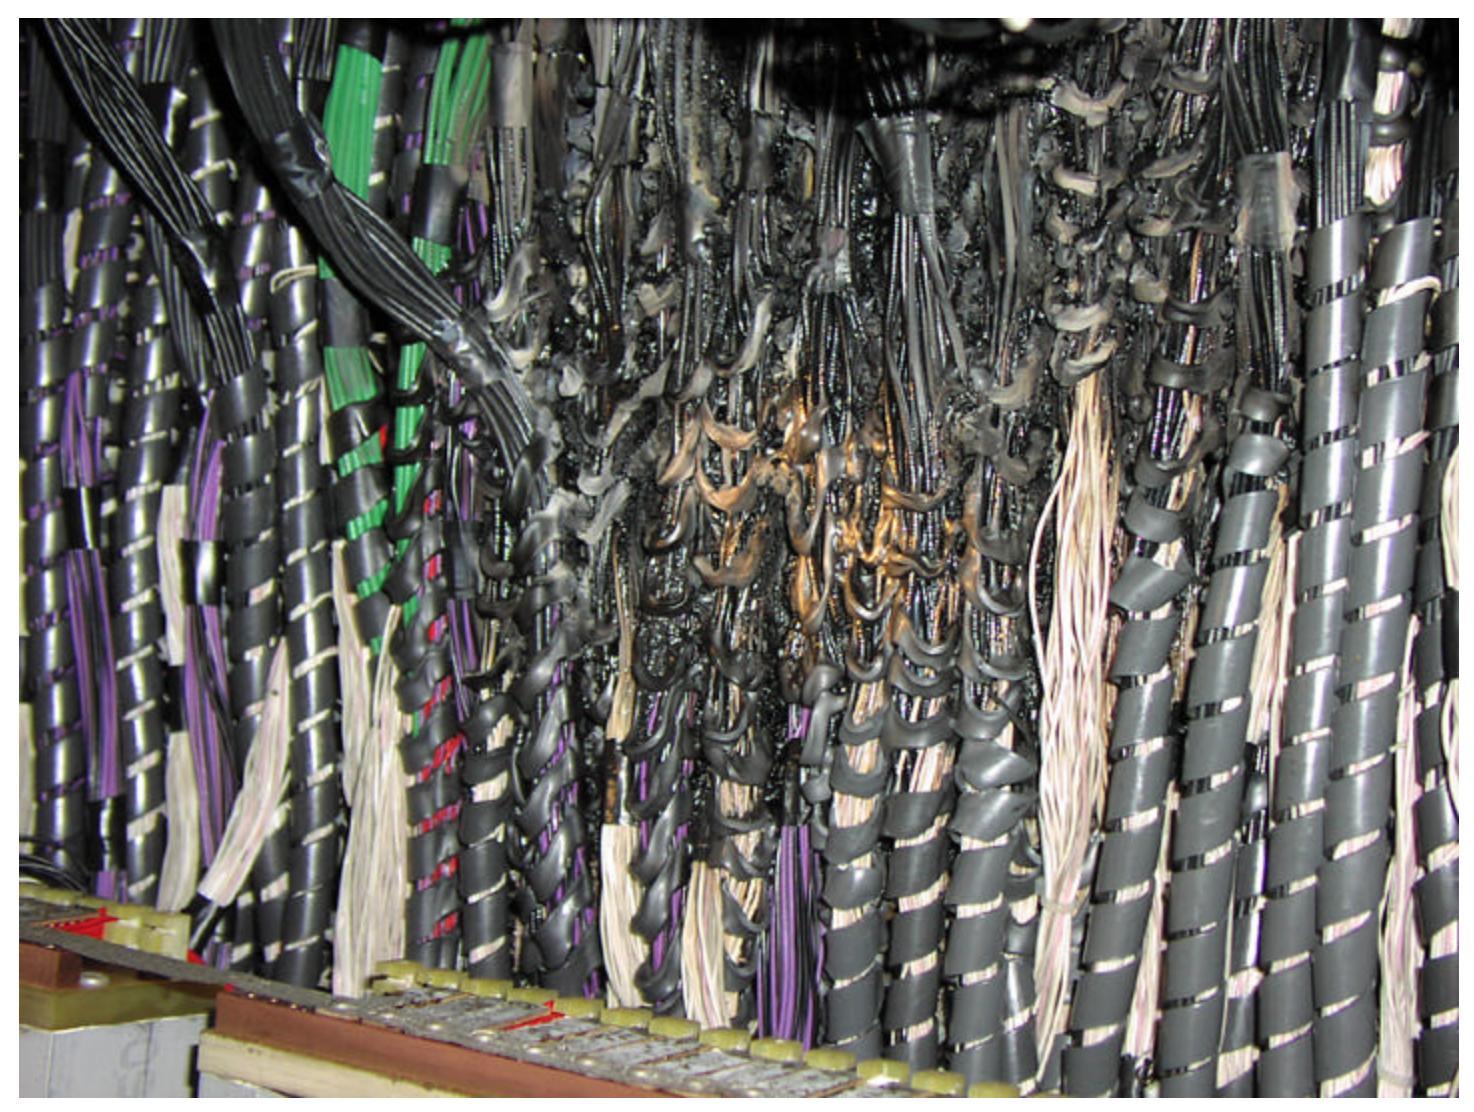
MIPP RICH

- On Sunday March 14,2004 MI PP had a smoke alarm. Three smoke detectors had tripped. The one the RI CH, Relay Rack 18 and Relay Rack 20.
- Upon further investigation, it was found that the cause of the smoke was in the RICH PMT box.
- We are investigating the extent of the damage.
- RICH readout system seems OK.
