Status of MIPP RICH

Rajendran Raja
Fermilab

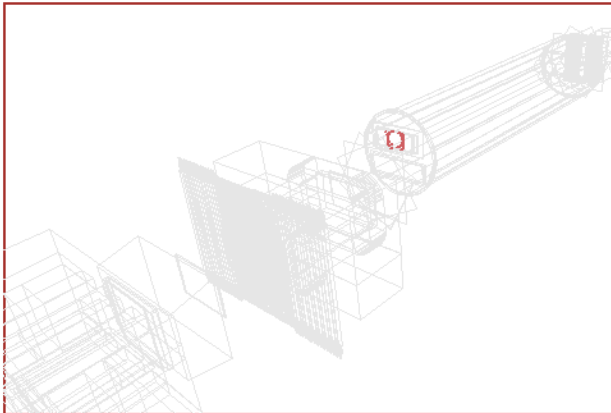
RICH was being read out successfully. We see rings.

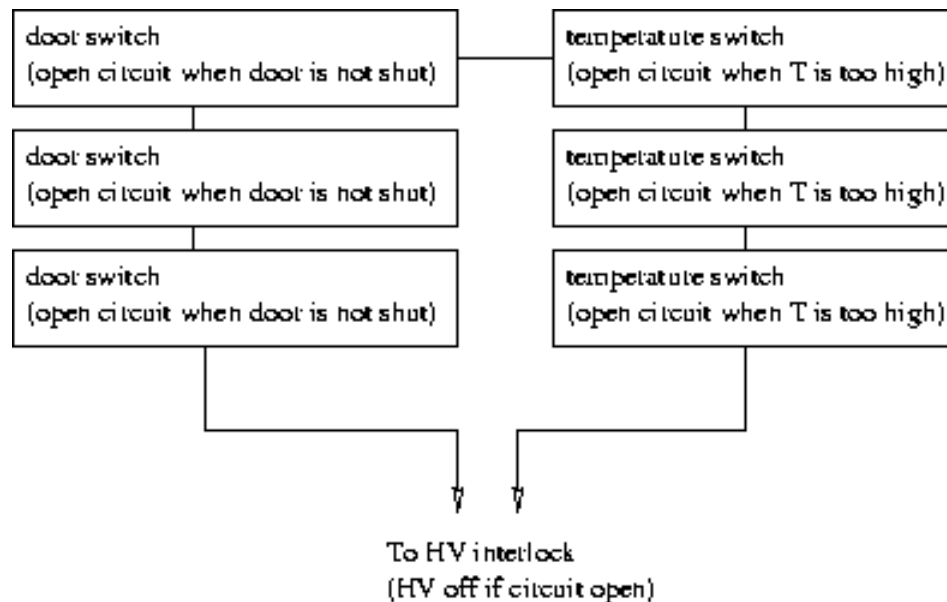
RICH Interlocks

Normally HVPS are powered through HV interlock box, which has two interlock inputs from interlock chain inside PMT box. Chain consists of 3 door switches and 3 thermo-switches hidden somewhere between PMT bases. Chain need to be closed for interlock to operate (You could use 50 Ohm BNC terminators for that). When this chain become open, main circuit breaker on the front of the box will trip.

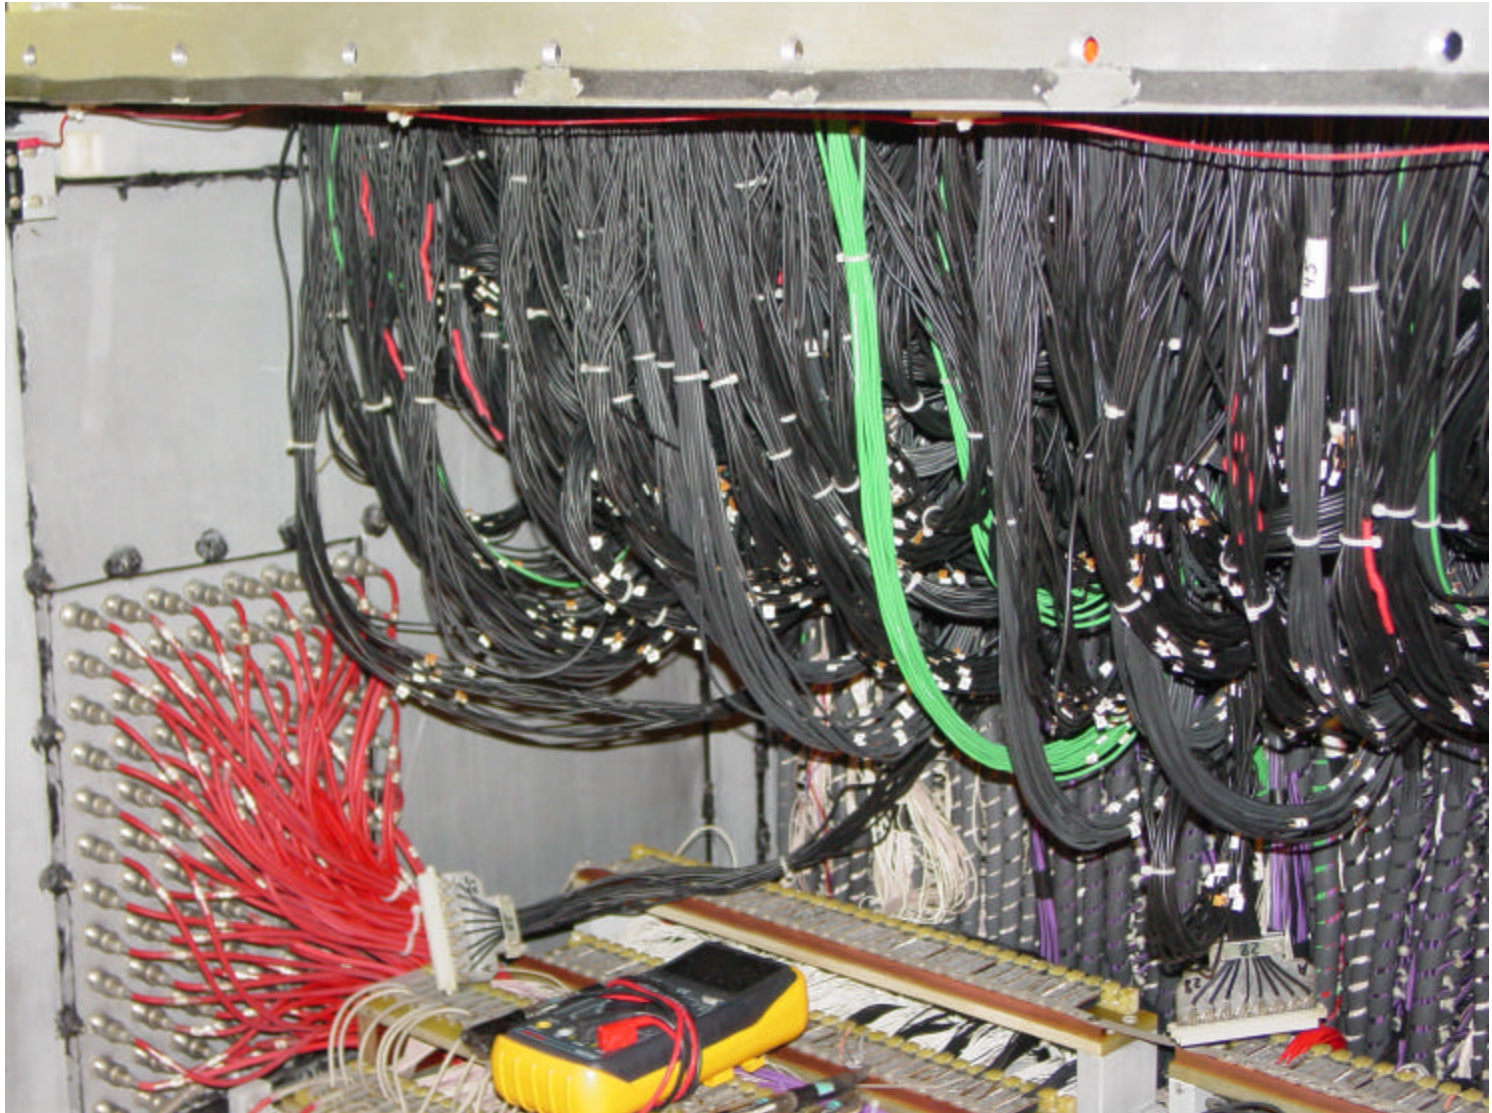
Number of RICH digits vs. time

- The HV was turned on March 2, 2004. All HV was set at 1400 V to begin with. This was 50-500 V below nominal.
- There was some sort of power glitch a week later. May be unconnected.
- Last event taken on March 14, 2003 at 11:13:11 AM.
