NOAA -14 September 28, 2006(DOY271) Tumble Anomaly

Milton C. Phenneger;
Principal Engineer, ASRC Aerospace Corporation

1. This work is supported by NOAA and performed under the direction of the NOAA Office of Space Operations (OSO) on the Engineering and Mission Operations Support Services Contract (EMOSS), in the NOAA Spacecraft Operations Facility (NSOF) in Suitland MD.

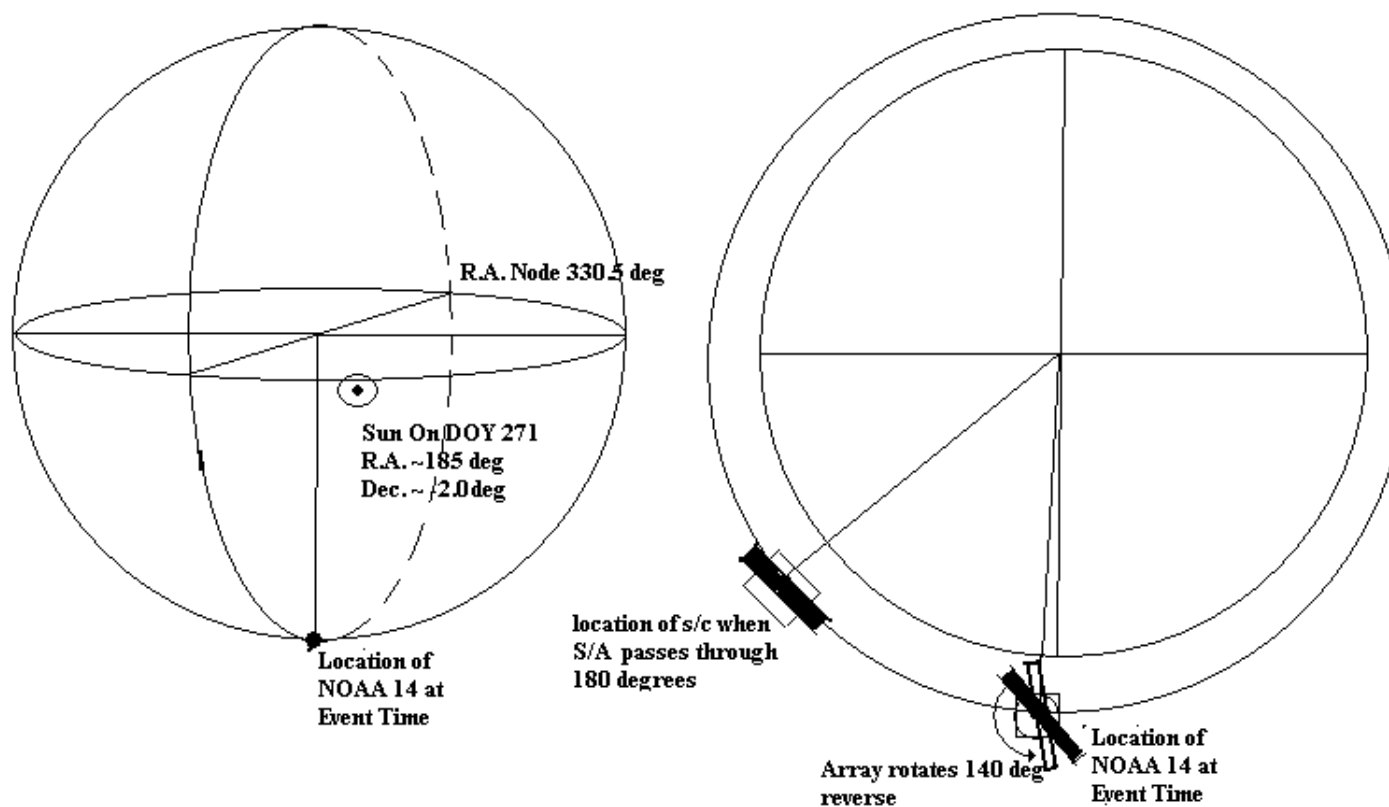
Solar Array and Orbital Geometry

- The large angular momentum impulse and solar array spin back of 140 degrees in 45 seconds was caused by the release and ignition of hydrazine propellant from the REA # 2 and deflection of the plume from the canted solar array causing a windmill torque.
