**Investigation of Top Drive Accident and Fatality
East Cameron Block 332,
Gulf of Mexico,
Off the Louisiana Coast
June 4, 1996**

Frank Pausina
Michael Hebert
Johnny Serrette

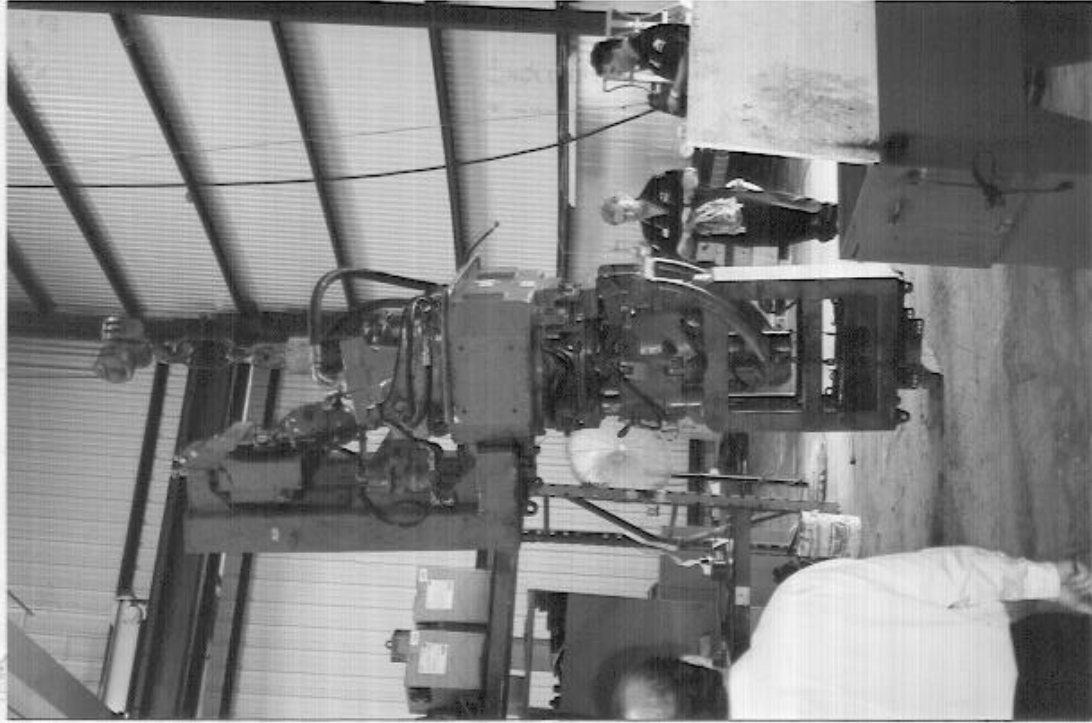
Top Drive at Maritime Facility

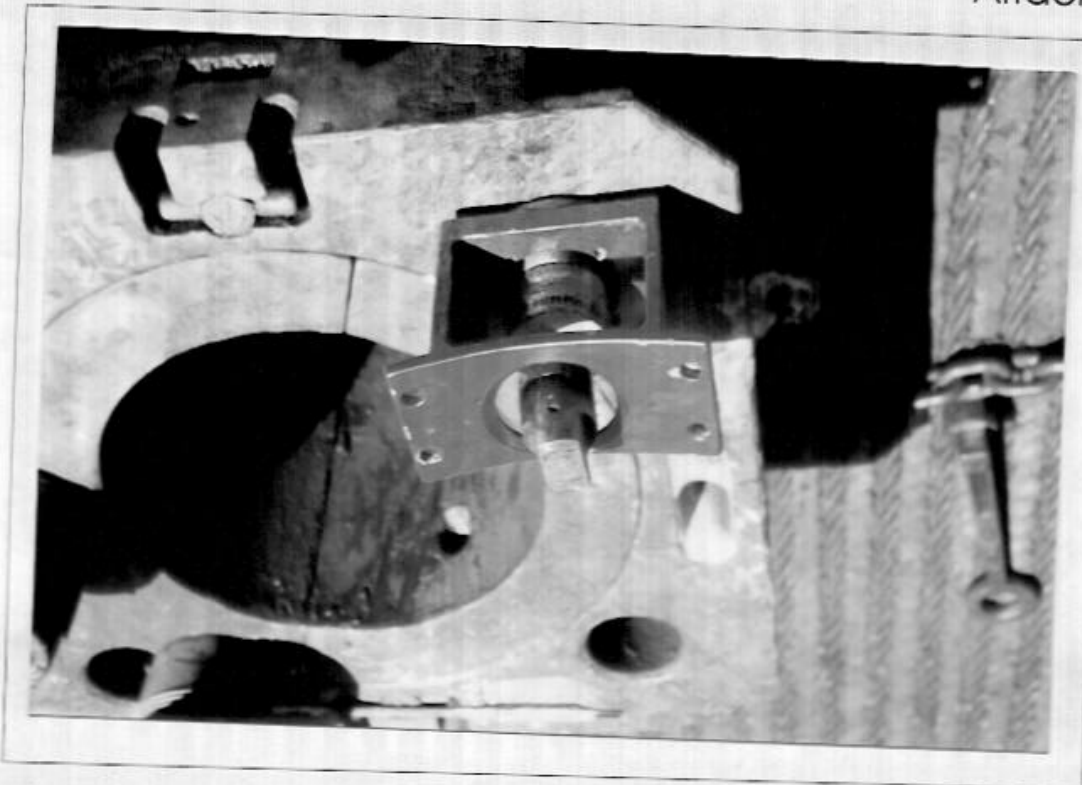
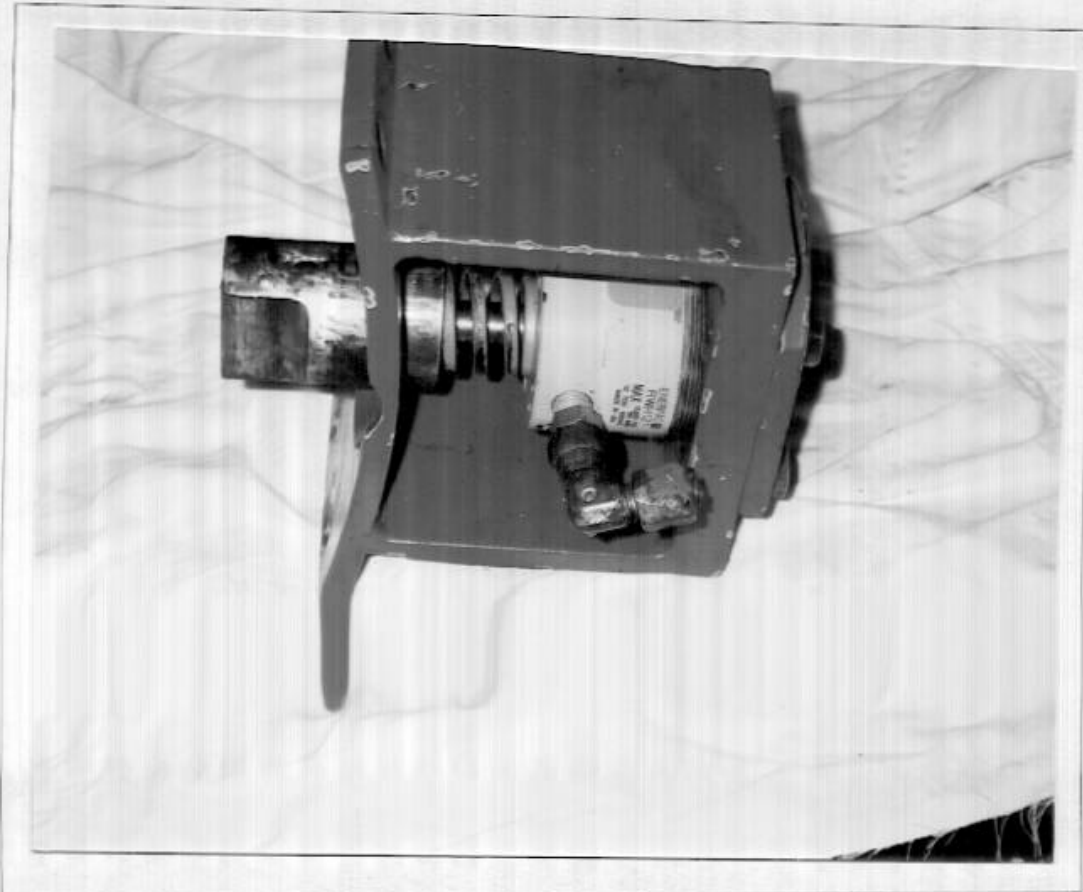
Top Drive Function Test, Disassembling, and Observations The test and the disassembling of the top drive did not reveal any significant operational problems. However, during an examination of the top drive it was discovered that the hydraulic pin was slightly bent and the edges of the lower flange teeth were worn. (For pictures of the bent hydraulic pin and worn teeth, see Attachment 13.)

Hydraulic Pin and Housing

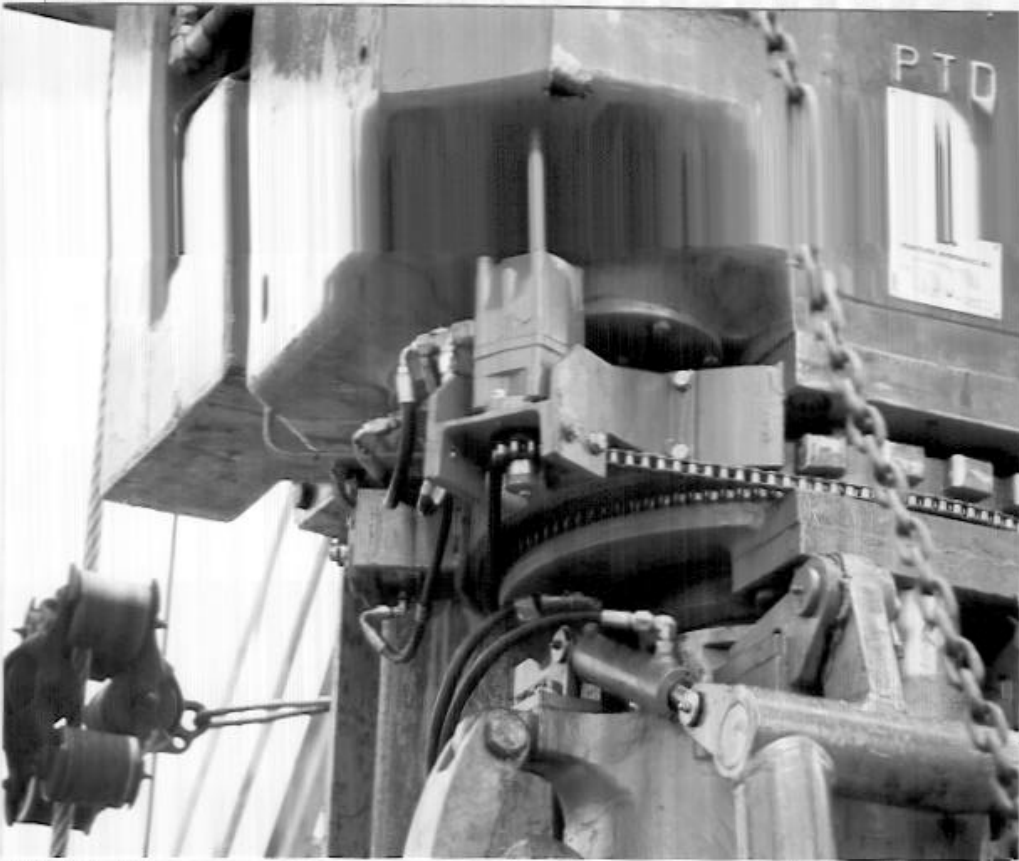
Photo 5

Attachment 6, Hydraulic Pin Housing and Lower Flange Teeth (Photograph)

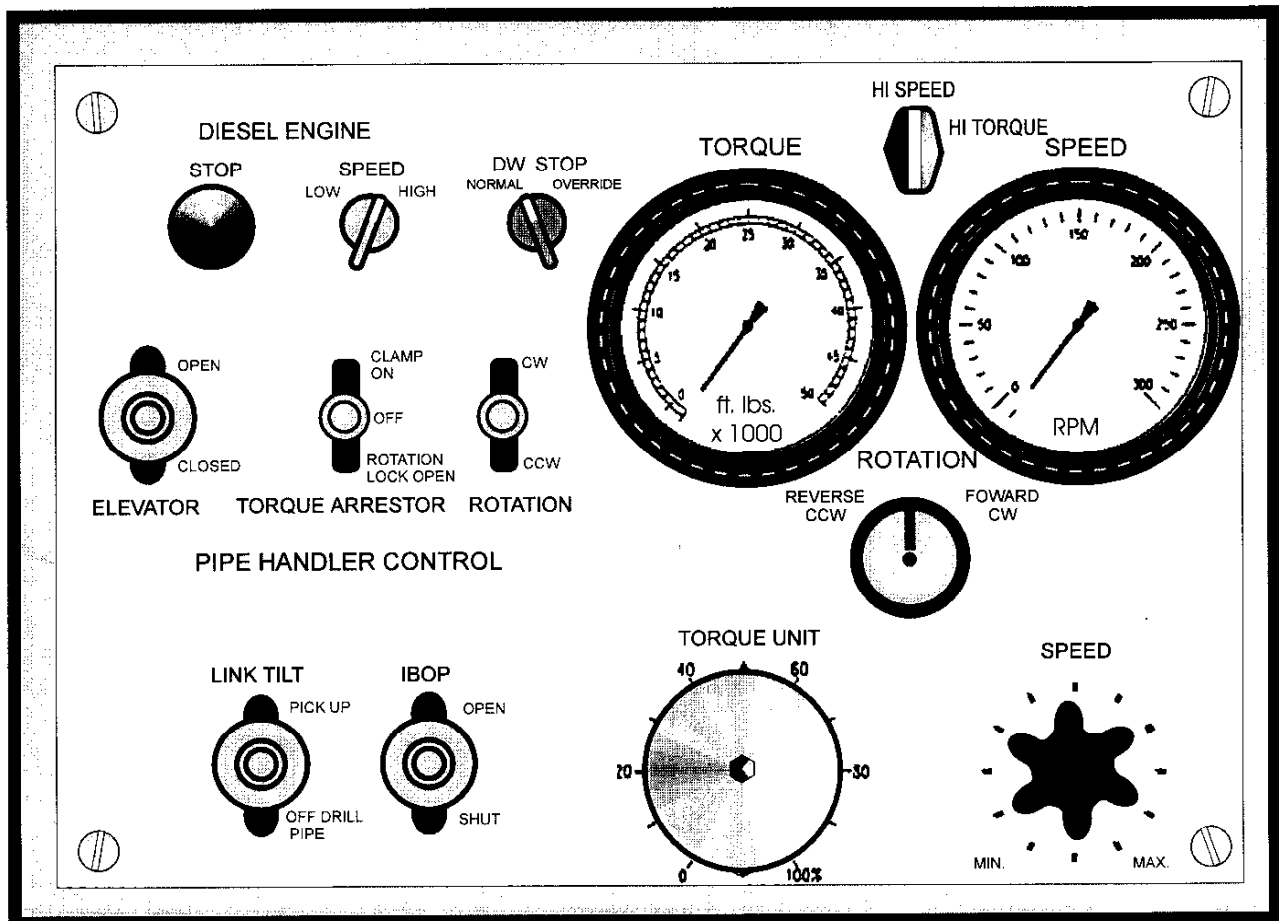
Schematic of Driller's Control Panel

However, only the use of the rotation knob could have caused a reversal in the direction of the rotation of the links, which resulted in the fatality. Hearing testimony indicated that in turning the knob there is a “small hesitation” at the zero position and that “if you worked it enough, you would feel it.”

1. Operations personnel be made aware of the ability of the elevator links to rotate when the hydraulic pin is not engaged, the torque arrestor is activated, and torque is applied;
2. A safe procedure for stopping the rotation of tilted elevator links, should such a rotation be undesirable and/or unintentional, be incorporated into a prescribed operational procedures statement and be made incumbent upon operations personnel;
3. Every practical precaution be taken to shield the drilling control panel from tilted rotating elevator links; and
4. Consideration be given to the redesigning of the driller's control panel to accommodate an indicator that would conspicuously signal the disengagement of the hydraulic pin.

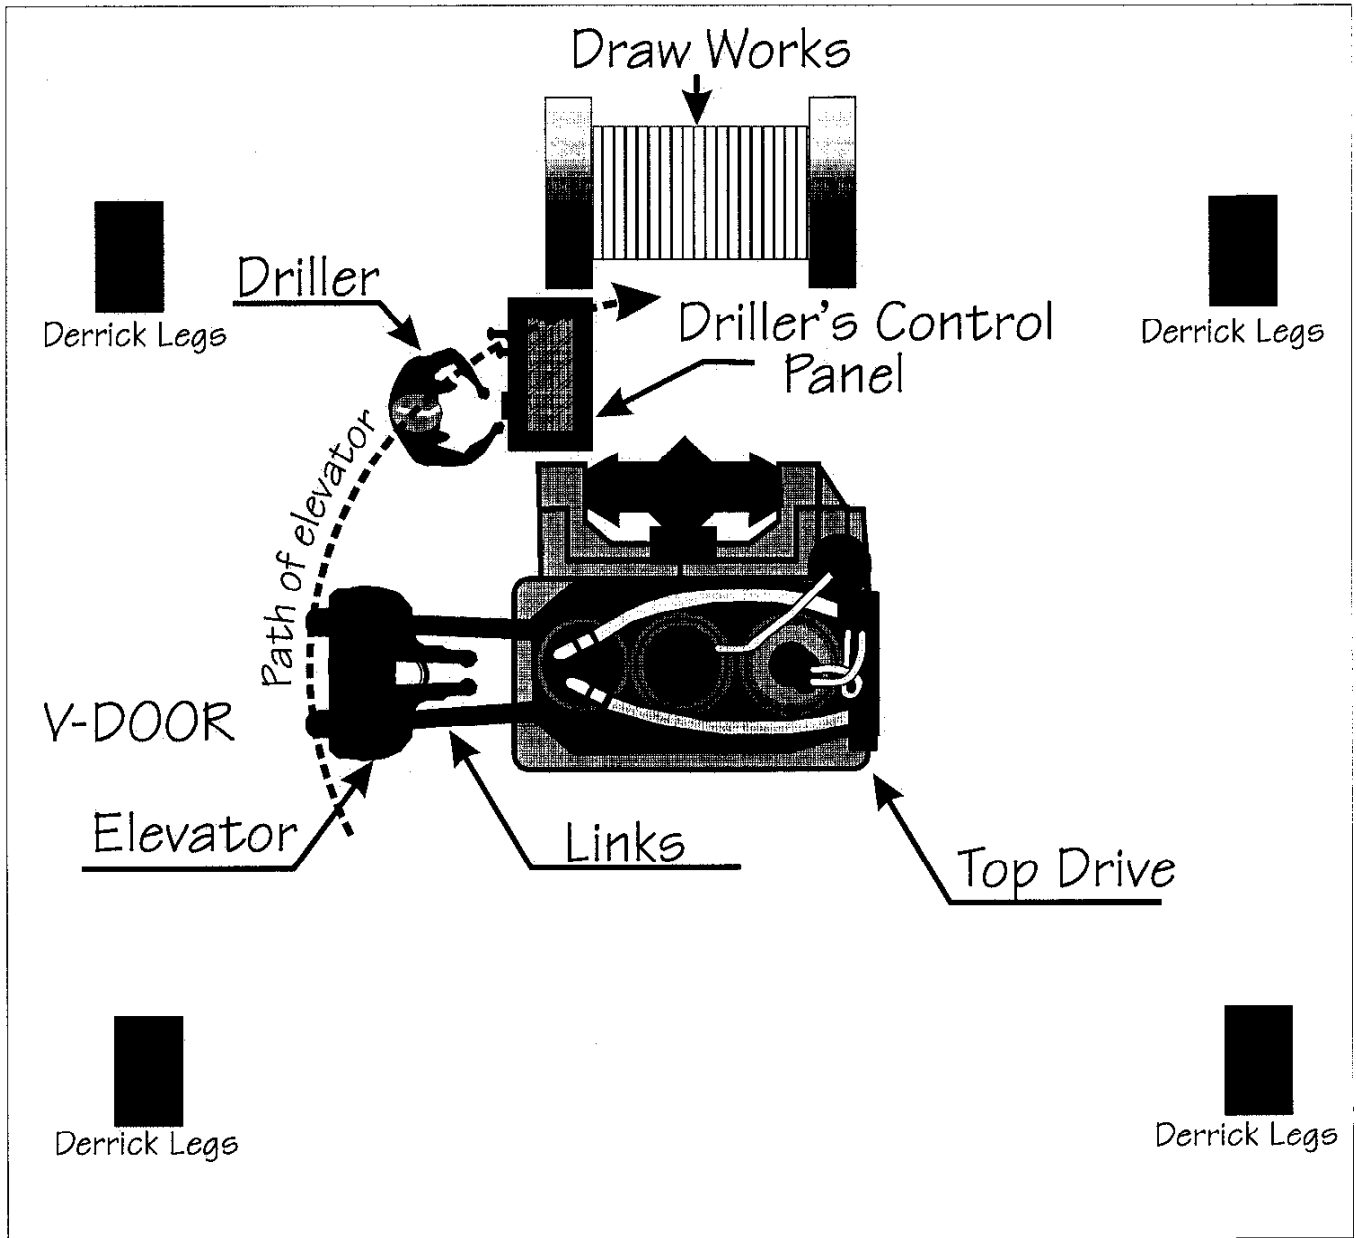
Simplified schematic of rig floor (Not to Scale)

With the top drive at the rig floor, Operator 2 who, according to Operator 1, was seemingly satisfied with the pin position, then began the breakout procedure. He activated the torque arrestor, set the rotation knob to reverse, i.e., counterclockwise, set the speed, and began inducing torque. After observing that the tilted elevator links began to rotate counterclockwise, Operator 1 shouted to Operator 2 to “stop it.” He observed Operator 2 place his hand on the rotation knob in an effort to stop the rotation. The links were then noticed to suddenly stop rotating and then quickly begin rotating in a clockwise direction. The elevator then struck Operator 2, fatally pinning him against the draw works.
