**Investigation of
Chevron Pipe Line Company
Pipeline Leak
South Pass Block 38
September 29, 1998**

**Gulf of Mexico
Off the Louisiana Coast**

**U.S. Department of the Interior
Minerals Management Service
Gulf of Mexico OCS Regional Office**

David M. Moore - MMS
Frank Torres - MMS
Mike Joseph - MMS
Buddy Sheets - USDOT
LCDR George Butler - USCG

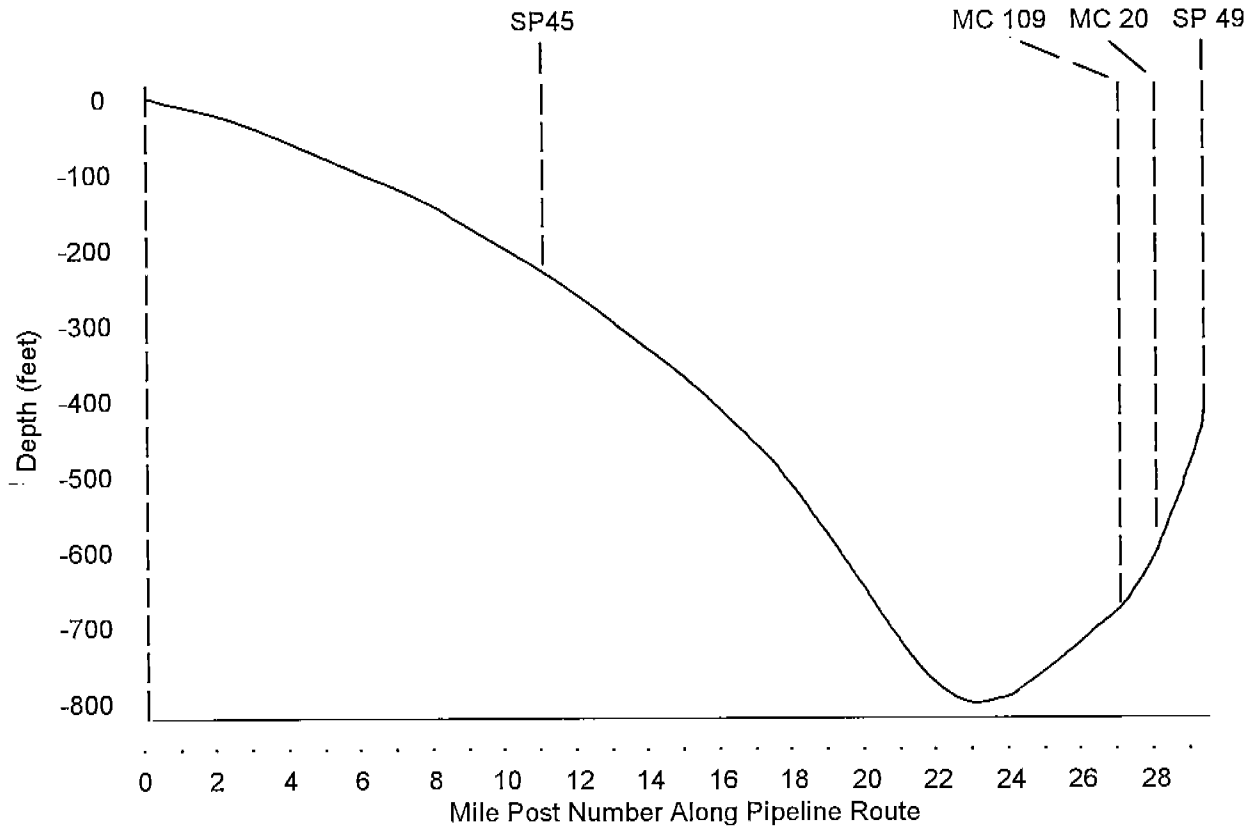
Tie-in Points of Platforms into SP 49 Pipeline System

As the preceding graph and scenarios show, hydrostatic pressure at the modeled leak locations was found in many cases to emulate the back pressure associated with a producer pumping into tankage at the SP 49 Onshore facility. This occurs as pressure losses associated with leaks are offset by the pressure of seawater at the given depth of the leak location below sea level. The operating pressure at the PSL sensing location at the producing facility thus showed little if any change, giving no indication that the pipeline integrity was no longer intact.

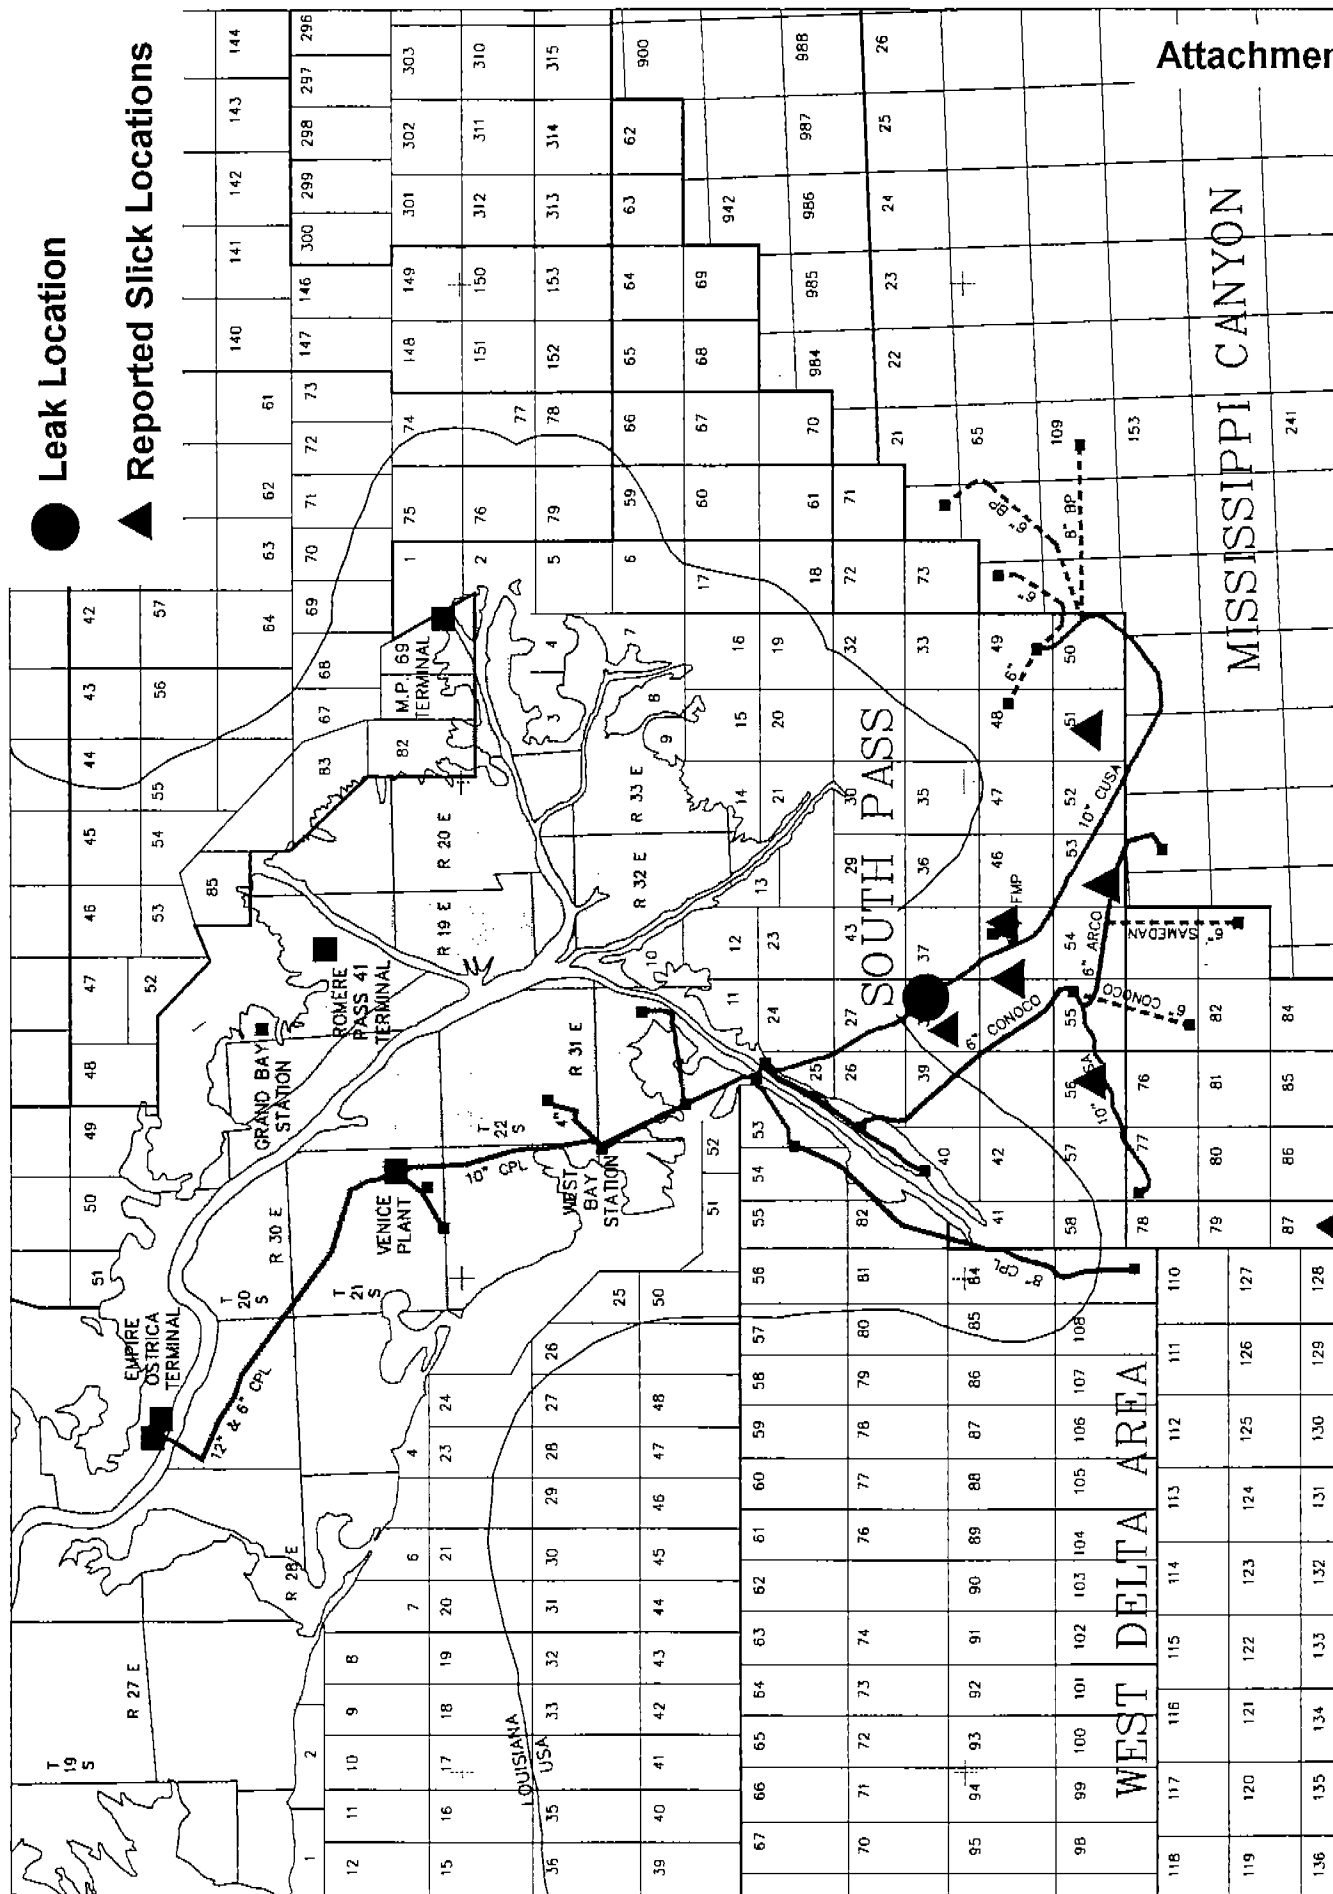
WEST BAY PIPELINE SYSTEM

● Leak Location

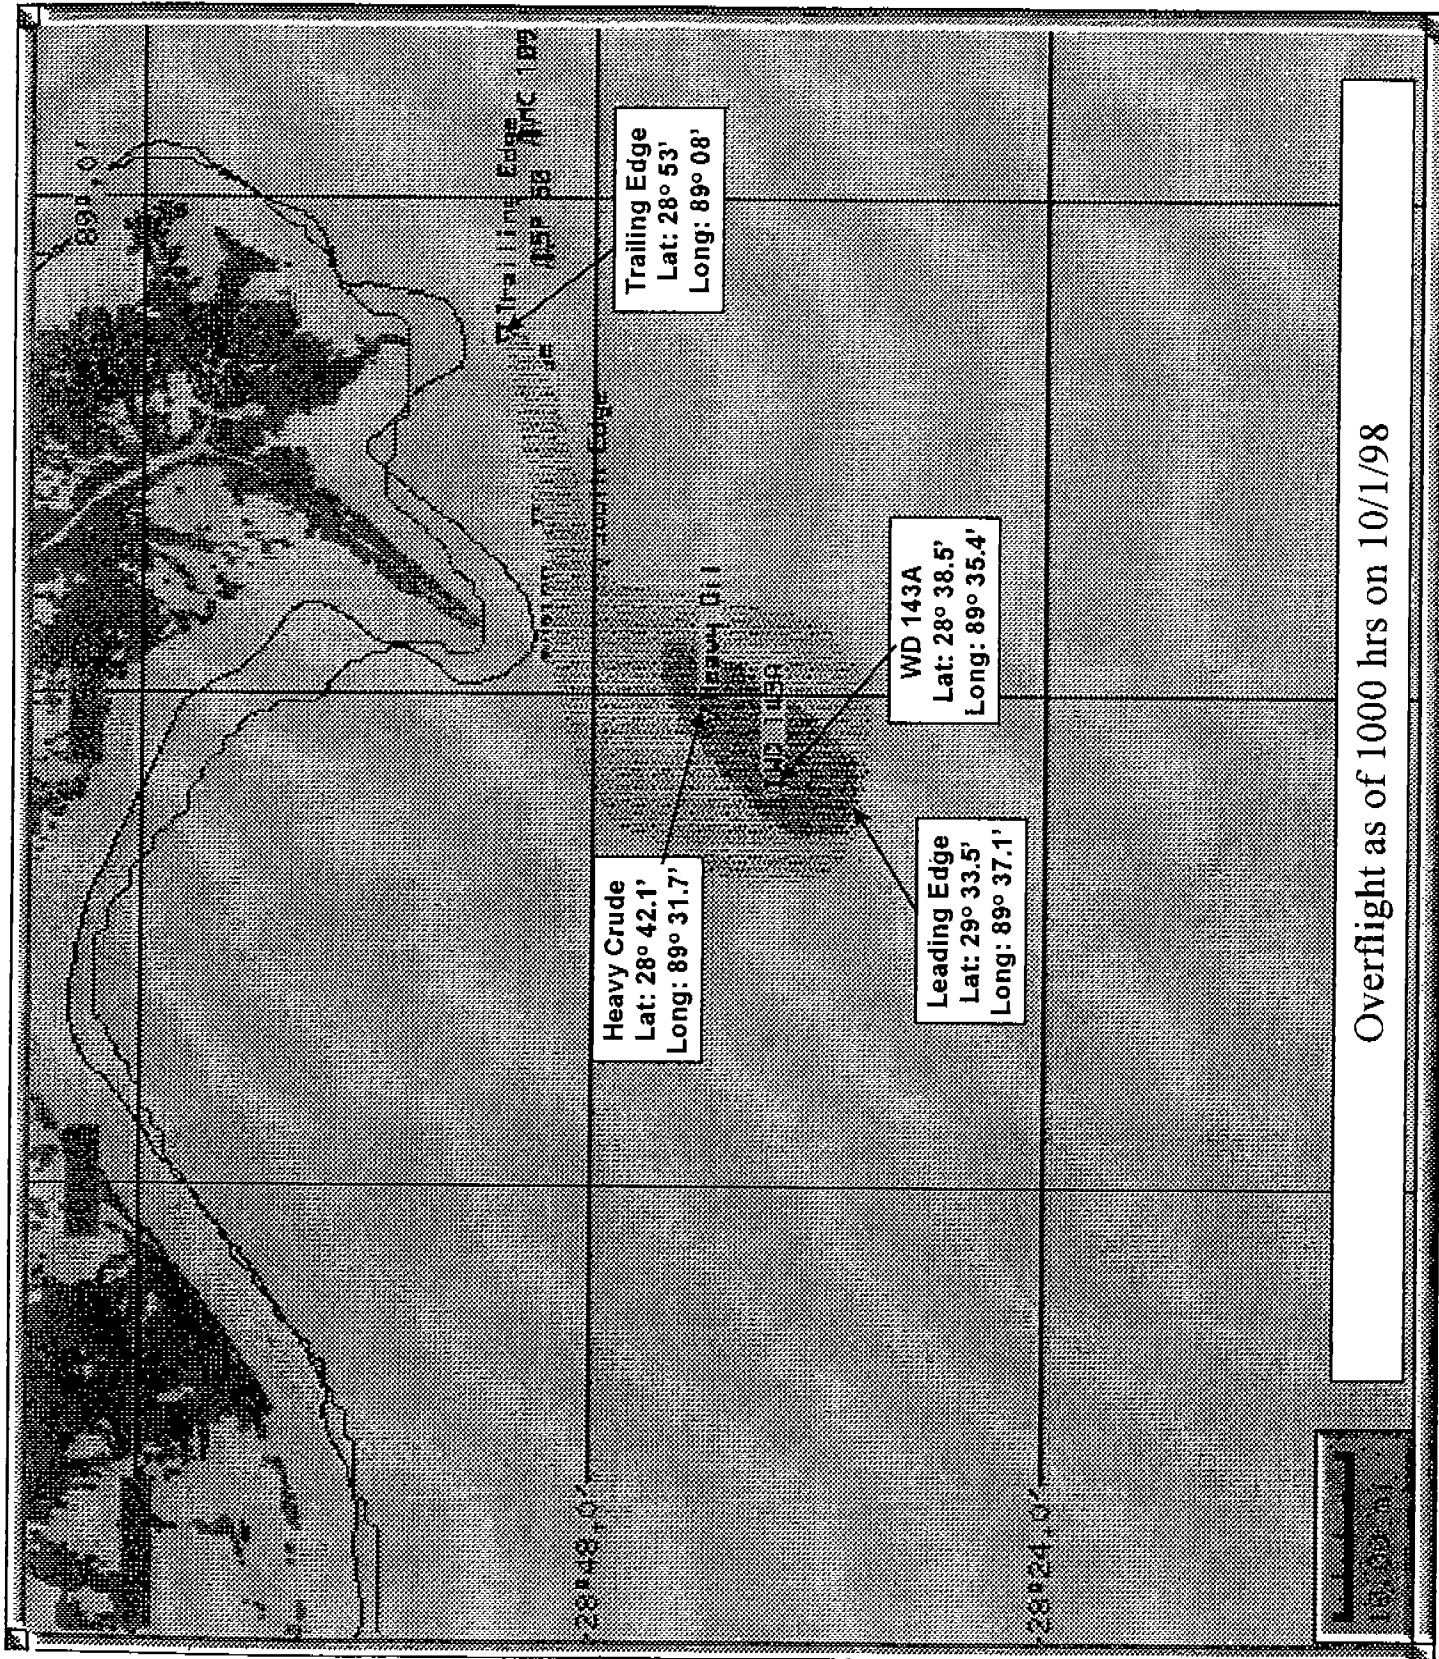
Situation Map (0810- 10/5/98)

Overflight as of 1000 hrs on 10/1/98

1. Lt. Sheen -200yds x 10 yds
2. Mod. Sheen -3/4 mi. x 1 mi. (potential shore impact)
3. Sheen
4. Sheen -200yds x 1/4 mi
