UNITED STATES  
DEPARTMENT OF LABOR  
MINE SAFETY AND HEALTH ADMINISTRATION  
COAL MINE SAFETY AND HEALTH

REPORT OF INVESTIGATION  
Fatal Underground Coal Mine Explosion  
May 20, 2006

Darby Mine No. 1  
Kentucky Darby LLC  
Holmes Mill, Harlan County, Kentucky  
ID No. 15-18185

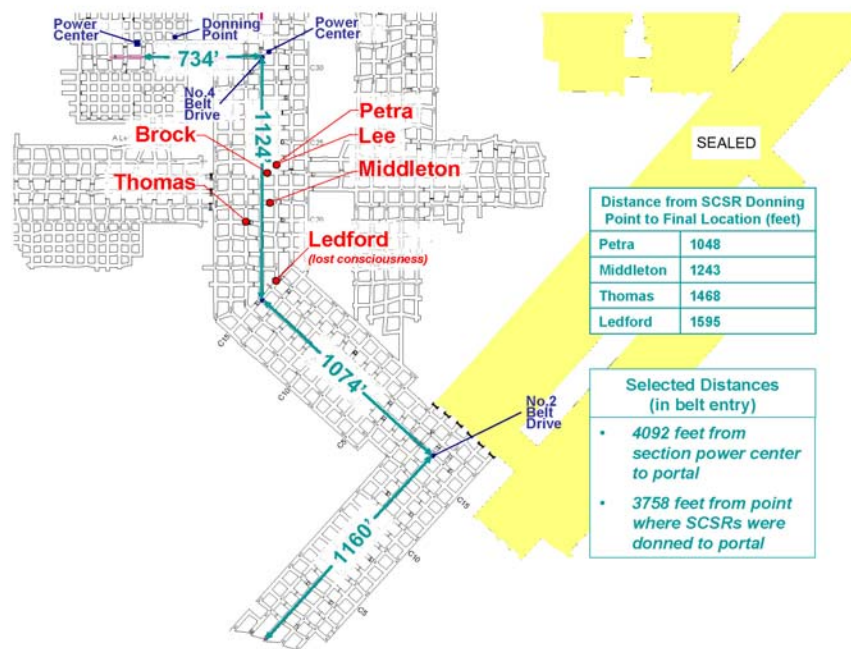
**Figure 5 - Distances from SCSR Donning Points to Final Location of Miners**

Petra, Middleton, and Thomas attempted to escape but eventually succumbed to carbon monoxide poisoning at different locations in the mine. Petra was found in the No. 5 Entry approximately 500 feet outby the No. 4 Belt Drive power center. Middleton was found approximately 700 feet outby the No. 4 Belt Drive power center in the left crosscut off of the No. 5 Entry. Thomas was found 800 feet outby the No. 4 Belt Drive power center in the crosscut between the No. 2 Entry and No. 3 Entry in the return air course. Figure 5 shows the distances from where the SCSRs were donned to the location where the miners were found.

Brock and Lee were located at or near the No. 3 Seal in the return air course when the ignition occurred and were both fatally injured by the forces resulting from the explosion. Brock was found 240 feet from the No. 3 Seal in the crosscut between the Nos. 4 and 5 Entries. Lee was found in the No. 5 Entry, approximately 340 feet from the No. 3 Seal and 20 feet outby where Petra was found.

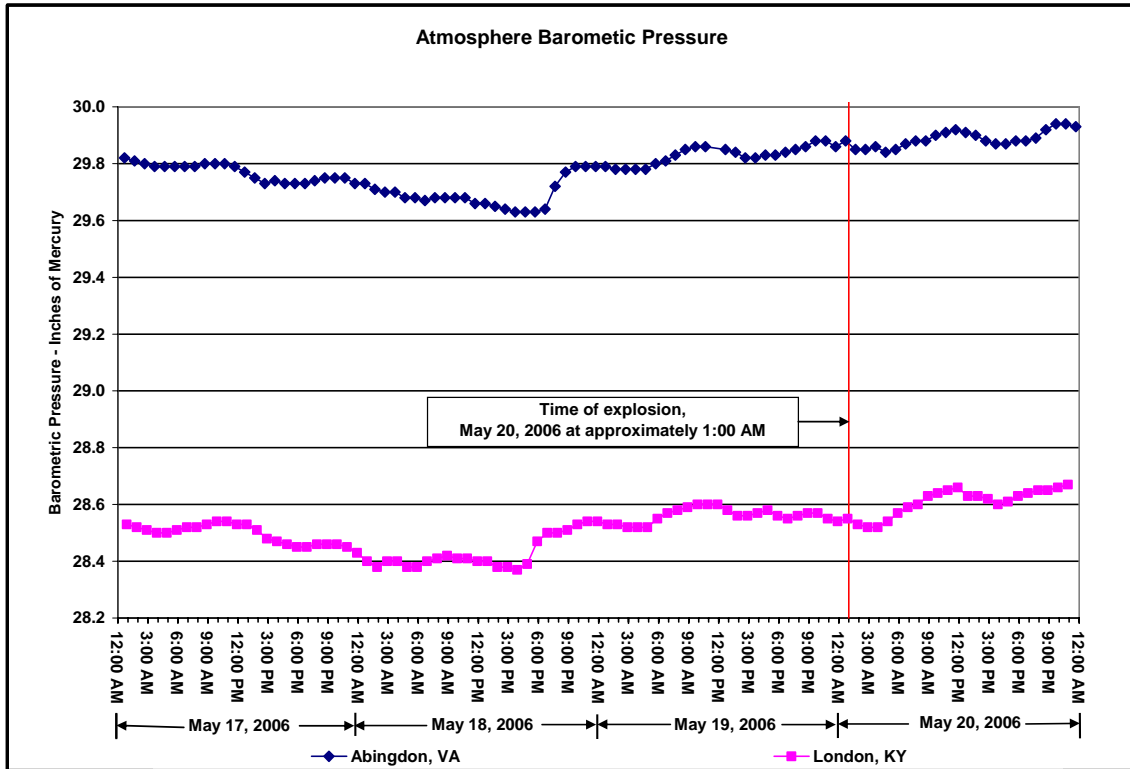
**Figure 7 - Graph of Barometric Pressure**

Records of the barometric pressures for Abingdon, Virginia and London, Kentucky for May 17 through May 20, 2006 were obtained from the National Oceanic and Atmospheric Administration (NOAA) and are depicted in Figure 7.

In the five hours prior to and after the accident, the barometric pressure fluctuated over a narrow range of 0.05 inches of mercury and appeared to reverse direction and started down near the time of the accident. A decreasing barometric pressure would cause the atmosphere behind the seals to expand in accordance with Boyle’s Law, which states that the volume of a gas varies inversely with the absolute pressure. The gas expansion would cause the atmosphere in the sealed area to mitigate towards the seals and into the active workings through any openings.
