## **Fire Origin Investigation Involving a DOT 3AL Cylinder Failure in Luraville, FL**

WHA Report 05H010

Date: September 29, 2006

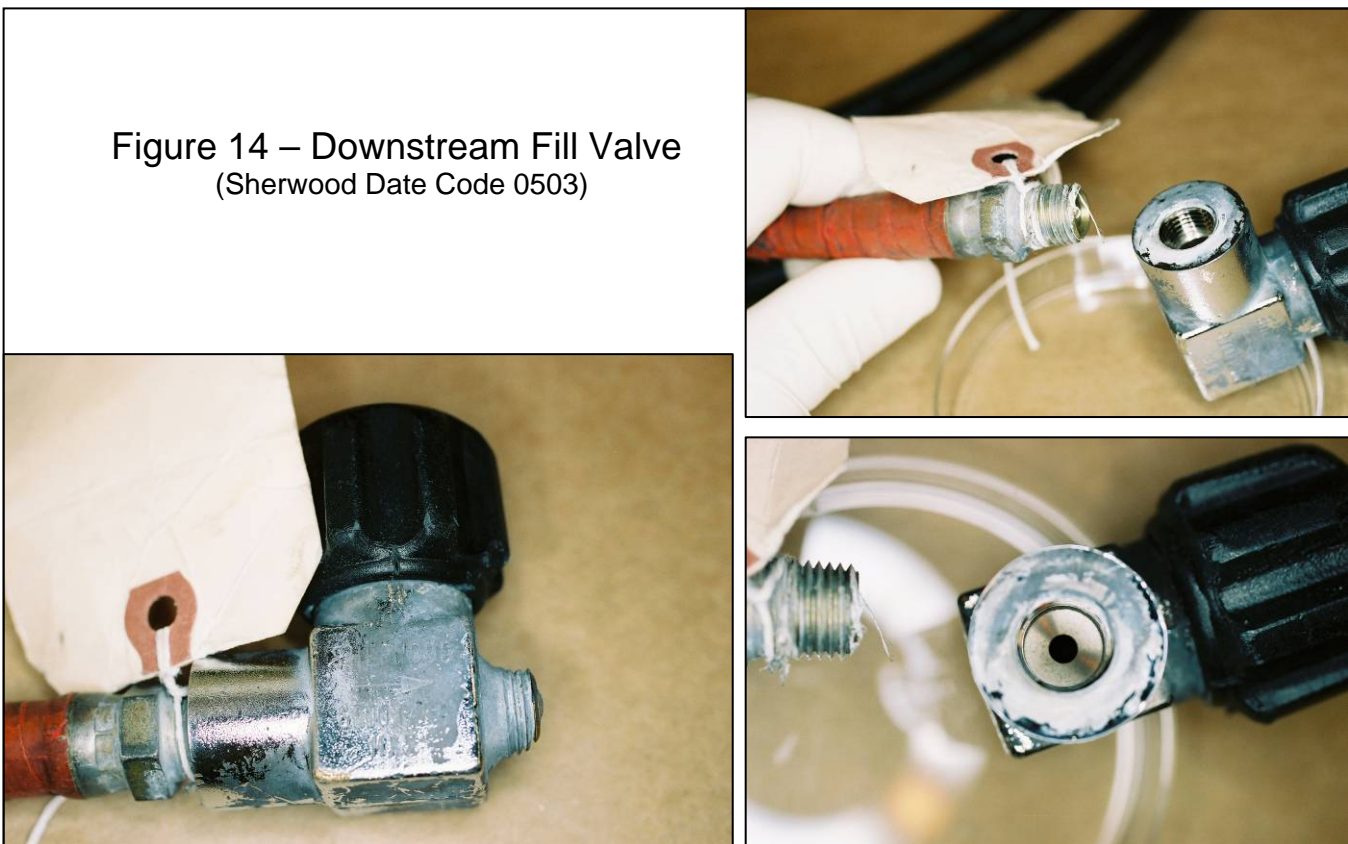
Figure 15 – Downstream Fill Valve Disassembly

Figures 14 through 16 depict the disassembly of the downstream fill valve as well as the flexible hose that was attached to the upstream fitting of this valve. The exterior of this valve exhibited deposits consistent with combustion residue (Figures 3-5), consistent with its close proximity to the burnout when the cylinder failed. However, disassembly of the valve indicated that the plastic seat was not consumed and did not exhibit evidence of combustion residue (Figure 15d). In addition, the nozzle of the valve was also intact and did not exhibit visual evidence of combustion residue (Figure 15c). Figure 16 depicts the condition of the flexible hose fitting that was attached to the upstream fitting of this fill valve. As with the fill valve interior surfaces, an AK225 solvent rinse was performed within the flexible hose to evaluate whether contaminants could be identified on the interior surfaces. The results of this analysis will also be presented and discussed later in this report.

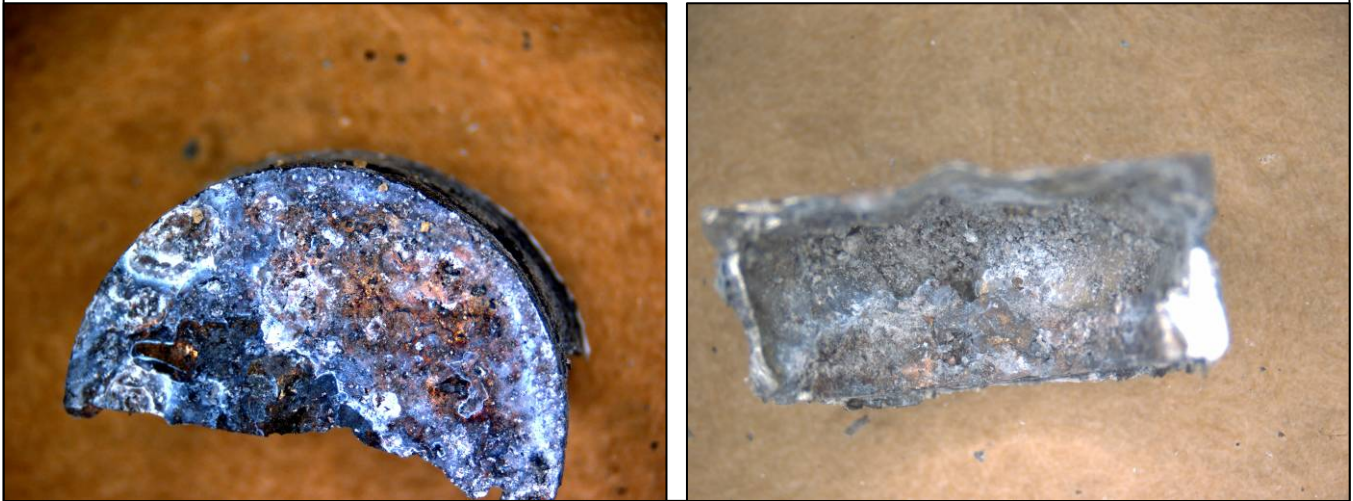
Figure 24 - Residue Removed from Cylinder Valve Outlet

Figures 21 and 22 depict the disassembly of the fill adaptor from the cylinder valve outlet. A very significant amount of combustion residue, also comprised of a resolidified mass of brass and aluminum-oxide (see Figures 23-25), was observed in the outlet port of the cylinder valve where the adaptor fitting would hinder free gas flow due to the change in flow direction. The adaptor fitting interface was also heavily deposited with brass and aluminum-oxide combustion residue (Figure 22). This resolidified mass was consistent with combustion product back-flow from the cylinder after combustion of the aluminum had developed. Based on the significant degree of combustion observed with the neck and upper crown of the aluminum cylinder (Figure 2), especially at the threaded connection, this mass was consistent with the melting of the base of the brass valve while exposed to the significant thermal energy release of aluminum combustion in oxygen<sup>6</sup>.

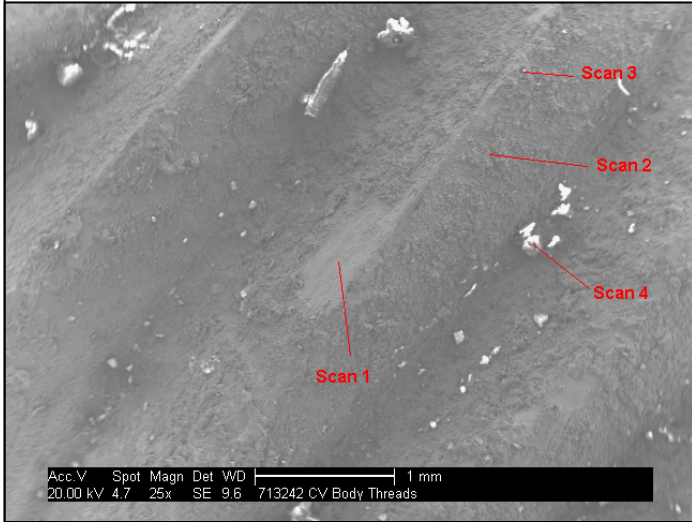
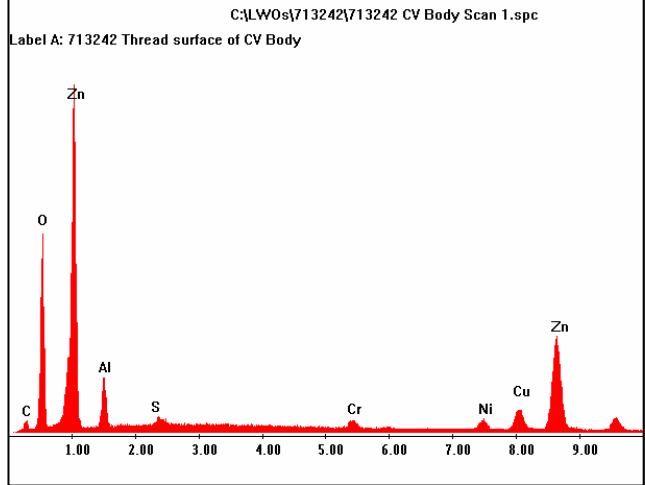
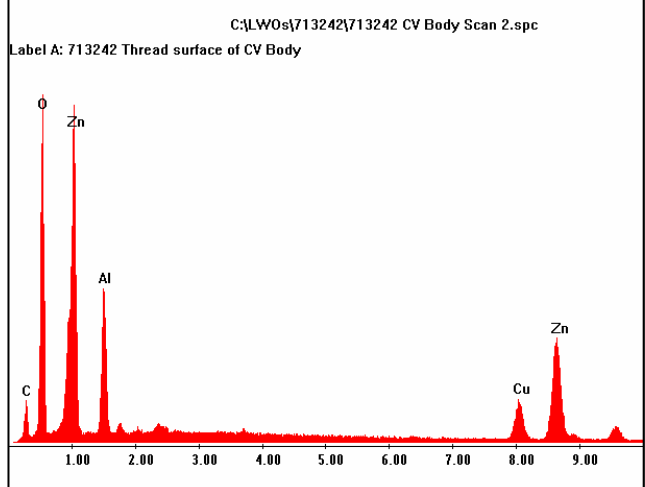
Figure 28 - Cylinder Valve Body Thread Residue (scans 3 and 4)

Figures 27 and 28 depict the SEM/EDS analysis of the threaded portion of the cylinder valve inlet, just above where the melt/flow patterns were observed. As was observed on the melt/flow residue in the valve's inlet port, a significant amount of aluminum-oxide was observed on the remaining threads. This result was considered consistent with the burning of the threaded portion of the cylinder neck, with deposits of aluminum-oxide to the valve threads, prior to the valve being ejected energetically from the cylinder.

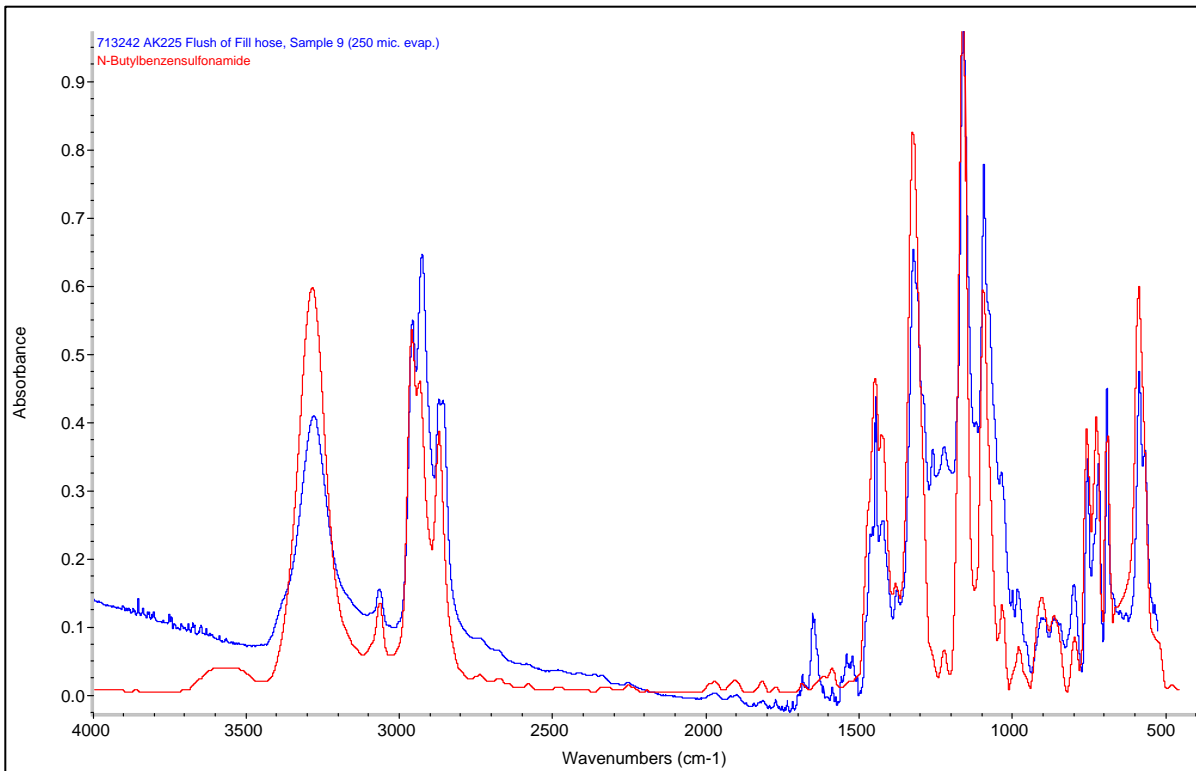
Figure 31 - FTIR of Internal Surface of Upstream Fill Valve  
(surface washed with AK225 solvent)

Figures 31 through 34 show FTIR spectra for the upstream fill valve wash and the swab of the interior base of the fire-damaged cylinder. Figures 31 through 33 were prepared to identify the very complex spectral appearance of the residue removed from the interior of the upstream fill valve and the cylinder. The spectra obtained indicated that several materials were involved and contributed to the spectral response both in the upstream valve and in the cylinder. It was concluded that the most likely explanation for all the frequencies observed was a mixture of compounds. Therefore, commonly used

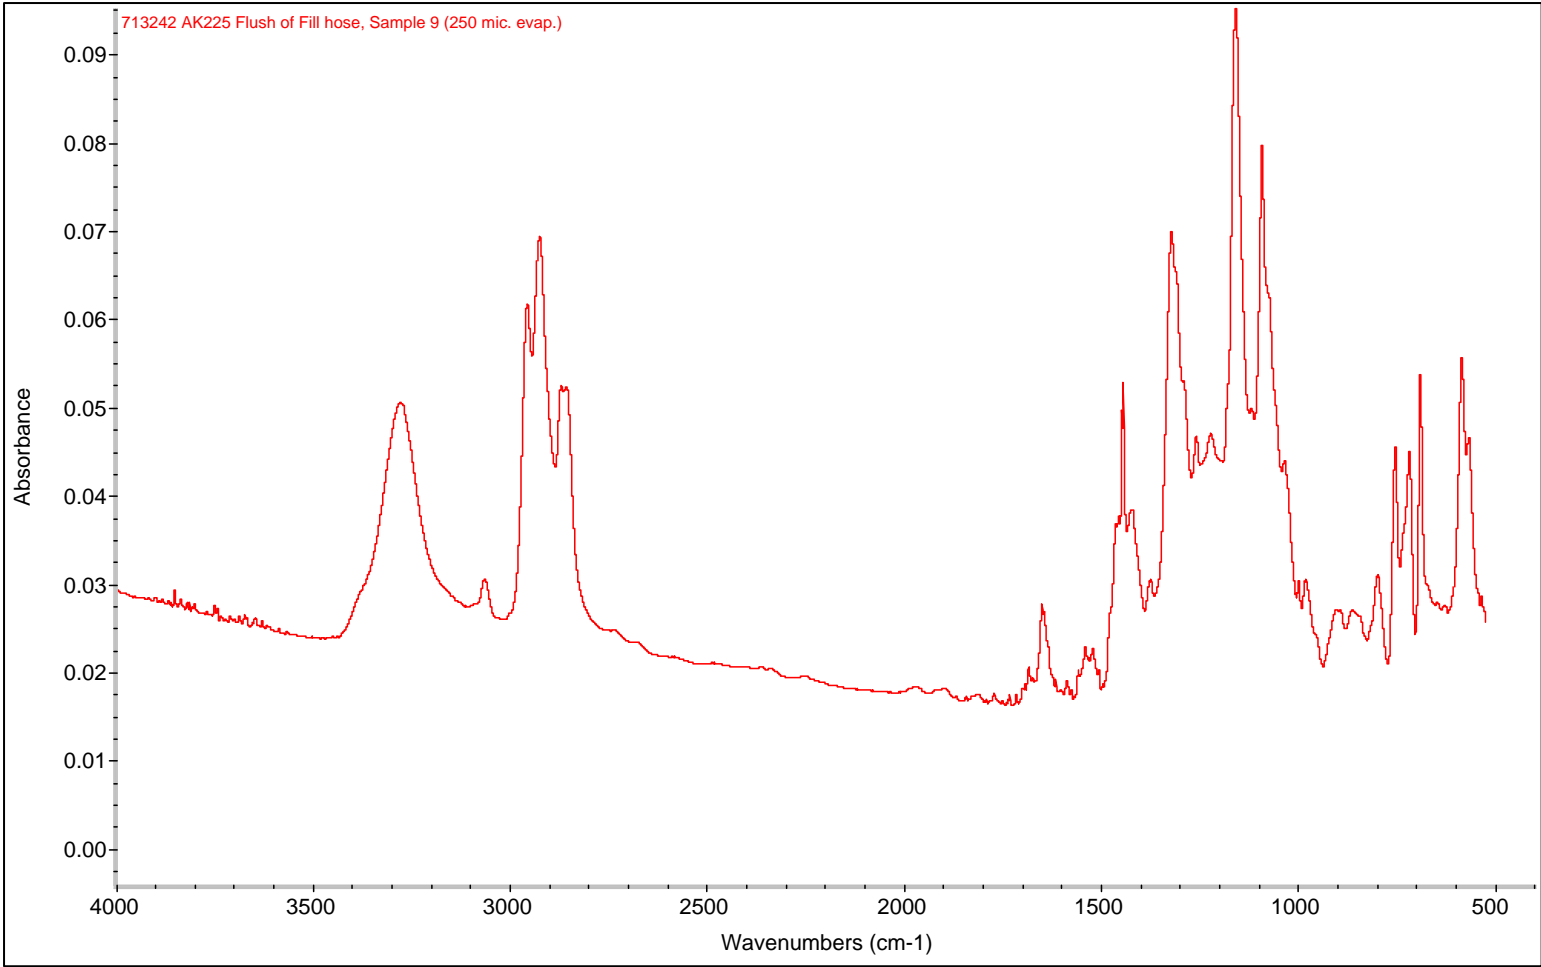
# FTIR of Flexhose Residue

(Internal surface washed with AK225 Solvent)

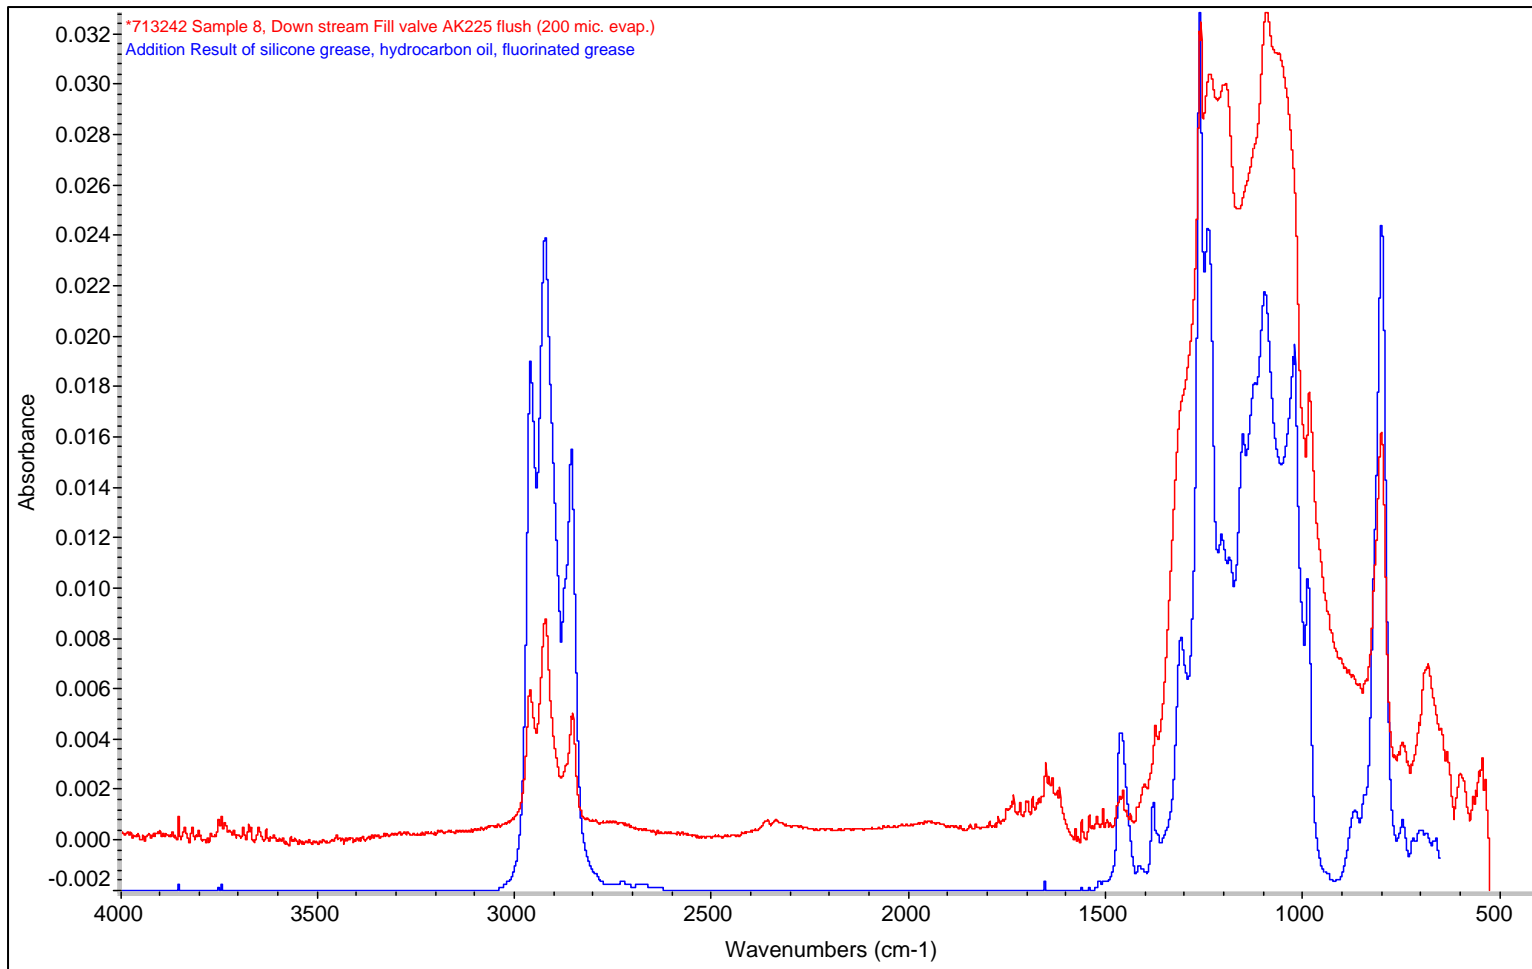
# Comparison FTIR Spectra of Upstream Fill Valve and Lubricant Composite

(Lubricant composite spectra comprised silicone oil, hydrocarbon oil, and fluorinated grease spectra added digitally)

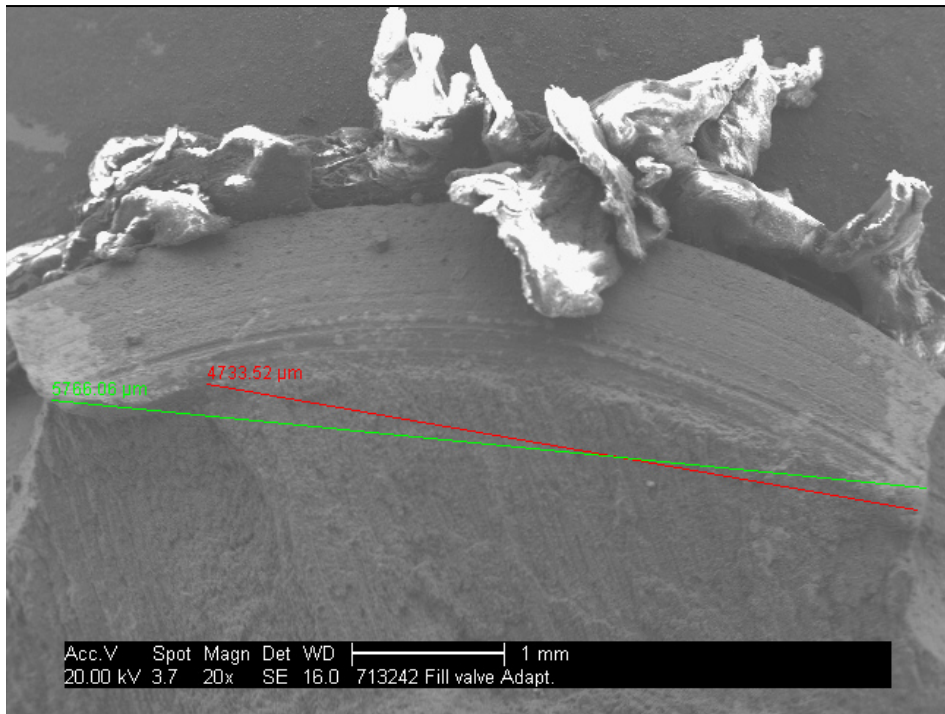
Fill Valve Adaptor Fracture

## Thread Root Comparison
