**METALLURGICAL
EVALUATION
OF DOT-3AL-2015
CYLINDER T-57003**

Prepared for

U.S. Department of Transportation
400 Seventh Street S.W.
Washington, DC 20590

November 1998

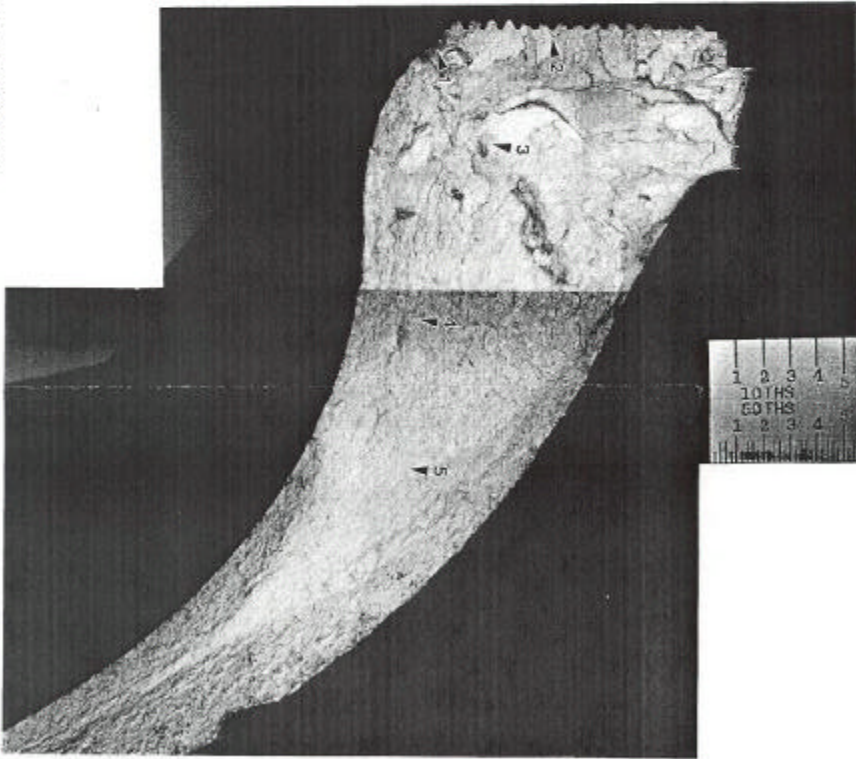
The wafer (samples 2A-1 and 2A-2) containing the flat-face fracture surface is shown in Figure 6. Optical examination revealed that the flat-face region of the fracture surface shows little macroscopic ductility. Just outside of this region, the fracture surface transitioned to an inclined shear-type of fracture.

Figure 6: Photo montage of the fracture surface at the neck from fragment 2A, photo id DC18128-R3E1.2,3,4
Regions 1 through 5 represent areas for further study.

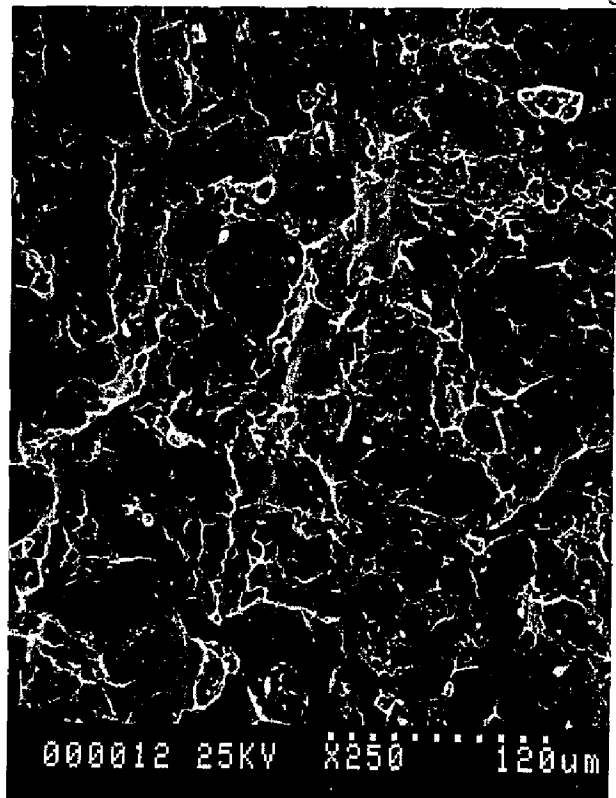
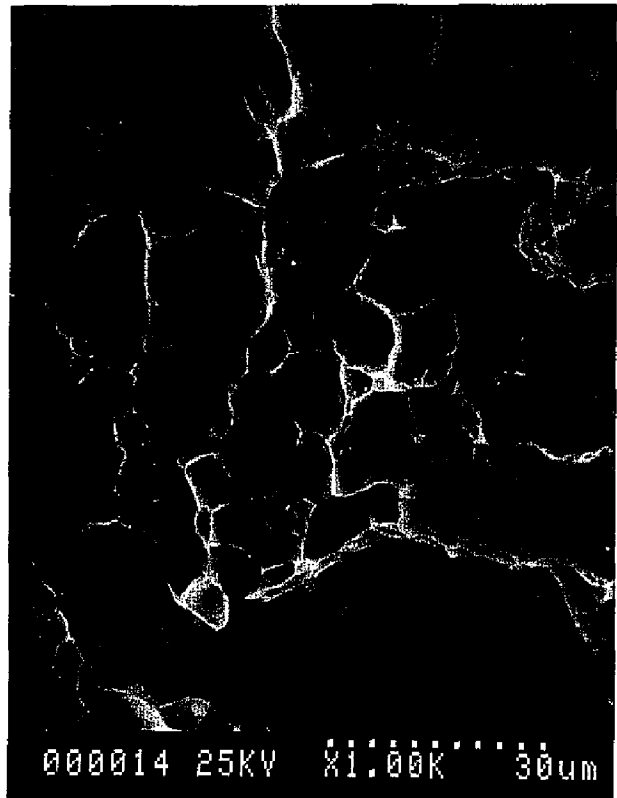
Region 2

Figure 13: Fractography of section 2A-2. Regions 1 through 5 are delineated in figure 6.

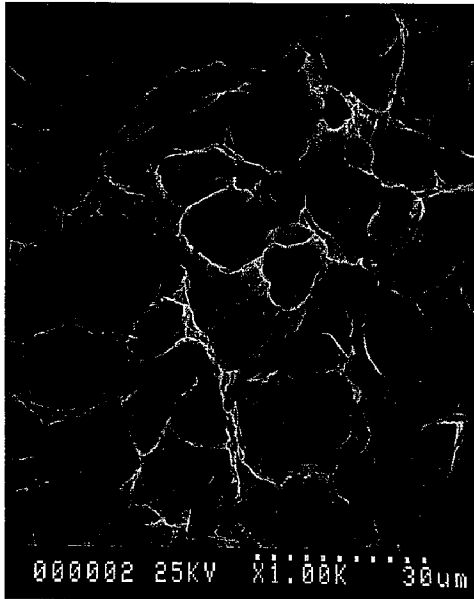
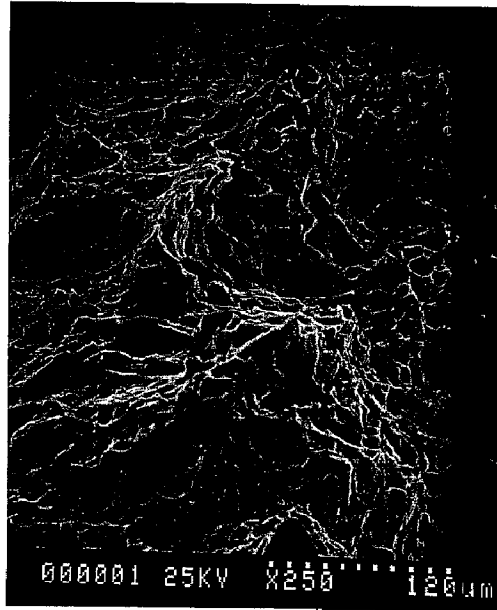
Region 5

SEM fractographs of the fracture surface from one of the tensile specimens (T2A) used for mechanical property determination are shown in Figure 14. Note that the fracture surface is ductile dimpled rupture. This morphology is consistent with fractographic studies of similar Al alloys in tensile and toughness testing [2]. This morphology compares well with the dimpled rupture morphologies shown in Figure 13.

Figure 14: SEM fractographs of a tensile specimen.
(a) 250X. Photo ID: DC18128-PAL2 9/30/98
(b) 1000X. Photo ID: DC18128-PAL3 9/30/98
