**CHEMICAL AND METALLURGICAL ANALYSIS
OF A RUPTURED DOT-3AL
SPECIFICATION COMPRESSED GAS CYLINDER**

Vishwanath Sahay
Paul J. Lare

December 15, 1994

U.S. DOT/RSPA
400 7th Street, S.W.,
Washington, D.C. 20590-0001

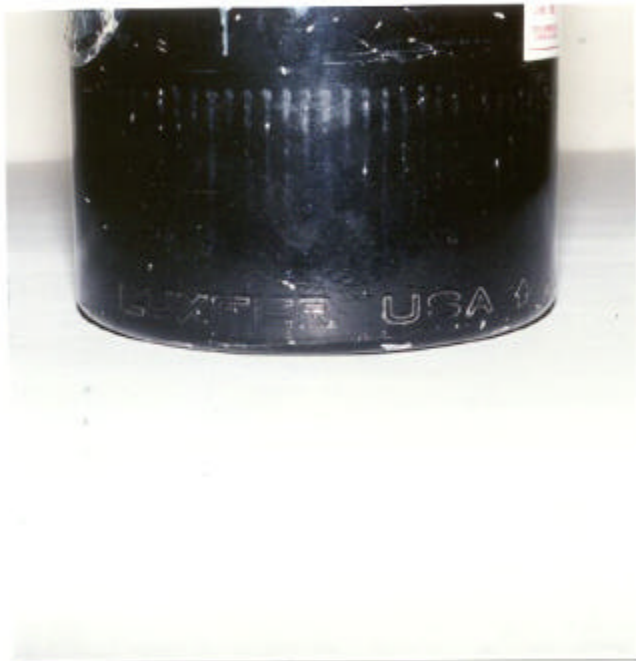
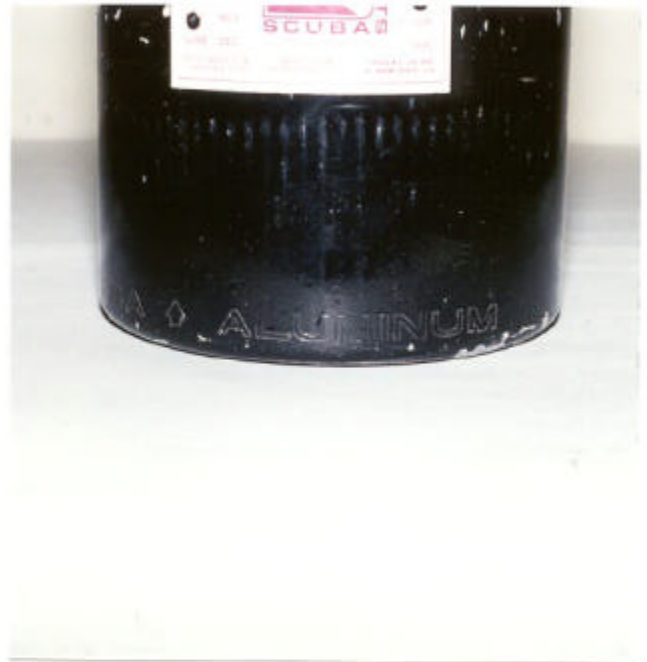
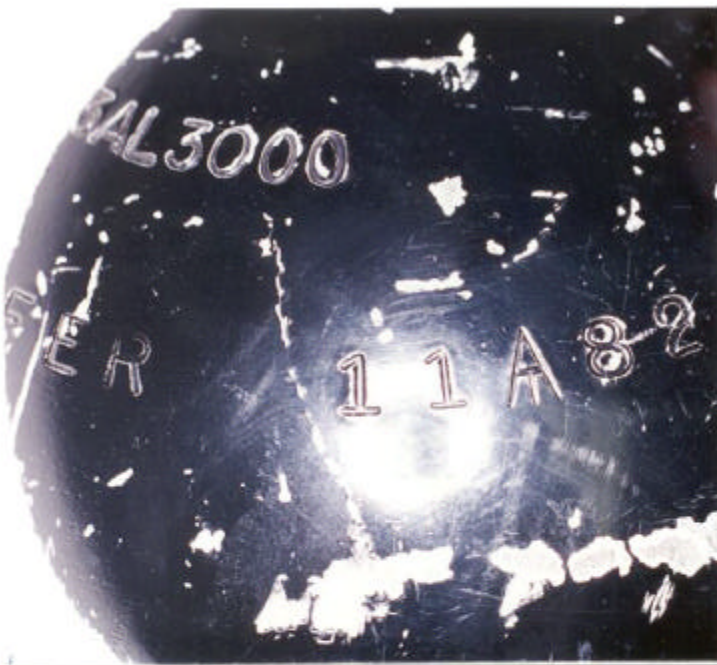
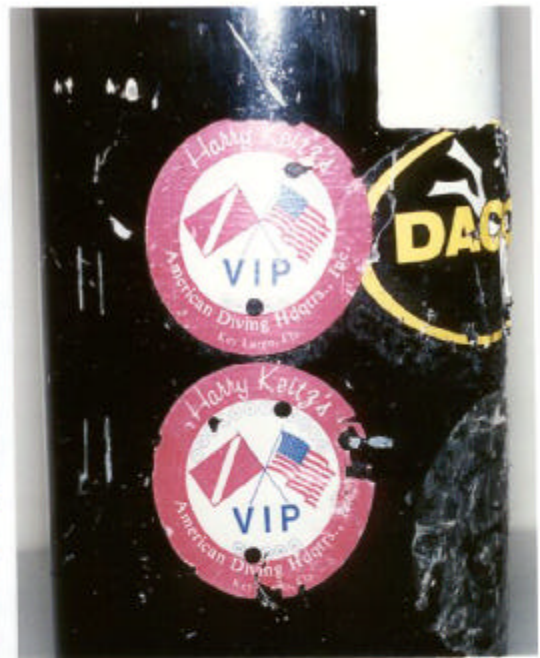
Figures 1-4: As-received views of the subject cylinder's general conditions, identification markings and an overall view of the fracture surfaces.

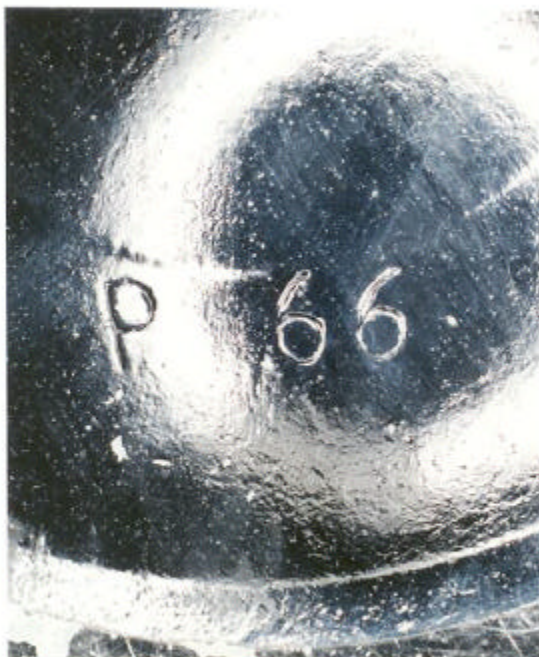
9A

Figure 5-8: As-received views of the subject cylinder showing manufacturer's name Luxfer USA (Figure 5) and other identifying markings.

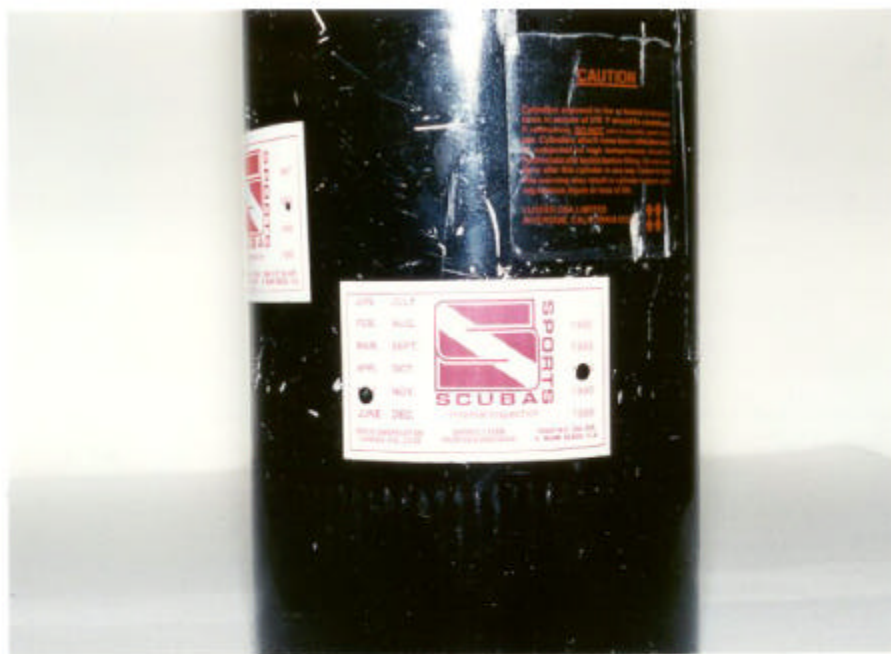
10

Figures 9-10: As-received views of the cylinder showing identification markings on its bottom (figure 9), caution sticker, and date of internal inspection (figure 10).

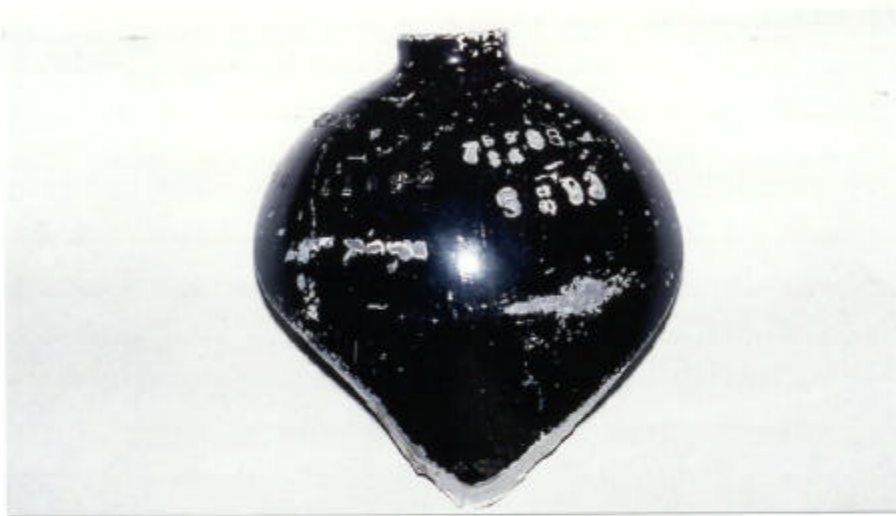
11, X 0.5 approx.

Figure 11-13: As-received views of two smaller pieces of fracture.

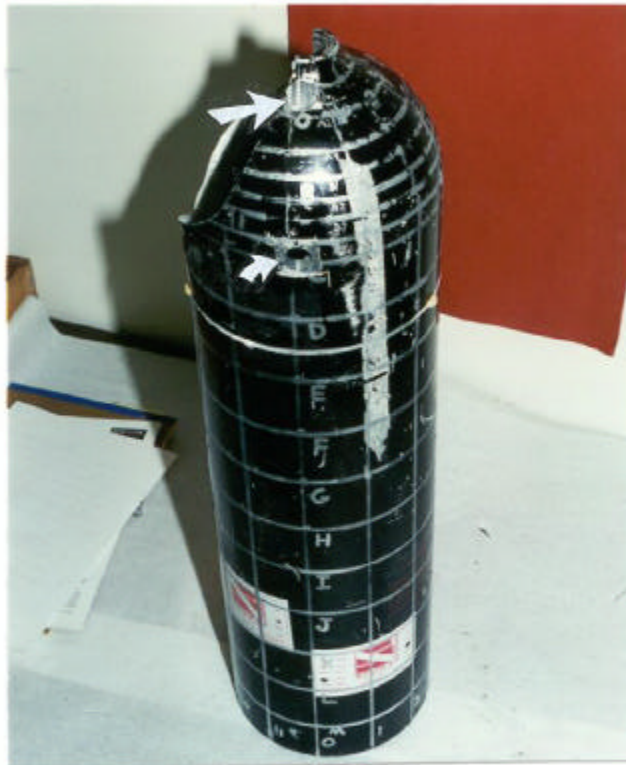
Two samples for chemical analysis were drilled (through thickness) from locations shown in figure 18A after removing coating/paint layer: one from near OC grid point (in straight part of the cylinder) and another from near OA2 grid point (in thick section near the neck of the cylinder). Analysis was performed per ASTM E34 Standard Method. Description of the test method is presented in the Appendix II. The test result is presented in Table II.

Figure 18A: Locations of chemical samples from near OC grid point (small arrow), and from near OA2 grid point (large arrow).

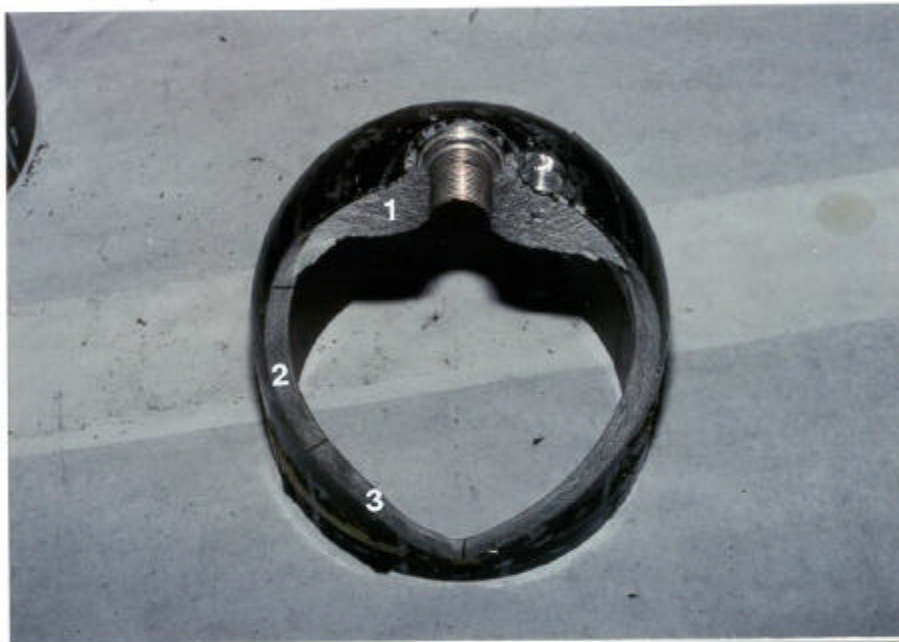
The fractured part of the cylinder was removed from the main barrel for examination; a through cut was made between the circumferential lines D and E for the purpose. Figure 18B shows the location of the cut. A macro view of the main crack front is presented in figure 19. Optical microscopic examination revealed fracture features being identical on either side of the threaded hole. Upon approval of the COTR, side A of the fracture front was used for detailed fractography; side B was used for metallographic examination (figure 19). Side A of the fracture front was removed and cut in three 3-inch segments for analysis. Referring to figure 18B for cutting plan, section 1 was located between axial grid lines 5-6, section 2 between grid lines 6-7 and section 3 between grid lines 7-9. All three sections were thoroughly cleaned ultrasonically in toluene and acetone prior to examination.

Figure 18B: View of the fractured dome part cut from the cylinder. It shows locations of fracture surface sections 1, 2 and 3, which were removed for examination.

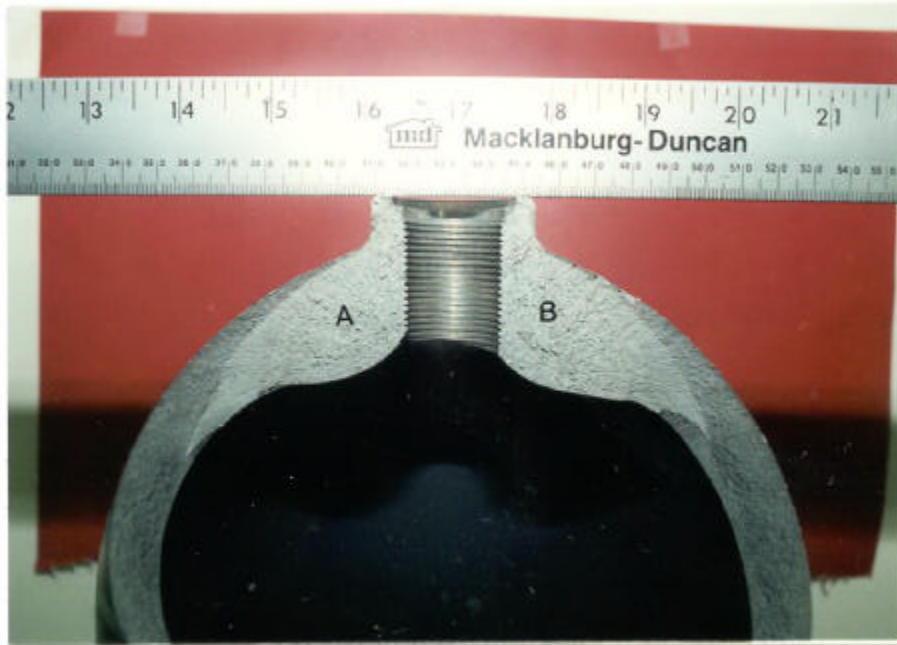
Figure 19: A macro view of the fracture surface. Side A was used for fractography and side B for metallography.

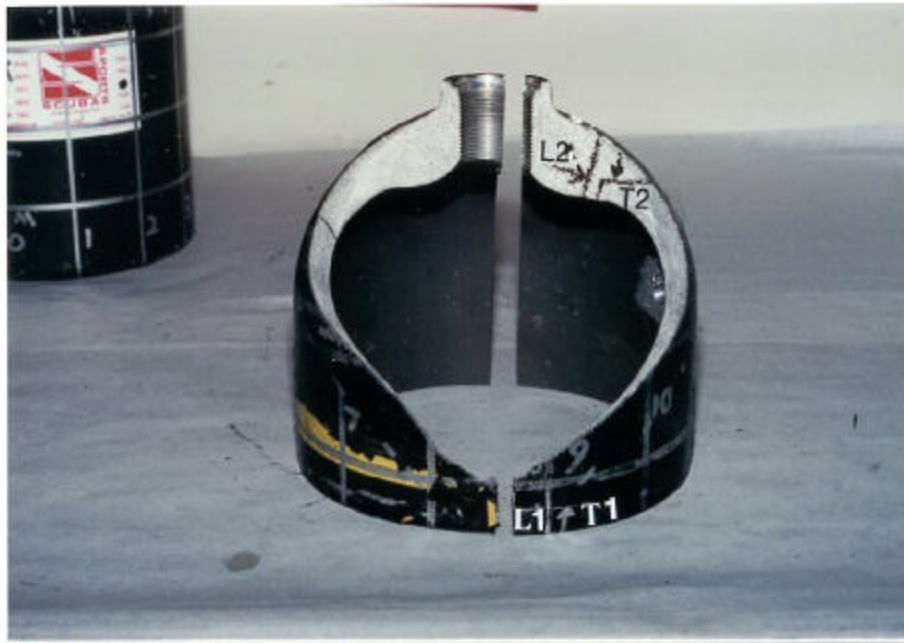
The sections outlined in figure 29 were prepared for micro-analysis. Typical photomicrographs exhibiting microstructures of the inside and outside surfaces of the longitudinal sections L1 and L2 are presented in figures 35 and 36, respectively.

Figure 29: Locations of longitudinal (L1 and L2) and transverse (T1 and T2) sections cut for metallographic examination, shown by arrows.

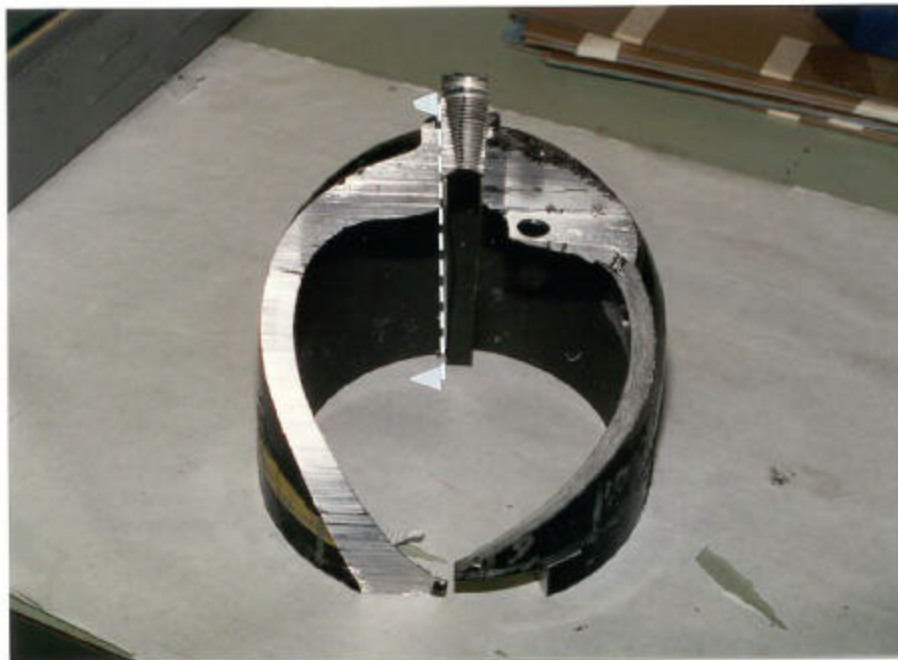
The macro section outlined in figure 30 was lapped up to 600 grit paper and etched with Keller's reagent. The overall macrograph of the section is shown in figure 31. It exhibits fine grain structure in the barrel region; grain size slowly becomes large towards the neck region. Areas marked 1, 2, and 3 were photographed at a larger magnification which clearly indicate significant difference in grain size between the neck and barrel regions; see figures 32-34. The material in the neck region appears to have undergone recrystallization and appreciable grain growth; no apparent grain growth was observed in the barrel region.

Figure 30: Photograph indicating the section used for macro analysis.
