Exponent
Failure Analysis Associates®

**Metallurgical Evaluation Of
DOT E6498-2216 Aluminum
Gas Cylinder – T119168**

08/30/99

Project No.: DC18234.000
QA ID No.: DC18234.000/C0F0/0899/TS03

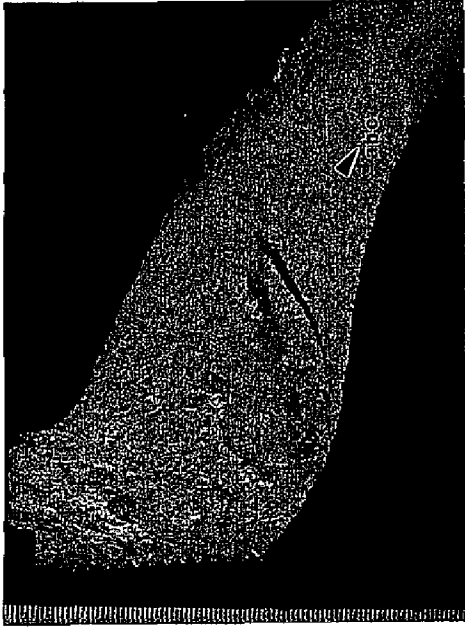
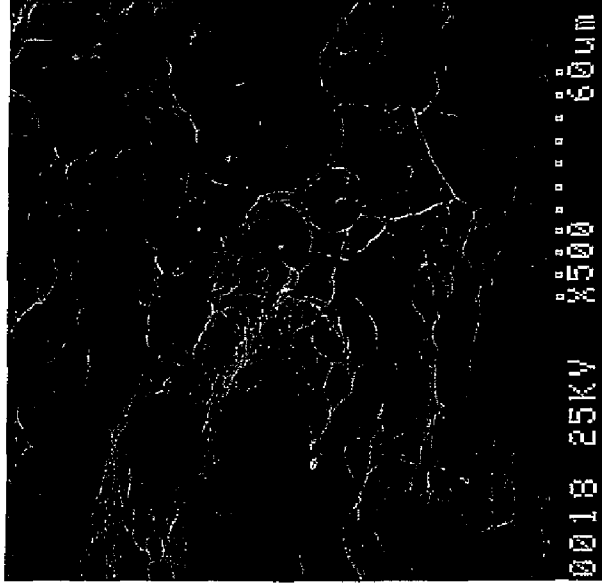
The area of the fracture surface near the neck fold in 1A-1 is shown in Figure 13. Near this fold, the fracture surface was flat, with fine scale features consisting of incompletely formed dimples and round, shallow holes. Although predominantly flat, the fracture surface did contain steps (reflecting the local grain size, see Figure 8), indicating that the cracking was intergranular. Similar flat fracture with microdimpling extended from the base of the neck (Figure 13) to the top of the inlet hole (Figure 15).

Figure 13: SEM fractography of specimen 1A-1, near fracture origin.

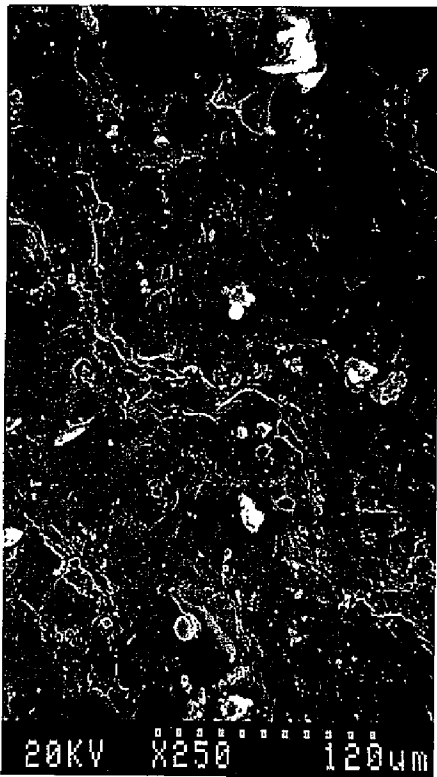
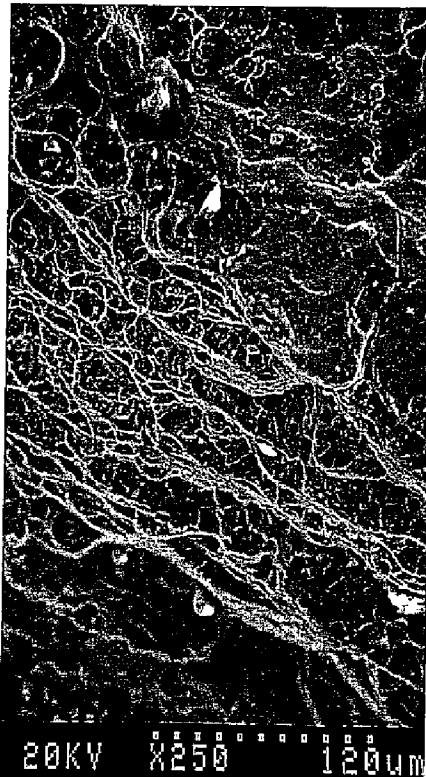
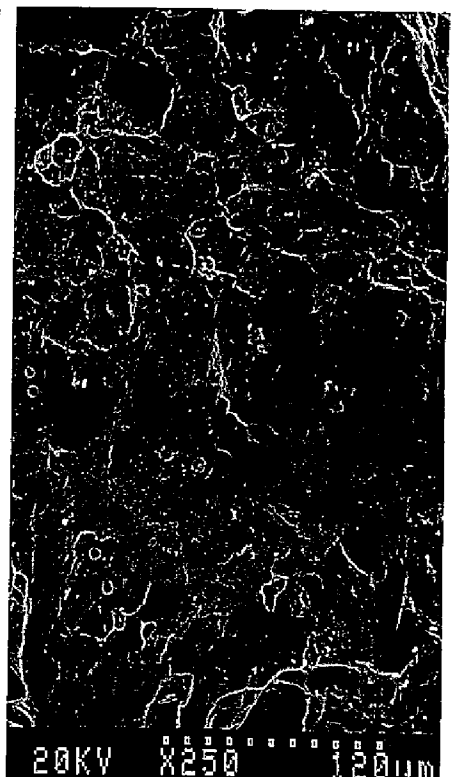
Fractographs in the region of a defined beach mark are shown in Figure 14. At location (b), the beach mark itself was observed to contain clearly defined dimples, suggestive of ductile fracture. Inside the beach mark at (a), the fracture surface was predominantly flat and intergranular, with very shallow or incompletely formed dimples, with a mixture of more ductile dimpled features. Outside the beach mark, at location (c), the fracture is similar to (a), but with larger dimples and a higher fraction of ductile regions. Based upon these observed features, the beach marks are believed to indicate an interruption in low ductility progressive cracking, which then resumed until the crack reached a critical length at a subsequent crack length. Outside the second defined beach mark, the fracture was observed to transition abruptly to shear fracture features, consisting of well-formed, elongated dimples.

Figure 14: SEM fractography of specimen 1A-2, at first beachmark.

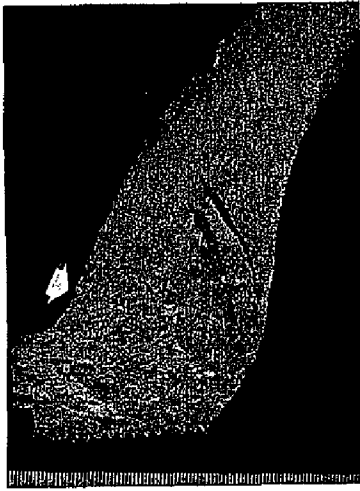
Figure 15: SEM fractography of specimen 1A-2, at top of neck (continued).
Detail of Figure 15(c).

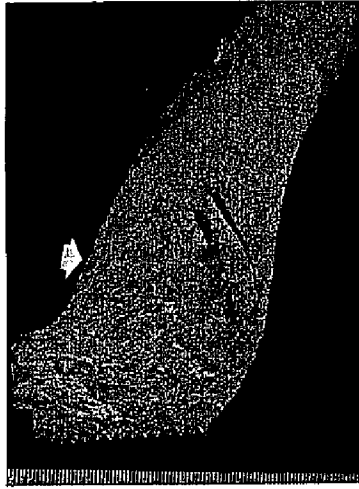
Near the outer surface of the cylinder neck, the fracture surface was again predominantly low ductility intergranular, with shallow holes and micro-dimples visible on the fracture surface. As the crack approached the outer surface, the fraction of ductile features increased. Figures 16 and 17 depict two areas in which "fingers" of low-ductility fracture were found to extend to the cylinder outside surface. The distance along the outer surface from Figure 16 to Figure 17 was approximately 1/4 inch.

Fractographic examination of the right-hand fracture surface (1A-2) revealed pathways of SLC propagation to the outer surface of the cylinder. Examples of these pathways are shown with a series of arrows in Figures 16 and 17. The SLC "fingers" reached the outer surface of the cylinder along a line at least 0.25 inches long. Thus, slow progressive crack growth extended to the outer surface of the cylinder in this area, prior to unstable crack growth and rupture. This finding is consistent with the report that the cylinder was leaking prior to rupture. No observations reliably estimate the width of a through-wall crack, or the time such a crack may have been present before rupture of the cylinder occurred. The stability of any such crack (and therefore, the time of leaking) would be expected to depend strongly on the crack shape or aspect ratio⁹, the pressure in the cylinder, the temperature, and possibly other factors that cannot be determined from a fractographic study alone.

Figure 16: SEM fractography of specimen 1A-2, at outer surface.
