**METALLURGICAL EVALUATION OF
A DOT-E6498-2216 CYLINDER
FaAA Project No.: DC17916.000**

U.S. Department of Transportation
400 Seventh Street S.W.
Washington D.C. 20590

Timothy R. Smith, Ph.D., P.E.
Failure Analysis Associates, Inc.
310 Montgomery Street
Alexandria, VA 22314

January 1997

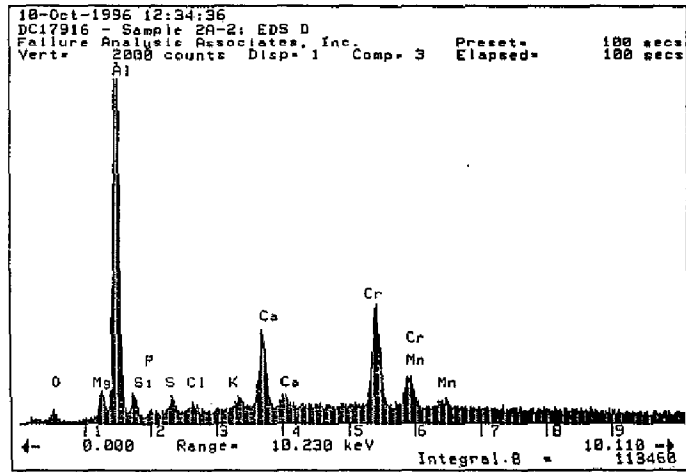
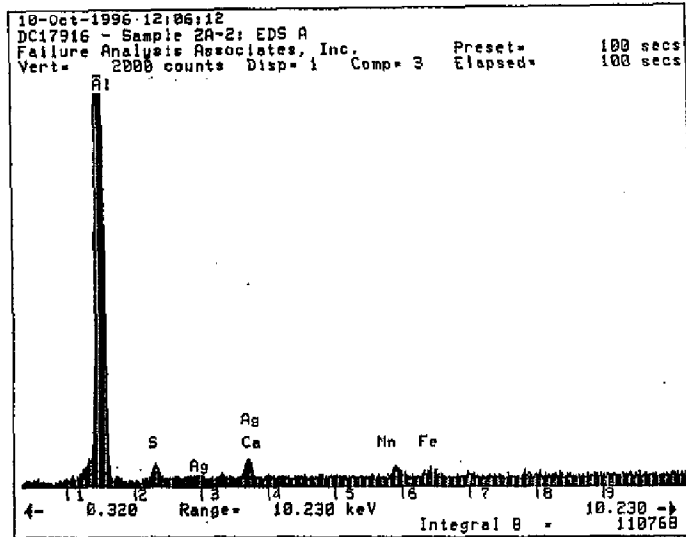
Figure 13. EDS Spectra captured from the flat-faced fracture surface.
 (a) Region 1.
 (b) Region 2.

Fractography of the wafer also shows an apparent beach mark (see Figure 6) in the flat-faced region. SEM fractographs taken from inside and beyond this beach mark, however, fail to provide a clear distinction in the failure mode between these two regions. Figure 12 shows a series of SEM fractographs taken from this fracture surface. Region 1 (Figure 12a) was from near the inside of the tank, close to the threads at the inlet hole. Higher magnification view of region 1 are shown in Figure 12(b) and (c). This region contains a mixture of intergranular and transgranular fracture, with very fine-scale dimples on the faceted surfaces. In region 2 (Figure 12a), in the flat-faced region, the fracture surface contains larger-scaled dimples but still contains intergranular facets with very fine-scale dimples. SEM fractographs of this region are shown in Figure 12 (d) and (e). Region 3 (Figure 12a) is in the shear-lipped region outside of the flat-faced portion of the fracture. This region shows predominantly dimpled rupture, Figure 12(f) and (g). Figure 13 shows energy dispersive spectroscopy (EDS) surface chemistry results captured from region 1 (near to the inlet hole threads) and region 2 (on the flat-faced fracture away from the inlet hole). The presence of oxygen in region 1, as compared to region 2, suggests that region 1 formed earlier. This is consistent with the flat oxidized appearance of the fracture surface in region 1. These spectra also show chromium (Cr), silver (Ag), calcium (Ca), and chloride (Cl) contamination. The Cr and Ag are likely from the exterior paint and/or the chromate interior coating, perhaps deposited during solvent cleaning of the remains.

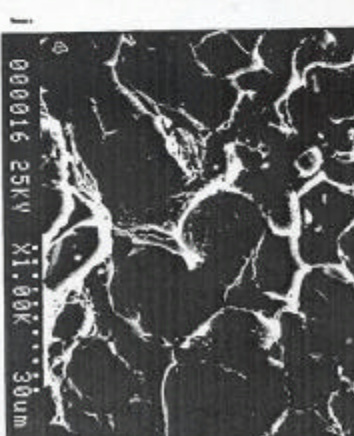
Figure 14.

Figure 14 shows fractographs of the crack SC2 (see Figures 3 and 7) that was forced open in the laboratory. Figure 14(a) and (b) show matching halves of the fracture surface. Three distinct regions are apparent: region 1, a flat-faced region near to the cylinder's inside surface at the inlet hole; region 3, a similar flat-faced region near to the cylinder's outside surface at the inlet hole; and region 2, a curved fracture surface joining regions 1 and 3. Figure 14 (c)-(j) are a series of SEM fractographs from regions 1 - 3 described above, and from region 4, (see Fig. 12a), close to the extremity of the crack prior to it being forced open. Figure 15 shows EDS spectra captured from the fracture surface (as shown in Figure 12) from regions 1 - 4. Note Ag and Ca contaminants in region 2, similar to those found on the original fracture surface (see Figures 12 and 13).

Fractography of fracture surfaces of crack SC2 forced open in the laboratory.

(a) Fracture surface. Photo ID: DCI7916-PAL-17A-12/10/96.

(b) Mating fracture surface to (a). Photo ID: DCI7916-PAL-18A-12/10/96.
