**FRACTOGRAPHIC AND MICROSTRUCTURAL EXAMINATION  
OF A RUPTURED DOT-3AL  
SPECIFICATION COMPRESSED GAS CYLINDER**

July 27, 1995

U.S. DOT/RSPA/  
400 7th Street, S.W.  
Washington, D.C. 20590-0001

ARTECH File No. 9509.004

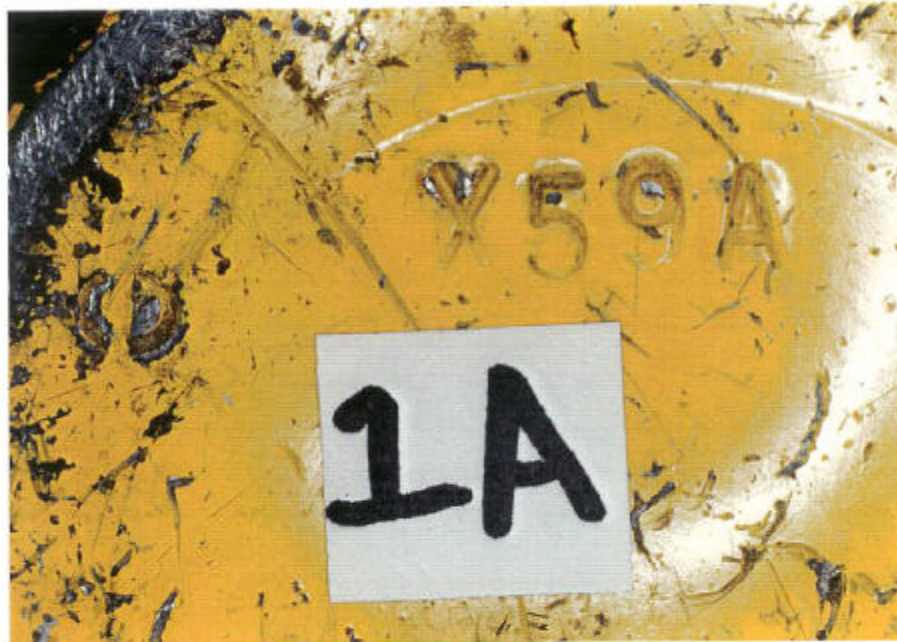
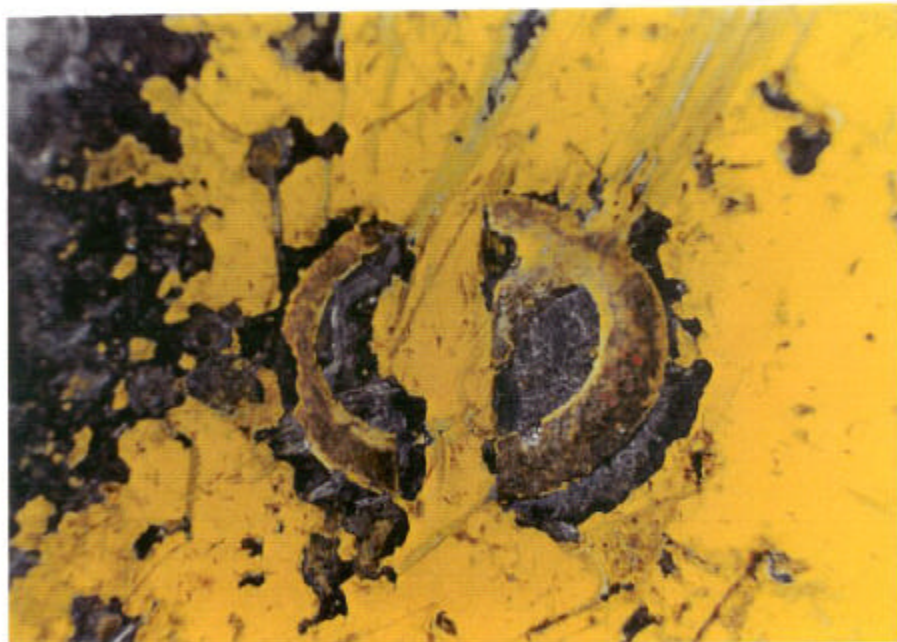
Figure 17.

Identification mark(s) on the bottom of the cylinder. The significance of letter "A" following "X59", the Lot Code, and the unrecognized symbol in the lower photograph is not known at this time.

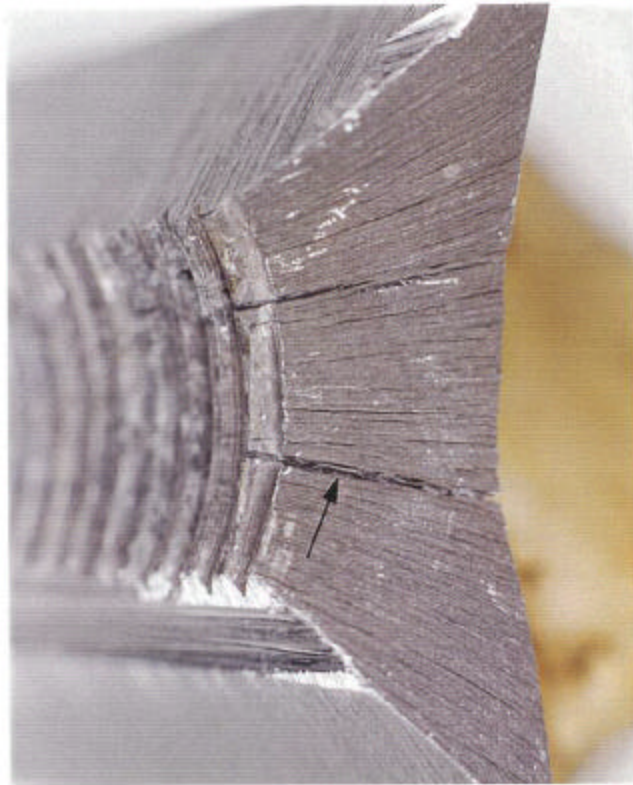
FRACTURE SURFACE #2 - A section from the neck region containing threads was removed from the piece shown in Figure 8. An

undisturbed view of the inside surface of the section is presented in Figure 33. Notice crack-like features in the threads as well as on the adjacent internal surface. A through-thickness saw cut was made along the dotted line shown in Figure 33a. A fresh fracture was created by flexing the remaining ligament; the newly created fracture contained the crack-like feature shown in Figure 33b. An enlarged view of the lab-created fracture surface is presented in Figure 34. The crack-like feature was about 0.017 inch deep. Its color was similar to the rest of the inside surface of the cylinder which suggests that the crack was formed during the manufacturing process. The presence of such cracks is detrimental to integrity of the cylinder because they offer a ready site for cracks to propagate under favorable stress conditions.
