NATIONAL TRANSPORTATION SAFETY BOARD

HIGHWAY ACCIDENT REPORT

COLLISION BETWEEN METROLINK TRAIN 901 AND
MERCURY TRANSPORTATION, INC., TRACTOR-COMBINATION
VEHICLE AT HIGHWAY-RAILROAD GRADE CROSSING
IN GLENDALE, CALIFORNIA
ON JANUARY 28, 2000

**NTSB/HAR-01/02
PB2001-916202
Notation 7410
Adopted November 27, 2001**

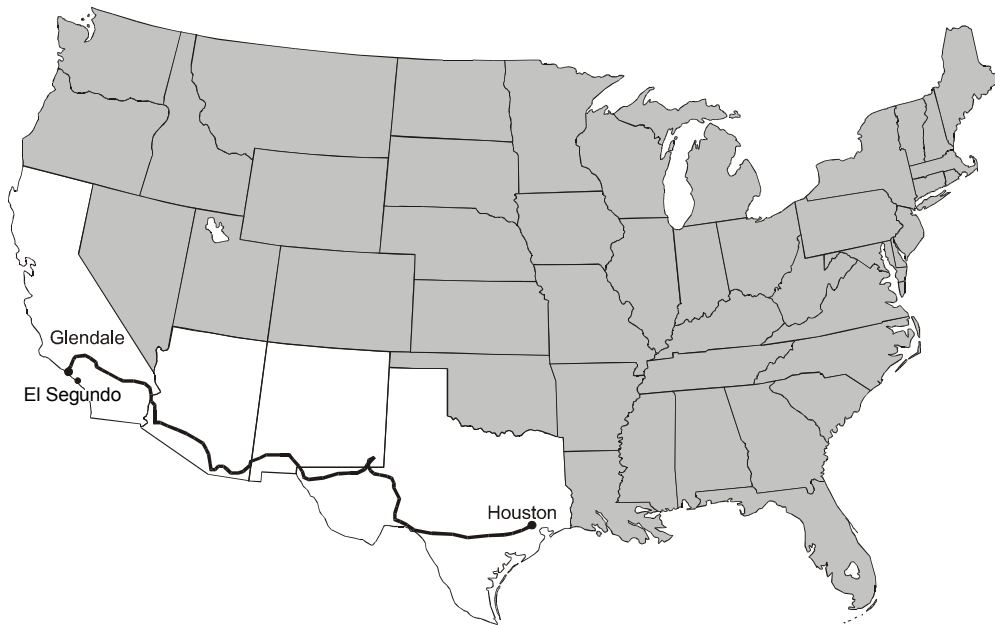
The transportation of this oversize/overweight load covered over 2,100 miles through 4 States (see figure 3); involved 5 pilot car companies, 2 permit companies, the permit issuing offices of 4 States, and in California, 12 local jurisdictions; and had been under way for 22 days at the time of the accident. The following description of the trip is segmented by State.

Figure 3. Map indicating convoy route from Houston, Texas, to El Segundo, California.

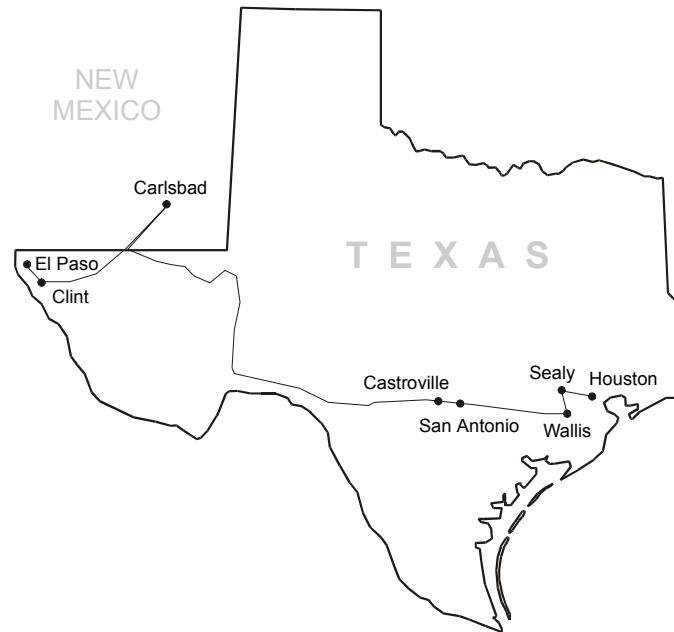
The truckdriver indicated that the convoy encountered subsequent problems with delays on seven other occasions in Texas (see figure 4):

Sealy	The load knocked down city hazard warning lights on a sign.
Wallis	The convoy encountered a raised railroad grade crossing that the truck could not traverse. They stopped for 3 hours until they received approved rerouting.

San Antonio	The convoy encountered a bridge with a height clearance lower than the load height and required rerouting.
Castroville	The load struck an overhead telephone line.
Clint	The load struck a traffic light.
El Paso	The convoy encountered overhead street signs with height clearances lower than the load height. A bucket truck had to be used to lift power lines to allow the load to pass through.
Unknown location ⁴	The convoy encountered a right turn that the truck could not negotiate and had to detour around.

Figure 4. Map indicating convoy route through Texas.

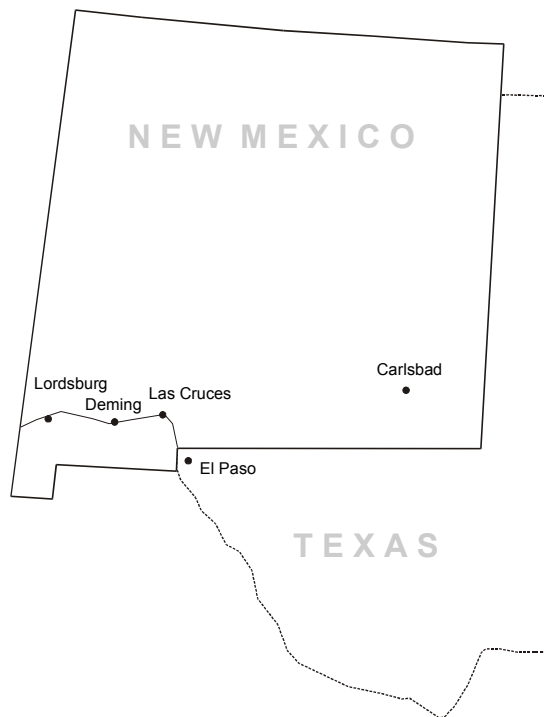
On January 21, the convoy resumed the trip, leaving El Paso and entering New Mexico near Las Cruces. The trip through New Mexico was along a southern route, roughly parallel to Interstate Highway 10 through Deming and Lordsburg, New Mexico, into Arizona. In Lordsburg, a pilot car from Billy's Pilot Car Company replaced the pilot car from Happy's Pilot Car Service, and the truckdriver parked the truck at 4:15 p.m. on January 22 until 9:45 a.m. on January 24. According to the truckdriver and pilot car drivers, the trip through New Mexico was uneventful. (See figure 5.)

Figure 5. Map indicating convoy route through New Mexico.

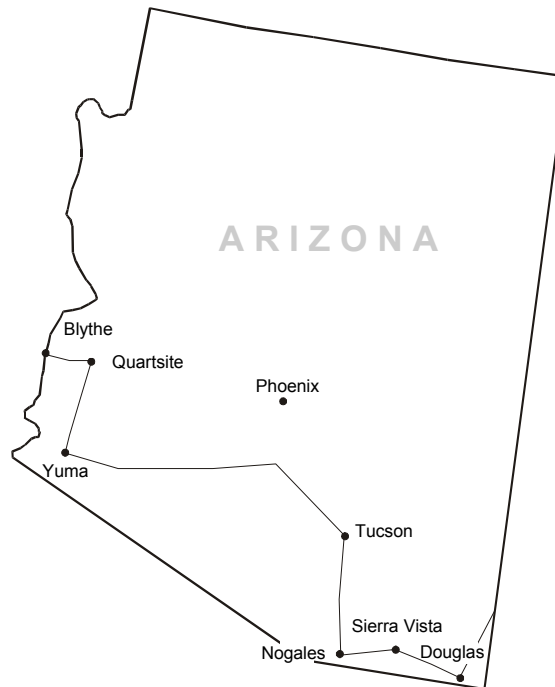
The truckdriver and the rear pilot car driver said they awoke about 7:30 a.m. on January 27. The public safety officers did not come back, and the convoy drove through Quartzsite without them. About 9:00 a.m., the convoy arrived at the California-Arizona border, where the truckdriver acquired the last of the faxed California permits from Mercury at a nearby truck stop. (See figure 6.)

Figure 6. Map indicating convoy route through Arizona.

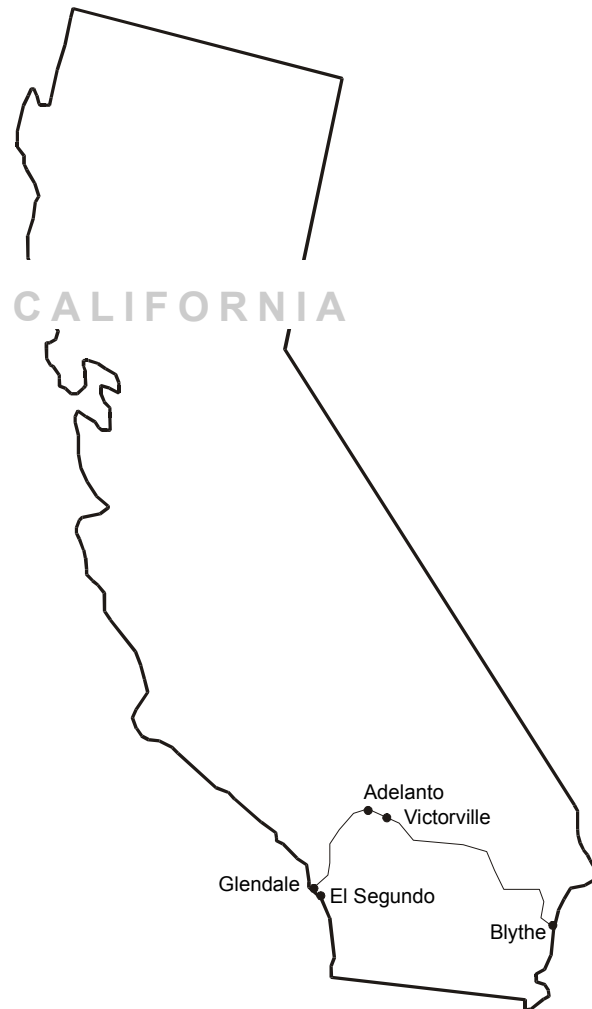
The movement of the convoy began about 8:30 a.m., and the convoy traveled several secondary routes from Blythe to Adelanto, California, through mostly desert area that was sparsely populated. Communication between vehicles was accomplished using CB and car-to-car CHP radios. Near Victorville, California, the convoy drove past a roadway¹⁰ onto which it should have turned. After driving one block, the convoy realized the error and turned around. The convoy arrived in Adelanto about 5:00 p.m., and the CHP officers from Blythe¹¹ departed. (See figure 7.)

Figure 7. Map indicating convoy route through California.

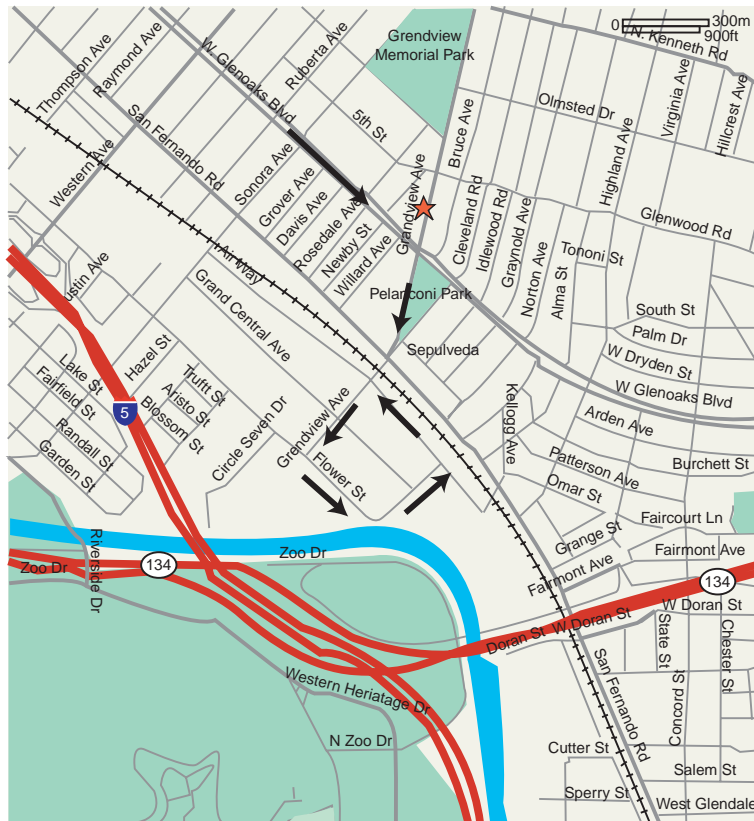
Grandview Avenue continued over a set of two Metrolink railroad tracks at an active highway-railroad grade crossing. The traffic control at the grade crossing consisted of pavement markings, signs, lights, bells, and gates. As the vehicle crossed over the tracks, the CHP officer-in-charge noticed that the vehicle scraped the surface of the grade crossing. He said he believed that this was not an unusual occurrence for a load of this size and ground clearance. The truckdriver said he did not feel the vehicle scrape when it went across the grade crossing. The time was approximately 5:15 a.m.

Figure 8. Map indicating convoy route through section of Glendale.

After crossing the railroad tracks, the lead pilot car driver saw that the street came to a dead end 2 blocks from the grade crossing. He stated that he realized then that he had made a mistake and stopped. The three CHP officers, both pilot car drivers, and the truckdriver stopped and exited their vehicles; together they examined a map to determine the best route of egress and return to the permit route. They found that the best route was to go around the block, eastbound on Flower Street (curved to the north), to westbound on Airway Street, and back to Grandview Avenue; the convoy could then turn east on San Fernando Road. After the lead pilot car and one CHP officer drove the route to assess its safety, the convoy returned to northbound Grandview Avenue. (See figure 8.) Upon reaching Grandview Avenue, the convoy encountered an eastbound Metrolink commuter train at the grade crossing and waited for the train to pass. The lead pilot car and two lead CHP escort units then entered the intersection. The lead pilot car turned east on San Fernando Road, while one CHP unit blocked westbound traffic and the other CHP unit blocked eastbound traffic.

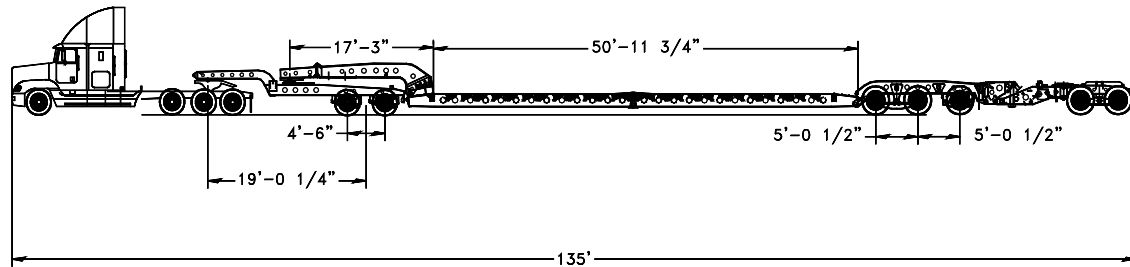
The truck consisted of a 1997 Peterbilt tractor and a 1992 Aspen semitrailer configured with a two-axle jeep, a three-axle low-boy semitrailer, and another two-axle jeep. (See figure 13.) The semitrailer was equipped with a hydraulic lift with a 13-horsepower motor. The tractor-combination vehicle was leased from Townsend Transportation in Buda, Texas.

Figure 13. Schematic of truck.

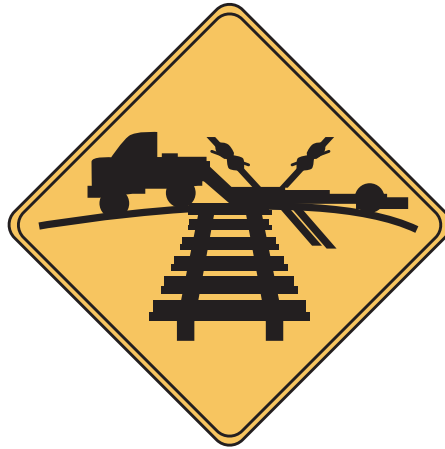
W10-5

In addition, section 8B.14 of the 2000 edition of the *Manual on Uniform Traffic Control Devices* includes a new low-ground clearance warning highway-railroad grade crossing sign (W10-5), shown in figure 14, and provides the following guidance for its use:

Figure 14. Low-ground clearance warning highway-railroad grade crossing sign.
