RAILROAD ACCIDENT REPORT

REAR-END COLLISION OF NATIONAL RAILROAD
PASSENGER CORPORATION (AMTRAK) TRAIN P286
WITH CSXT FREIGHT TRAIN Q620 ON THE CSX
RAILROAD AT SYRACUSE, NEWYORK
FEBRUARY 5, 2001

**NTSB/RAR-01/04
PB2001-916304
Notation 7411
Adopted November 27, 2001**

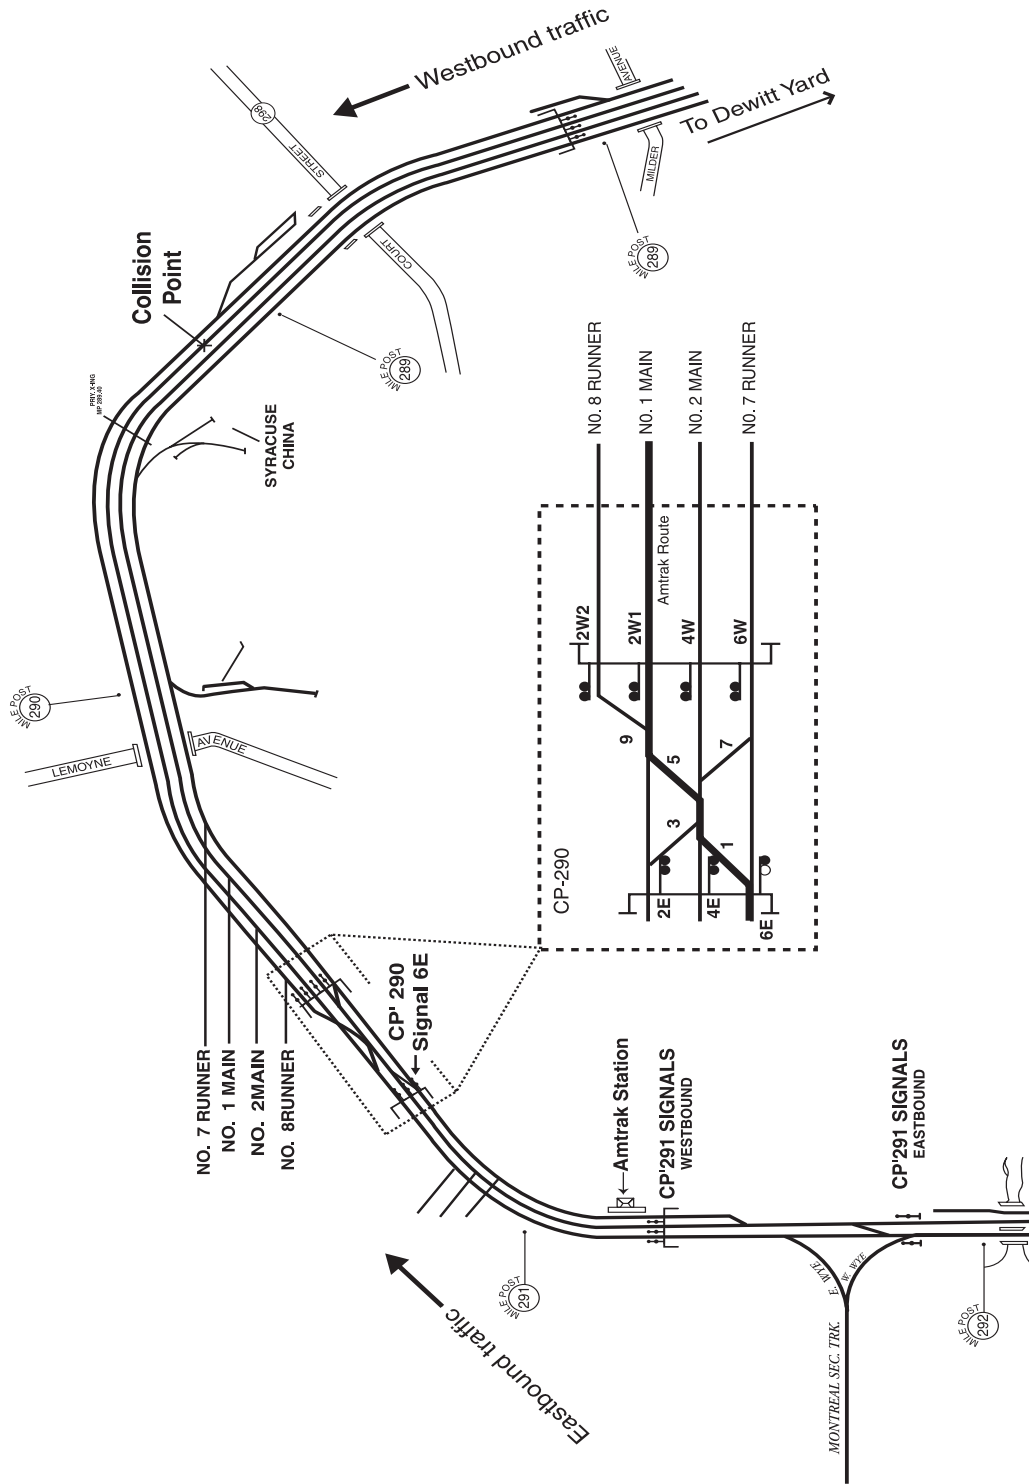
Figure 2. Accident area (not to scale).

After the briefing, the inbound engineer left and the accident engineer mounted the control cab of the lead locomotive unit. With the engineer as the only crewmember in the cab, the train departed the Syracuse station at about 11:33 a.m., 20 minutes behind schedule. The train dispatcher had lined Amtrak train 286 from No. 7 track (on which the train had entered the station), through the interlocking at CP (control point) 290 (about 3/4 mile from the station), onto main track No. 1, the northernmost of two parallel east-west main line tracks. Because of repairs being performed on main track No. 2, that track was temporarily out of service, and the dispatcher was using No. 1 track for all through trains, as well as for trains bound for DeWitt yard. When Amtrak train 286 entered track No. 1, it would be following CSXT freight train Q620. (See figure 2.)
