Derailment of Amtrak Auto Train P052-18 on the CSXT Railroad Near Crescent City, Florida April 18, 2002

Railroad Accident Report **NTSB/RAR-03/02**

**NTSB/RAR-03/02
PB2003-916302
Notation 7487A
Adopted August 5, 2003**

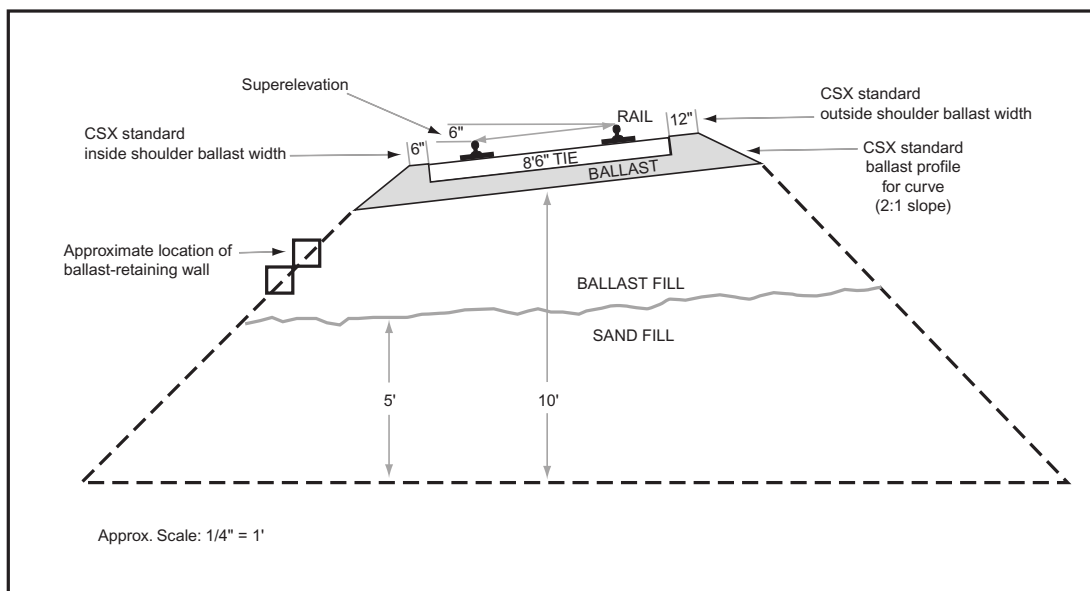
On March 6, 2002, the track inspector had the local track maintenance personnel construct a ballast-retaining wall of used concrete ties along the inside of the curve. Regional engineering managers were aware of this operation. Used concrete cross-ties were placed on the inside of the curve about 4 feet below the track level (the embankment was about 10 feet high at this location) to form a shallow, ballast-retaining wall. Concrete cross-ties were stacked 2 ties high (creating a wall about 16 inches high) end-to-end on the inside of the curve down from the toe of the shoulder ballast slope for about 240 feet along the track. The concrete ties were not secured into the embankment. (The point of derailment was near the south end of the ballast-retaining wall.) A number of CSXT maintenance and management personnel familiar with this section of track indicated that the ballast-retaining wall appeared to prevent further ballast migration down the slope. They also indicated that the ballast section on the curve was holding to standard after the wall was constructed. (See figure 9 for a representation of the relative location of the ballast-retaining wall, showing the general relationship between various roadbed and track elements.)

Figure 9. Conceptual drawing of cross section of the roadbed in the accident curve showing the estimated location of the ballast-retaining wall, as well as some roadbed, track, and ballast section elements.

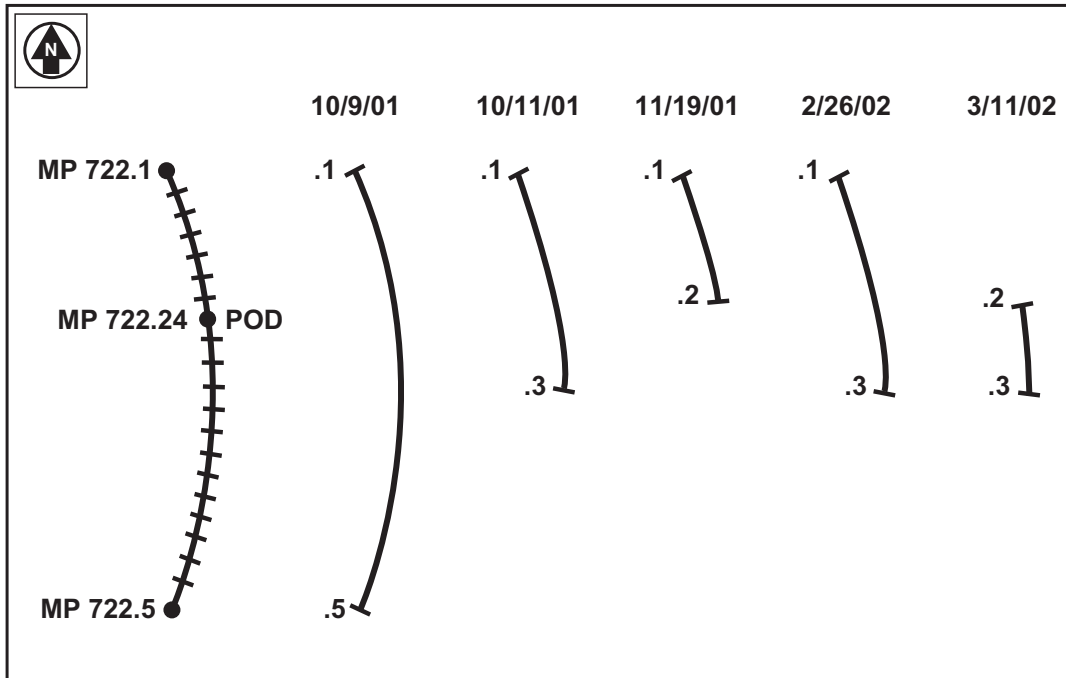
that had been deposited on March 8 to help establish the track. The liner-tamper machine started in the body of the curve and moved northward through the spiral of the curve to create a 1-inch lift. Because the surfacing gang foreman “forgot to make out a Track Disturbance Report,” he did not record any rail temperature. (See figure 10 for a visual representation of the relative locations of the surfacing work carried out on the curve between October 9, 2001, and March 11, 2002.)

Figure 10. Relative locations of machine surfacing operations conducted on the accident curve between October 9, 2001, and March 11, 2002.

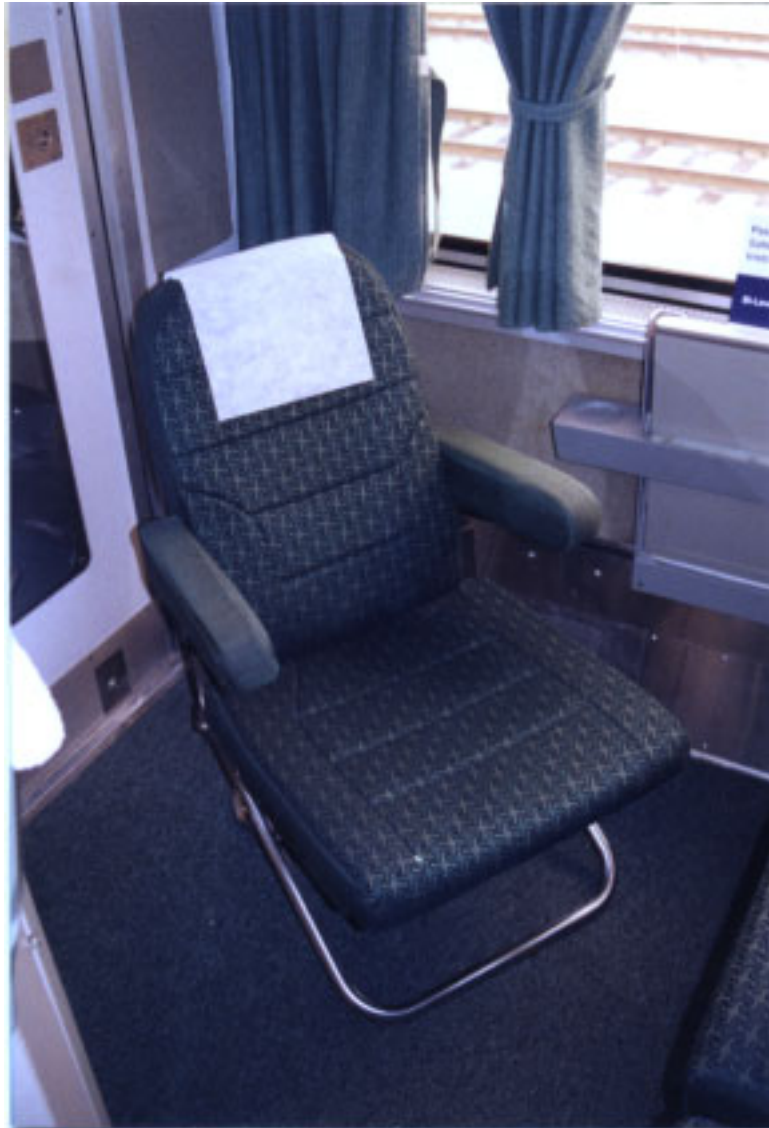
bottom cushion, an upholstered seatback cushion, and folding upholstered armrests. The chair weighs about 55 pounds. In its open configuration, it measures about 25 inches wide by about 28 inches deep by about 25 1/2 inches high. When folded, it measures about 23 inches wide by about 25 inches deep by about 10 inches high. The folding armchair cannot be readily moved through the sliding main access door of the deluxe bedroom without first folding it. (See figure 12 showing the folding armchair.)

Figure 12. Exemplar of Superliner sleeper car folding armchair.
