**Derailment of Amtrak Train No. 58,  
*City of New Orleans*, Near Flora, Mississippi  
April 6, 2004**

**Railroad Accident Report**  
**NTSB/RAR-05/02**

**NTSB/RAR-05/02  
PB2005-916302  
Notation 7642A  
Adopted July 26, 2005**

**Abstract:** About 6:33 p.m. central daylight time on April 6, 2004, northbound National Railroad Passenger Corporation (Amtrak) train No. 58 (*City of New Orleans*), derailed on Canadian National Railway Company railroad track near Flora, Mississippi. The entire train, consisting of one locomotive, one baggage car, and eight passenger cars, derailed near milepost 196.5 while traveling about 78 mph. The train was carrying 61 passengers and 12 Amtrak employees. The derailment resulted in 1 fatality, 3 serious injuries, and 43 minor injuries. The equipment costs associated with the accident totaled about \$7 million.

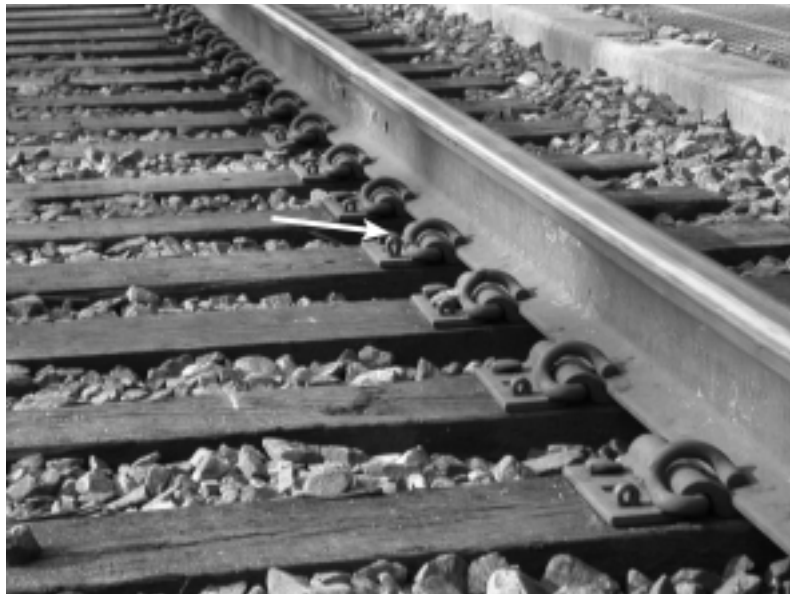
Just south of the derailment site, the rail was box anchored<sup>16</sup> at every tie on the 200-foot approach to the Big Black River Bridge. The rail on the open deck portion of the Big Black River Bridge was anchored on every tie with elastic metal clip fasteners.<sup>17</sup> (See figure 6.) The anchor applies pressure on the top of the base of the rail. If a rail moves longitudinally, shiny areas appear where the anchor contacts the rail. No shiny areas were found on the open deck portion of the bridge.

**Figure 6.** Elastic metal clip anchors.
