**Crash During Landing
Executive Airlines (doing business as
American Eagle) Flight 5401
Avions de Transport Regional 72-212, N438AT
San Juan, Puerto Rico
May 9, 2004**

NTSB/AAR-05/02

**NTSB/AAR-05/02
PB2005-910402
Notation 7650A
Adopted September 7, 2005**

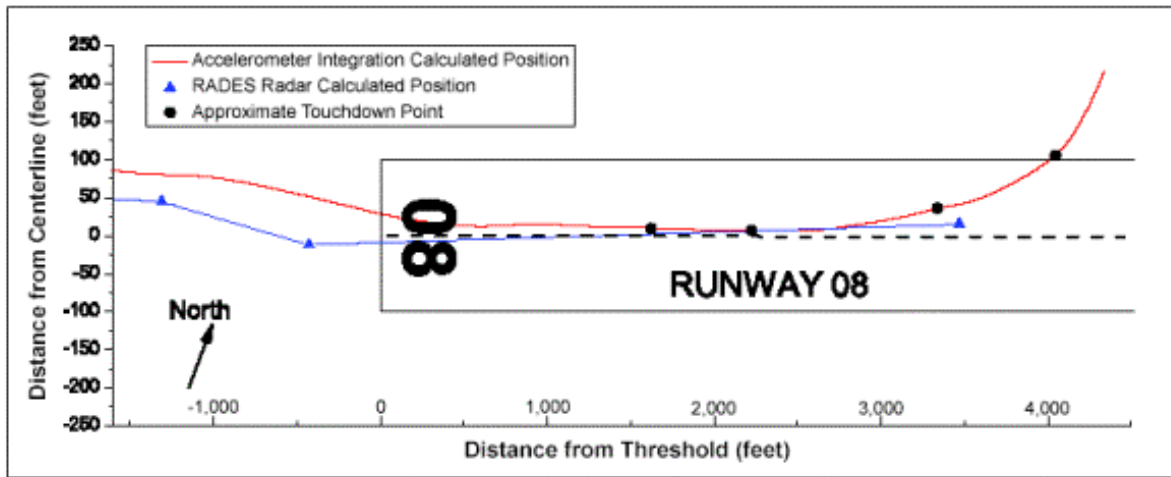
Figure 1. Ground track of the accident flight.

CVR and FDR information indicated that the airplane touched down a fourth time about 1449:56 (about 15 seconds after the initial touchdown) and about 4,000 feet beyond the runway 8 threshold. FDR data indicated that the airplane pitched down to -7° and that it was banked 29° left wing down. The airplane came to a complete stop about 4,317 feet from the runway threshold. Figure 1 shows the ground track of the accident flight, and figure 1a shows the altitude profile of the accident flight.
