NTSB/AAR-06/04
PB2007-910401

**Runway Overrun and Collision
Platinum Jet Management, LLC
Bombardier Challenger CL-600-1A11, N370V,
Teterboro, New Jersey
February 2, 2005**

**NTSB/AAR-06/04
PB2007-910401
Notation 7715C
Adopted October 31, 2006**

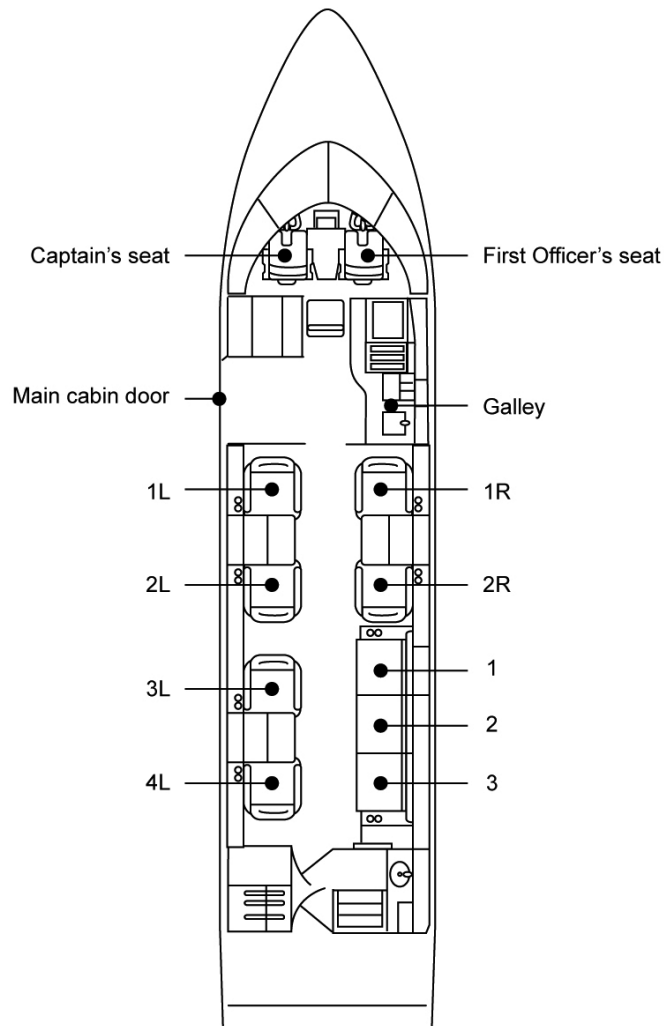
Figure 2. A diagram of the accident airplane's cockpit and cabin configuration.

Postaccident interviews indicated that, at the beginning of the takeoff roll, only four of the eight passengers (in seats 1L, 1R, 2L, and 2R) had their seatbelts fastened. Two of the four remaining passengers (in seats 3L and 4L) fastened their seatbelts during the takeoff roll.¹⁷ The two passengers seated on the divan (in seats 2 and 3) could not locate and, therefore did not fasten, their seatbelts.¹⁸ Passenger statements indicated that the two unrestrained passengers were thrown to the cabin aisle floor during the RTO.

The accident airplane was configured with two flight crew seats in the cockpit, a forward-facing jumpseat aft of the cockpit throttle console, and nine passenger seats (six fore-or-aft-facing individual seats and a three-seat, side-facing divan) in the cabin (see figure 2). The main cabin door was located on the forward left side of the fuselage, aft of the cockpit and across from the galley. The overwing emergency exit was located on the right side of the fuselage, behind the seatbacks of the side-facing divan.
