INVESTIGATION REPORT

VENT COLLECTION SYSTEM EXPLOSION

TECHNIC INC.

REPORT NO. 2003-08-I-RI

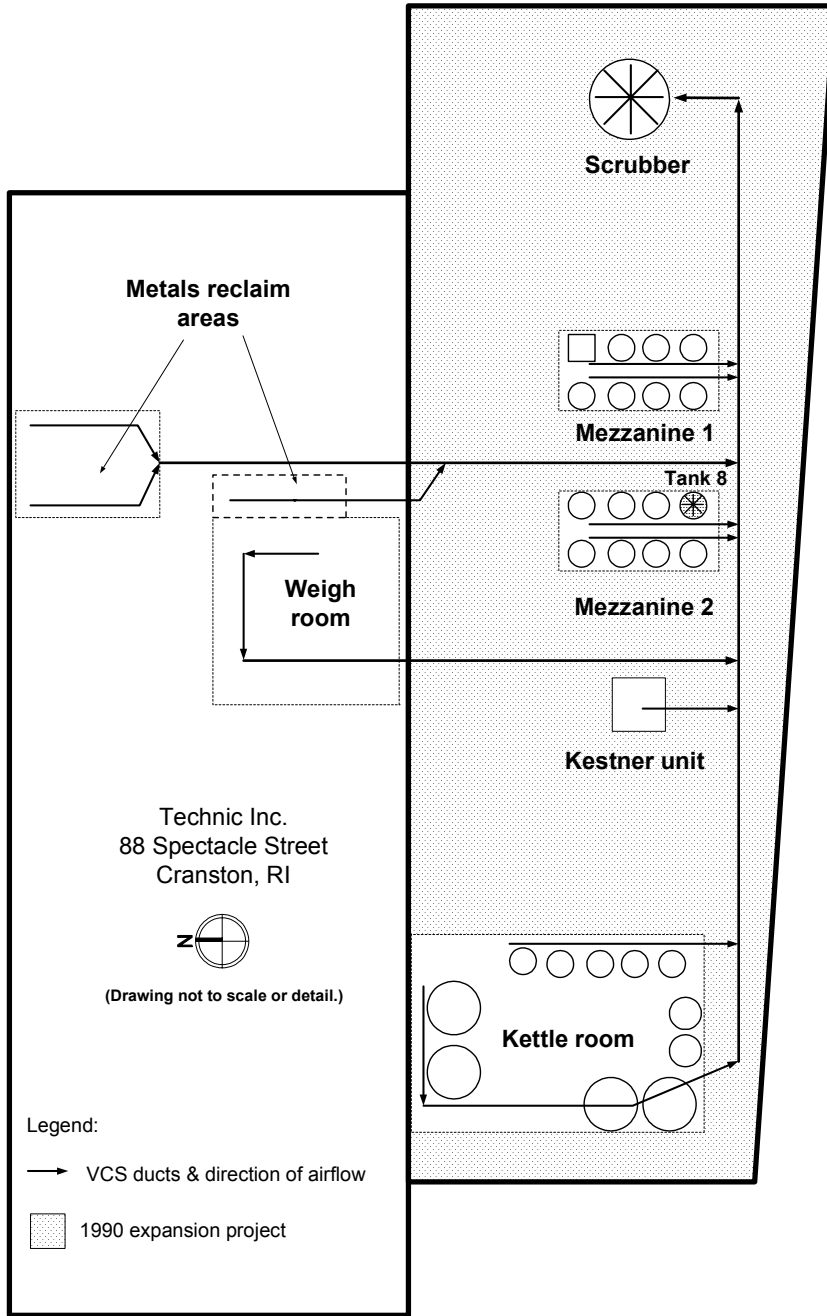
Figure 1. Vent collection system and connected processes.

The following processes connected to the vent collection system may have contributed to the incident (Figure 1):

With the addition of vent ducts from over 20 process vessels from 1992 to 2003, the demand on the vent collection system increased significantly from the time of the plant expansion in 1990. These additions were designed and installed without engineering analysis. See Appendix A for detailed descriptions of the chemical processes and emissions.

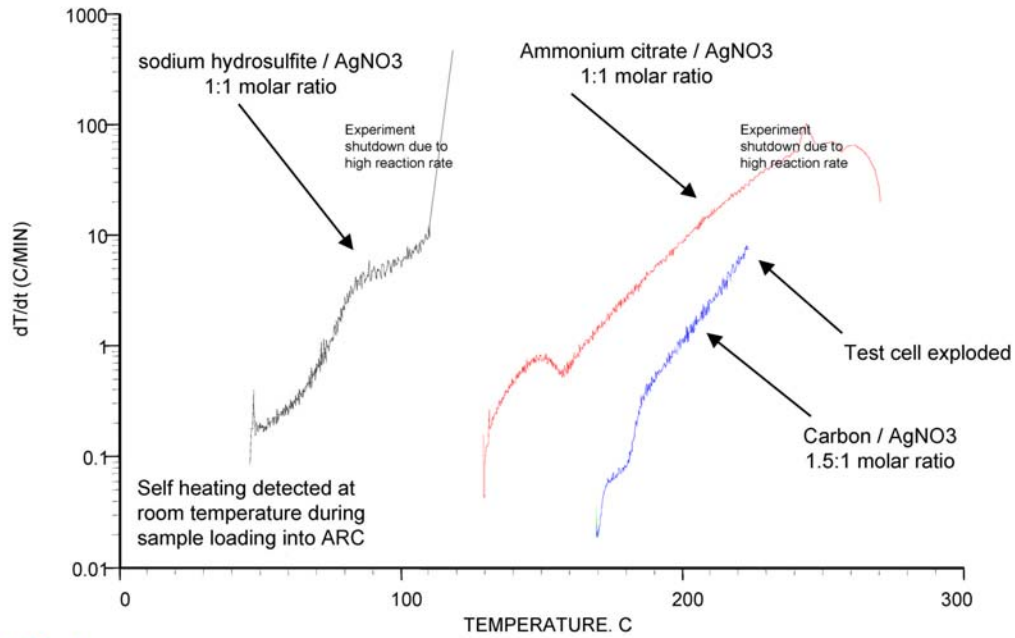
Comparison of silver nitrate reactions with carbon, sodium hydrosulfite, and ammonium citrate

Mixture 3 had the highest onset temperature (170°C; less sensitive than mixture 1), but once initiated led to an actual explosion that destroyed the test cell. Mixture 2 onset was detected at 130°C. The data clearly show that a violent reaction between silver nitrate and other organics can be initiated at temperatures as low as 35°C. Although these tests were conducted in a near adiabatic environment, the results are directly applicable to the Technic vent collection system because the reacting materials could have been present in the system under inertial confinement.
