NBS TECHNICAL NOTE 558

LUBBOCK TORNADO: A Survey of Building Damage in an Urban Area

N. F. Somes, R. D. Dikkers, and T. H. Boone

Building Research Division
Institute for Applied Technology
National Bureau of Standards
Washington, D.C. 20234

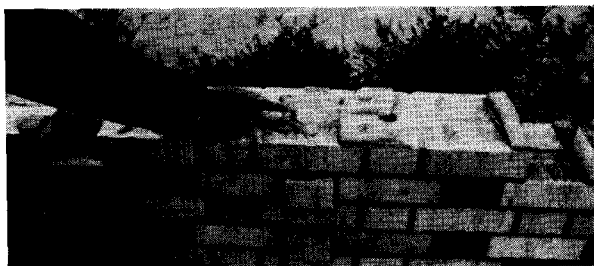
The wall contained vertical reinforcement but unfortunately this reinforcement terminated at mid-height; note photograph 29. Based on the wall dimensions and an assumed bond strength of 20 psi, the minimum wind speed was calculated as 83 miles per hour. Although the type of mortar is not known, the value assumed for the bond strength is conservative and hence the wind speed derived from this calculation is conservative.

Photograph 29—Overturning of wall occurred at level at which vertical reinforcement was terminated. (Location 14)

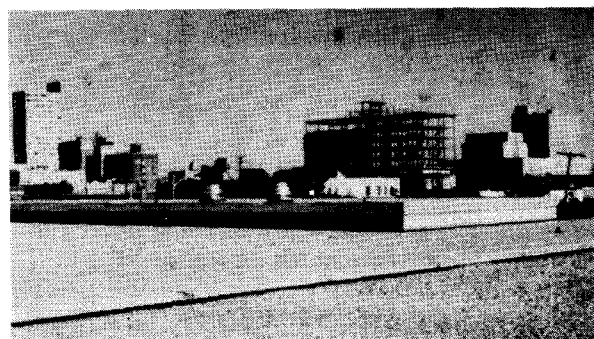
Photograph 30—Lubbock skyline from roof of Post Office building which was just outside the area of severe damage. View looking northwest. (Location 15)

The new Post Office Building is located outside the boundary of the severe damage area in downtown Lubbock. This one-story building sustained only minor window damage on the west elevation. As illustrated in photograph 30, the gravel-surfaced roofing, metal flashing, and roof ventilators were not damaged. The Great Plains Life Building, five blocks to the northwest, can be seen on the left side of this photograph.

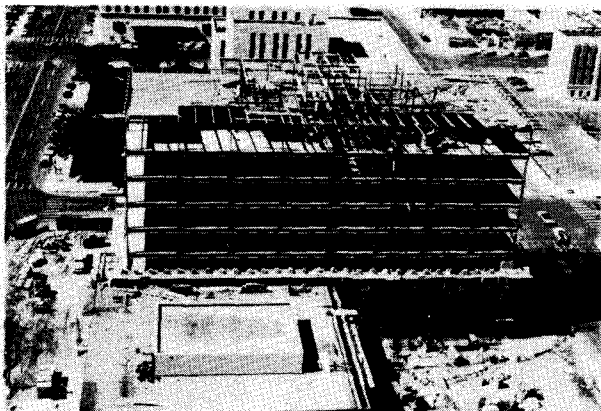
Photograph 32—Federal Office Building under construction. View looking north. (Location 17)

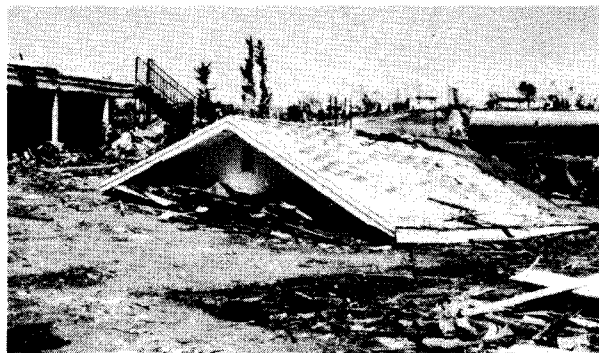
Photographs 44 and 45 show the severe extent of the destruction. This brick veneer, wood frame structure was hit by a considerable amount of flying debris. The damage is particularly evident on the southwest elevation shown in photograph 45. Flying debris may have also contributed to the loss of brick veneer which was attached with conventional corrugated metal ties to the wood frame backing. The roof of the motel entrance carport was lifted completely from its supports and set down intact approximately 40 feet to the north. This roof is shown in photograph 46 and its location may be identified in photograph 44.

Photograph 46—Complete wood frame roof sucked from the forecourt building of the Ramada Inn Motel and transported 40 feet. (Location 27)

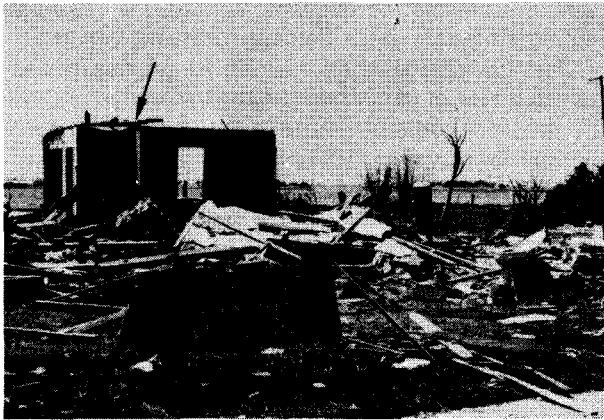
Photograph 57—A loss of everything but a sense of humor. (Location 31)
