U.S. Department  
of Transportation  
**Federal Aviation  
Administration**

## ADVISORY CIRCULAR

# AVIATION MAINTENANCE ALERTS

**ALERT  
NUMBER  
355**

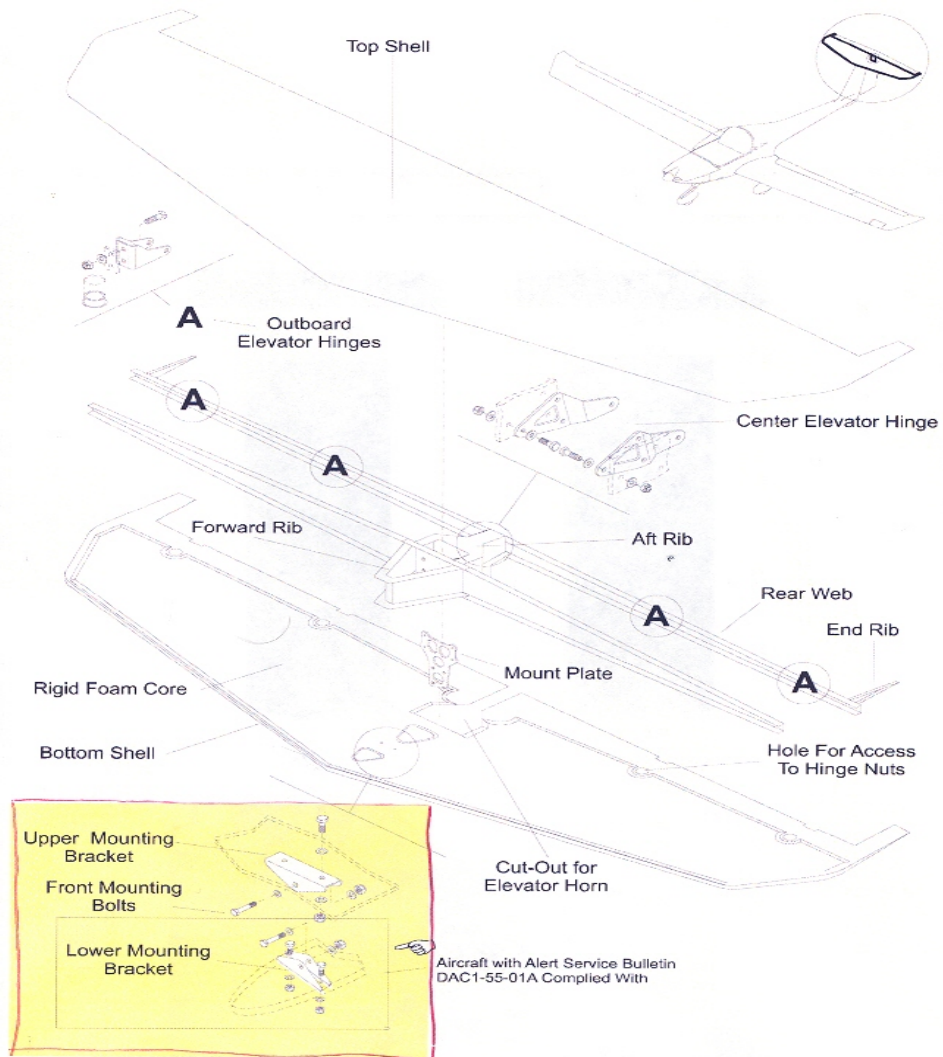
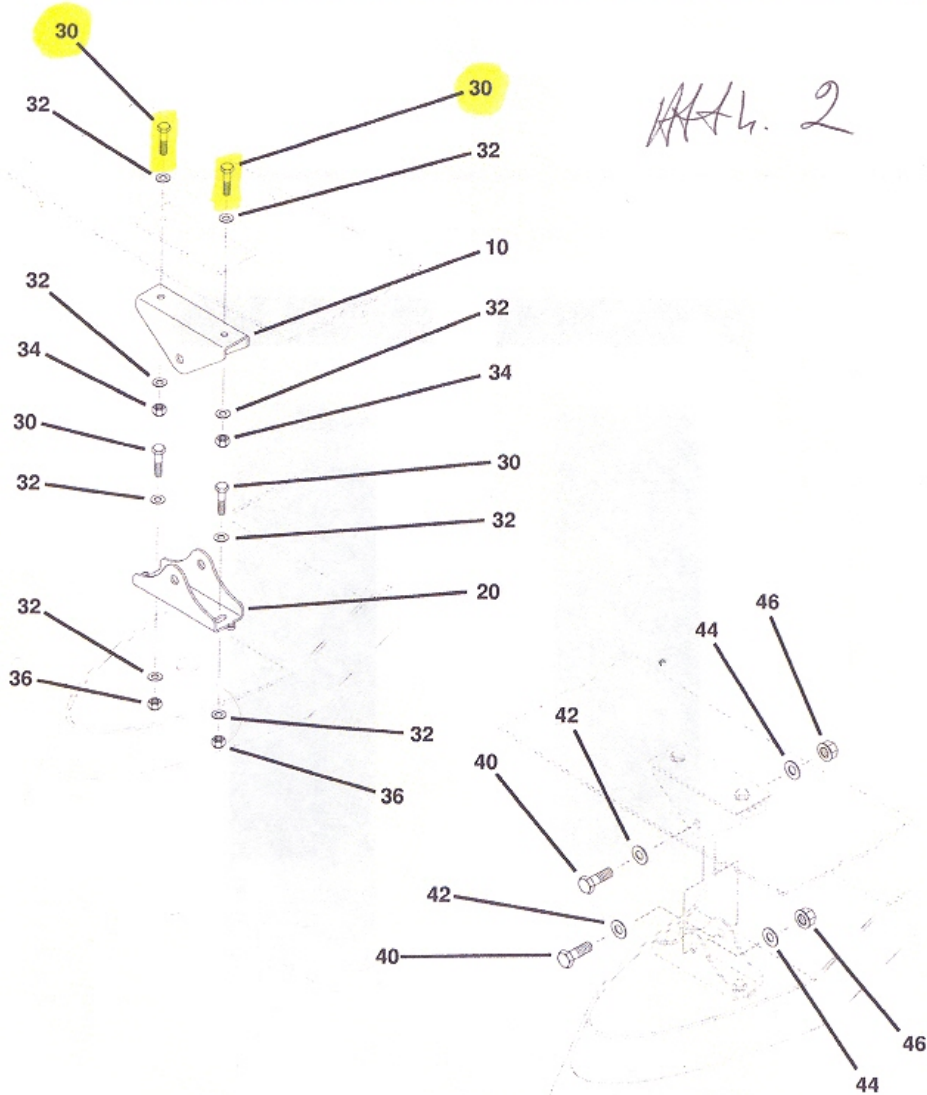
EXCERPT FROM PARTS MANUAL

### **Diamond: DA-20; Broken Horizontal Stabilizer Bolts; ATA 5551**

A technician for a flight training school writes, “*(This aircraft)* returned from flight with both horizontal stabilizer mount bolts broken (*P/N AN3-11A*).” “We removed the rudder and horizontal stabilizer to inspect the entire area. The aft mount plate and forward mount bracket were replaced, along with all new bolts, washers, and nuts. We also inspected our other (*DA-20*) aircraft and replaced all of their (*horizontal stabilizer mounting*) bolts. No other issues were found on our aircraft. Diamond Aircraft has been briefed and they are working with the NTSB (*National Transportation Safety Board*).”
