U.S. GEOLOGICAL SURVEY DEPARTMENT OF THE INTERIOR

Map showing Features and Displacements of the Scenic Drive Landslide, La Honda, California, During the Period March 31-May 7, 2005

Ray E. Wells, Michael J. Rymer, Carol S. Prentice and Karen L. Wheeler

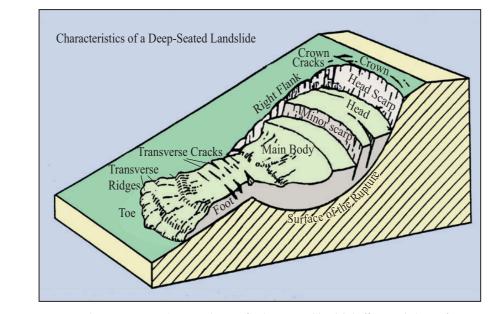
Figure 3. Characteristics and nomenclature of a deep-seated landslide (from Eckel, 1958).

The Scenic drive landslide is roughly triangular in shape and about 200 m on a side. It has most of the characteristics of a deep-seated landslide (Figure 3). Its eastern, upslope edge is the head scarp--the steep, exposed part of the surface along which the landslide mass moved downhill. The head scarp is slickensided and grooved and is more than 7 meters high (21+ feet) at its southern end. Displacements along the head scarp diminish to near zero at its northern end. Internally, the landslide is locally folded and cut by numerous extensional cracks and normal-displacement scarps up to 2 m high.
