ACCIDENTAL RELEASES OF SLURRY AND WATER FROM COAL IMPOUNDMENTS THROUGH ABANDONED UNDERGROUND COAL MINES

*Stanley J. Michalek, P.E., George H. Gardner, P.E., Kelvin K. Wu, Ph.D., P.E.
Mine Safety and Health Administration, Pittsburgh Safety and Health Technology Center*

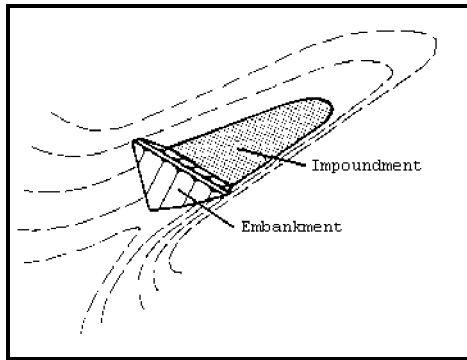
Figure 1
Cross-valley configuration

course and would subsequently alter the site's drainage conditions. Under normal operating conditions, the slurry produced by the coal cleaning plant would be pumped behind the structure for storage. Figure 1 shows a typical cross-valley configuration. Although these structures were functioning as dams, they were not always designed and operated as such. While some of these dams were well engineered and constructed, others were built with very little engineering. The specific techniques used to construct the refuse dams varied with the materials and equipment available at each mine site. There were no design standards or regulations to govern this activity. As a result, impoundment sites were often selected solely on the basis of convenience and cost. In some cases, few, if any, site

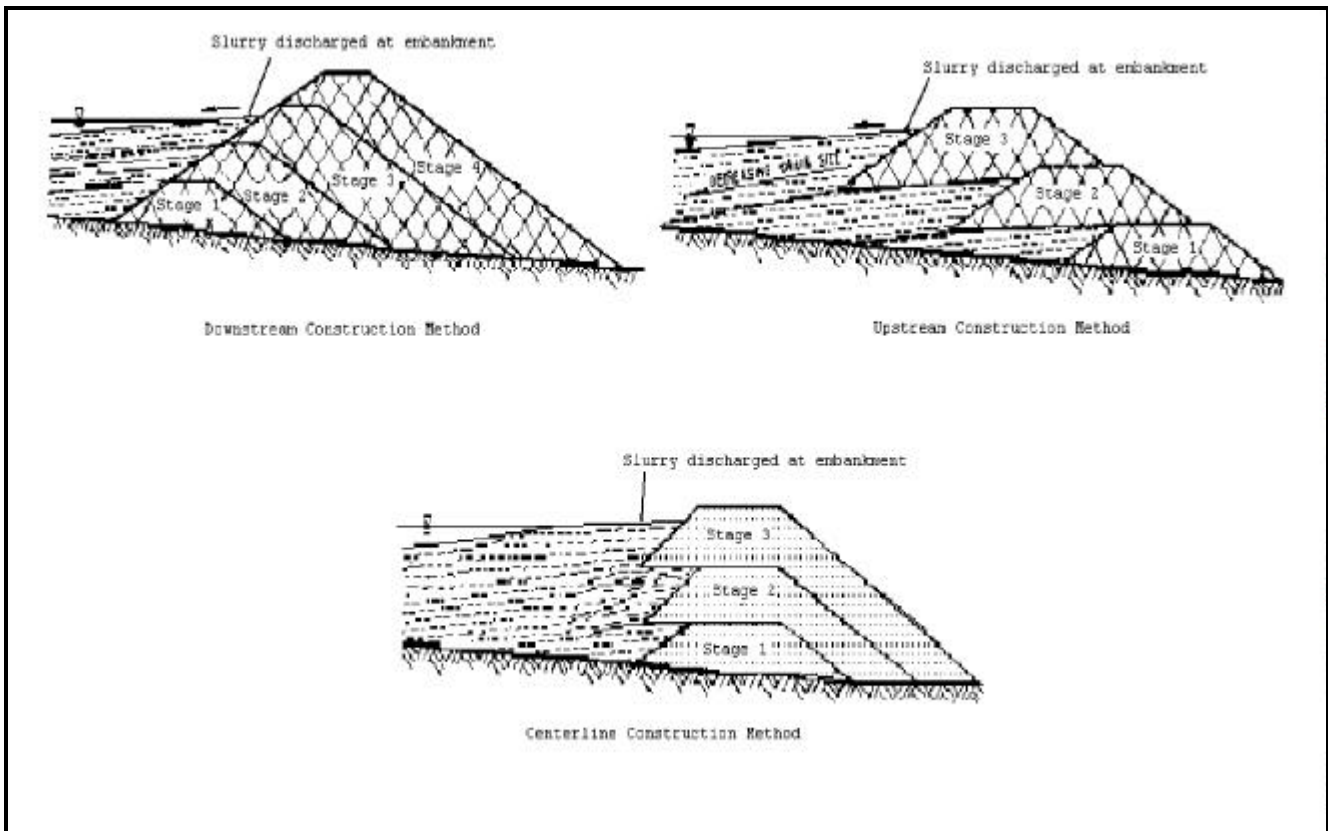
Figure 2
 Typical refuse facility construction methods.

The slurry was piped from the preparation plant to the impoundment. The solids settled out of the slurry and formed a deposit overlain by water. This pumping and deposition would continue as the impounding embankment was raised concurrently using coarse refuse, creating additional storage capacity. This practice generally resulted in the embankment crest moving in a downstream direction. This type of construction is referred to as the downstream method. When sufficient quantities of coarse refuse were not available, or other site conditions dictated, alternative construction methods were employed to raise the embankment crest. One method, which required significantly less coarse refuse, was the upstream construction method. In this method, coarse refuse is placed over the existing settled fine refuse, resulting in the embankment crest moving in an upstream direction. A third method of construction is the centerline method, which is essentially a combination of the previous two methods. Figure 2 illustrates these various construction methods.
