4.1 INTRODUCTION

4.2 HEALTH CARE FACILITIES

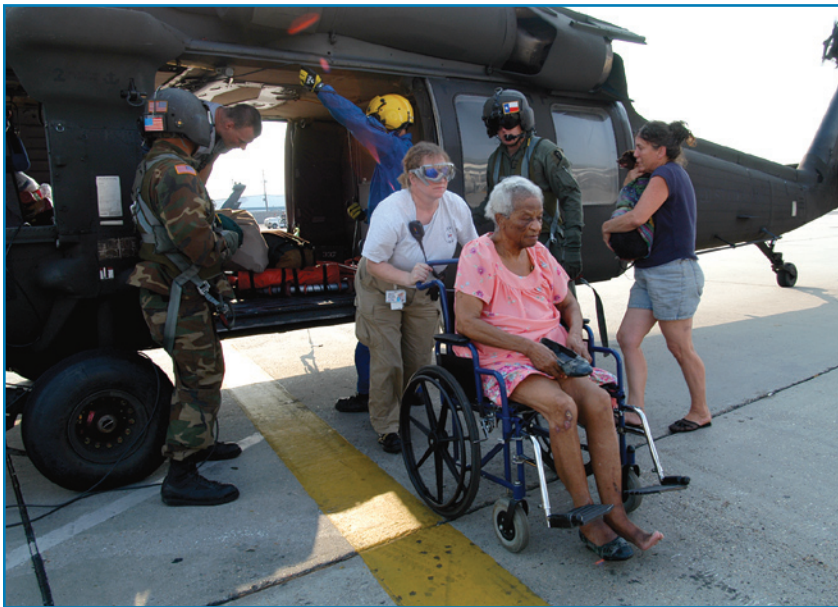
Figure 4-2: Evacuation of New
Orleans by helicopter

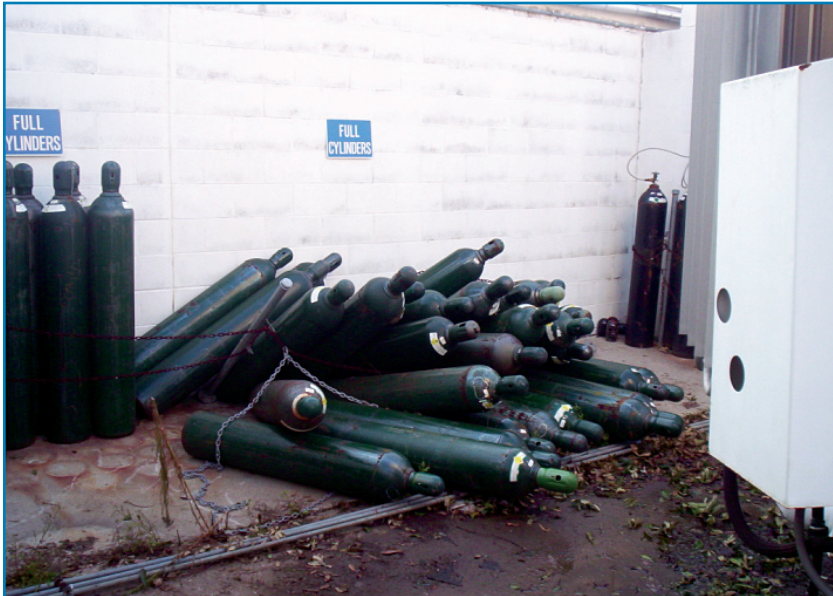
Piped oxygen and nitrous oxide supplies are essential for many patients. With electrical systems out, pumping of medical gas was not possible. Most of the hospitals maintained tanks of oxygen that could be brought to the bedside (Figure 4-13), but once the emergency supplies of medical gas ran out, the patients at serious risk had to be evacuated.

Figure 4-13:
Oxygen supplies at
Hancock Medical Center

The experience of hospitals during Katrina indicates that the requirements for emergency power should have high priority. Generators should be located above the base flood elevation, be protected from flying debris, and have appropriate exhaust vent systems installed. Fuel storage tanks should be located above the flood elevation, or adequately anchored to ensure that the tank will not float off its foundation under pressure from rising floodwaters. Hospitals in hurricane-prone regions should store sufficient fuel to support running generators at full load for at

least 96 hours (4 days). Emergency power distribution systems should be able to provide power to every system in the hospital, and have switching capabilities to shift loads to different parts of the hospital as needed.

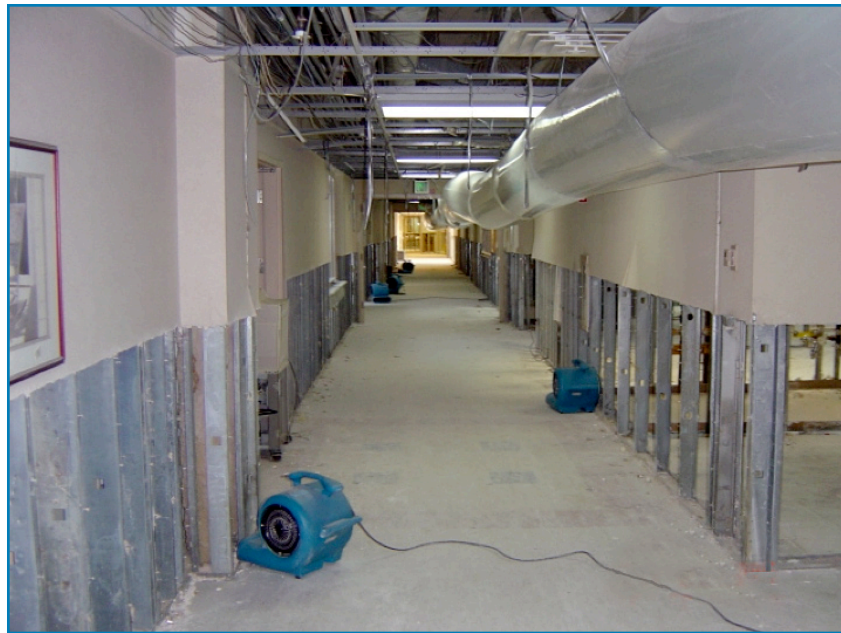
Nonstructural systems, among others, include interior non-load-bearing walls, ceilings, and floors. In hospitals flooded with storm surge, floors were destroyed and gypsum board walls were soaked. At Hancock Medical Center the water level reached 3 feet. The hospital must replace all the flooring material, rewire the outlets, and replace the wall sheathing at a level about 2 feet above the high water mark (see Figure 4-15).

Figure 4-15:
Drying of flooded ground
floor at Hancock Medical
Center

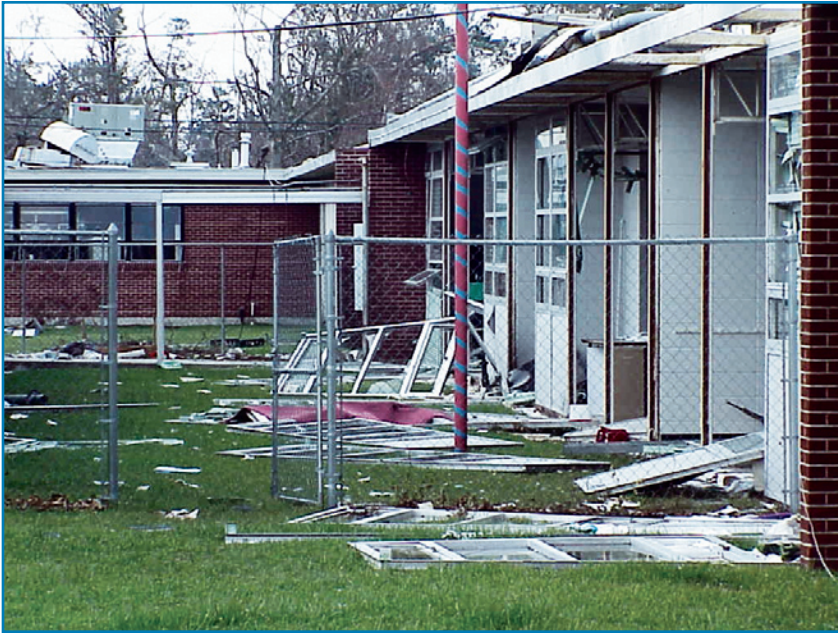
Pineville Elementary School near Pass Christian, Mississippi, was used as a place of refuge during the storm, but when the water rose to a depth of 2 feet, the people had to be moved by school buses to another shelter (see Figure 4-18). The buses were driven by school bus mechanics struggling to maintain control in rising water and 80 mph winds.

Figure 4-18:
Pineville Elementary
School shelter had to
be evacuated when the
floodwaters started to rise.

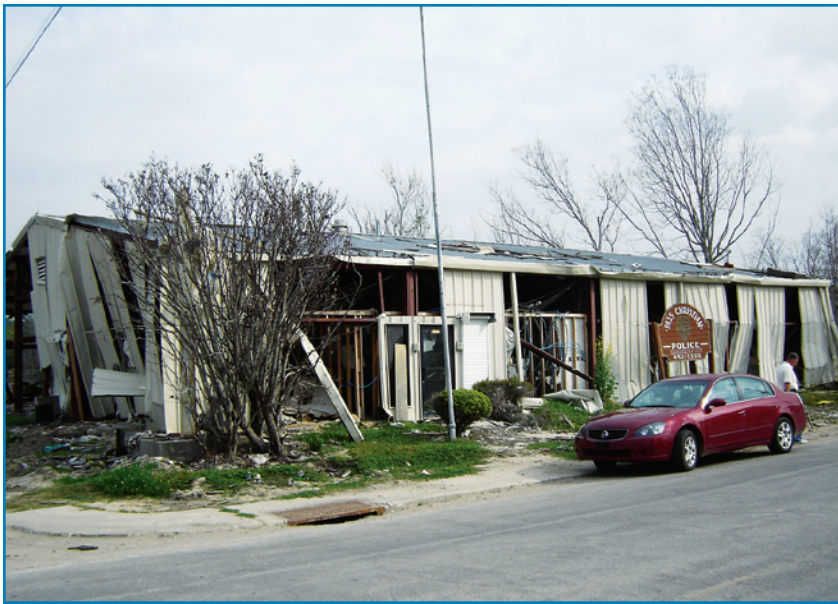
The Pass Christian police and west side fire station were less fortunate, as the storm surge flooding at these sites far exceeded the base flood elevation. It was estimated that the storm surge wave that hit the police building was at least 15 to 20 feet high, which rendered the building and the equipment stored inside totally unusable. The facility is currently looking at an alternative site on higher ground as a possible site for relocation and construction of a new station.

Figure 4-32:
Police station in Pass
Christian

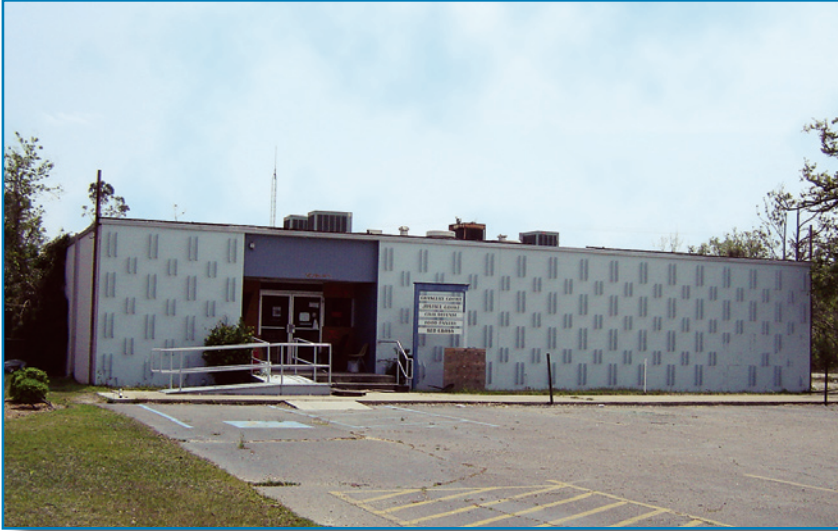
The Hancock County EOC in Bay St. Louis, Mississippi, is located on naturally high ground outside mapped flood hazard areas. Nevertheless, the floodwaters inundated the ground level, damaging the interior finishes and practically destroying all equipment and contents (see Figure 4-35). Most of the EOC's operations were transferred to an alternate location prior to Katrina's landfall, most likely because the facility is mapped as part of an evacuation zone in case of a hurricane.

Figure 4-35:
Hancock County EOC

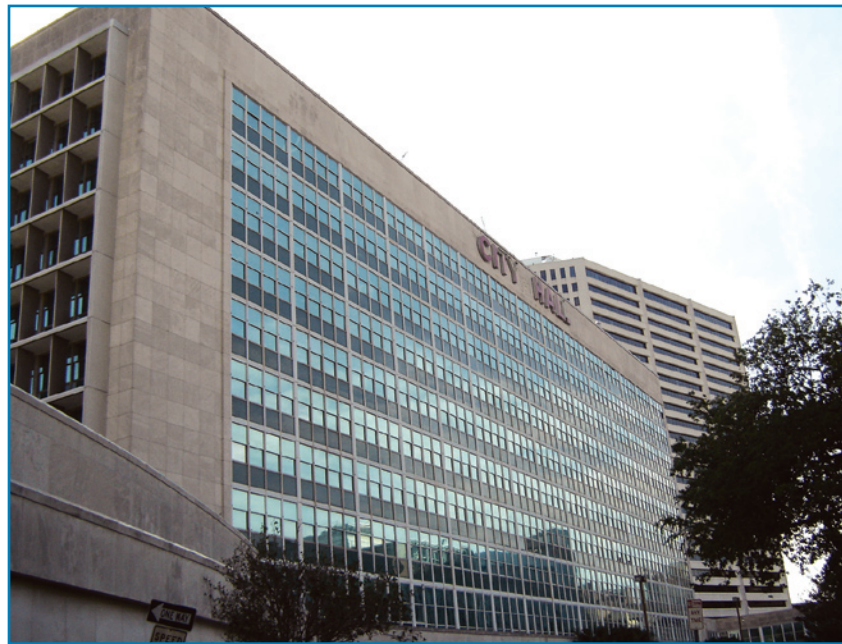
For example, EOC facilities in New Orleans were placed into civic center offices, which were not equipped with kitchens, showers, and other facilities essential for the smooth and continuous operation of an EOC (see Figure 4-36). As a consequence, the facility had to be relocated immediately after Katrina because the available accommodations were insufficient and poorly equipped. Some of the buildings occupied by first responders were originally designed for a different purpose and subsequently converted to their current use.

Figure 4-36:
New Orleans EOC in the
City Hall building

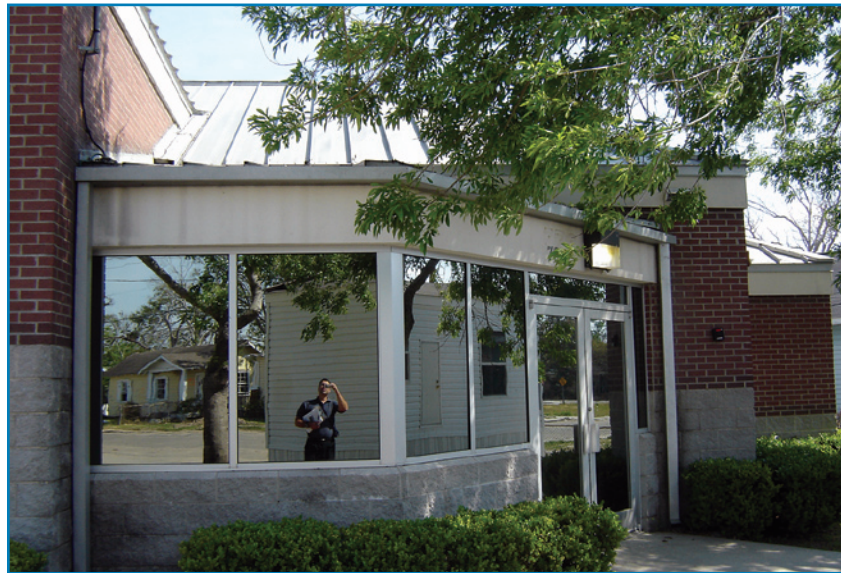
The relatively new Back Bay Fire Company #3 station in Biloxi, Mississippi, was built in 1996, and yet its design does not reflect the current needs of its occupants. The spaces are too small to accommodate the duty shifts. The kitchen is inadequate for longer stays, while the sleeping area has unprotected, large, storefront-type windows that represent a serious hazard in high-wind situations (see Figure 4-37). These minor architectural deficiencies may be amplified during the times of crisis and adversely affect the operation of the facility, especially if combined with other building component failures.

Figure 4-37:
Back Bay Fire Company
#3

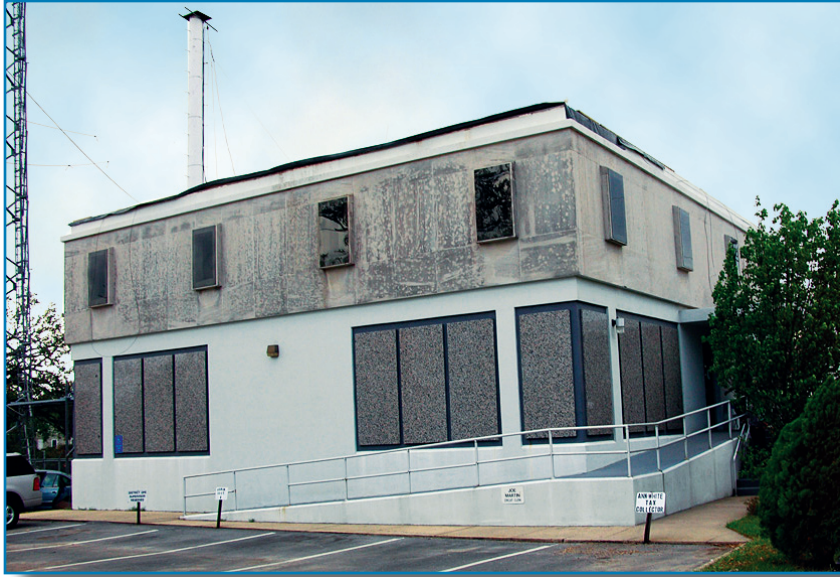
The Jackson County EOC, located in Pascagoula, Mississippi, was built in 1977 and is an example of a structurally well-designed facility. The structure is composed of cast-in-place concrete, and performed remarkably well (see Figure 4-38). Although the EOC is located on the second floor of the building, water only came within 1 inch of the ground floor, which is approximately 4 to 5 feet above the surrounding grade. Other structural systems proven to be resistant to flood and wind loads are steel or concrete frames that are covered with precast concrete panels. These systems have very high reserve capacities that perform extremely well during high winds and storm surges.

Figure 4-38:
Reinforced concrete building
for Jackson County EOC

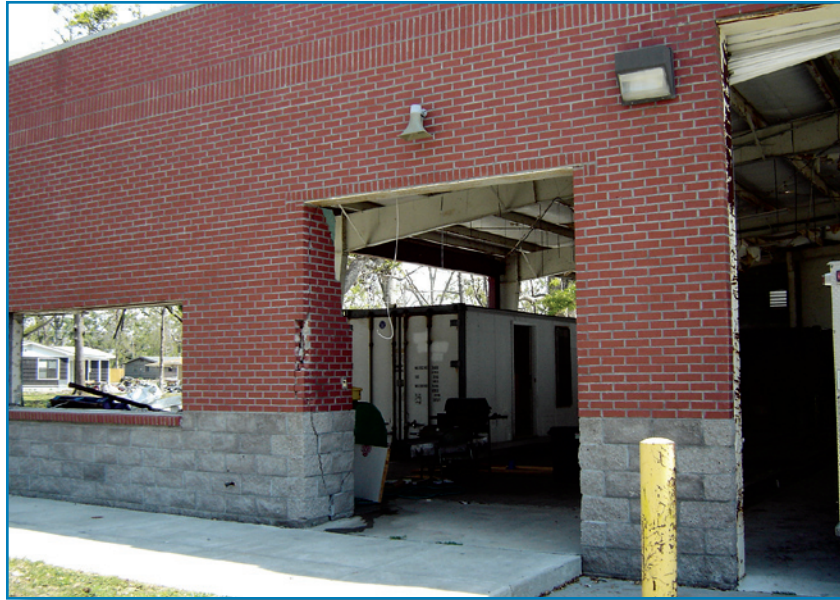
In contrast, pre-engineered metal buildings performed less well. Although the main structural components of most of these buildings remained standing, suffering only light damage, the rest of the building components were not able to resist the forces of storm surge. Two prime examples of these buildings are the Pass Christian Police Department Headquarters and the Gulfport Fire Department Station #7 (see Figures 4-32 and 4-39). Both of these buildings were severely damaged and all equipment stored inside was destroyed.

Figure 4-39:
Gulfport Fire Station #7

Fire stations are especially susceptible to breaches of the building envelope, because of their large sectional and rolling doors that are usually not strong enough to resist wind forces, and even less so the hydrodynamic forces of storm surge. The apparatus bay doors failed in many fire stations affected by flooding. (see Figures 4-39 and 4-45).

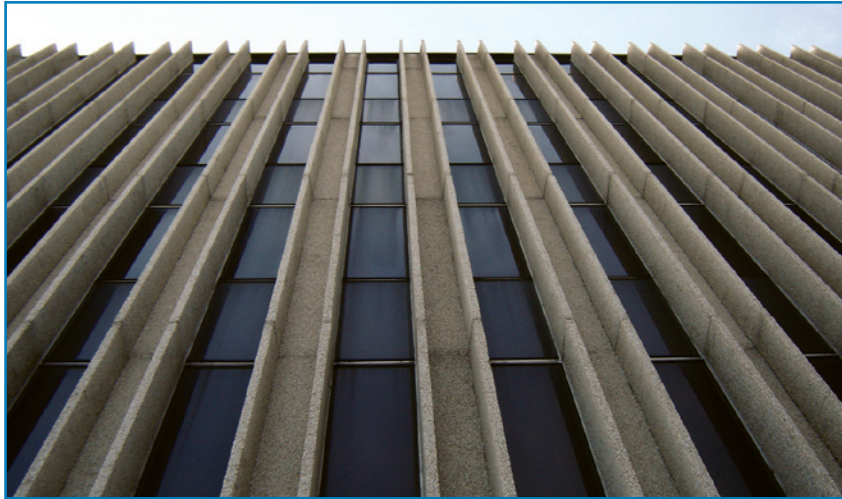
Hurricane Katrina also affected facilities by damaging or destroying mechanical systems. Hurricane season occurs in the warmest months of the year, and many of these facilities were not designed to allow natural ventilation. For example, the New Orleans Police Department Headquarters Building is a multi-story building where the main circuitry for the HVAC system, which was located in the basement, was severely damaged by the flood. Since the building was designed as a closed structure, natural ventilation was a problem (see Figure 4-46). All the equipment located in the basement needed to be completely rebuilt or replaced before the building could be occupied again. In the interim, the entire department was forced to relocate its operations to other facilities in the city, placing a strain on facilities not intended to house additional personnel and take on additional responsibilities.

Figure 4-46:
Fixed windows on New
Orleans Police Department
Headquarters

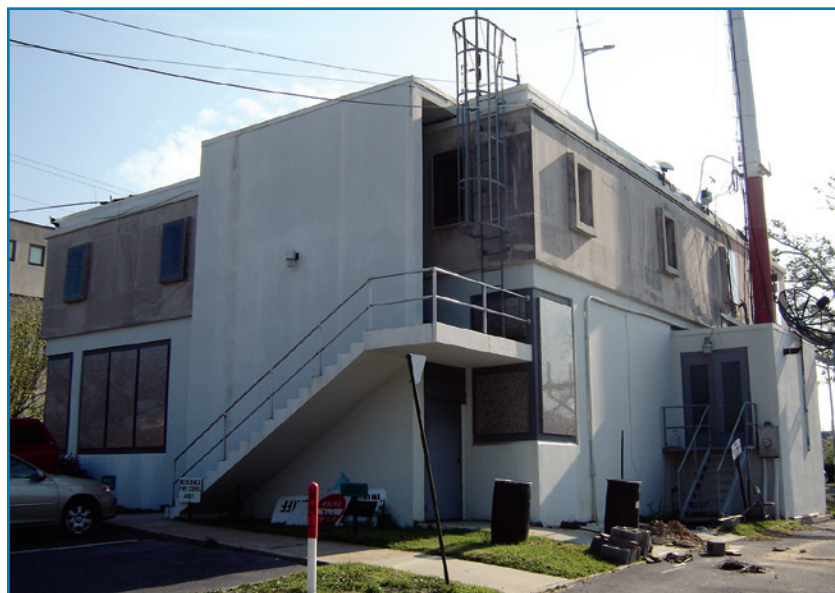
The need to provide a back-up generator at a safe and elevated location is confirmed by the experiences during Hurricane Katrina. Many facilities were without power because of the low elevation and subsequent flooding of their generators. Jackson County EOC had its emergency power station elevated and protected in a separate enclosure, which allowed the facility to operate without interruption (see Figure 4-48).

Figure 4-48:
Jackson County EOC's
elevated generator
enclosure
