U.S.-Canada Power System Outage Task Force

**Interim Report:
Causes of the
August 14th Blackout
in the
United States and Canada**

November 2003

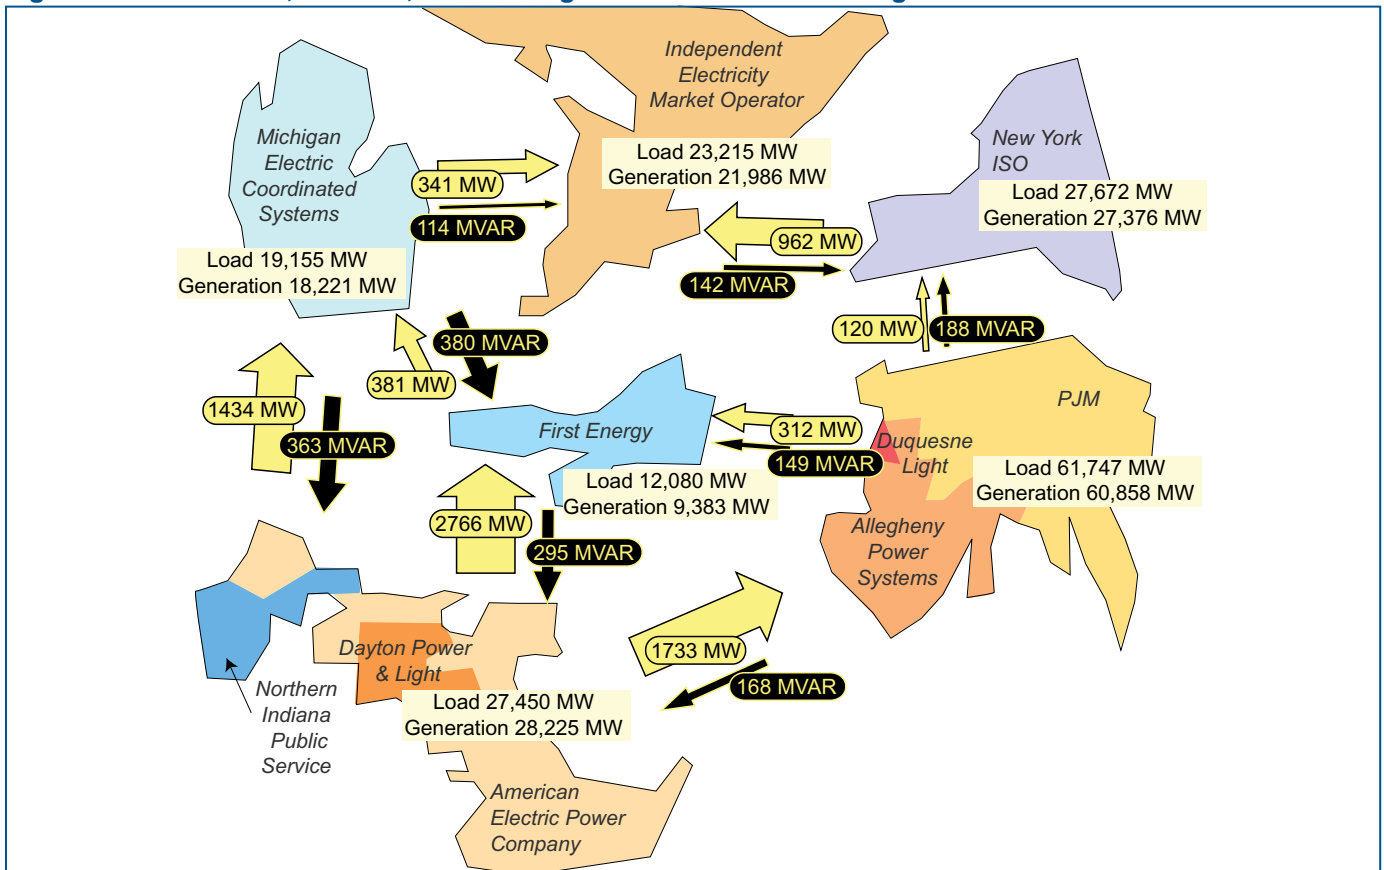
Figure 3.2. Generation, Demand, and Interregional Power Flows on August 14 at 15:05 EDT

On August 14, the flow of power through the ECAR region was heavy as a result of large transfers of power from the south (Tennessee, Kentucky, Missouri, etc.) and west (Wisconsin, Minnesota, Illinois, etc.) to the north (Ohio, Michigan, and Ontario) and east (New York). The destinations for much of the power were northern Ohio, Michigan, PJM, and Ontario (Figure 3.2).

The power flow data for northern Ohio on August 14 just before the Harding-Chamberlin line tripped at 15:05 EDT (Figure 3.2) show that FE's load was approximately 12,080 MW. FE was importing about 2,575 MW, 21% of its total system needs, and generating the remainder. With this high level of imports and high air conditioning loads in the

metropolitan areas around the southern end of Lake Erie, FE's system reactive power needs rose further. Investigation team modeling indicates that at 15:00 EDT, with Eastlake 5 out of service, FE was a net importer of about 132 MVar. A significant amount of power also was flowing through northern Ohio on its way to Michigan and Ontario (Figure 3.2). The net effect of this flow pattern and load composition was to depress voltages in northern Ohio.

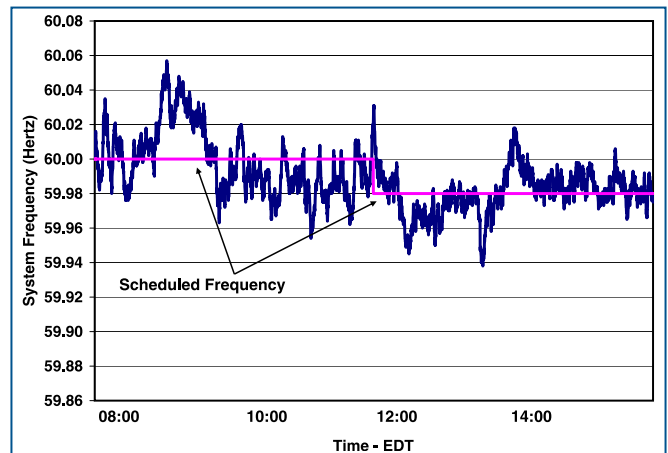
Figure 3.4. Frequency on August 14, 2003, up to 15:31 EDT

August 14 prior to 15:05 EDT compared with recent history, it was well within the bounds of safe operating practices as outlined in NERC operating policies. As a result, system frequency variation was not a cause of the initiation of the blackout. But once the cascade was initiated, the large frequency swings that were induced became

a principal means by which the blackout spread across a wide area (Figure 3.4).

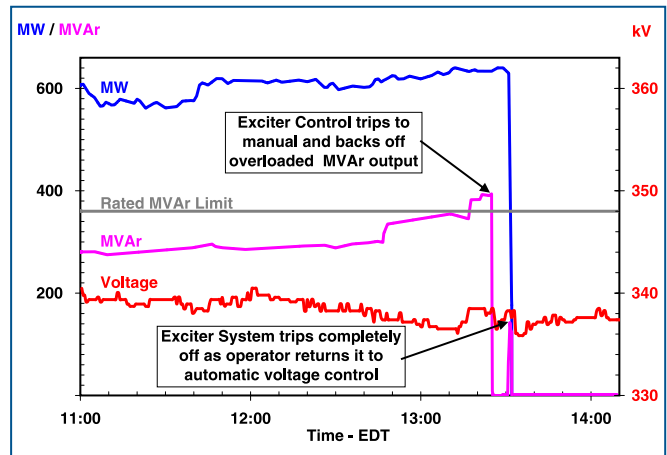
Figure 3.5. MW and MVar Output from Eastlake Unit 5 on August 14

output (Figure 3.5), the unit’s protection system detected a failure and tripped the unit off-line. The loss of the Eastlake 5 unit did not put the grid into an unreliable state—i.e., it was still able to withstand safely another contingency. However, the loss of the unit required FE to import additional power to make up for the loss of the unit’s output (540 MW), made voltage management in northern Ohio more challenging, and gave FE operators less flexibility in operating their system (see details below, page 27).

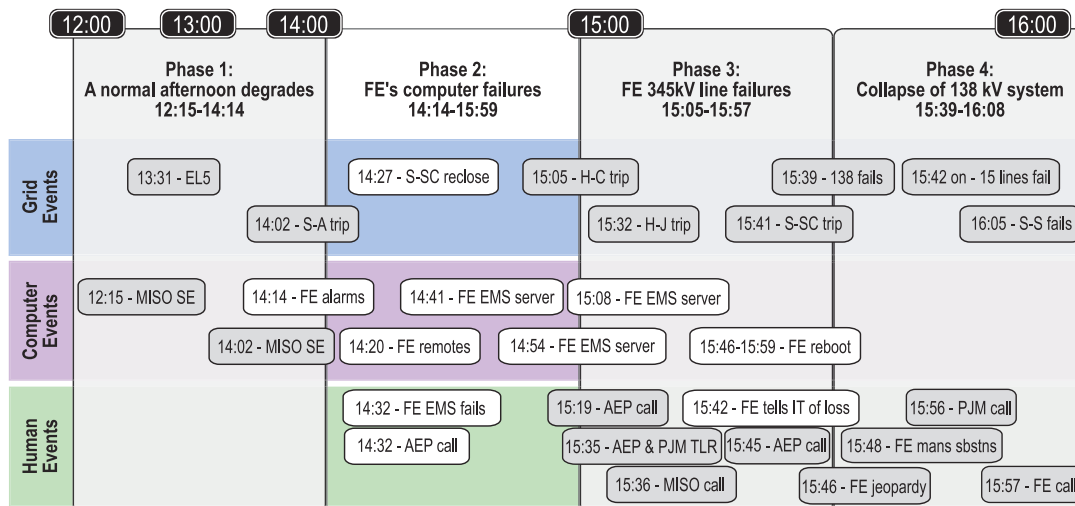
Figure 4.4. Timeline Phase 2

- 2A) 14:14 EDT: FE alarm and logging software failed. Neither FE's control room operators nor FE's IT EMS support personnel were aware of the alarm failure.
- 2B) 14:20 EDT: Several FE remote location consoles failed. FE Information Technology (IT) engineer was computer auto-paged.
- 2C) 14:27:16 EDT: Star-South Canton 345-kV transmission line tripped and successfully reclosed.
- 2D) 14:32 EDT: AEP called FE control room about AEP indication of Star-South Canton 345-kV line trip and reclosure. FE had no alarm or log of this line trip.
- 2E) 14:41 EDT: The primary FE control system server hosting the alarm function failed. Its applications and functions were passed over to a backup computer. FE's IT engineer was auto-paged.

2F) 14:54 EDT: The FE back-up computer failed and all functions that were running on it stopped. FE’s IT engineer was auto-paged.

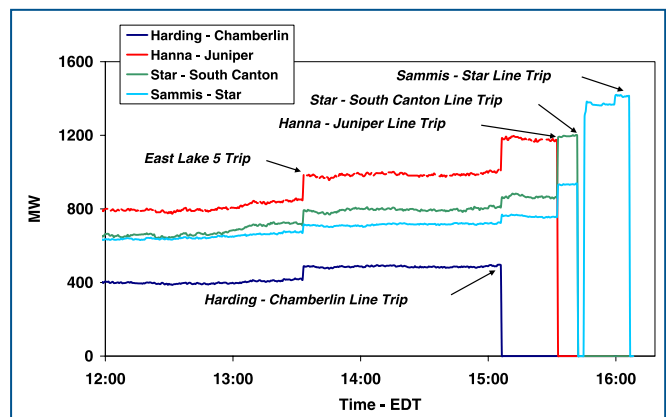
Figure 4.5. FirstEnergy 345-kV Line Flows

From 15:05:41 EDT to 15:41:35 EDT, three 345-kV lines failed with power flows at or below each transmission line's emergency rating. Each was the result of a contact between a line and a tree that had grown so tall that, over a period of years, it encroached into the required clearance height for the line. As each line failed, its outage increased the loading on the remaining lines (Figure 4.5). As each of the transmission lines failed, and power flows shifted to other transmission paths, voltages on the rest of FE's system degraded further (Figure 4.6).

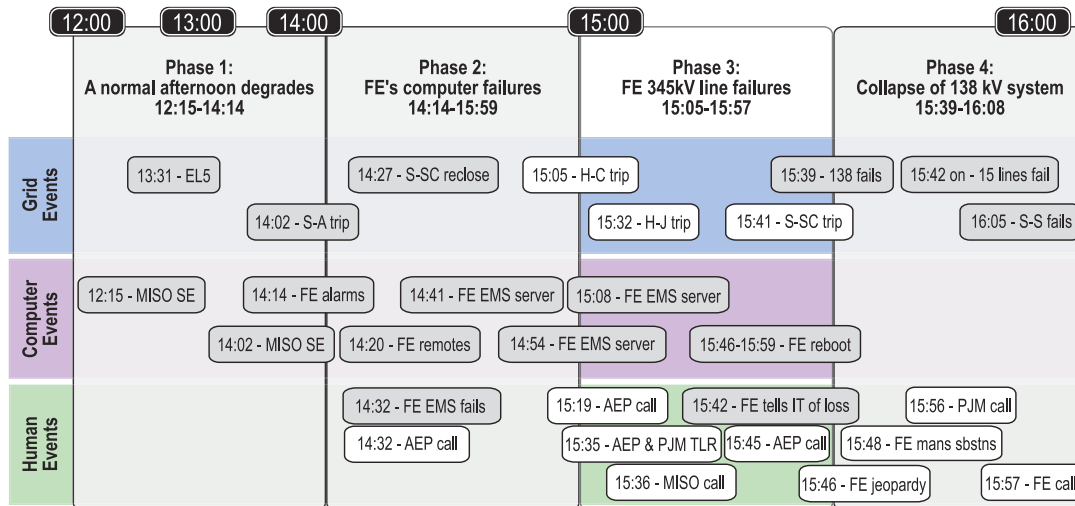
Figure 4.7. Timeline Phase 3

- 3A) 15:05:41 EDT: Harding-Chamberlin 345-kV line tripped.
- 3B) 15:31-33 EDT: MISO called PJM to determine if PJM had seen the Stuart-Atlanta 345-kV line outage. PJM confirmed Stuart-Atlanta was out.

- 3C) 15:32:03 EDT: Hanna-Juniper 345-kV line tripped.
- 3D) 15:35 EDT: AEP asked PJM to begin work on a 350-MW TLR to relieve overloading on the Star-South Canton line, not knowing the Hanna-Juniper 345-kV line had already tripped at 15:32 EDT.
- 3E) 15:36 EDT: MISO called FE regarding post-contingency overload on Star-Juniper 345-kV line for the contingency loss of the Hanna-Juniper 345-kV line, unaware at the start of the call that Hanna-Juniper had already tripped.
- 3F) 15:41:33-41 EDT: Star-South Canton 345-kV tripped, reclosed, tripped again at 15:41 EDT and remained out of service, all while AEP and PJM were discussing TLR relief options (event 3D).

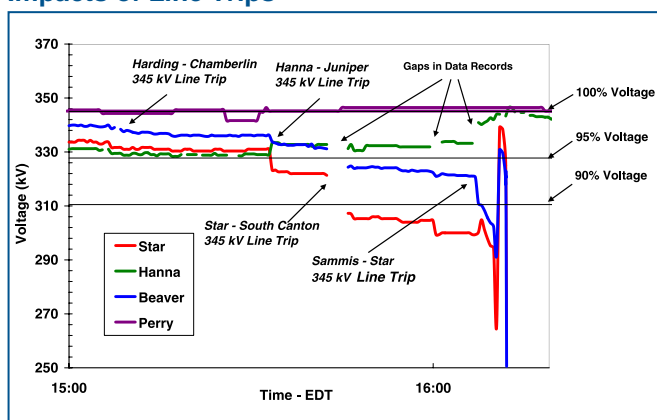
Figure 4.6. Voltages on FirstEnergy’s 345-kV Lines: Impacts of Line Trips

A short-circuit occurred on the Harding-Chamberlin 345-kV line due to a contact between the line conductor and a tree. This line failed with power flow at only 43.5% of its normal and emergency line rating. Incremental line current and temperature increases, escalated by the loss of Harding-Chamberlin, caused enough sag on the Hanna-Juniper line that it contacted a tree and faulted with power flow at 87.5% of its normal and emergency line rating. Star-South Canton contacted a tree three times between 14:27:15 EDT and 15:41:33 EDT, opening and reclosing each time before finally locking out while loaded at 93.2% of its emergency rating at 15:42:35 EDT.

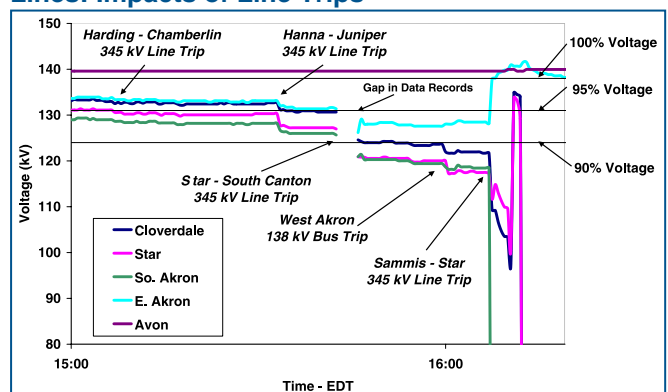
Figure 4.14. Voltages on FirstEnergy’s 138-kV Lines: Impacts of Line Trips

As each of FE’s 345-kV lines in the Cleveland area tripped out, it increased loading and decreased voltage on the underlying 138-kV system serving Cleveland and Akron, pushing those lines into overload. Starting at 15:39 EDT, the first of an eventual sixteen 138-kV lines began to fail. Figure 4.14 shows how actual voltages declined at key 138-kV buses as the 345- and 138-kV lines were lost. As these lines failed, the voltage drops caused a number of large industrial customers with voltage-sensitive equipment to go off-line automatically to protect their operations. As the 138-kV lines opened, they blacked out customers in

Akron and the areas west and south of the city, ultimately dropping about 600 MW of load.

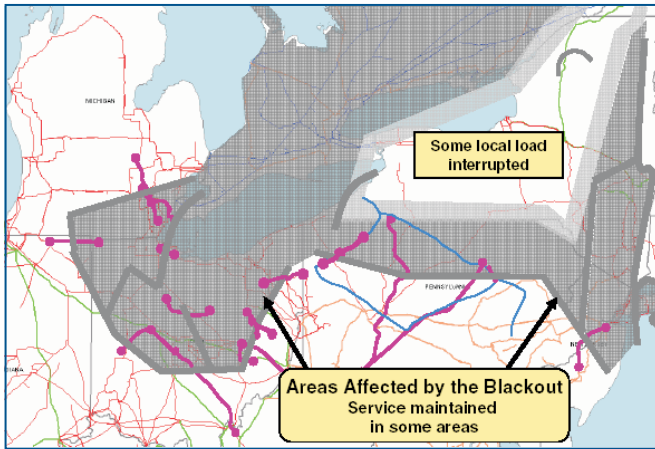
Figure 5.1. Area Affected by the Blackout

Phase 7. In the final phase, the large electrical island in the northeast was deficient in generation and unstable with large power surges and swings in frequency and voltage. As a result, many lines and generators across the disturbance area tripped, breaking the area into several electrical islands. Generation and load within these smaller islands was often unbalanced, leading to further tripping of lines and generating units until equilibrium was established in each island. Although much of the disturbance area was fully blacked out in this process, some islands were able to reach equilibrium without total loss of service. For example, most of New England was stabilized and generation and load restored to balance. Approximately half of the generation and load remained on in western New York, which has an abundance of generation. By comparison, other areas with large load centers and insufficient generation nearby to meet that load collapsed into a blackout condition (Figure 5.1).

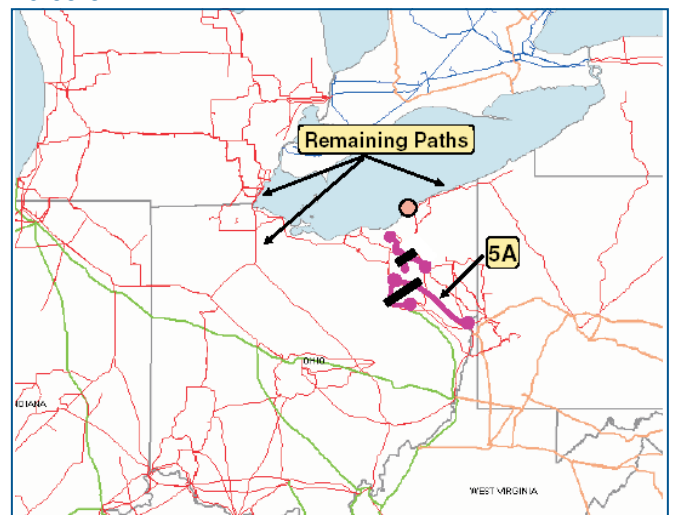
Figure 5.2. Sammis-Star 345-kV Line Trip, 16:05:57 EDT

This initial phase of the cascade began because after the loss of FE's Sammis-Star 345-kV line and the underlying 138-kV system, there were no large transmission paths left from the south to support the significant amount of load in northern Ohio (Figure 5.2). This placed a significant load burden

onto the transmission paths north and northwest into Michigan, causing a steady loss of lines and power plants.

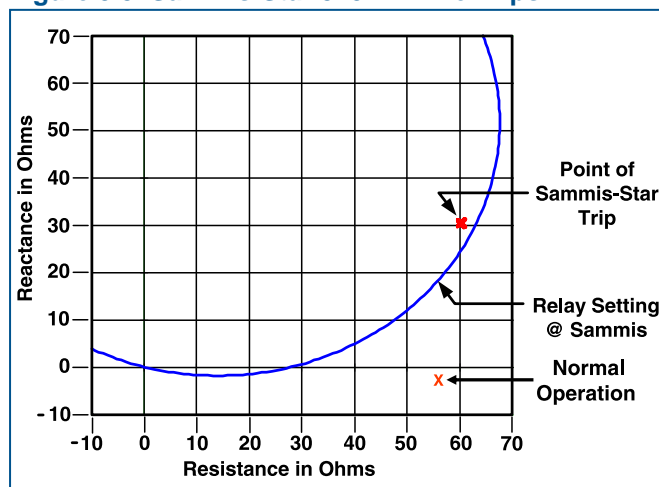
Figure 5.3. Sammis-Star 345-kV Line Trips

Sammis-Star did not trip due to a short circuit to ground (as did the prior 345-kV lines that tripped). Sammis-Star tripped due to protective relay action that measured low apparent impedance (depressed voltage divided by abnormally high line current) (Figure 5.3). There was no fault and no major power swing at the time of the trip—rather, high flows above the line’s emergency rating together with depressed voltages caused the overload to appear to the protective relays as a remote fault on the system. In effect, the relay could no longer differentiate between a remote three-phase fault and an exceptionally high line-load condition. Moreover, the reactive flows (VARs) on the line were almost ten times higher than they had been earlier in the day. The relay operated as it was designed to do.

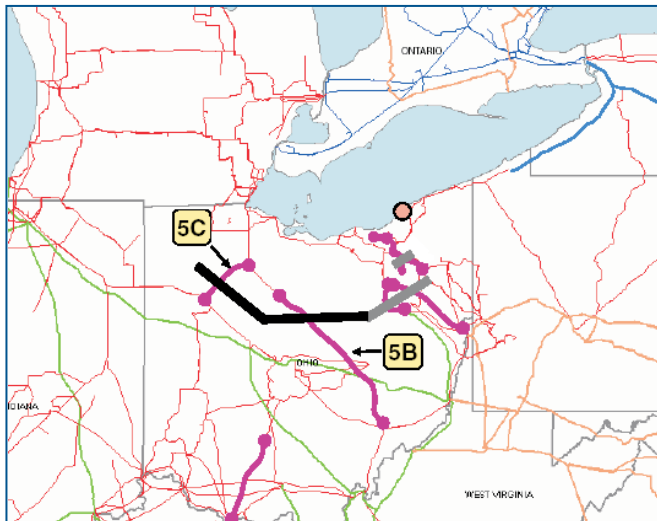
Figure 5.4. Ohio 345-kV Lines Trip, 16:08:59 to 16:09:07 EDT

The tripping of the Galion-Ohio Central-Muskingum and East Lima-Fostoria Central 345-kV transmission lines removed the transmission paths from southern and western Ohio into northern Ohio and eastern Michigan. Northern Ohio was connected to eastern Michigan by only three 345-kV transmission lines near the southwestern

bend of Lake Erie. Thus, the combined northern Ohio and eastern Michigan load centers were left connected to the rest of the grid only by: (1) transmission lines eastward from northeast Ohio to northwest Pennsylvania along the southern shore of Lake Erie, and (2) westward by lines west and northwest of Detroit, Michigan and from Michigan into Ontario (Figure 5.4).

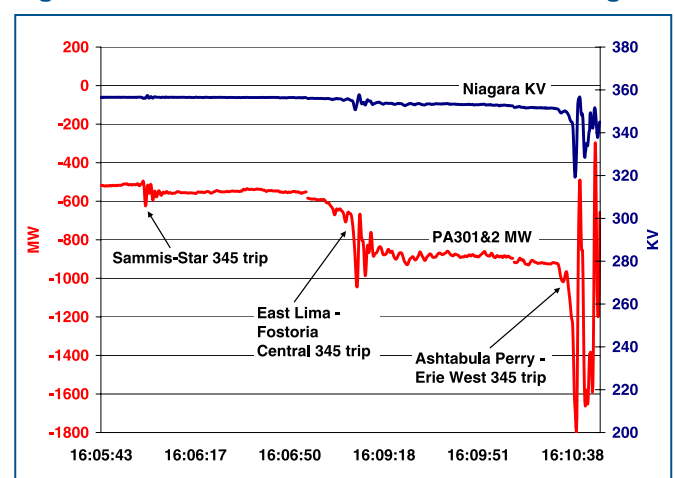
Figure 5.5. New York-Ontario Line Flows at Niagara

In Figure 5.5, a high-speed recording of 345-kV flows past Niagara Falls shows the New York to Ontario power swing, which continued to oscillate for over 10 seconds. The recording shows the magnitude of subsequent flows triggered by the trips of the Hampton-Pontiac and Thetford-Jewell 345-kV lines in Michigan and the Perry-Ashtabula 345-kV line linking the Cleveland area to Pennsylvania. The very low voltages on the northern Ohio transmission system made it very difficult for the generation in the Cleveland and Lake Erie area to maintain synchronization with the Eastern Interconnection. Over the next two minutes, generators in this area shut down after reaching a point of no

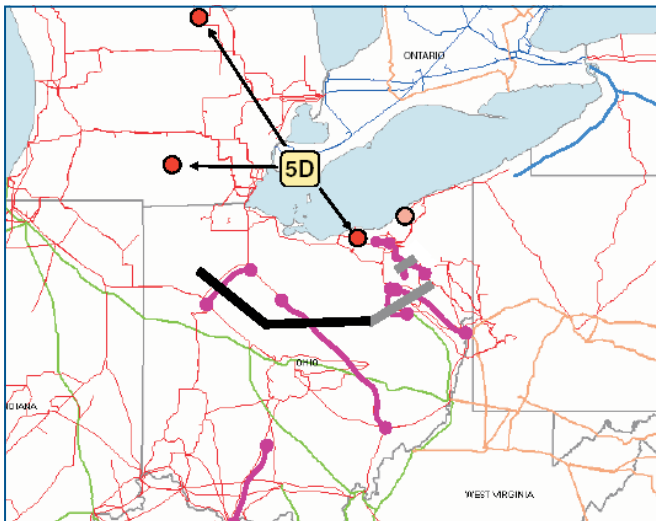
Figure 5.6. Michigan and Ohio Power Plants Trip

The Midland Cogeneration Venture (MCV) plant is in central Michigan. Kinder Morgan is in south-central Michigan. The large power reversal caused frequency and voltage fluctuations at the plants. Their automatic control systems responded to these transients by trying to adjust output to raise voltage or respond to the frequency changes, but subsequently tripped off-line. The Avon Lake and Burger units, in or near Cleveland, likely tripped off due to the low voltages prevailing in the Cleveland area and 138-kV line trips near Burger 138-kV substation (northern Ohio) (Figure 5.6).

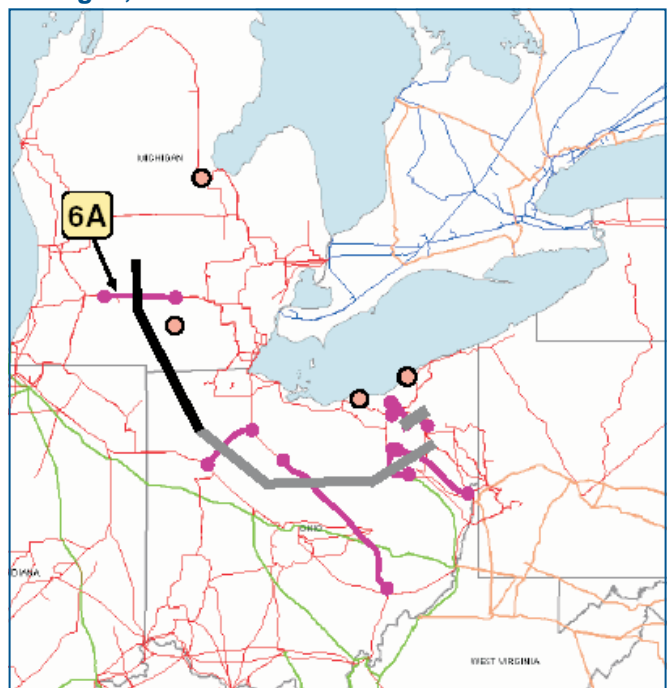
Figure 5.7. Transmission and Generation Trips in Michigan, 16:10:36 to 16:10:37 EDT

Together, the above line outages interrupted the east-to-west transmission paths into the Detroit area from south-central Michigan. The Sumpter generation units tripped in response to under-voltage on the system. Michigan lines northwest of Detroit then began to trip, as noted below (Figure 5.7).

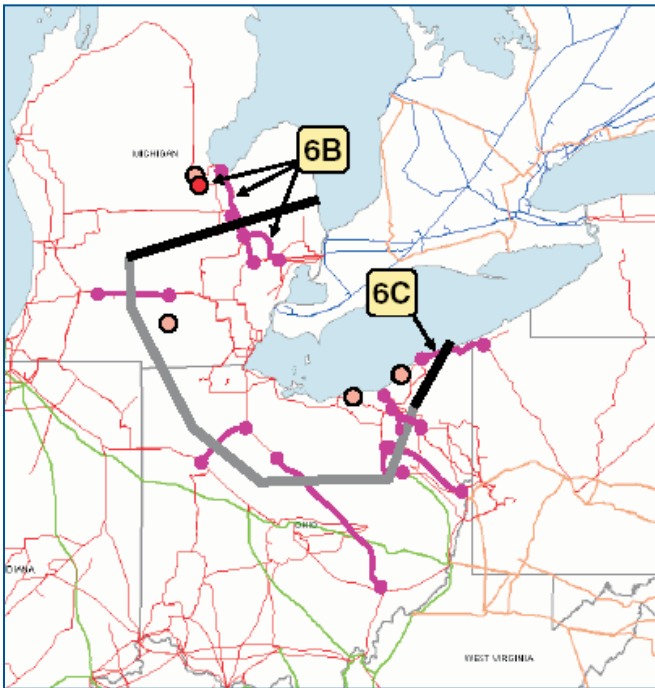
Figure 5.8. Michigan Lines Trip and Ohio Separates from Pennsylvania, 16:10:36 to 16:10:38.6 EDT

Perry-Ashtabula-West Erie was the last 345-kV line connecting northern Ohio to the east. This line's trip separated the Ohio 345-kV transmission system from Pennsylvania. When it tripped, the load centers in eastern Michigan and northern Ohio remained connected to the rest of the Eastern Interconnection only at the interface between the

Michigan and Ontario systems (Figure 5.8). Eastern Michigan and northern Ohio now had little internal generation left and voltage was declining. Between 16:10:39 EDT and 16:10:50 EDT under-frequency load shedding in the Cleveland area operated and interrupted about 1,750 MW of load. The frequency in the Cleveland area (by then separated from the Eastern Interconnection to the south) was also dropping rapidly and the load shedding was not enough to arrest the frequency decline. Since the electrical system always seeks to balance load and generation, the high loads in Cleveland drew power over the only major transmission path remaining—the lines from eastern Michigan east into Ontario.

This was a transient frequency swing, so frequency was not the same across the Eastern Interconnection. As Figure 5.8 shows, this frequency imbalance and the accompanying power swing resulted in a rapid rate of voltage decay. Flows into Detroit exceeded 3,500 MW and 1,500 MVAR, meaning that the power surge was draining both active and reactive power out of the northeast to prop up the low voltages in eastern Michigan and Detroit. This magnitude of reactive power draw caused voltages in Ontario and New York to drop. At the same time, local voltages in the Detroit area were low because there was still not enough supply to meet load. Detroit would soon black out (as evidenced by the rapid power swings decaying after 16:10:43 EDT).

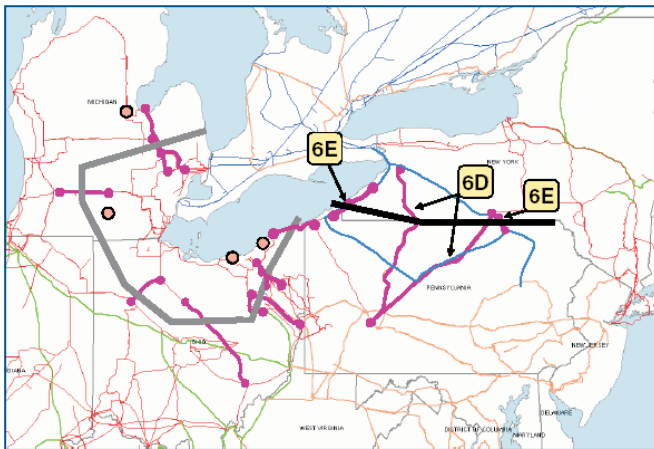
Figure 5.10. Western Pennsylvania Separates from New York, 16:10:39 EDT to 16:10:44 EDT

Responding to the surge of power flowing north out of Pennsylvania through New York and Ontario into Michigan, relays on these lines activated on apparent impedance within a five-second period and separated Pennsylvania from New York (Figure 5.10).

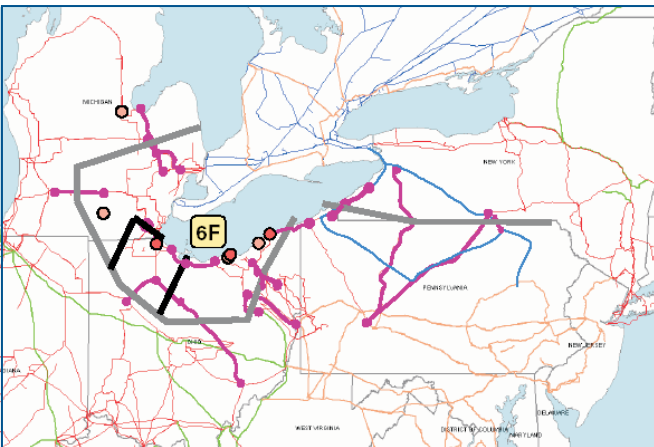
Figure 5.11. More Transmission Line and Power Plant Losses

Back in northern Ohio, the trips of the Majestic 345-kV substation in southeast Michigan, the Bay Shore-Monroe 345-kV line, and the Ashtabula 345/138-kV transformer created a Toledo and Cleveland electrical “island” (Figure 5.11). Frequency in this large island began to fall rapidly. This led to a series of power plants in the area shutting down due to the operation of under-frequency relays, including the Bay Shore units. When the Beaver-Davis Besse 345-kV line connecting Cleveland and Toledo tripped, it left the Cleveland area completely isolated. Cleveland area load was disconnected by automatic under-frequency load-shedding (approximately 1,300

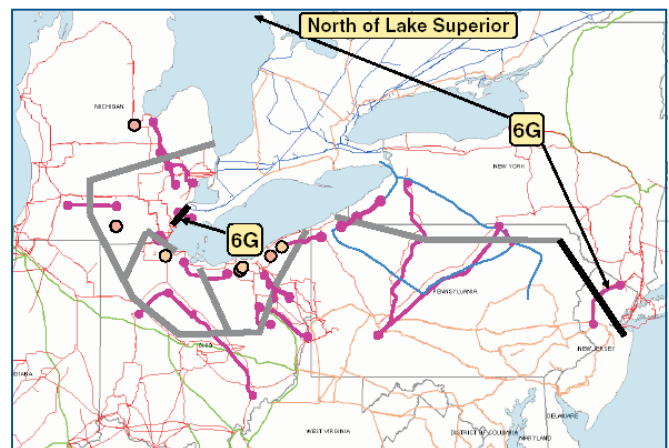
Figure 5.12. Northeast Disconnects from Eastern Interconnection

A significant amount of the remaining generation serving Detroit tripped off-line in response to these events. At 16:10:43 EDT, eastern Michigan was still connected to Ontario, but the Keith-Waterman 230-kV line that forms part of that interface disconnected due to apparent impedance (Figure 5.12).

At this point, the Eastern Interconnection was split into two major sections. To the north and east of the separation point lay New York City, northern New Jersey, New York state, New England, the Canadian Maritime provinces, eastern Michigan, the majority of Ontario, and the Québec system. The rest of the Eastern Interconnection, to the south and west of the separation boundary, was not seriously affected by the blackout.

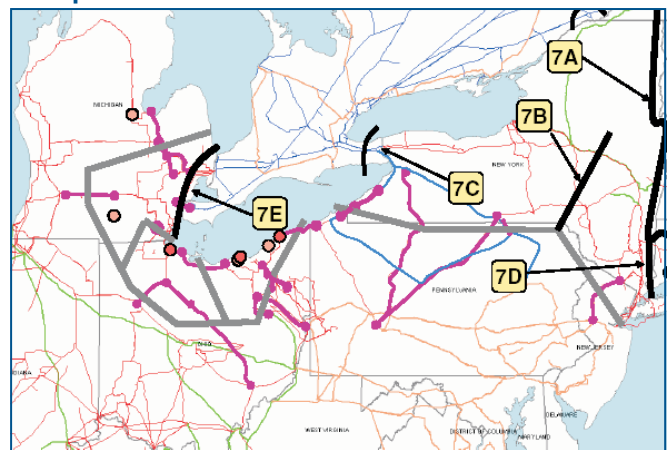
Figure 5.13. New York and New England Separate, Multiple Islands Form

New England (except southwestern Connecticut) and the Maritimes separated from New York and remained intact; New York split east to west: 16:10:46 EDT to 16:11:57 EDT. Figure 5.13 illustrates the events of this phase.

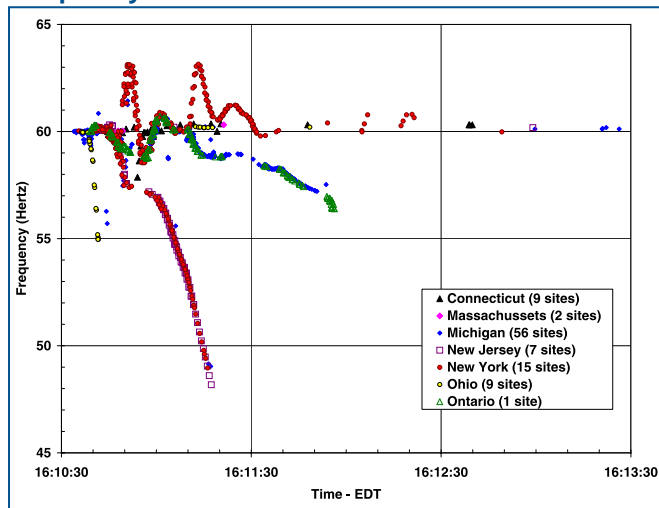
Figure 5.14. Electric Islands Reflected in Frequency Plot

Figure 5.14 shows frequency data collected by the distribution-level monitors of Softswitching Technologies, Inc. (a commercial power quality company serving industrial customers) for the area affected by the blackout. The data reveal at least five separate electrical islands in the Northeast as the cascade progressed. The two paths of red diamonds on the frequency scale reflect the Albany area island (upper path) versus the New York city island, which declined and blacked out much earlier.

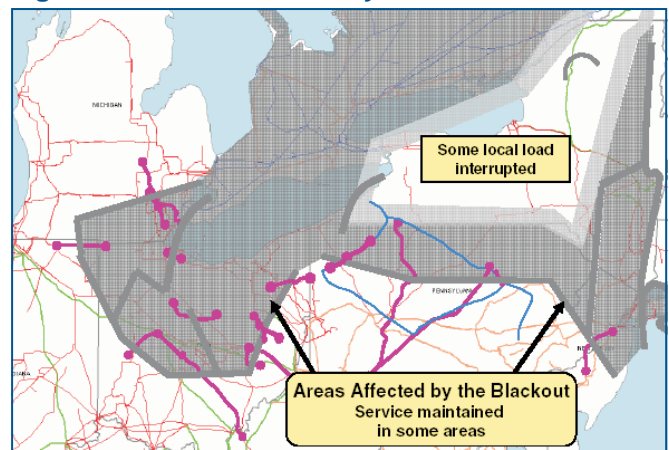
Figure 5.15. Area Affected by the Blackout

Most of the Northeast (the area shown in gray in Figure 5.15) was now blacked out. Some isolated areas of generation and load remained on-line for several minutes. Some of those areas in which a close generation-demand balance could be maintained remained operational; other generators ultimately tripped off line and the areas they served were blacked out.

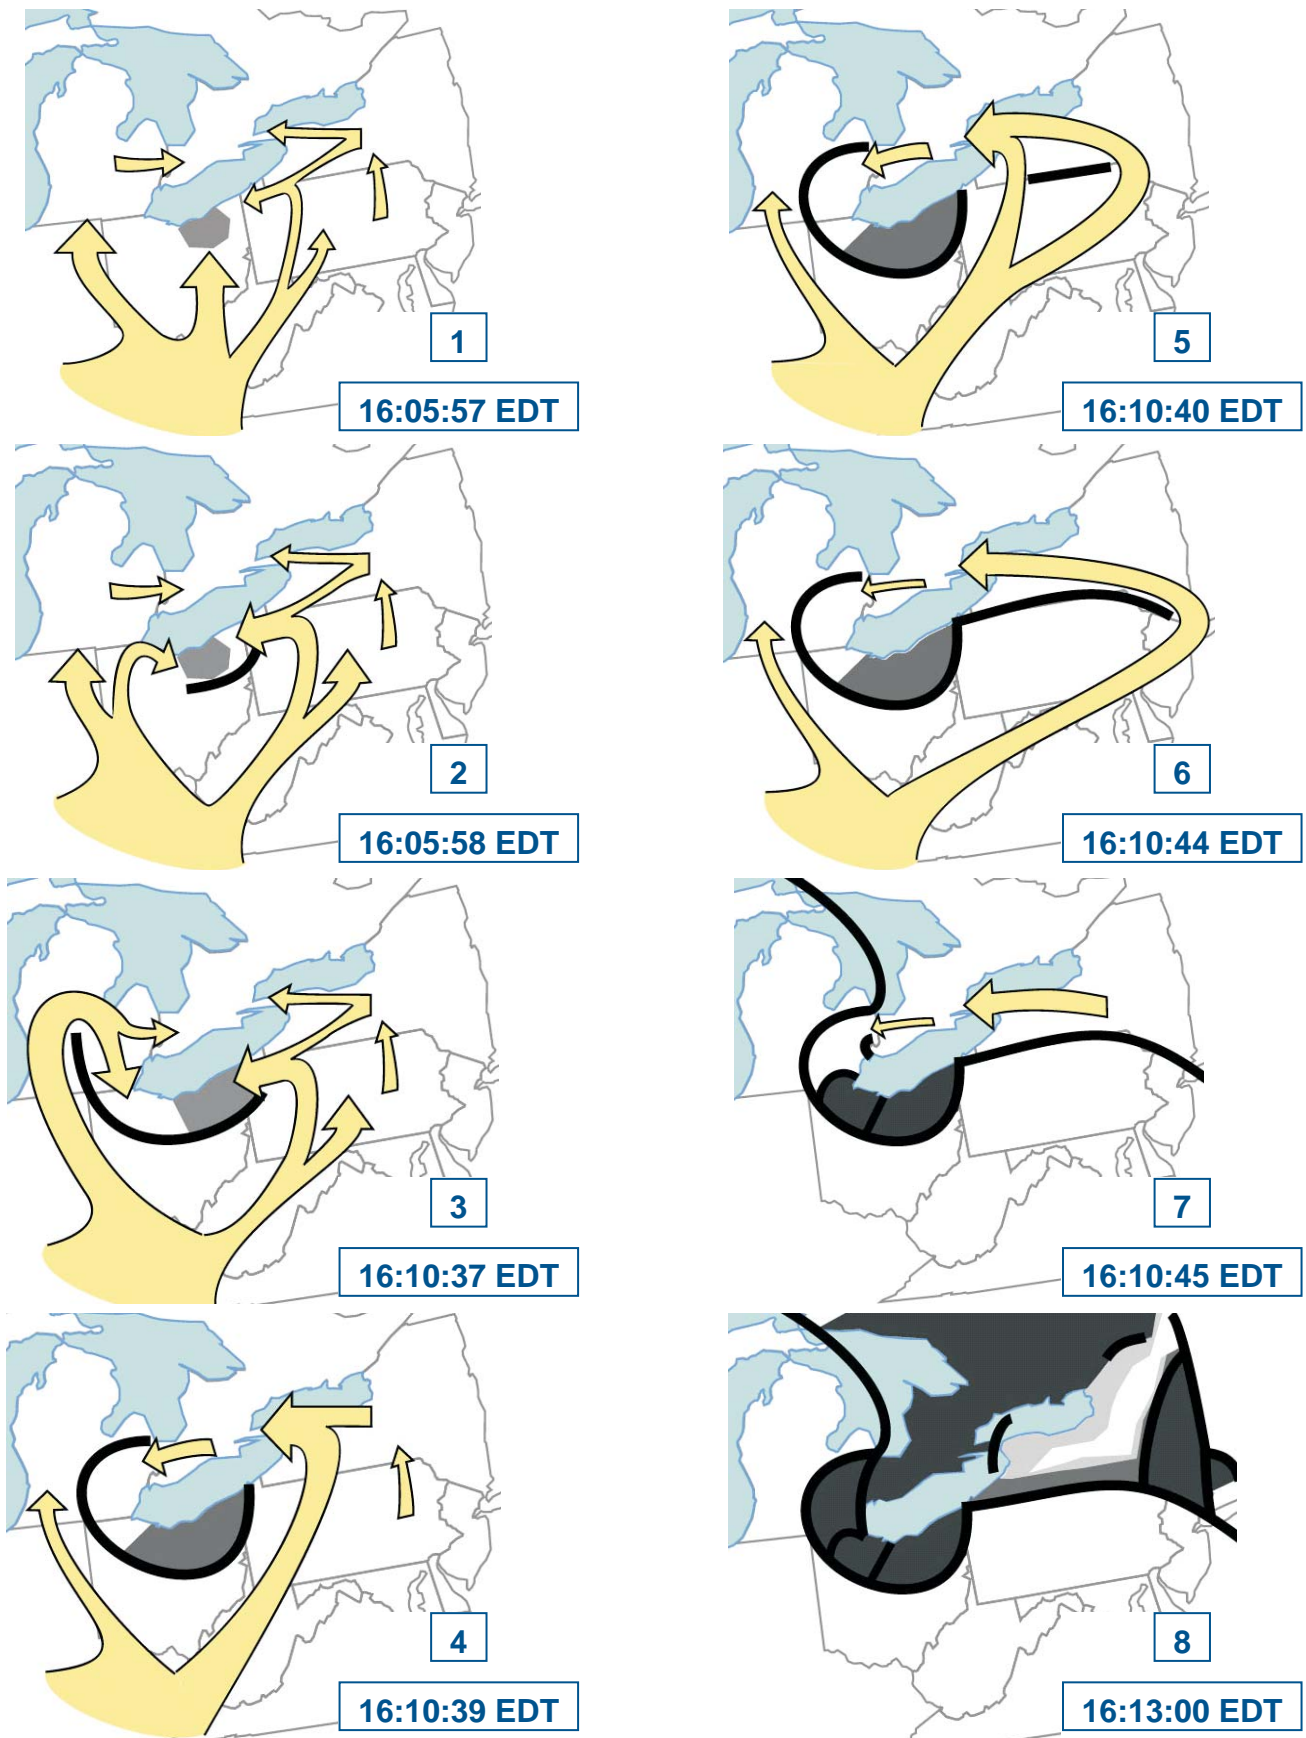
Figure 5.16. Cascade Sequence

The entire cascade sequence is depicted graphically in Figure 5.16 on the following page.

Relative voltage levels across the northeast affected which areas blacked out and which areas stayed on-line. Within the Midwest, there were relatively low reserves of reactive power, so as voltage levels declined many generators in the affected area were operating at maximum reactive power output before the blackout. This left the system little slack to deal with the low voltage conditions by ramping up more generators to higher reactive power output levels, so there was little room to absorb any system “bumps” in voltage or frequency. In contrast, in the northeast—particularly PJM, New York, and ISO-New England—operators were anticipating high power demands on the afternoon of August 14, and had already set up the system to maintain higher voltage levels and therefore had more reactive reserves on-line in anticipation of later afternoon needs. Thus, when the voltage and frequency swings began, these systems had reactive power already or readily available to help buffer their areas against a voltage collapse without widespread generation trips.

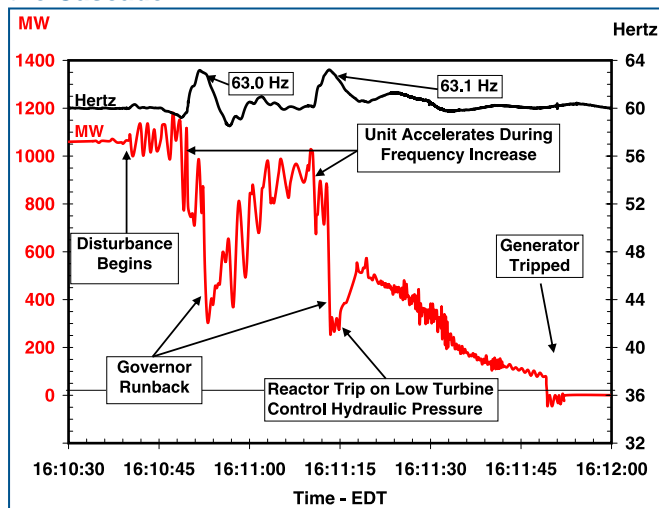
Figure 5.17. Events at One Large Generator During the Cascade

Excitation failures. The Eastlake 5 trip at 1:31 p.m. was an excitation system failure—as voltage fell at the generator bus, the generator tried to increase its production of voltage on the coil (excitation) quickly. This caused the generator’s excitation protection scheme to trip the plant off to protect its windings and coils from over-heating. Several of the other generators which tripped early in the cascade came off under similar circumstances as excitation systems were overstressed to hold voltages up.

After the cascade was initiated, huge power swings across the torn transmission system and excursions of system frequency put all the units in their path through a sequence of major disturbances that shocked several units into tripping. Plant controls had actuated fast governor action on several of these to turn back the throttle, then turn it forward, only to turn it back again as some frequencies changed several times by as much as 3 Hz (about 100 times normal). Figure 5.17 is a plot of the MW output and frequency for one large unit that nearly survived the disruption but tripped when in-plant hydraulic control pressure limits were eventually violated. After the plant control system called for shutdown, the turbine control valves closed and the generator electrical output ramped down to a preset value before the field excitation tripped and the generator breakers opened to disconnect the unit from the system.

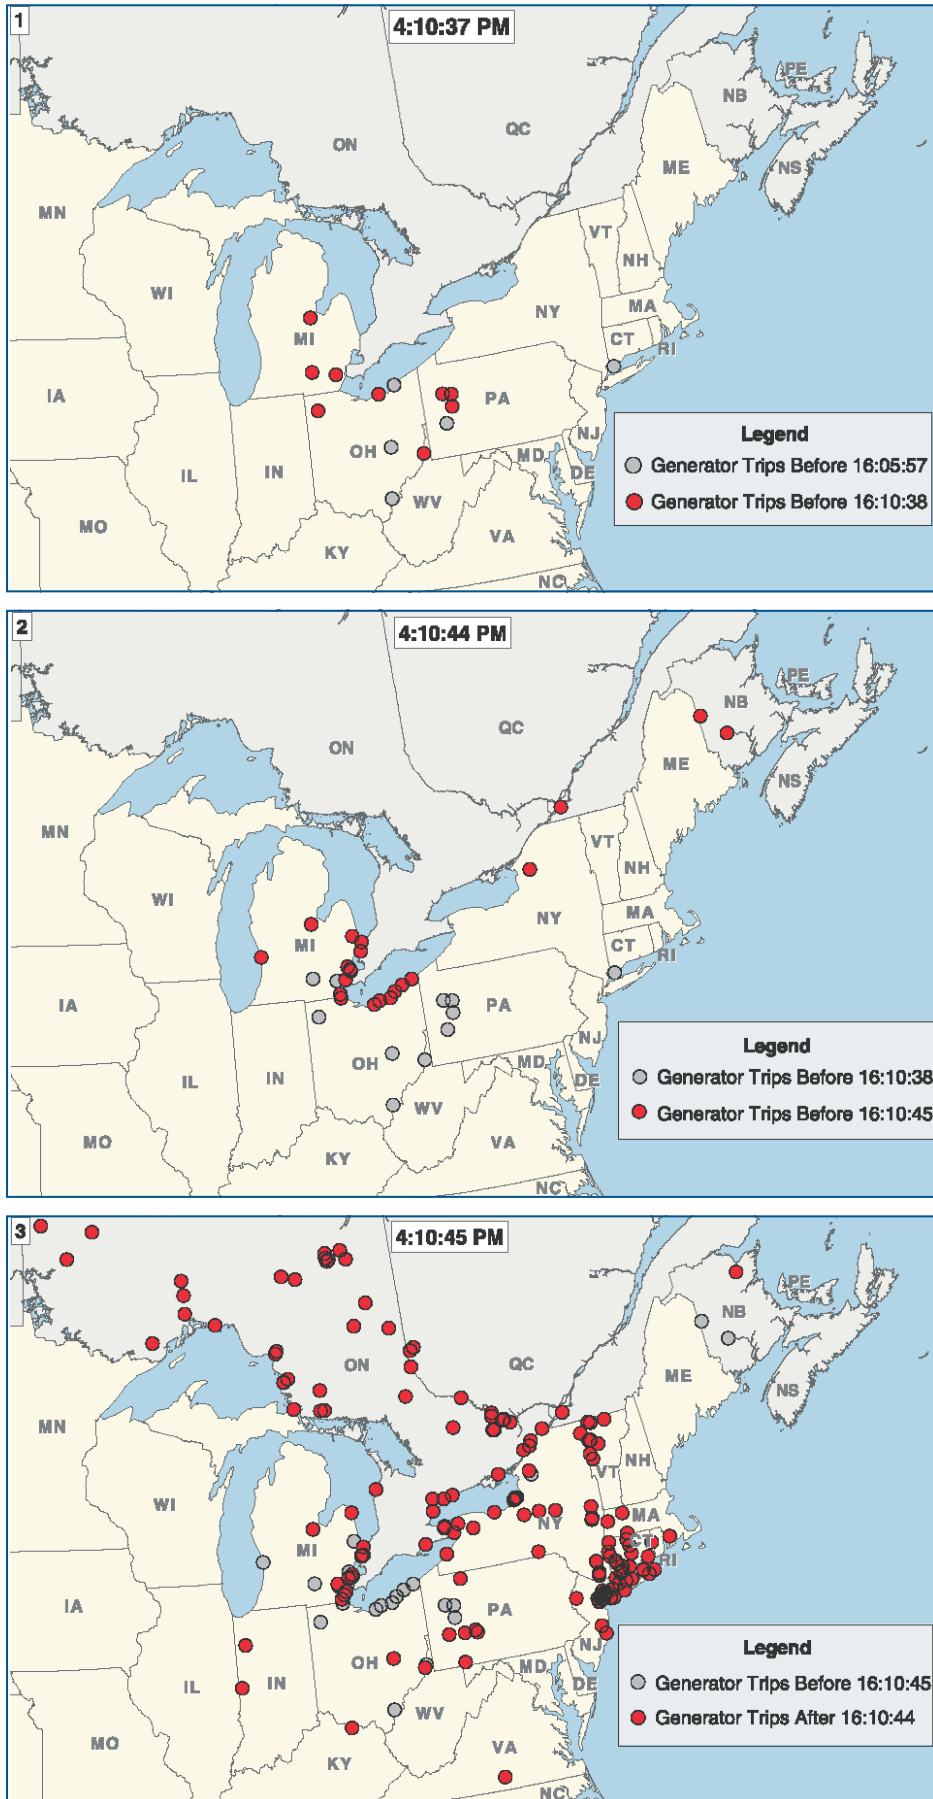
Figure 5.18. Power Plants Tripped During the Cascade

Consequential trips. Most of the unit separations fell in the third category of consequential tripping—they tripped off-line in response to some outside condition on the grid, not because of any problem internal to the plant. Some generators became completely removed from all loads; because the fundamental operating principle of the grid is that load and generation must balance, if there was no load to be served the power plant shut down in response to over-speed and/or over-voltage protection schemes. Others were overwhelmed because they were among a few power plants within an electrical island, and were suddenly called on to serve huge customer loads, so the imbalance caused them to trip on under-frequency and/or under-voltage protection. A few were tripped by special protection schemes that activated on excessive frequency or loss of pre-studied major transmission elements known to require large blocks of generation rejection.

The maps in Figure 5.18 show the sequence of power plants lost in three blocks of time during the cascade.
