Safety Bulletin

U.S. Chemical Safety and Hazard Investigation Board

No. 2005-03-B | January 2006

EXPLOSION AT ASCO: DANGERS OF FLAMMABLE GAS ACCUMULATION

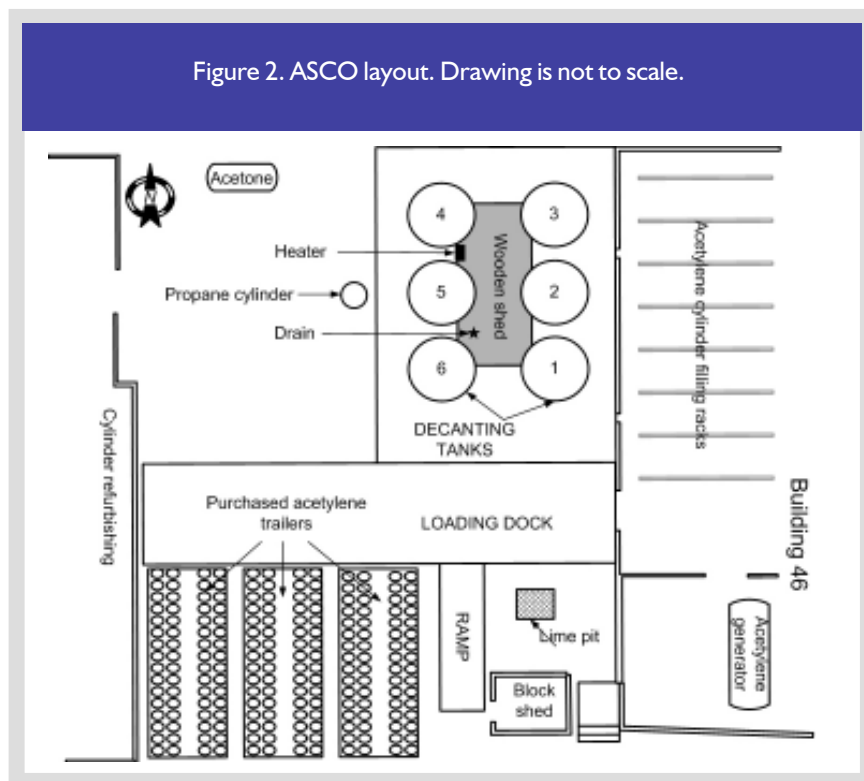
The ASCO manufacturing facility was located in an industrial area northwest of the Outercrossing Bridge which connects New Jersey to Staten Island, NY. The acetylene generating process equipment (manufactured by Rexarc²), cylinder filling operations, offices, and break room were housed in Building 46 (Figure 2). Directly outside Building 46 were six decanting tanks that surrounded a wood-framed shed. The shed contained water pumps and related piping. Receiving docks used to offload purchased acetylene, an adjacent building used for cylinder refurbishing, and an acetone storage tank were also part of the operation at ASCO.

Figure 2. ASCO layout. Drawing is not to scale.

The ASCO facility included a wooden shed constructed in-between the six decant tanks. It was approximately 15 feet wide by 28 feet long and had a roof that sloped from 8 feet to 6 feet in height. The shed was constructed using the tank shells to make up portions of the walls, as shown in Figure 2. The concrete pad that supported the tanks served as the shed floor.

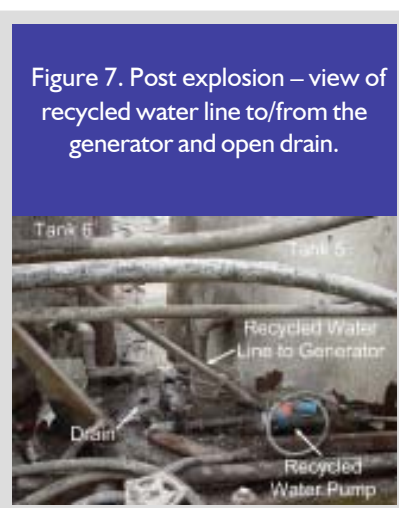
It was normal practice at ASCO to leave the decant water line open at night to drain to the shed floor through a low-point valve. This protected the outside section of the line from damage due to freezing during cold weather. The open valve created a potential pathway for acetylene to flow from the generator into the shed; an enclosed space that was not designed for the presence of

acetylene. This potential hazard was not recognized by ASCO.

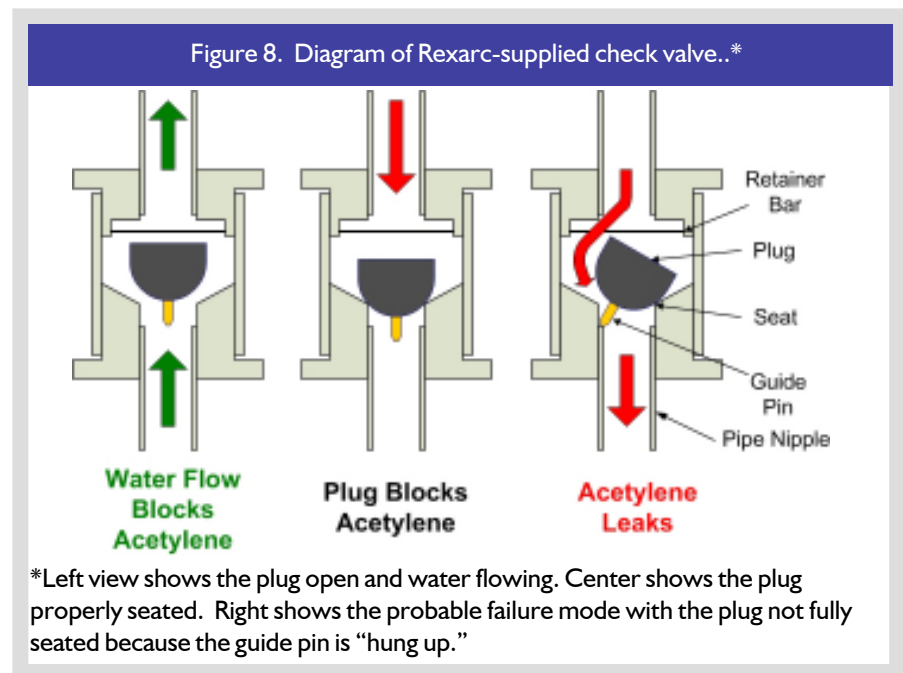
- The valve depends on gravity and back pressure to seal. No springs are used to assist seating of the plug.
- The plug is not effectively guided and is prone to misalignment.
- The check valve internal surfaces are susceptible to solids build up, such as scale or from lime particles entrained in the recycled water.

While check valves are valuable in preventing backflow in process lines, they should not be solely relied on in hazardous applications. It is good practice to provide a positive means of isolation, such as a double-block valve arrangement with a bleed to

a safe location, in addition to the check valve to ensure that backflow of explosive gases does not occur.
