**ASSESSMENT OF DRILLING & WORKOVER RIG STORM SEA  
FASTENINGS ON OFFSHORE FLOATING PLATFORMS DURING  
HURRICANE IVAN  
PHASE 1: Data Collection Report**

**E.G. Ward (OTRC) and J.M. Gebara (Technip)**

**Prepared for the Minerals Management Service**

**August 1, 2006**

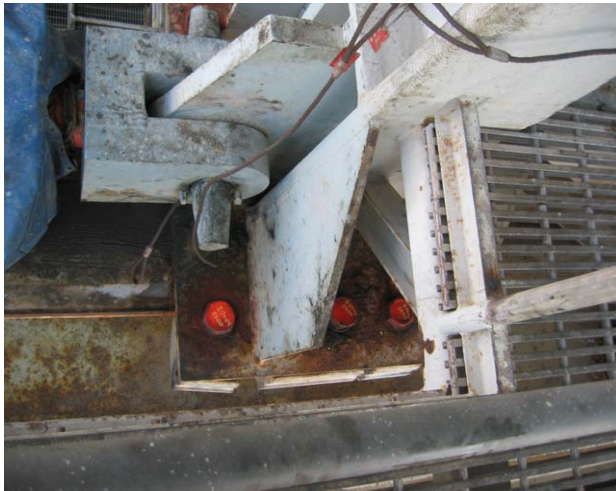
Drill Floor to Skid Beam

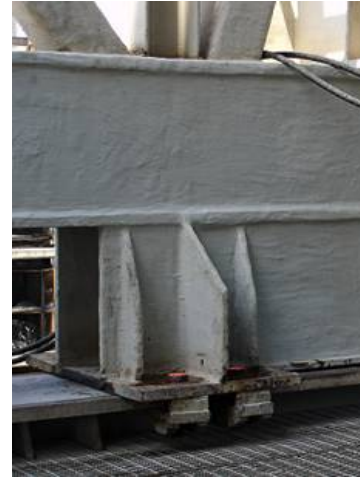
Skid Beam to Deck

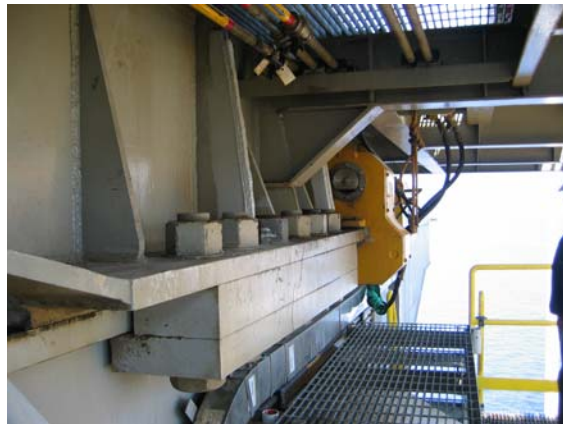
Skid base on deck skid beam - beam on bolted runner guide & hydraulic clamp

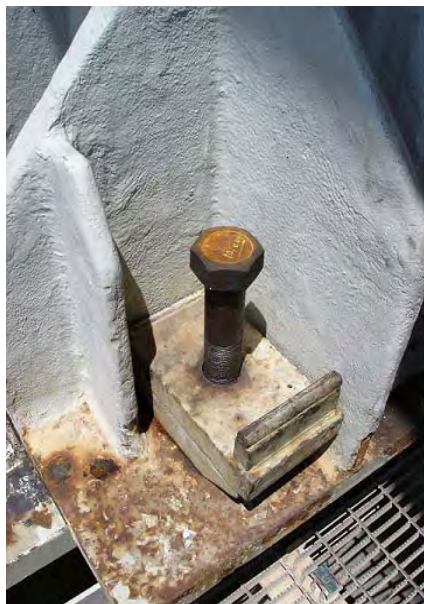
Figure 2 – Loosened Bolt for Tie-Down
