Shell's Experience with Hurricane Ivan

Shell Exploration and Production Co.

API – 2005 Hurricane Readiness and Recovery
Conference

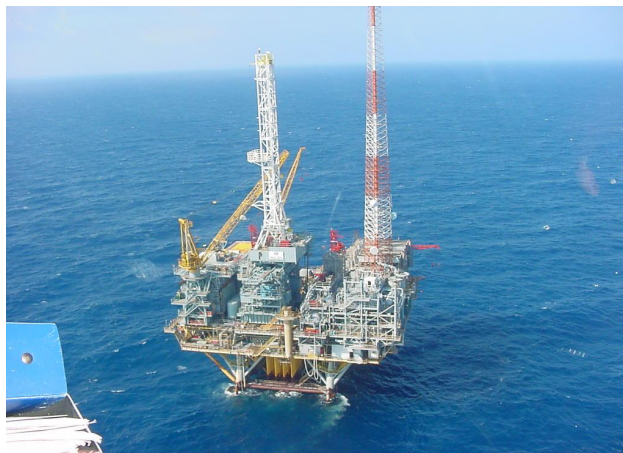
Cognac Description

➤ Mississippi Canyon 194 A (Cognac) is a drilling and production platform in 1025 ft of water, installed in 1978.

- Evidence of Green Water in the deck, 45 feet above the water line; platform 100 miles from the eye of the storm.

- Platform damage consisted of:
 - ❖ Missing Grating and Handrails
 - ❖ Minor Facilities equipment
 - ❖ Gaugers Shack

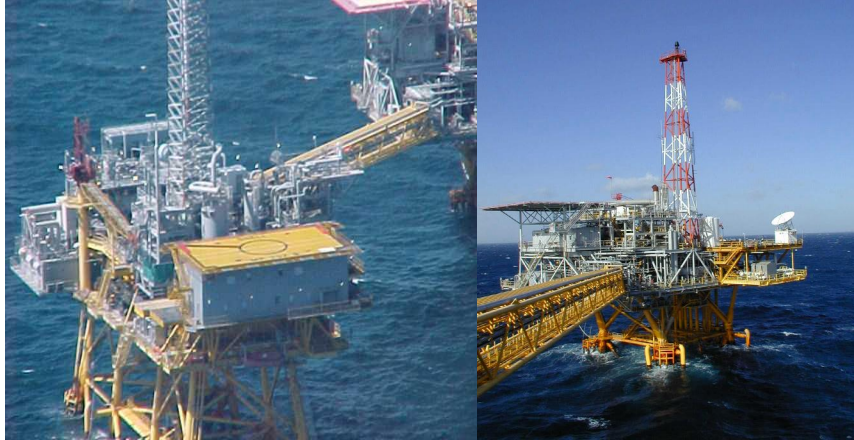
Main Pass 252 Description

- The Main Pass 252 complex consists of 2 bridge connected platforms in 300 feet of water. The 252 complex primarily supports 7 subsea wells.

- Evidence of Green Water in the deck, 50 feet above the water line. Platform was near the eye of the storm.
- Estimated wave height 65 - 70 ft which corresponds to the maximum design wave of 72 feet.
- Platform damaged consisted of:
 - ❖ Missing Grating and Handrails (100 % at boatlanding to 20 % on lower deck)
 - ❖ Facilities equipment, cable tray and mostly support utilities

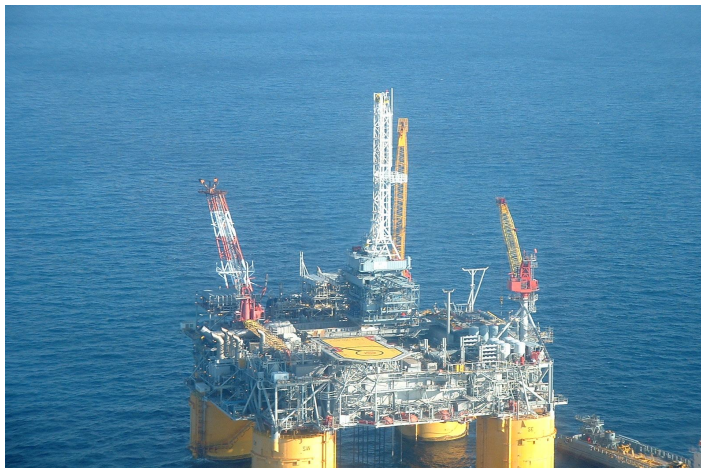
Viosca Knoll 956 A Description

➤ Viosca Knoll 956 A (Ram Powell) is a TLP in 3214 feet of water.

- Evidence of Green Water in the deck, 90 feet above the water line. Platform near the eye of the storm.
- Estimated wave height at this location is around 100 ft. Design wave was around 87 ft.
- Platform damaged consisted of:
 - ❖ Drilling rig moved off location
 - ❖ FGC 2 exhaust
 - ❖ Missing Grating and Handrails (100 % at boatlanding to 20 % on lower deck)
 - ❖ Facilities equipment, cable tray and mostly support utilities
