***ASSESSMENT OF FIXED OFFSHORE
PLATFORM PERFORMANCE IN HURRICANES
ANDREW, LILI AND IVAN***

January 2006

Prepared for:
**U.S. Department of the Interior
Mineral Management Service
Engineering and Research Branch
381 Elden Street
Herndon, VA 20170**

Prepared by:
**Energo Engineering, Inc.
3100 Wilcrest Drive, Suite 240
Houston, Texas 77042**

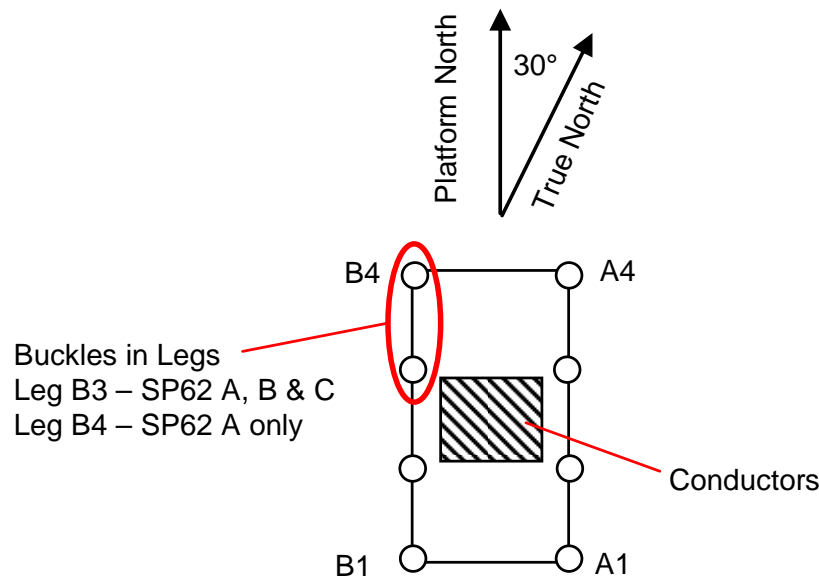
Figure 2.8 – Platform Orientation of SP62 Platforms

Local buckling was observed on four of the platforms that sustained major damage. Three of the platforms (SP 62 A/B/C) the platforms are very similar designs, installed in late 1960s in approximately 230 feet of water. All three have an 8 pile with 8 skirt piles configuration and are orientated in the same direction. The orientation is shown in Figure 2.8. During hurricane Ivan wave-in-deck was observed on all three platforms and local buckles were observed on the North/Northwest legs. The storm track of Ivan approached the platforms from the southeast. Hence it was the leeward side legs (legs under higher compression loading) that had the leg buckles.

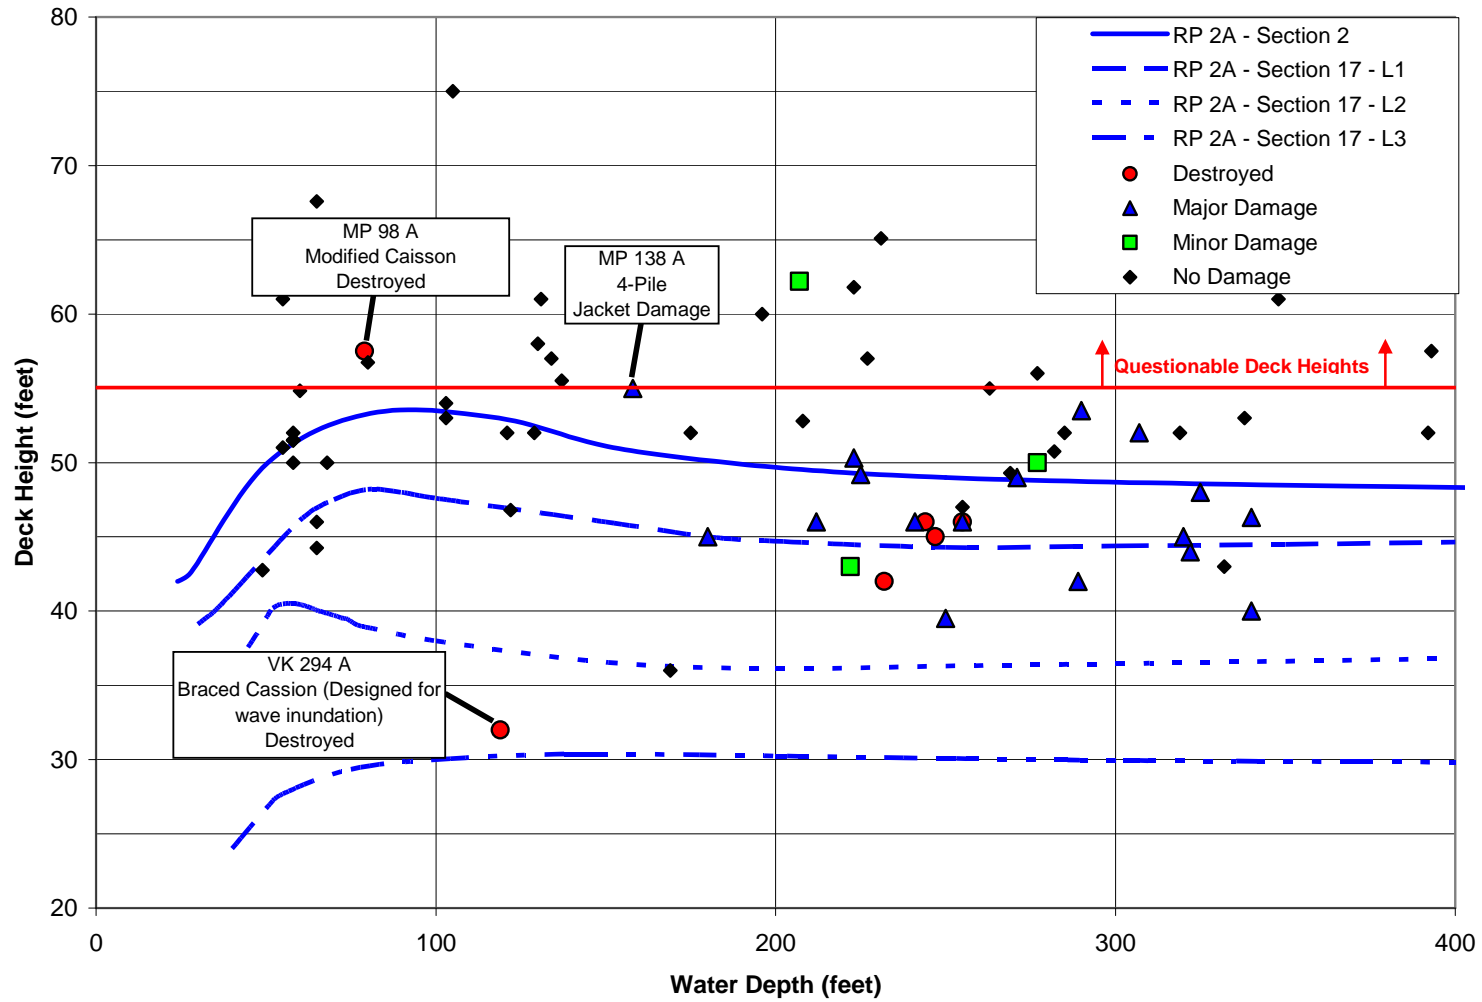
Figure 2.14 – Deck Heights of Platforms in Path of Ivan

What should be the appropriate deck height for new design as well as for structural assessments of older vintage platforms is a hotly debated topic since Ivan as well as after Katrina and Rita. Figure 2.14 shows the deck heights of the platforms in the path of hurricane Ivan. When reviewing the figure there is a noted cluster of 200-350 ft water depth platforms with decks lower than the API RP 2A Section 2 (New Design Criteria) platforms that either failed or sustained major damage during Ivan. The majority of the platforms with decks above the Section 2 deck height criteria did not sustain major damage. One item to note in the figure is there are a number of deck heights which appear to be questionable since they are over 55 feet. The deck height data shown in the figure was obtained from the MMS platform database. It is suspected that some of these deck heights are the cellar deck top of steel or in some case the drill deck instead of the required cellar deck bottom of steel. However, the figure does indicate that for those platforms in the path of Ivan with deck heights at or above the API RP 2A Section 2 (new design) requirements generally did not sustain major structural damage.

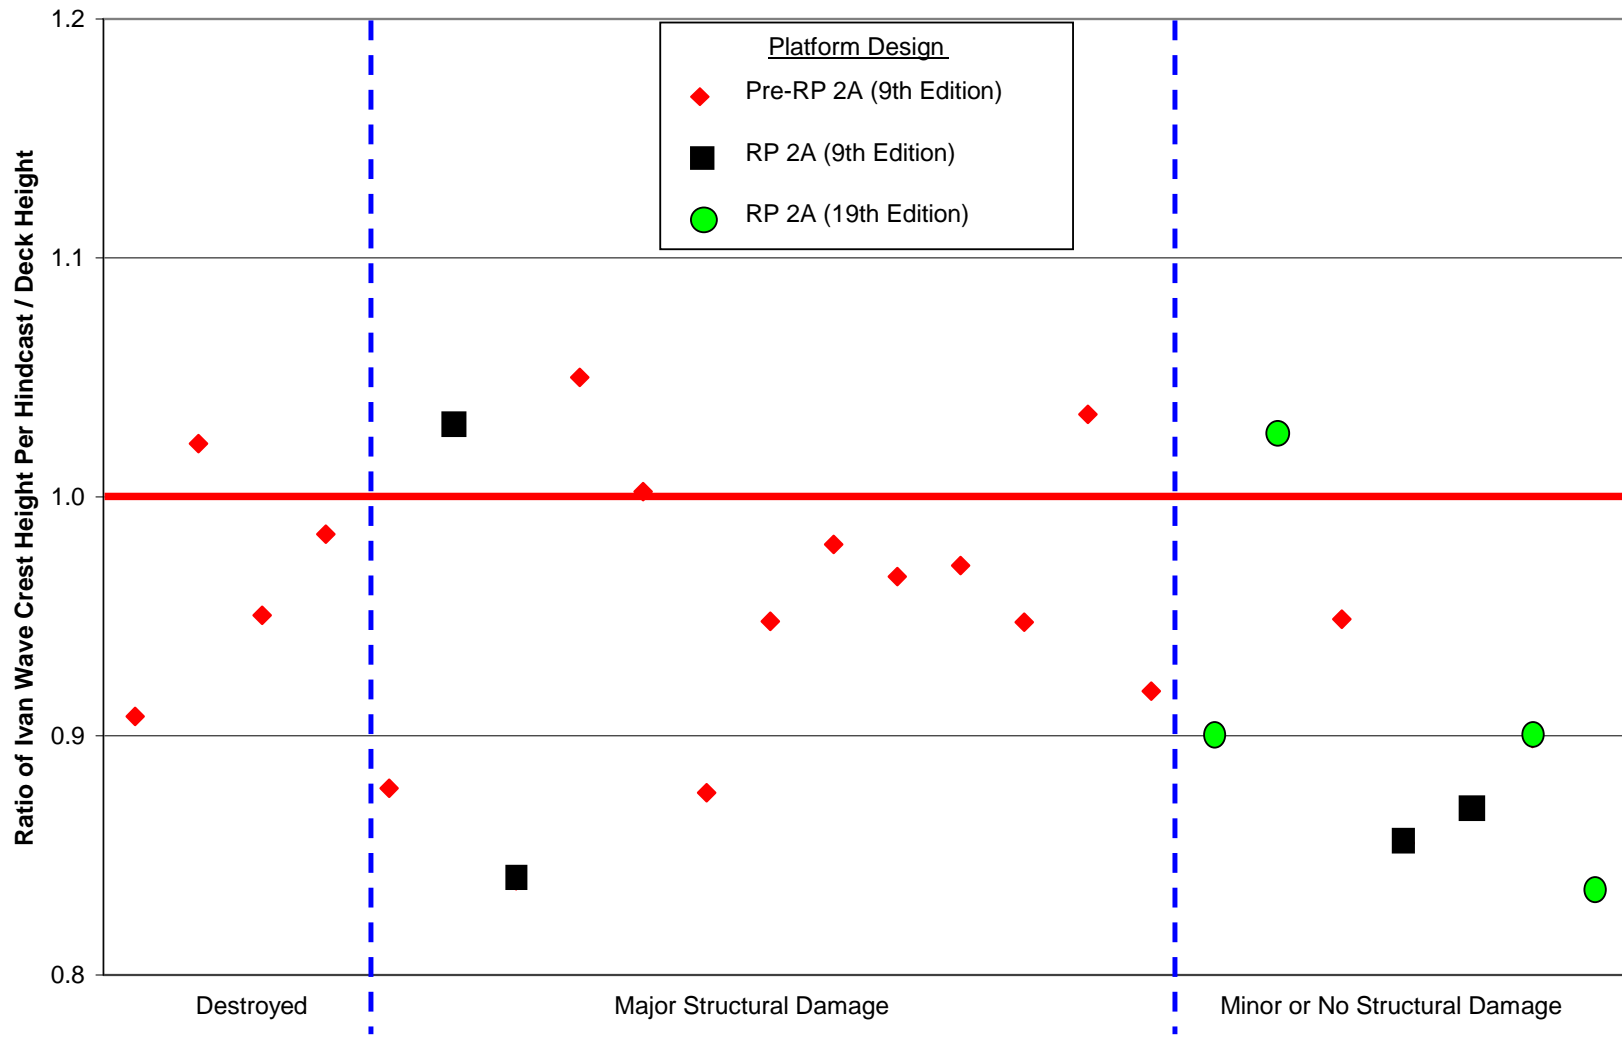
Figure 2.16 – Ratio of Ivan Hindcast Wave Crest versus Deck Heights

Figure 2.16, the ratios between the Ivan hindcast crest elevations and the platform deck height are plotted. If the ratio is greater than or equal to 1, wave-in-deck should have occurred during the storm based on the Ivan hindcast estimates. The vintage of the platform and the damage category is also presented in the figure. Based on the hindcast data only a few of the platforms should have seen wave-in-deck. However, based on site observations of the damage to many of these platforms indicates that wave crests were higher than predicted via the hindcast.

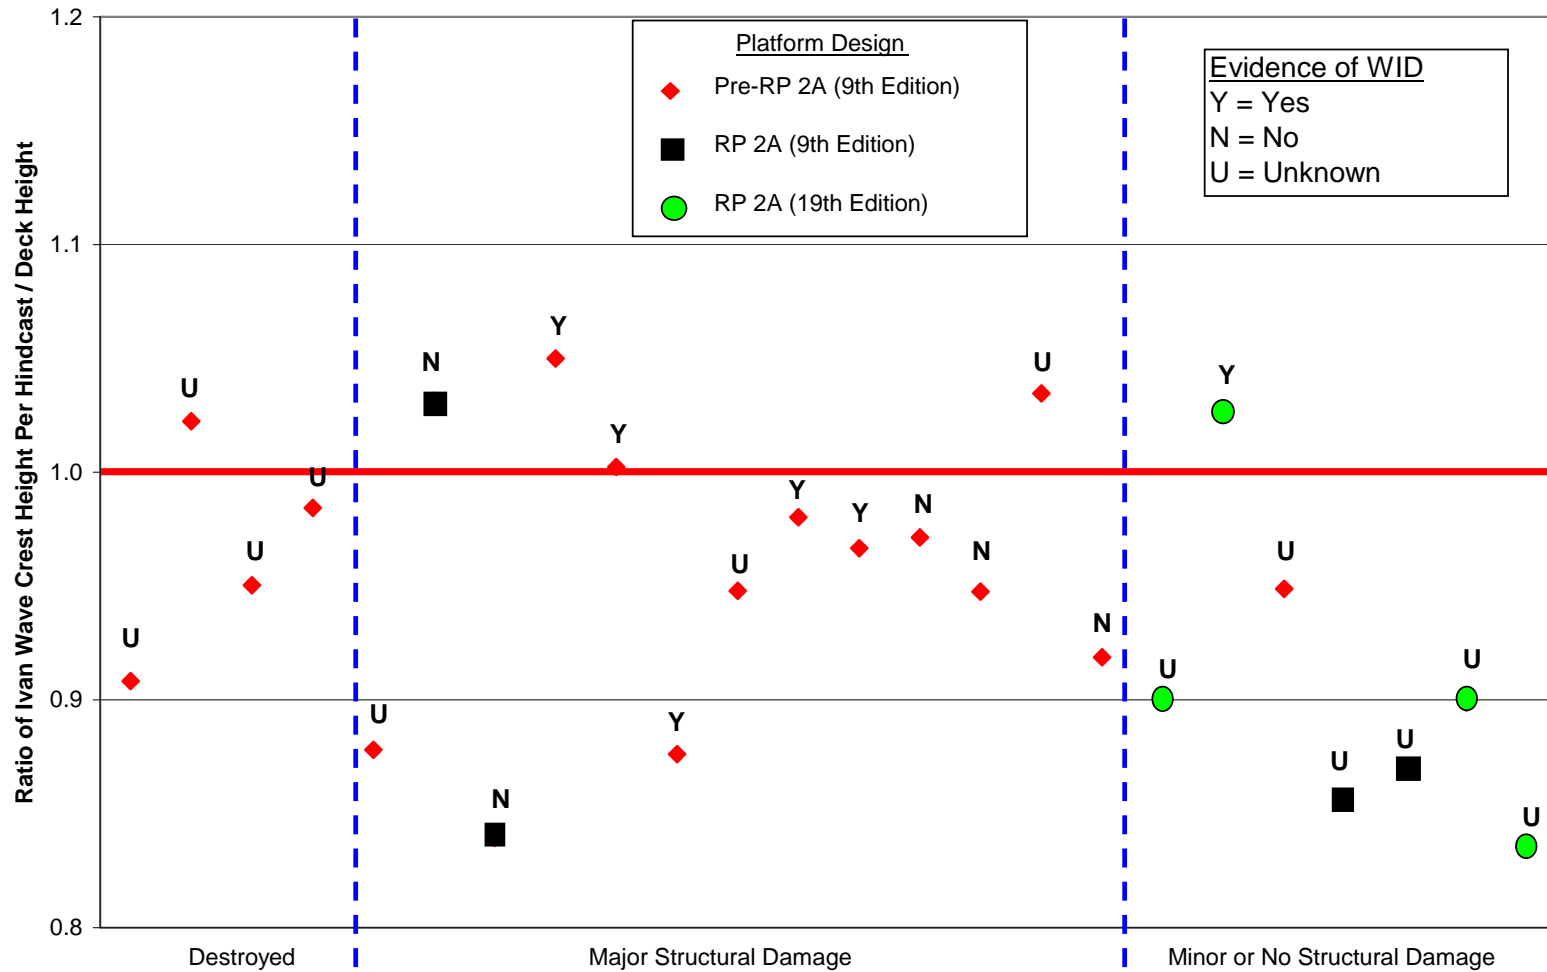
Figure 2.17 – Ratio of Ivan Hindcast Wave Crest versus Deck Heights

In Figure 2.17, presents the same information as shown in Figure 2.16, but the platforms that observed wave-in-deck are indicated on the figure. The figure shows there are a significant number of platforms that sustained major damage and reported wave-in-deck but the calculated wave crests from the hindcast are predicted to be lower than the deck heights.

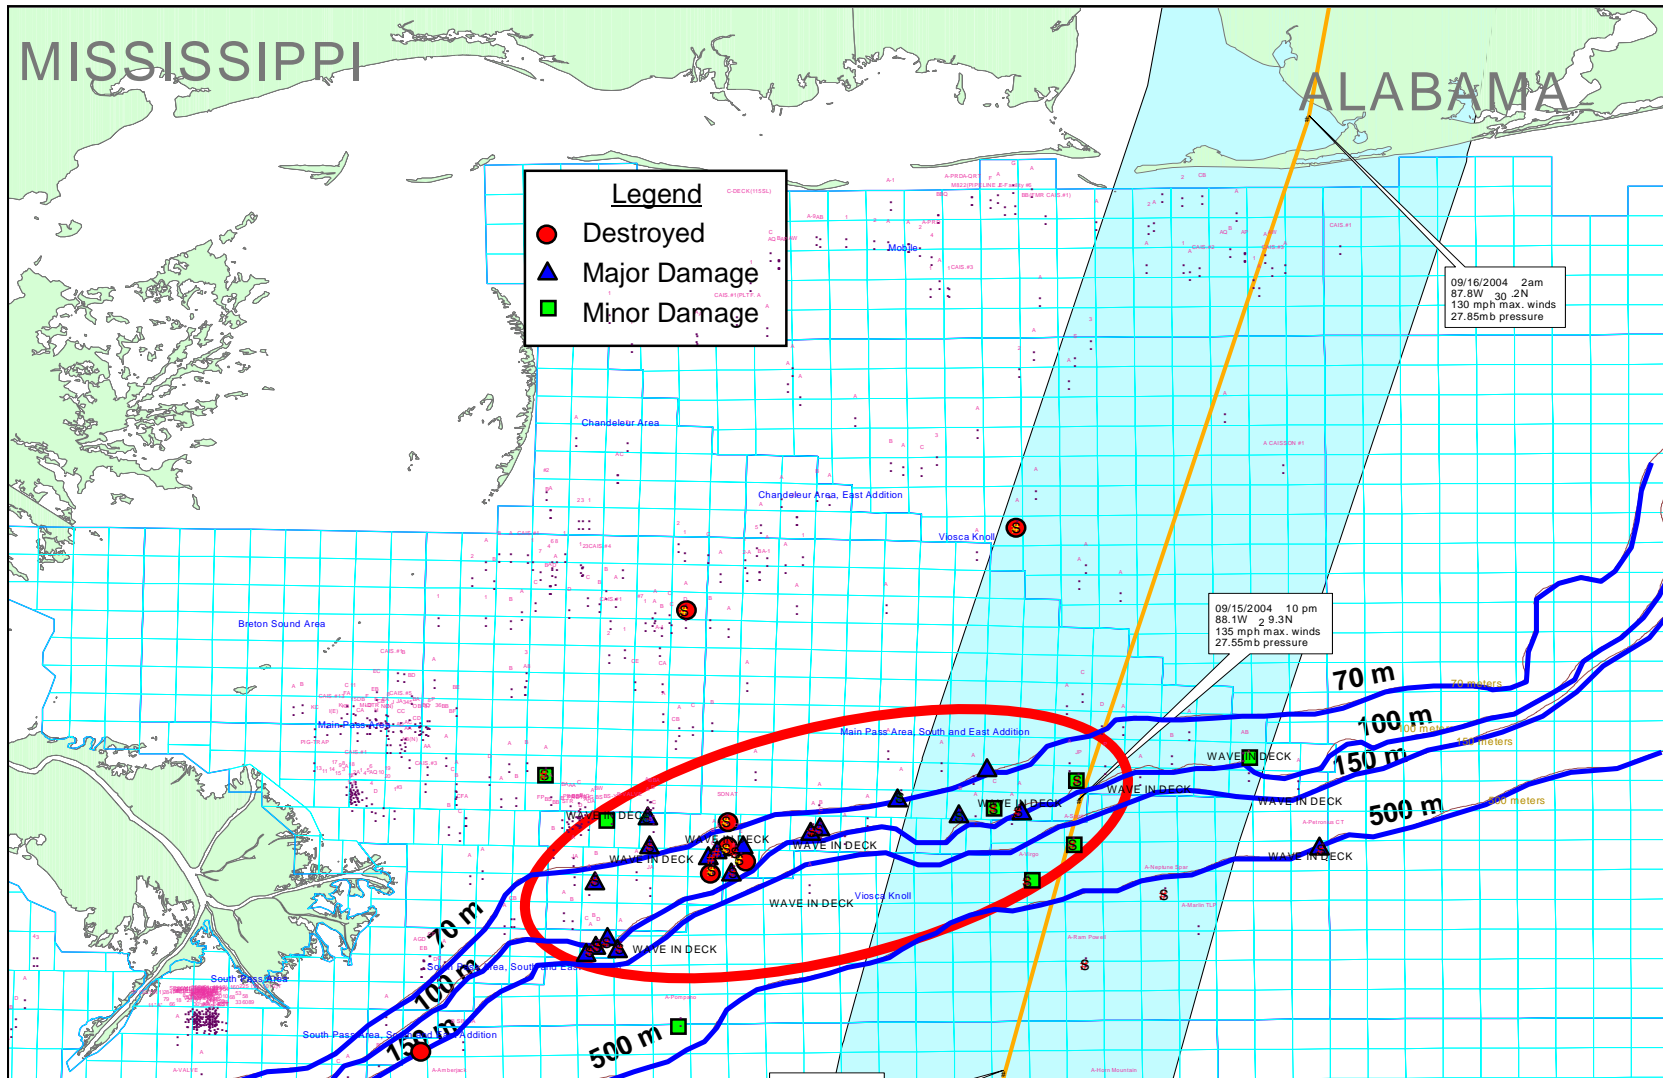
Figure 2.19 – Seafloor Bathymetry and Location of Damaged Platforms

Figure 2.19 shows the locations of the damaged platforms in relation to the seafloor bathymetry. One important factor that stands out when reviewing the figure is the proximity of the damaged platforms to a significant drop in water depth. To the south the water depth drops from approximately 200 feet down to 1600 feet over a relatively short distance. Many of these platforms in this area experienced very high wave crests based on the observed topside damage. The high density of damaged platforms along this seafloor ridge may indicate some form of “shoaling” effect in which the wave crest heights were amplified as they approached the shallower waters of the shelf.

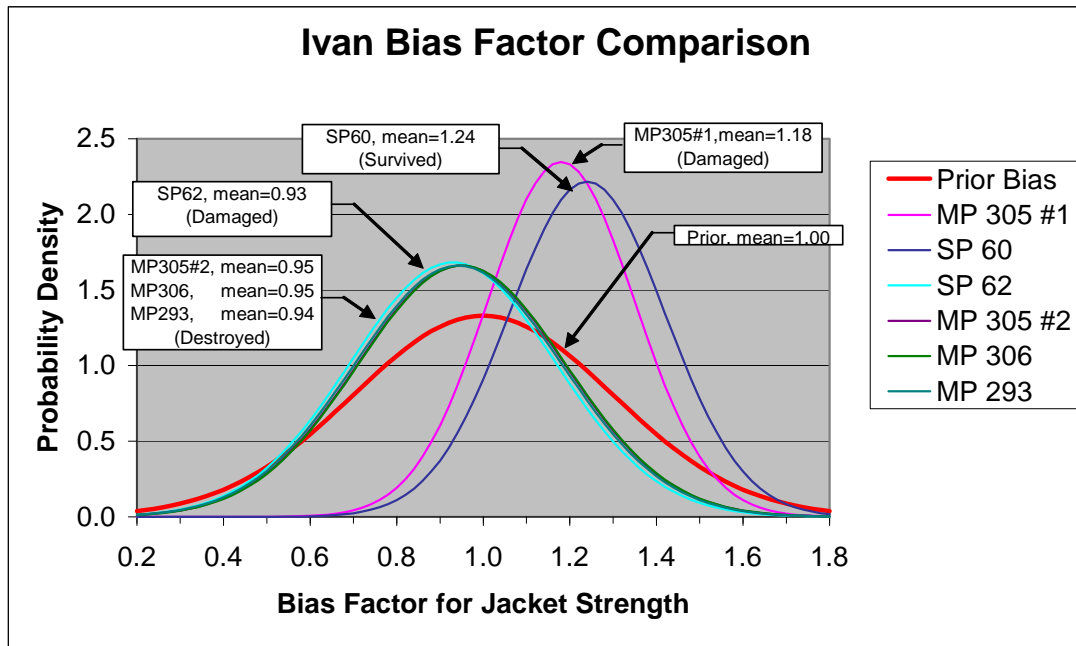
Figure 3.1 - Jacket Bias Factors for Six Platforms Analyzed for Hurricane Ivan

The jacket Bias Factors calculated for the platforms in Table 3.1 are shown in Figure 3.1. The “prior” Bias Factor is also shown in Figure 3.1 with an assumed mean value of 1.0 (no bias) and a COV (coefficient of variation) of 30% [PMB, 1994; PMB, 1996, ABS Consulting, 2004]. The MP305 No.1 platform has a Bias Factor of 1.18 after the Bayesian updating calculation. This is explained by comparing the capacity and the load values for this platform as listed in Table 3.1. For this platform, the maximum base shear during the Hurricane is 5,200 kips, while the ultimate resistance (collapse strength) of the jacket is 4,400 kips. This platform is therefore expected to be destroyed during Ivan, yet it only sustained a few damaged braces.

The Bias Factor for the SP62 Platform is calculated as 0.93, and can be explained similarly as described above. The maximum base shear during Ivan is predicted at 5,900 kips, with the ultimate resistance at 8,500 kips. This platform is therefore expected to survive during Ivan without damage, yet it sustained substantial damage. As a result, the Bias Factor is 0.93 and on the un-conservative side.
